AA-962

Administration Building

Crownsville Hospital Center

# Maryland Historical Trust State Historic Sites Inventory Form

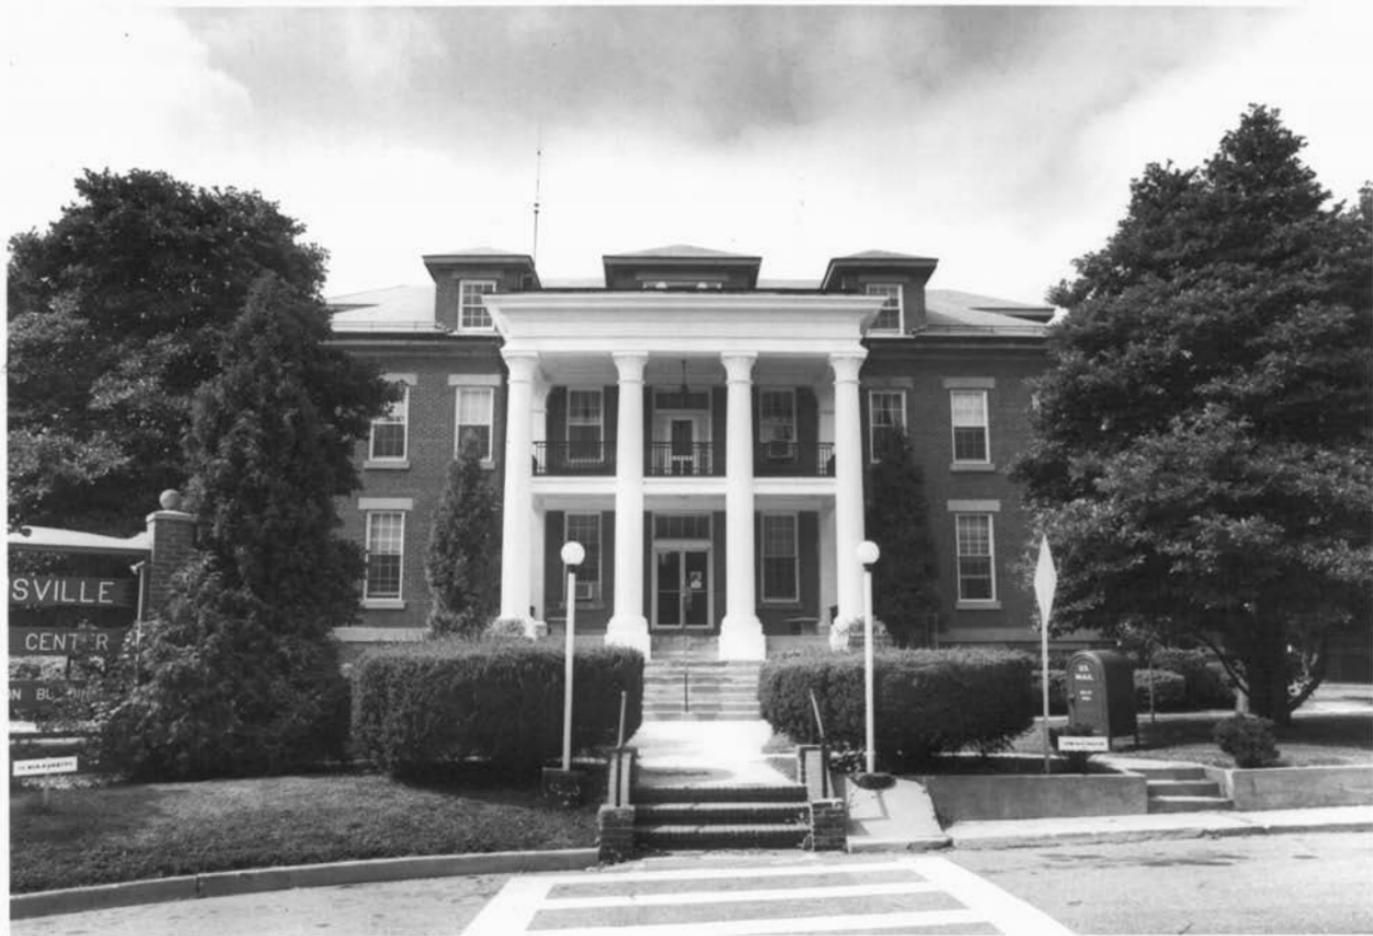
Negatives at MHT  
East

The east facade displays a two story portico which incorporates the central three bays of the wall. Four concrete order support the flat roof and the delevoped entablature of the portico. The columns and pilasters rest on a brick foundation which provides access to the altered entrance door. The original door treatment of a transom, single door and sidelights. A fresh coat of paint enhances the concrete.

Administration Building  
Crownsville Hospital Center  
Crownsville, Maryland

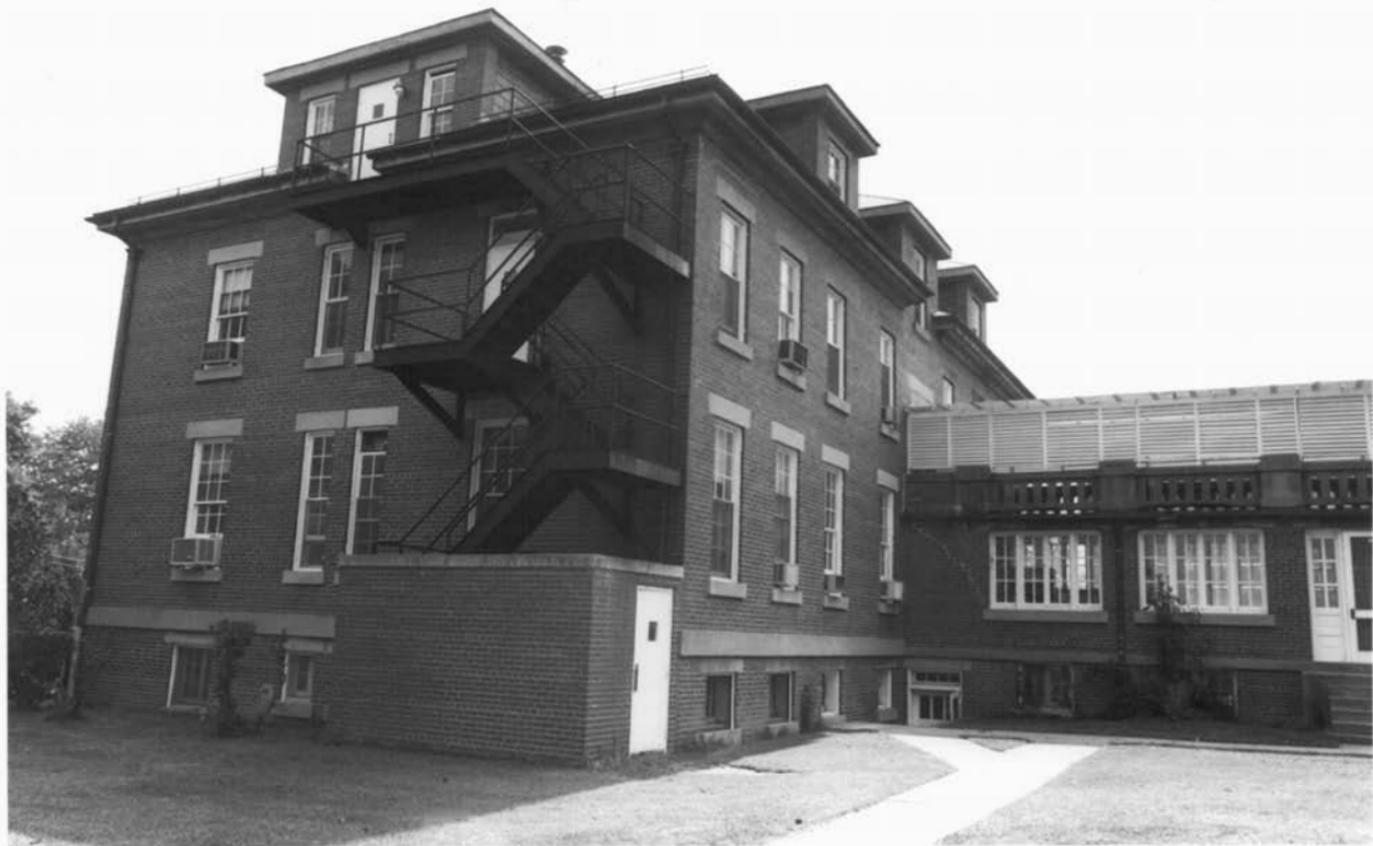
Administration Building  
Crownsville Hospital Center  
Crownsville, Maryland  
Don Jewell, 9/86  
Negatives at MHT  
Northwest
