AA-965

Laundry Building

Crownsville Hospital Center

# Maryland Historical Trust State Historic Sites Inventory Form

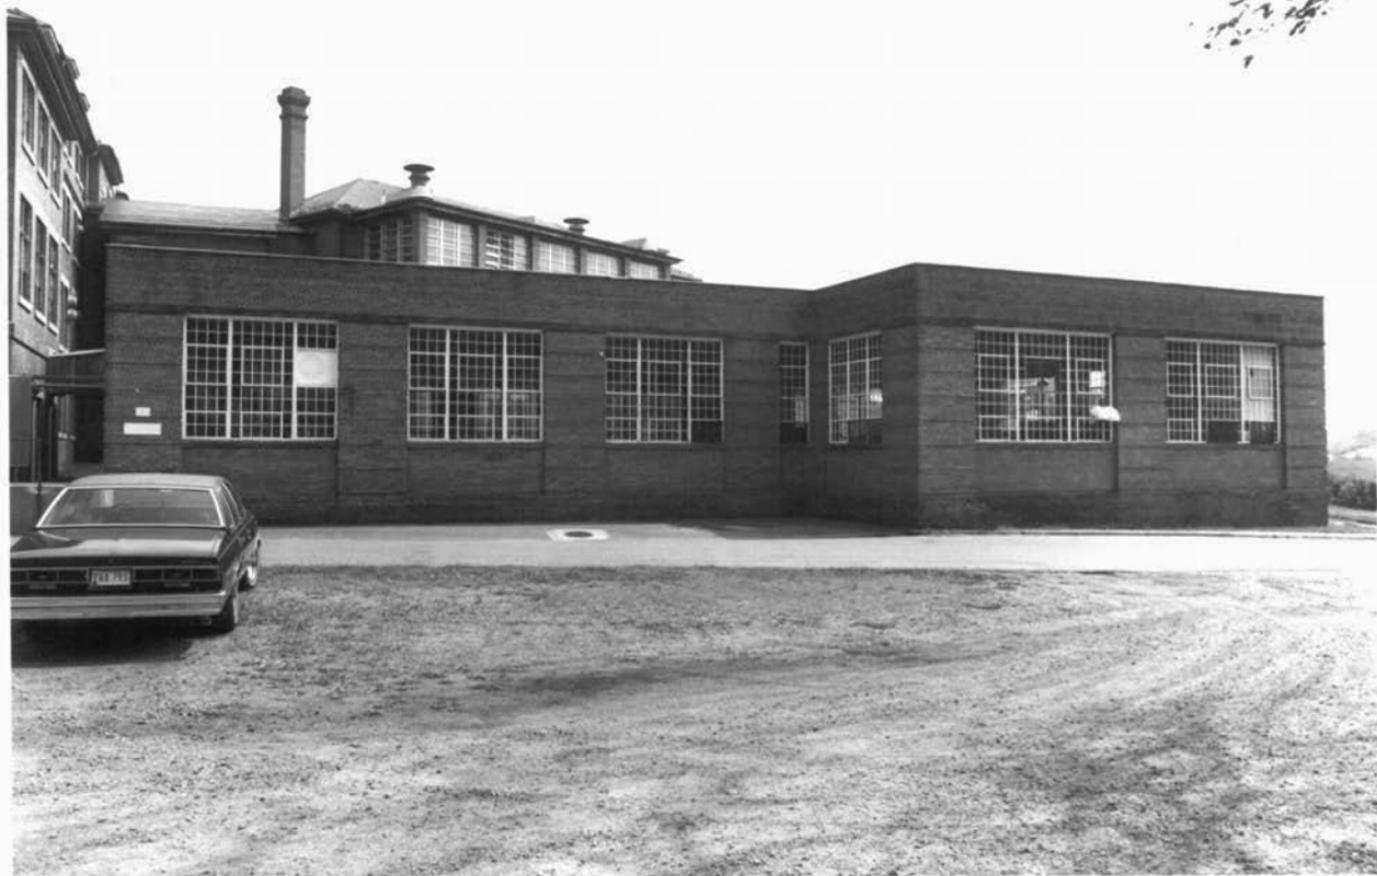
West

The Laundry Building is a one-story, common bond brick structure which stands in the shadows of the southern wing of the "A" Building. The two buildings are connected by a shorter one story, enclosed corridor that attaches to the east wall of the Laundry Building. The shape of the building is an unproportional L plan with basic measurements of five bays wide and four bays deep. Though difficult to distinguish, the main facade faces north.

The building displays limited ornamentation. The terra cotta cornice is the most noticeable feature as it caps the wall and draws attention to the flat roof. Brick sills detail the steel projecting windows. The single sash pattern is seven panes by nine panes with the central panes that open. Bricks form pilasters which separate the windows as well as quions that decorate the corners. Two wooden doors appear on the north face. One is original while the second has been fashioned out of an original window.
