AA-997
William Downs House
Glen Burnie
Private

MARYLAND COMPREHENSIVE STATE HISTORIC PRESERVATION PLAN DATA

7. Description

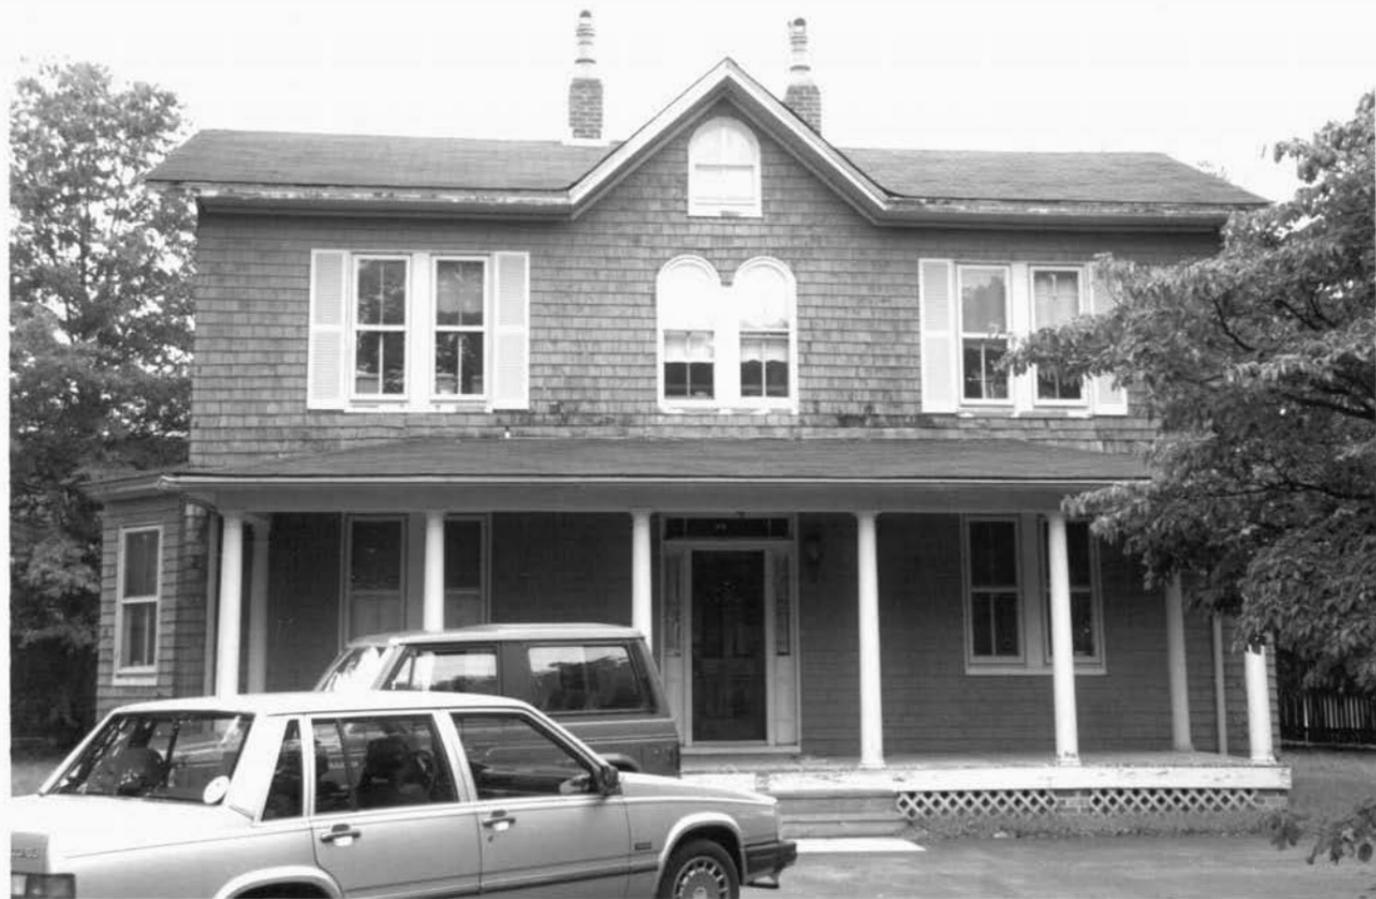
Photo 1 of 4

This frame dwelling is a two-and-a-half story, three-bay, single-pile, center-hall plan, cross-gable, I-house, with a two-story rear ell. Both sections are sheathed with wooden shingles that are painted blue. The gable-roof has overhanging eaves and a boxed cornice. The two interior chimneys, one on either side of the cross-gable, are topped with decorative terra cotta chimney pots.

Fenestration on the principal facade is evenly spaced and arranged in pairs. Windows are two-over-two, double-hung sash types. Second-story, center-bay windows are accented with segmental casings. This motif is reiterated in the cross-gable window that illuminates the attic level. The centrally located front door displays six panels, and is surrounded by a multi-paned transom and sidelights. The entrance is protected by an open, hipped-roof porch. The porch, which spans the full width of the front facade, is supported by six, Doric-stye columns that rise up to engage a wide cornice board.

Photo By Sherri M. Marsh, September 1996
Negative at MD SHPO
EAST Elevation

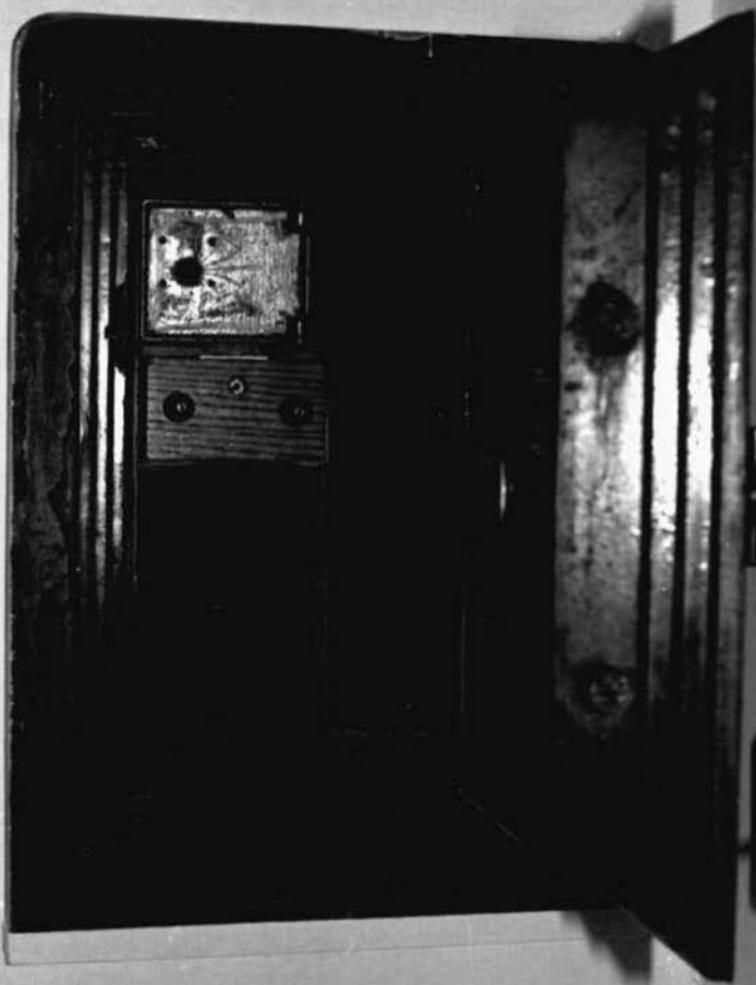
Photo 3 of 11

WALL SAFE

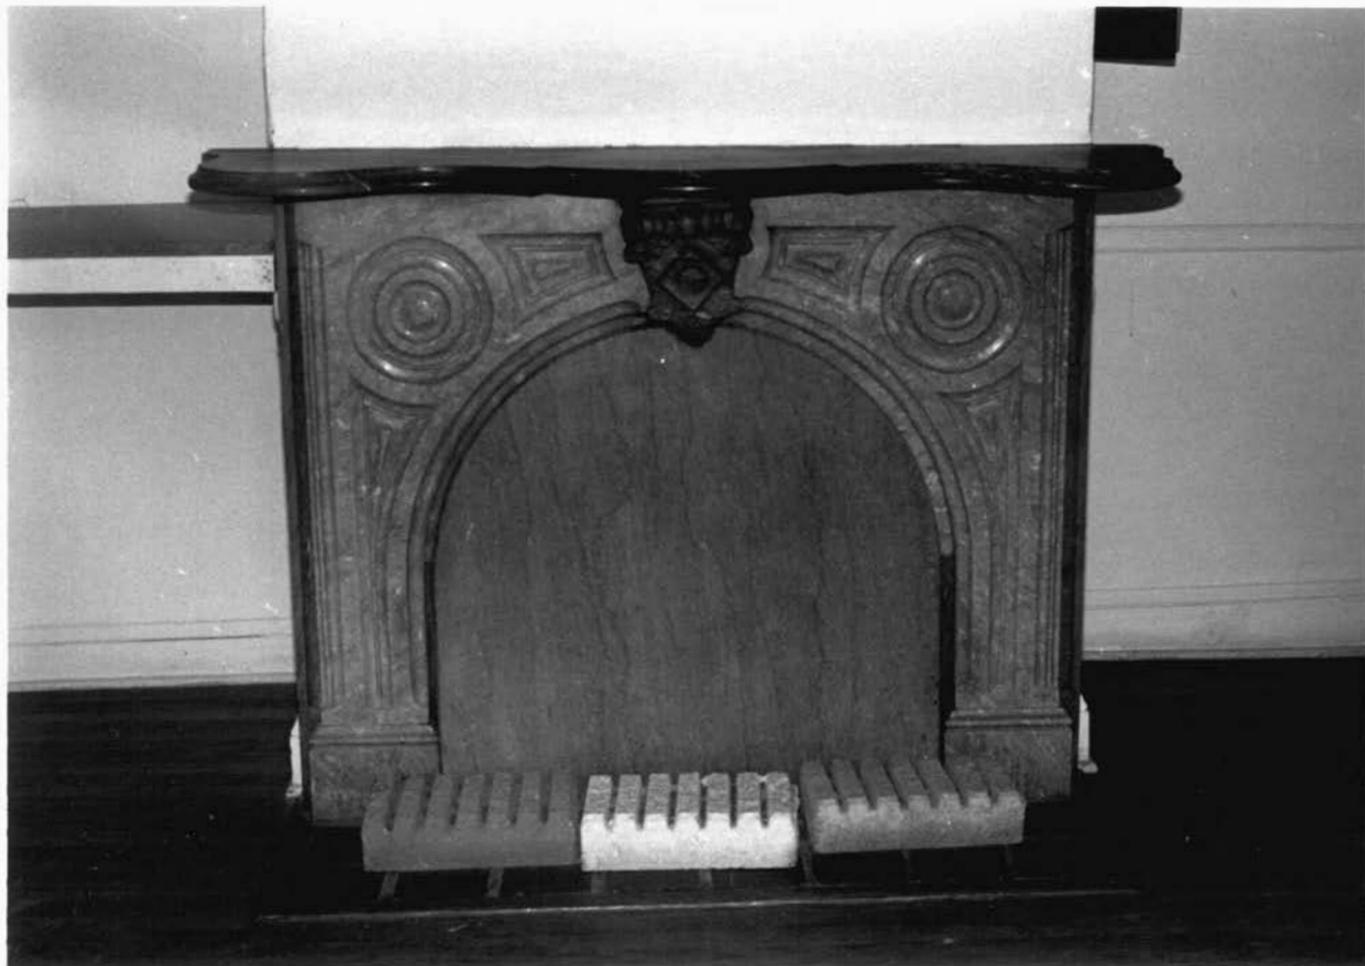
Photo 4 of 4

The building's interior is renovated but historic fabric survives including the newel and balustrade, door and window surrounds, two marble mantels, and a built-in wall safe. The building's floorplan, which on each floor features one large room on either side of a center hall and two rooms on each level of the ell, is original.

FIRE PLACE
