Maryland Historical Trust State Historic Sites Inventory Form

historic Central Savings Bank

street & number 1-3 East Lexington Street _____ not for publication

Survey No. B-1128

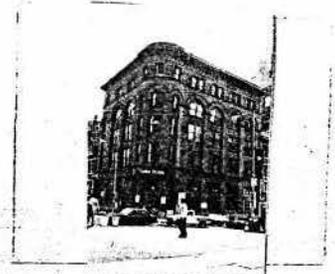
Description: The Central Savings Bank is a Romanesque, red brick and brownstone commercial building located on the southeast corner of Charles and East Lexington Streets. The building is five stories high, not including the basement, and it has a flat roof. The building measures three bays wide on East Lexington Street, with one large bay at the corner. This building features such architectural details as elaborate cornices, Corinthian entablatures, geometric moldings, semicircular arches with pronounced archivolt trim, and an elegant portico at the main entrance embellished with Sullivanesque details. Presently the building is occupied by the Radio Shack, and although the interior has been altered, the exterior is in excellent condition and has not been significantly altered since 1891.

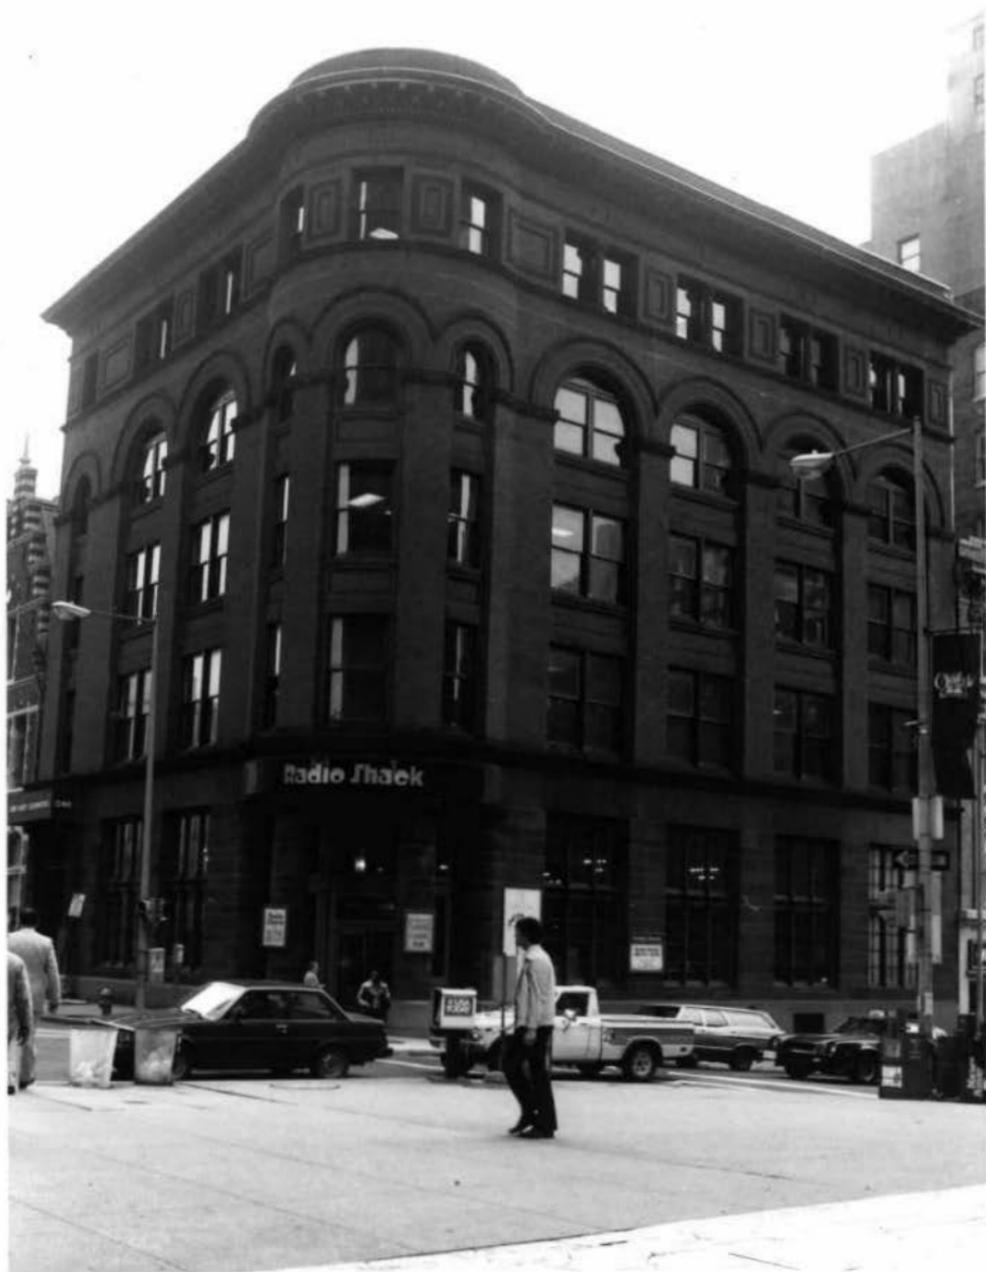
B-1128

Central savings Bank
1-3 East Lexington Street
Financial District - Metrocenter Survey
Baltimore (City), Maryland
Photo: Fred B. Shoken
Date: October 1983
Neg. Loc.: Maryland Historical Trust
Northwest Corner

The curved bay that makes up the corner contains a line of large rectangular curved windows with smaller, one over one windows on either side. The corner facade contains all the same details as the west facade, except less detail appears in the transoms around the fourth story windows.

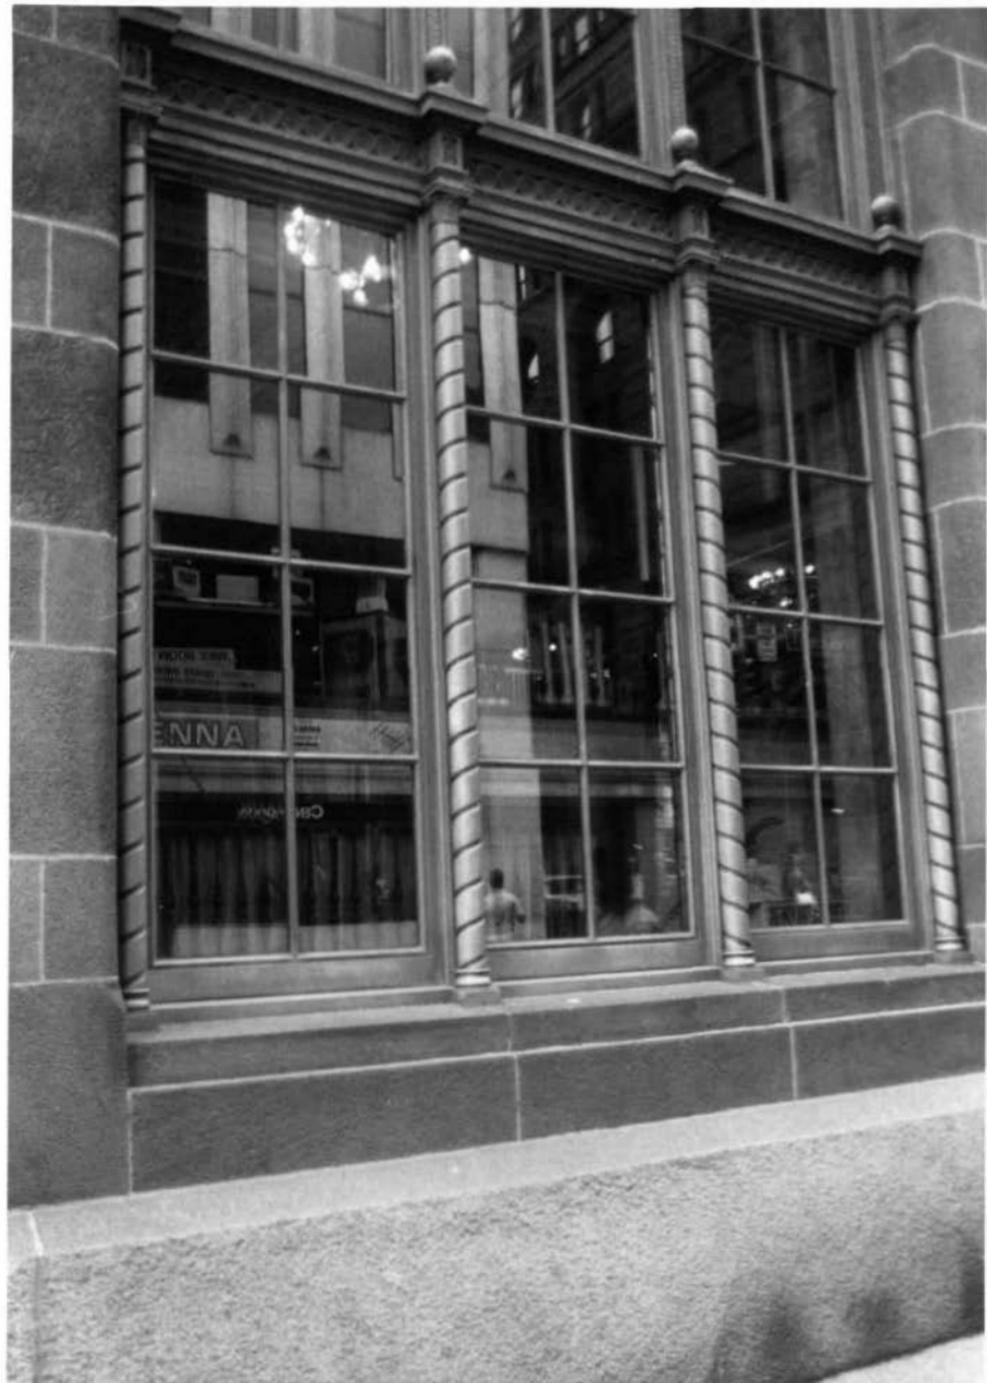
B-1128

Central Savings Bank
1-3 East Lexington Street
Financial District-Metrocenter Survey
Baltimore (City), Maryland
Photo: Caroline Hardy
Date: July 1985
Neg.loc.: Maryland Historical Trust
Detail of windows

Dividing the first and the second story windows is a heavy elaborate cornice. Bead and reel and egg and dart molding is located at the frieze with square billet molding above it and a two foot wide band of leaf molding with small scroll details between the leaves. Double, one over one windows with embellished frames appear on the second and third stories. More square billet molding runs in a narrow band between the second and third story windows. The common bond, red brick facade begins on the second story and continues up to the roofline. The window frames are a much darker, reddish brown color.

The considerably more detailed, fourth story facade contains semi-circular, recessed arched, double, one over one windows with pronounced archivolt trim above each window. A one and a half foot wide band of elaborate leaf details and small, square billet molding runs between the windows on the fourth story. Projecting, curved pediments with modillions and dentils appear on the semicircular arches along the fourth story. On the springing line, between the fourth story windows, there are projecting grotesques. The rectangular frames around the double, one over one windows are all elegantly detailed with geometric molding.

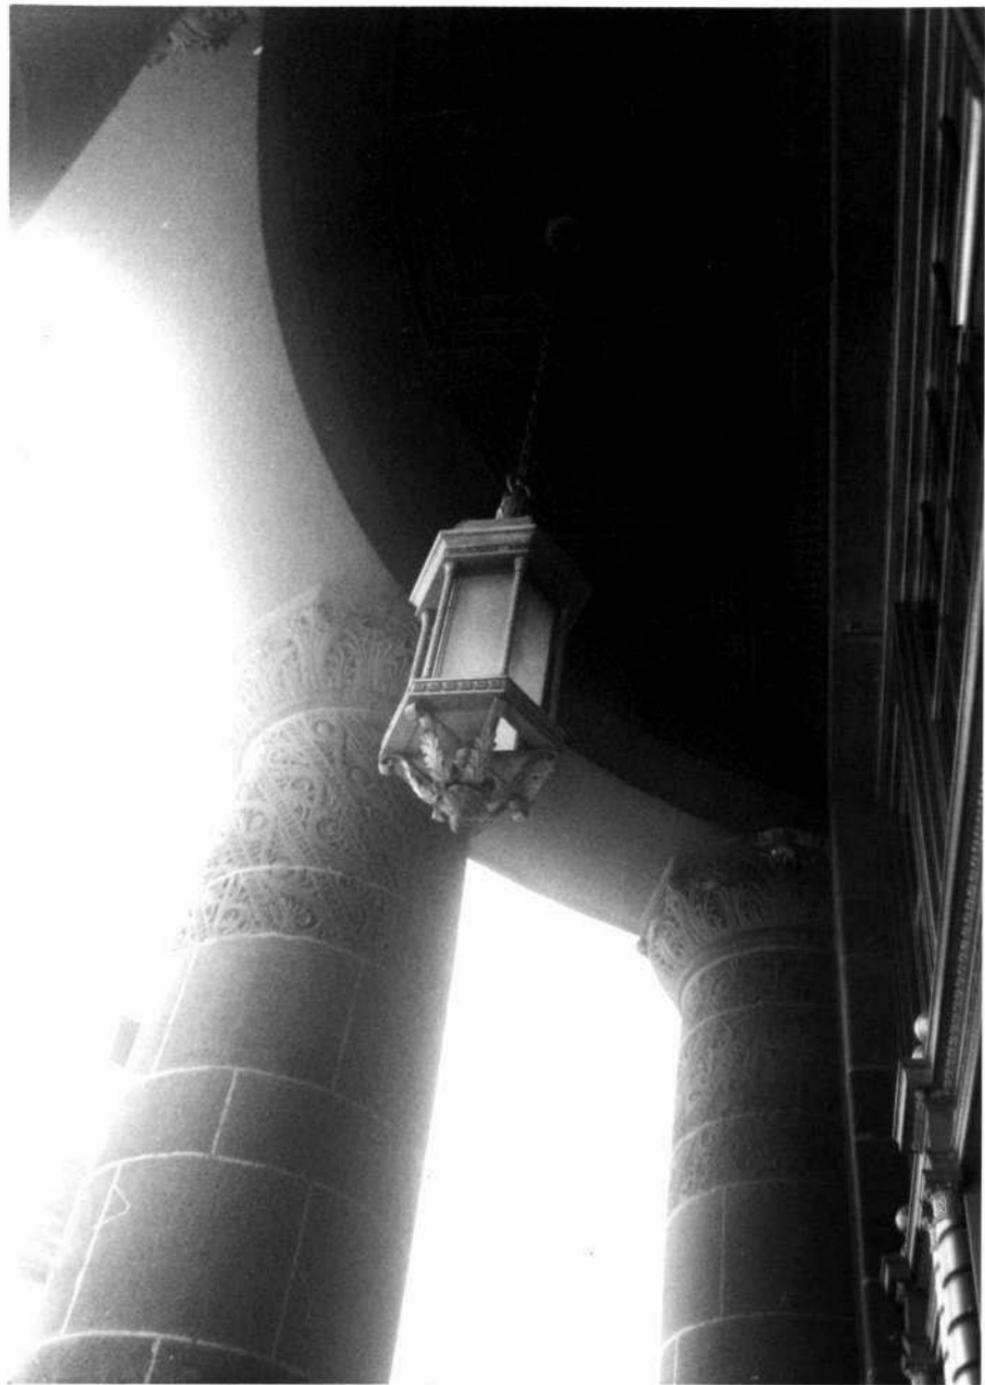
B-1128

Central Savings Bank
1-3 East Lexington Street
Financial District-Metrocenter Survey
Baltimore (City), Maryland
Photo: Caroline Hardy
Date: July 1985
Neg.loc.: Maryland Historical Trust
Detail of portico ceiling

The main entrance to the Central Savings Bank is on the southeast corner of East Lexington and Charles Streets. There is a semicircular open portico in front of the main entrance which consists of two large, detached Corinthian columns with intricate Sullivanesque scroll detailing engraved at the top quarter of the columns. These two columns extend the height of the first story. The entrance consists of double doors, flanked by large rectangular windows, divided into several smaller panes. These windows are flanked by narrow attached columns with roping design. The wood framing around the doors and windows and the lantern hanging from the portico ceiling are all painted gold. The doors and windows are flanked by attached columns, enhanced with egg and dart molding and a narrow, partially hidden, embellished cornice above. Three rectangular windows appear above the cornice, and in the central window, above the door, is a "Radio Shack Computer Center," sign. Square billet and other geometric moldings appear on the portico ceiling.
