Demolished - 1991  
Maryland Historical Trust  
State Historic Sites Inventory Form

Survey No. B-2070

historic Johnston-Wolf House

street & number 113 West Franklin Street

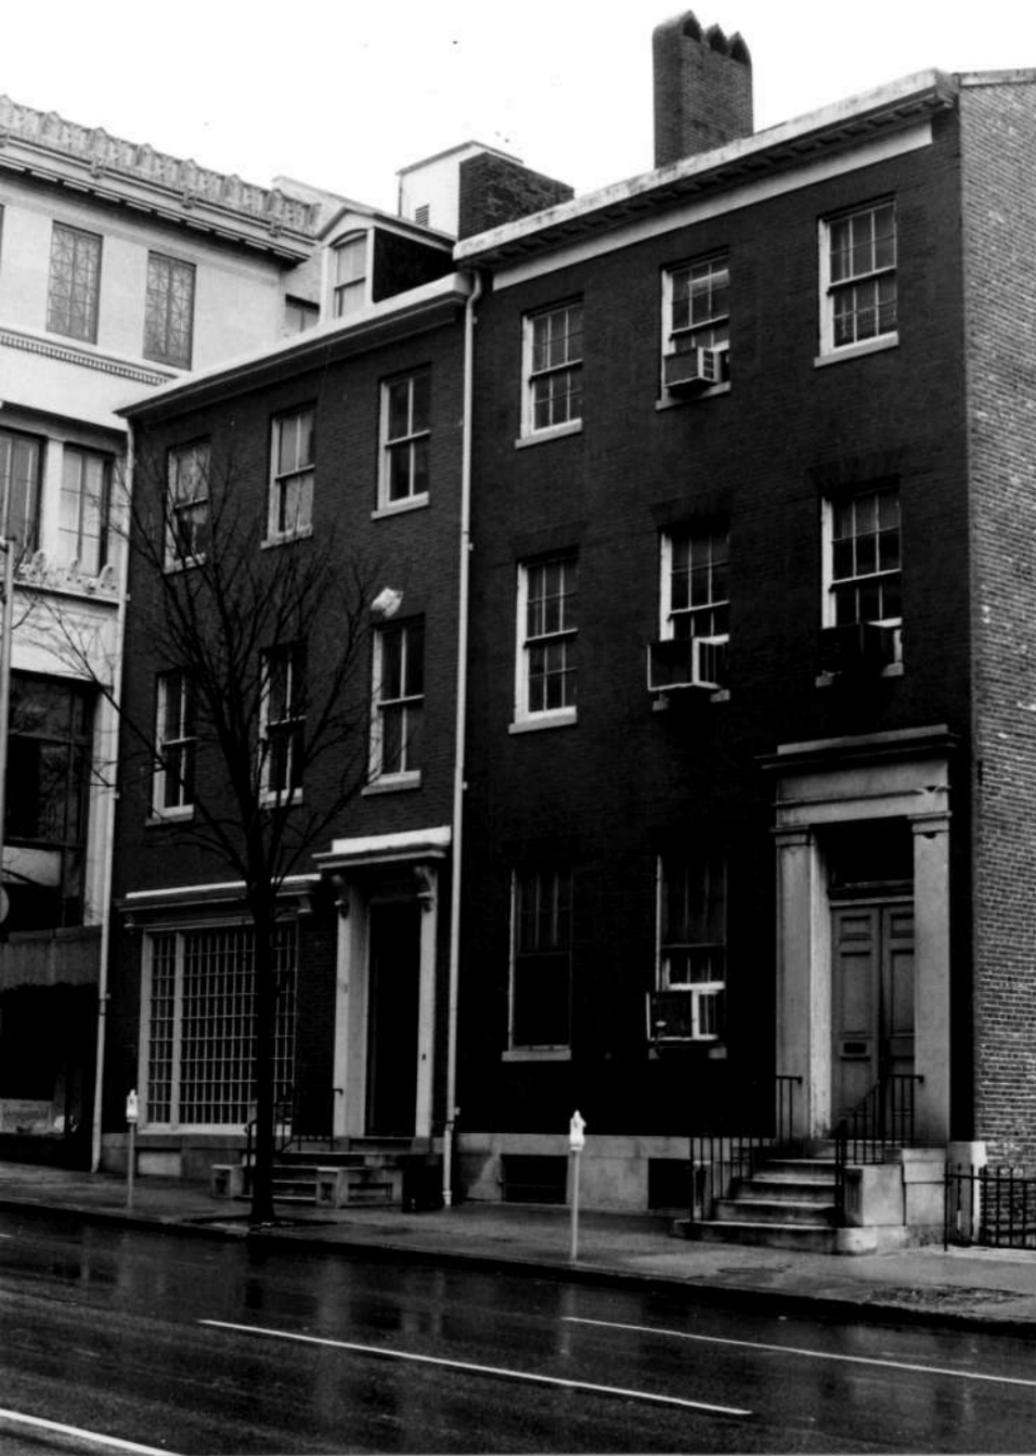
- B-2070-1 VIEW SOUTHEAST LOOKING AT NORTH ELEVATIONS OF JOHNSTON-WOLF HOUSE AND MOALE-McGLANNAN HOUSE (B-2071).
- B-2070-2 VIEW SOUTHWEST LOOKING AT EAST AND NORTH ELEVATIONS OF THE ENOCH PRATT FREE LIBRARY GARAGE (B-2068A), THE JOHNSTON-WOLF HOUSE AND THE MOALE-McGLANNAN HOUSE (B-2071).
- B-2070-3 VIEW NORTH LOOKING AT SOUTH ELEVATION.
- B-2070-4 VIEW NORTHEAST LOOKING AT WEST AND SOUTH ELEVATIONS.
- B-2070-5 DETAIL OF PRINCIPAL ENTRANCE, NORTH ELEVATION.
- B-2070-6 DETAIL OF PRINCIPAL ENTRANCE, NORTH ELEVATION.
- B-2070-7 DETAIL OF FOYER, NORTH ELEVATION.
- B-2070-8 DETAIL OF CEILING MEDALLION, FIRST FLOOR HALL.
- B-2070-9 DETAIL OF CEILING MOLDING, FIRST FLOOR, NORTHEAST CHAMBER.
- B-2070-10 DETAIL, VIEW NORTH OF DOOR SURROUND, FIRST FLOOR ELL.
- B-2070-11 VIEW SOUTH OF STAIRCASE, FIRST FLOOR HALL.

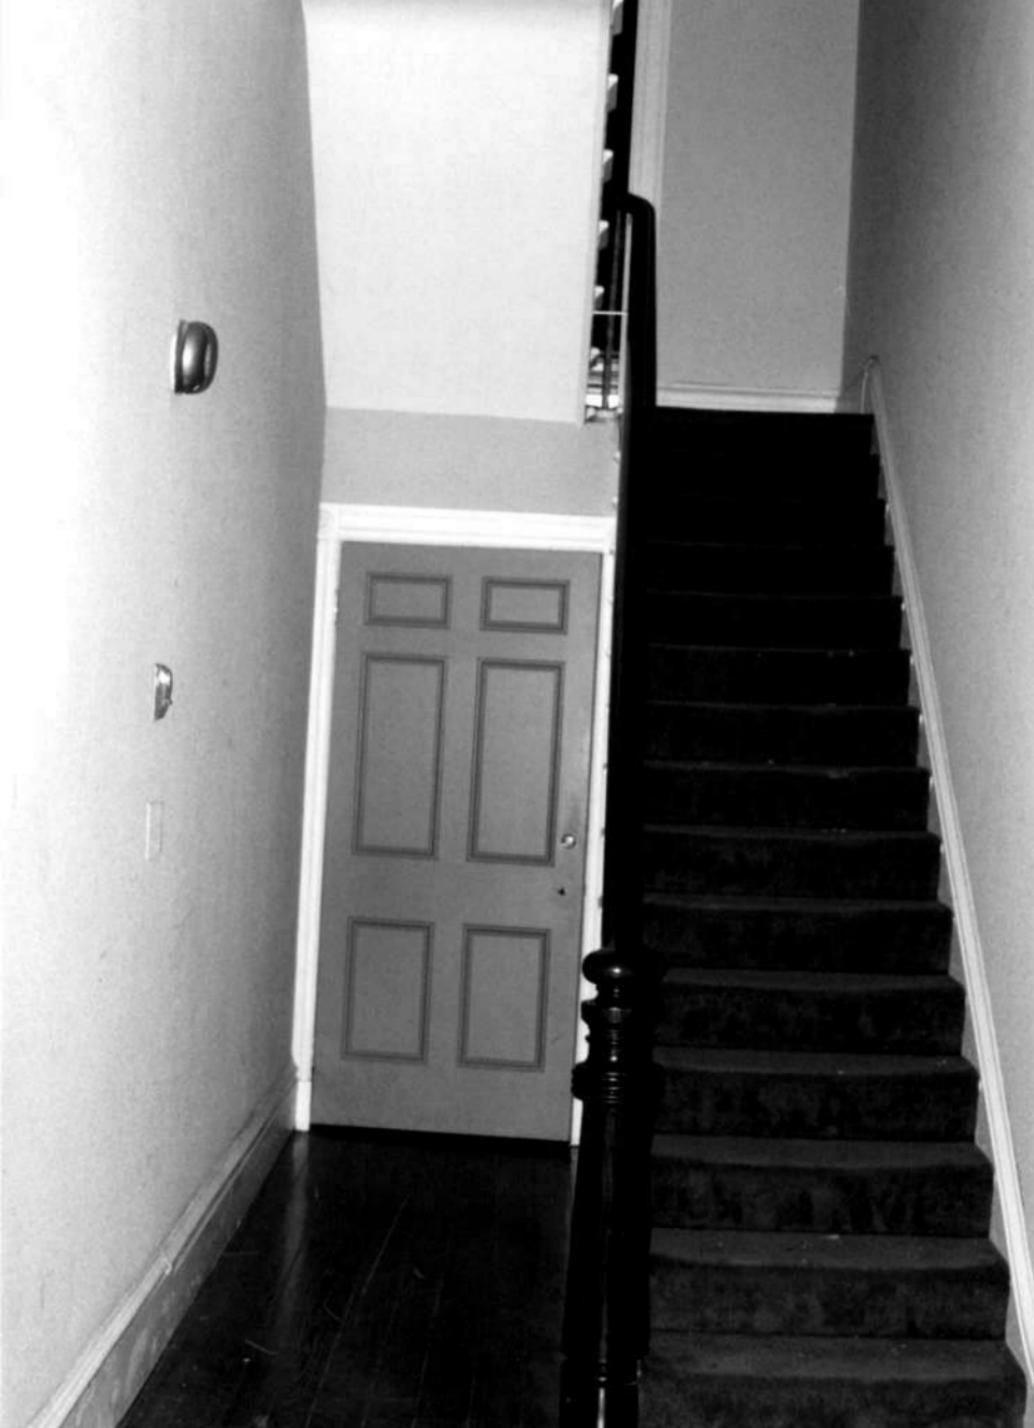
B-2070-11

The hall extended the depth of the principal block. An open dog-leg stair located along the west interior wall originally rose the height of the three principal floors. This stair was enclosed at the second story level in 1983. The staircase included a turned newel, simple tapered balusters, and a delicate three-quarter round handrail. The stringer was accented by wave molding. This wave motif was repeated at the third floor level and also was incorporated in the panelled foyer to the building.

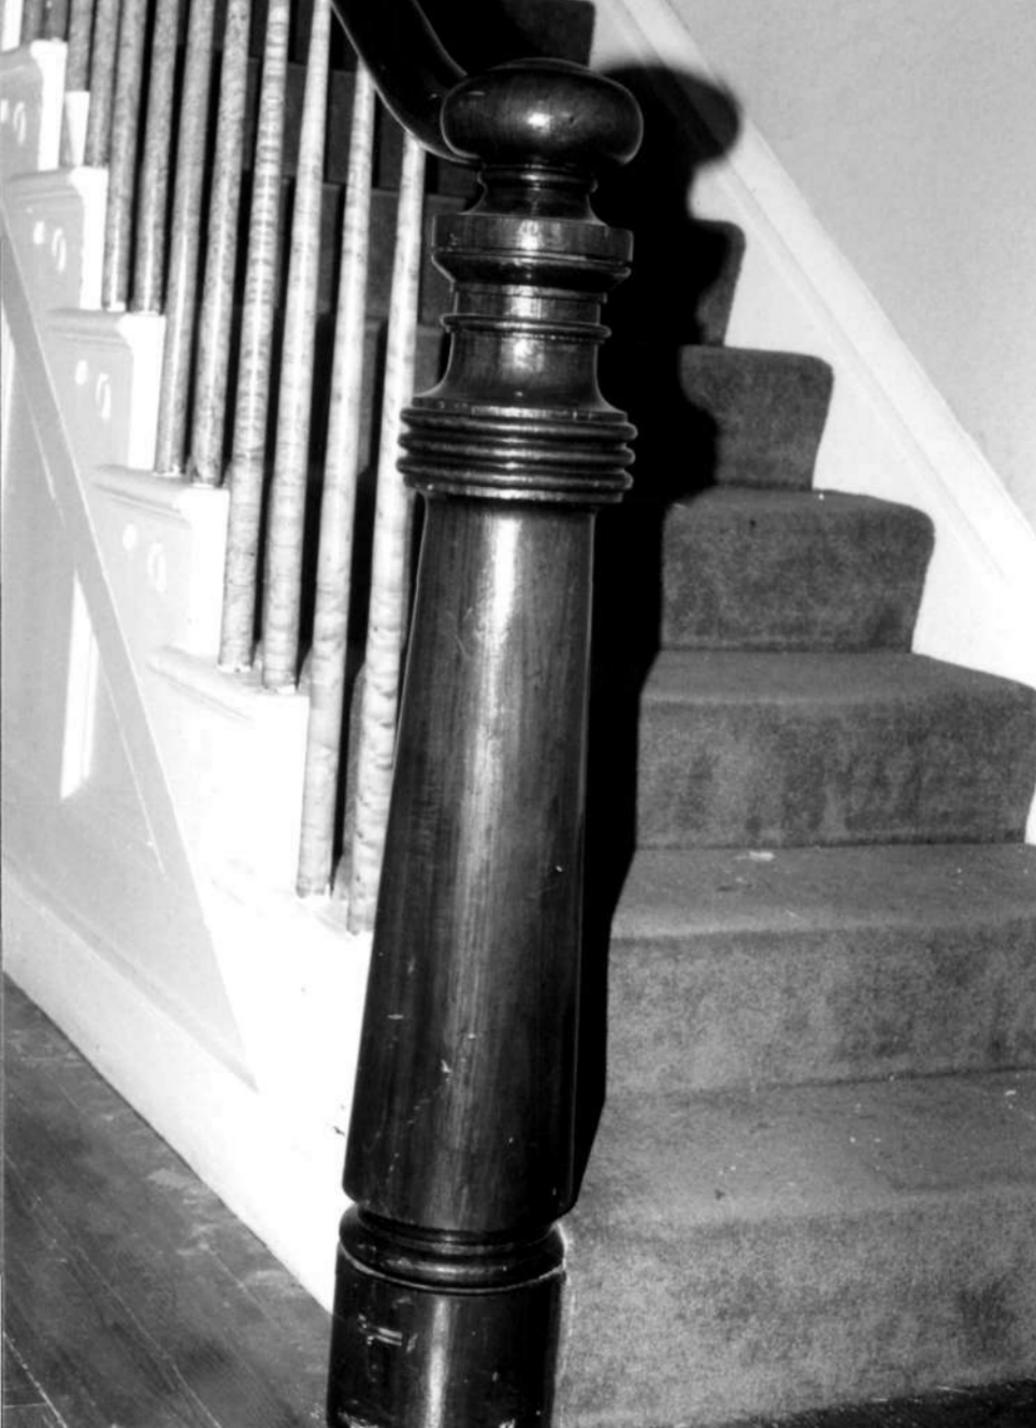
- B-2070-12   DETAIL, NEWEL, FIRST FLOOR HALL.
- B-2070-13   DETAIL, STRINGER, FIRST FLOOR HALL.
- B-2070-14   DETAIL, BALUSTER AND HANDRAIL, FIRST FLOOR STAIR LANDING.
- B-2070-15   DETAIL, NORTH WALL WINDOW, SECOND FLOOR NORTHEAST CHAMBER.
- B-2070-16   DETAIL, SOUTH WALL WINDOW, SECOND FLOOR SOUTHEAST CHAMBER.
- B-2070-17   DETAIL, EXTENDED STAIR STRINGER, THIRD FLOOR.
- B-2070-18   DETAIL, NORTH WALL WINDOW, THIRD FLOOR.
- B-2070-19   DETAIL, SOUTH WALL WINDOWS, THIRD FLOOR.
- B-2070-20   DETAIL, SOUTH WALL WINDOWS, ATTIC.

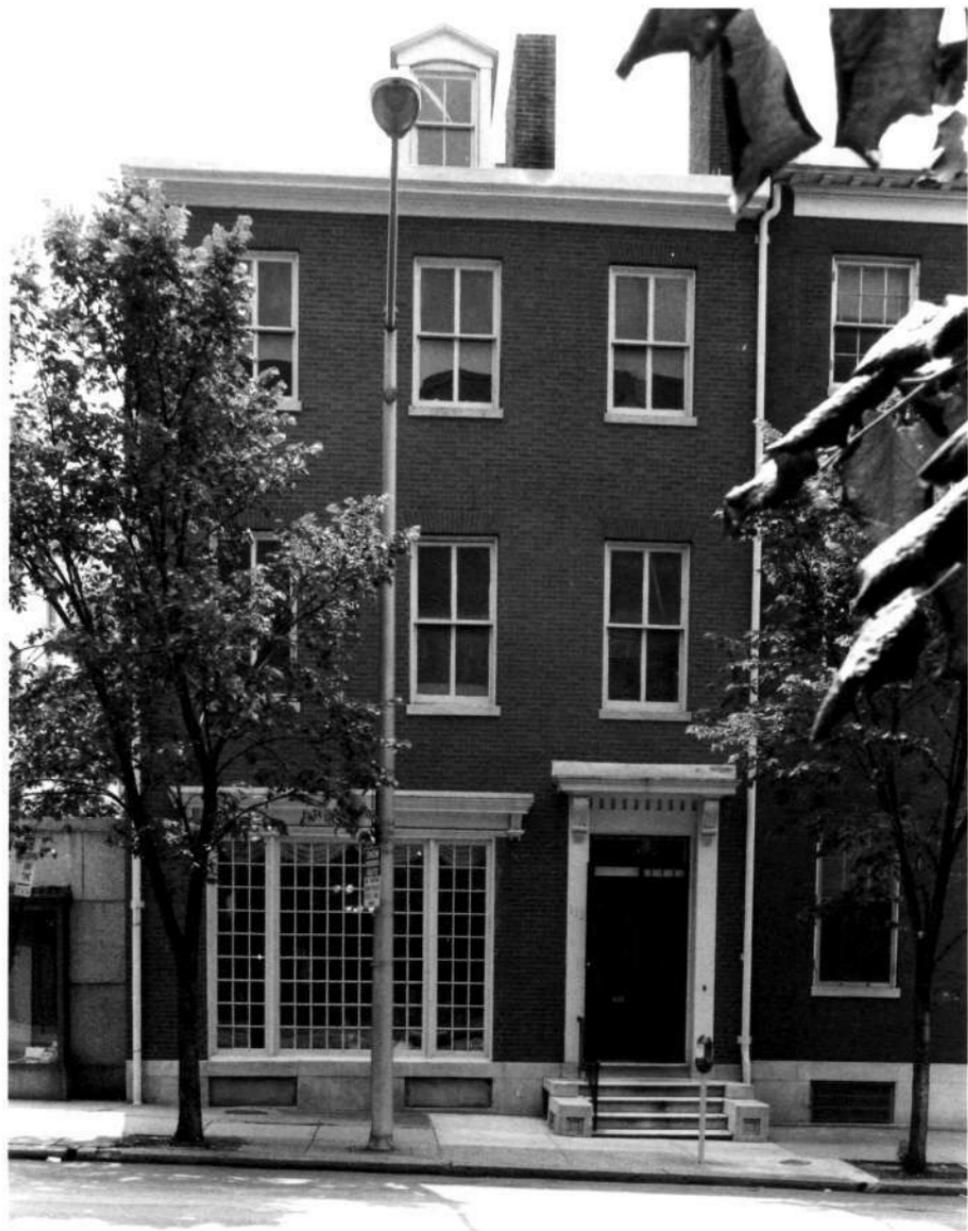
Description: The three-bay facade is Flemish bond. The first floor has a large three-part display window with multiple lights. The small cornice hood has geometric brackets at each end. The window is a recent replacement of the former display window. The doorway has a short run of marble steps, simple pilasters, and a dentil hood with console brackets. The upper floors have 2/2 windows, gauged jack arches, and stone sills. The cornice is very plain and narrow. The gable roof has a single central dormer with a 1/1 window. Adjoining the house on the east is a one-story display window used by the Enoch Pratt Free Library. It is essentially a stone faced block with a duplicate of the projecting first floor windows on the main elevation of the Library Central Building.

Johnston-Wolf House B-2070  
113 West Franklin Street  
Cathedral Hill - Metrocenter Survey  
Baltimore (City), Maryland  
Photo: Janet Davis  
Date: August 1984  
Neg. loc.: Maryland Historical Trust  
North elevation  
1/2
