Baltimore Metrocenter Survey
Cathedral Hill Area
Joshua Royston House
113 West Mulberry Street
B-2156

Joshua Royston House B-2156
113 West Mulberry Street
Cathedral Hill - Metrocenter Survey
Baltimore (City), Maryland
Photo: Janet Davis
Date: August 1984
Neg. loc.: Maryland Historical Trust
North elevation

**NOMINATION FORM
for the
NATIONAL REGISTER OF HISTORIC PLACES, NATIONAL PARKS SERVICE**

COMMON:
Wrenn, Lewis and Jencks (architects) 113 W. Mulberry St.

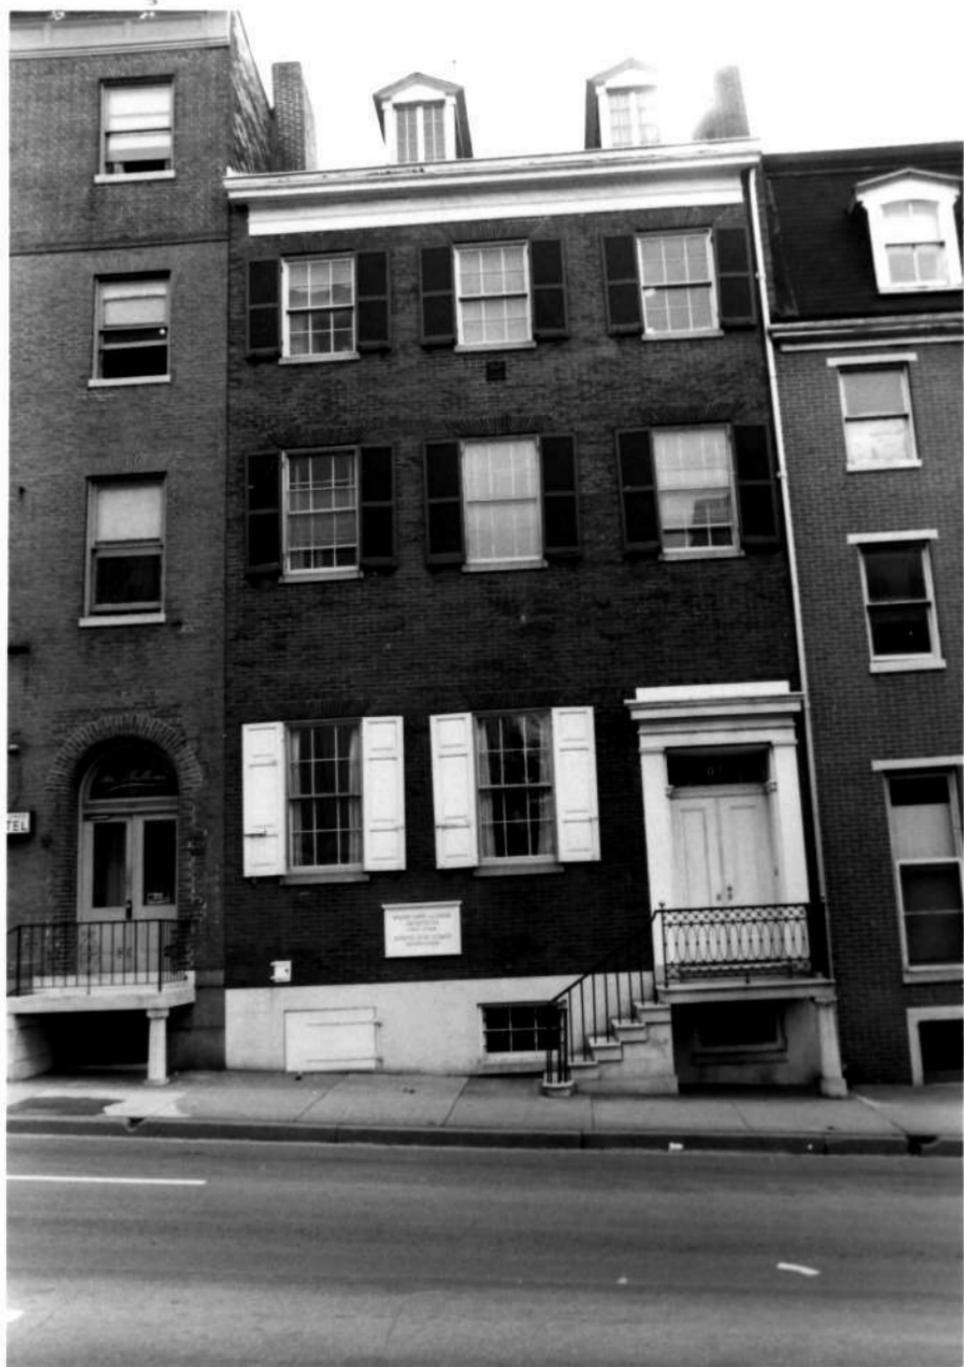
113 West Mulberry Street
4-2-579-11

113 West Mulberry Street is an example of a nineteenth-century Georgian style urban rowhouse typical of the dwellings of Baltimore merchants at the turn of the nineteenth-century. Both the interior and the exterior are in good condition. The building is quite well preserved and has few renovations, additions, or subtractions. The stone foundation is exposed at the front elevation and has two six-paned awning windows and one doored former coal-chute window. The brickwork is of running bond with the window lintels of flat brick arches. The house is a wood frame, with exterior brick bearing walls. Five marble steps and a stoop supported on one end by a marble column service the front entrance. The stairs and stoop are edged with an original iron railing with brass finials. The fine wrought iron railing ends in a cage on the first half circle step. There two brick chimneys, one on each party wall, of simple brick construction.
