POPPLETON HISTORIC STUDY

B-2498

<u>Block</u>	<u>Lot</u>	<u>Address</u>
185	69-61	1101-1117 W. Lexington Street

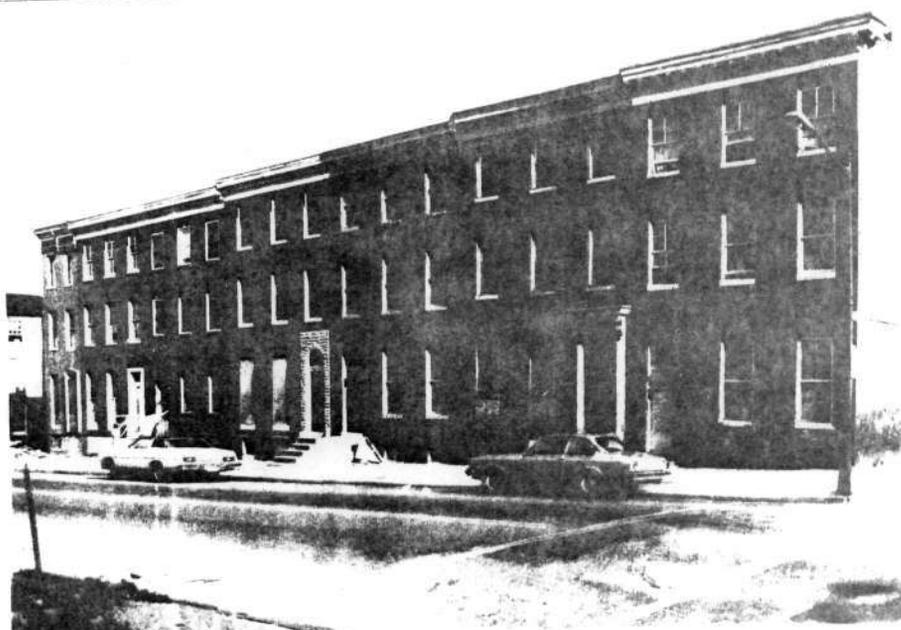
B-2498
1101-1117 W. Lexington Street
Block 185 Lots 061-069
Baltimore City
Baltimore West Quad.

The west end of a long terrace. The houses are generally in poor condition but the essential form of the row survives and is worthy of rehabilitation. Numbers 1107-1115 are a matched group -- cornice is uniform, severe in design, dentils; only 1115 has original door surround. All have large back buildings seriously deteriorated. Number 1113 has round-headed windows at first and second floor which appear to be replacements for flat arches. Formstone door surround at 1111 is a blemish and should be removed.

Numbers 1115, 1111, 1105 are vacant and lots at 1103 and 1101 are vacant. These houses are part of a long terrace of varied periods and style, but one possessed of interest and visual impressiveness. Excellent house-to-house scale and stands well against school and church across-street. Lexington Street is wide, busy; needs street trees.
