POPPLETON HISTORIC STUDY

B-2504
MAG#0425045404

<u>Block</u>	<u>Lot</u>	<u>Address</u>
185	111-117	116-128 N. Schroeder Street

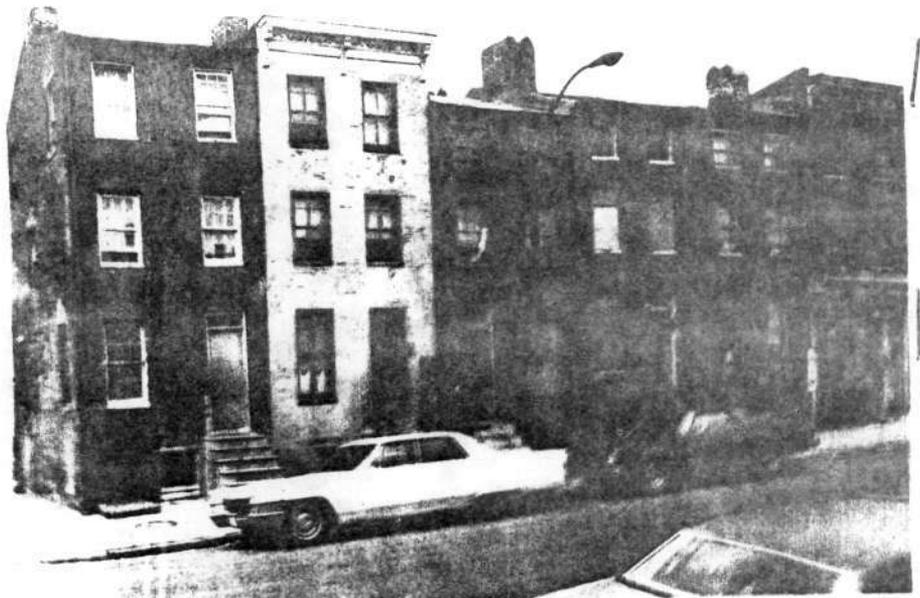
Number 116 bears the marker "Kandscha Place." A pleasantly scaled terrace which should be rehabilitated. Number 126 has original store front. The condition of the structures is very bad, with cracked and bulging front walls -- the Schroeder Street side wall of 1001 W. Lexington is bulging hazardously.

Numbers 122, 126 are vacant. Wide but not busy street; needs street trees. House-to-house scale is good and across-street is okay.
