POTTRETON HISTORIC STUDY

B-2529

<u>Block</u>	<u>Lot</u>	<u>Address</u>
188	43-40	112-118 N. Fremont Avenue

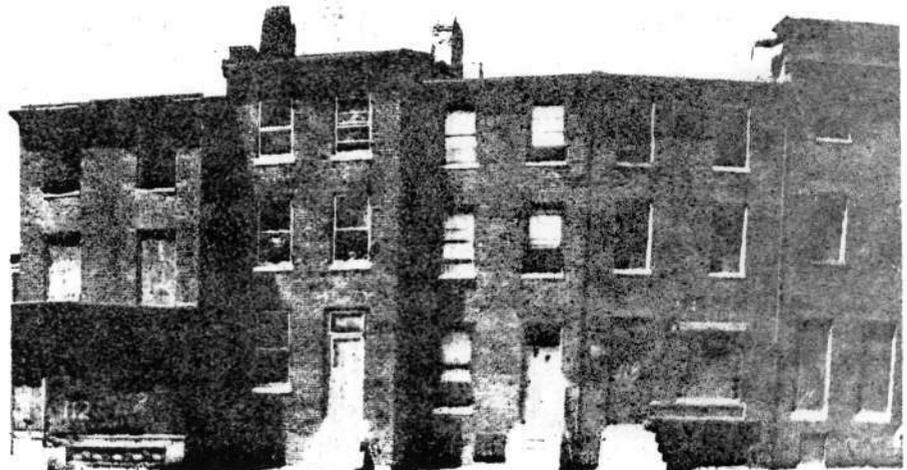
This is essentially good group because of the slipped arrangement of the facades to fit the line of Fremont Avenue. Number 118 has had its facade altered but it is worth rehabilitation. All have back buildings in poor repair.

The row faces Fremont Avenue and Lexington Terrace homes. Numbers 112 and 118 are vacant. Noisy, busy street; needs trees. House-to-house scale good and intact group lends continuity.
