POPPLETON HISTORIC STUDY

B-2561

<u>Block</u>	<u>Lot</u>	<u>Address</u>
200	78-70	1042-1058 W. Baltimore Street

HISTORIC PRESERVATION CERTIFICATION
APPLICATION—PART 1

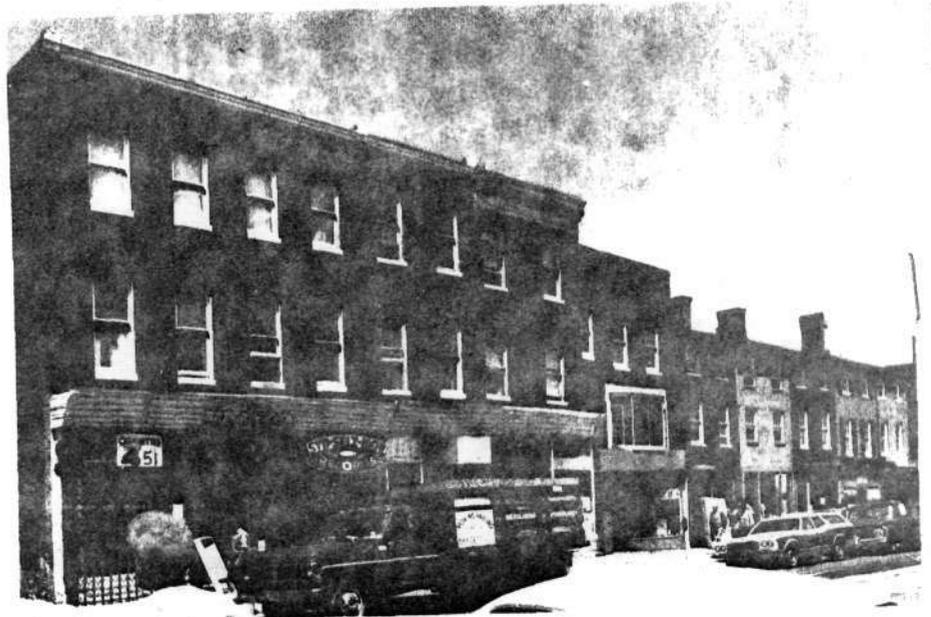
Numbers 1042-1050 are 2½ story gable roof houses; 1042 now serves as a church; 1048 has a new front. Number 1050 has either an extra door or a sallyport. Some of this group have 6/6 windows. Numbers 1052-1058 are original shop fronts which have been gravely damaged by modern revisions.

Very nice house-to-house and across-street scale relationships; could be super shops with residences above (see comment for 1110-1128 W. Baltimore Street).

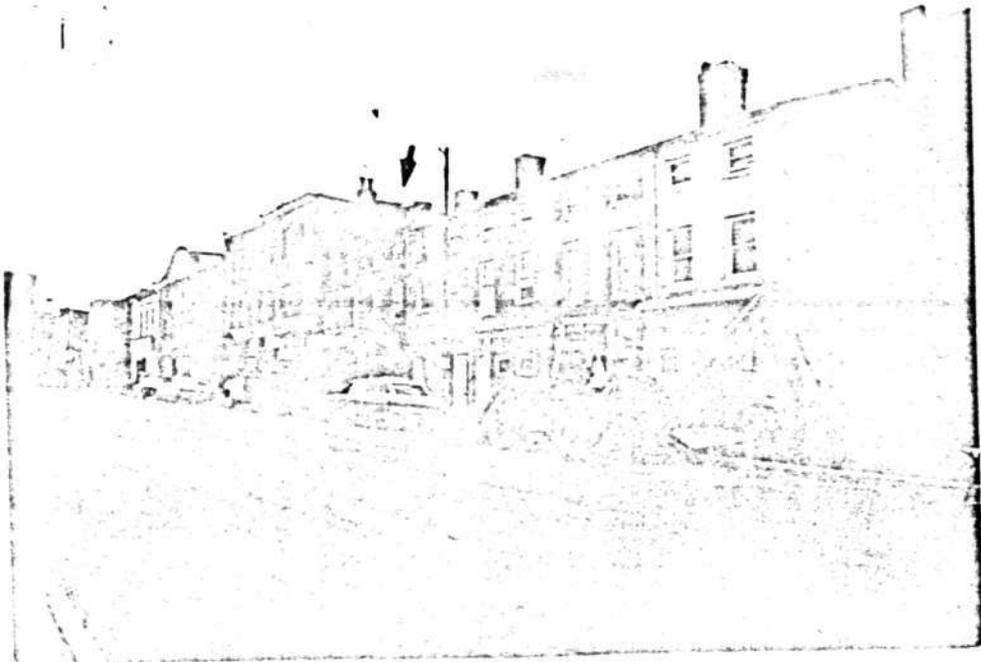
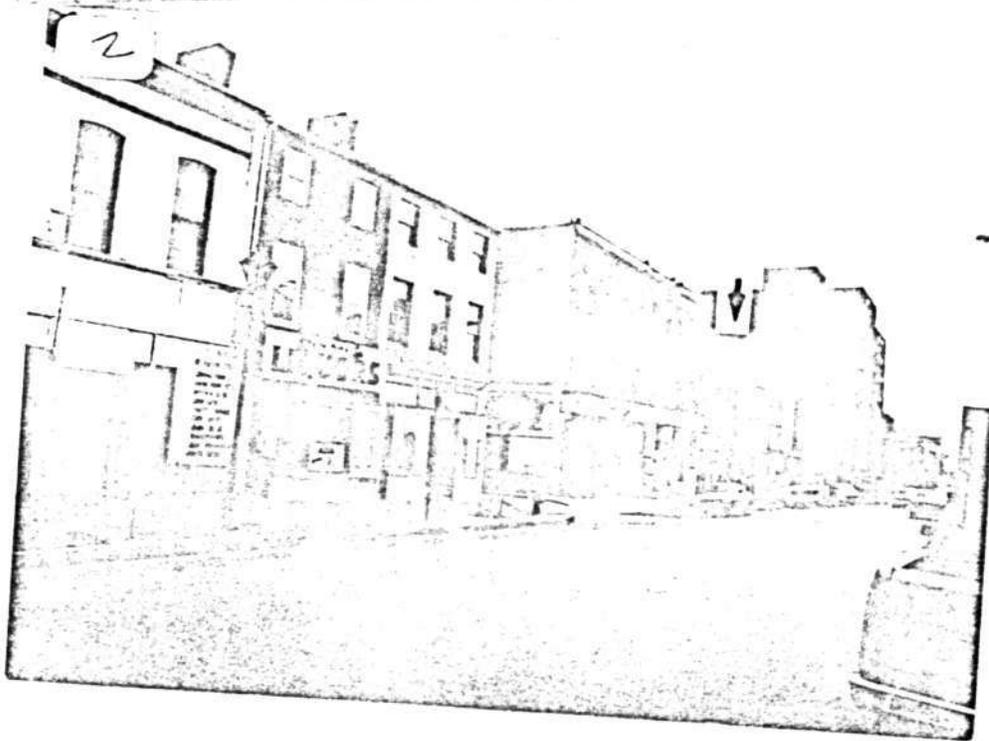
1050 WEST EXCHANGE

1050 West Baltimore Street is a Greek Revival style, two and a half bay wide, two and a half story high, brick rowhouse with a first floor shop. It has a rectangular plan; a gabled roof; and a two and a half bay wide, two story high, shed roofed, rectangular backbuilding.

Facade (south elevation) features include an entrance at each extremity, rectangular window openings with double hung wood sashes; and a corbeled brick cornice.

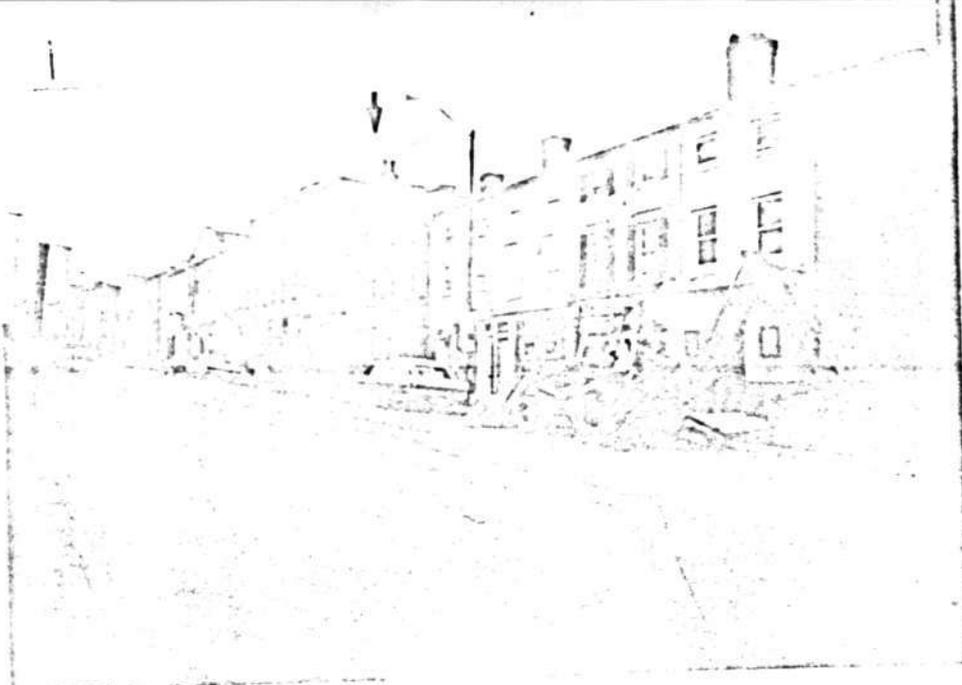
1052 WEST BETHANUE

1052 West Baltimore is a two and a half bay wide, three story high, painted brick attached residence/shop. It has a rectangular plan, a shed roof, and a one and a half bay wide, two story high, shed roofed, rectangular, brick backbuilding. Attached to the north wall of this structure is a five bay long, one and a half bay wide, shed roofed, stuccoed block warehouse. Facade (south elevation) features include a first floor storefront; two entrances in the west bay; a steel, oriel window at the second story; and rectangular, double hung windows at the third floor.

The building has undergone numerous changes; originally it was a Greek Revival style building identical to 1050 West Baltimore Street. Over time, the salleyport adjacent to the west wall was converted into a stairway; the attic floor was enlarged into a full third story; the metal oriel was installed in the second floor; the shopfront was added and then covered with metal; and the warehouse was added to the rear.

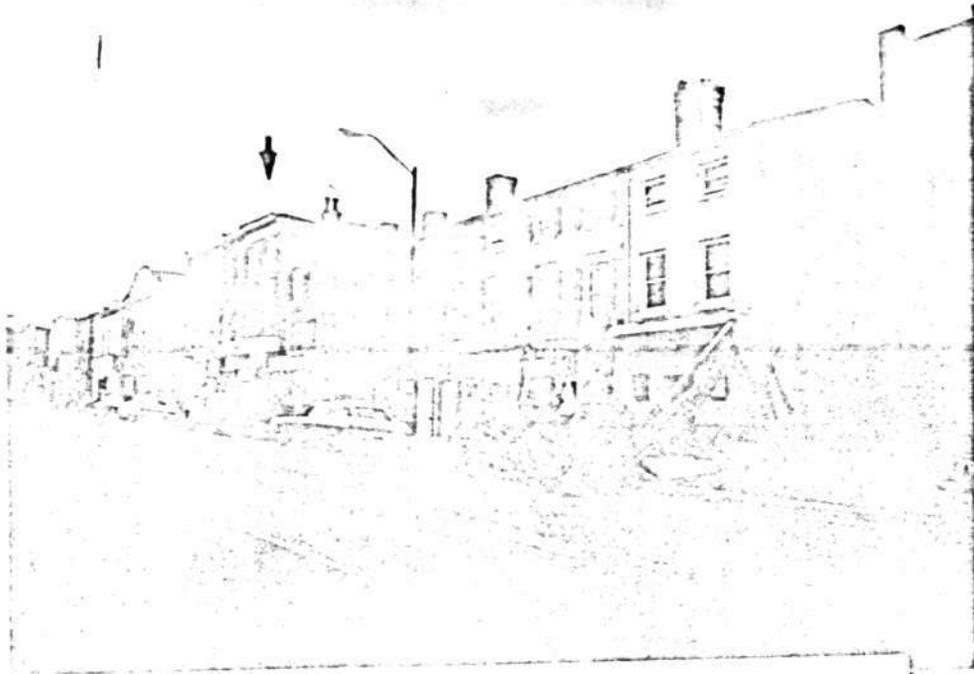
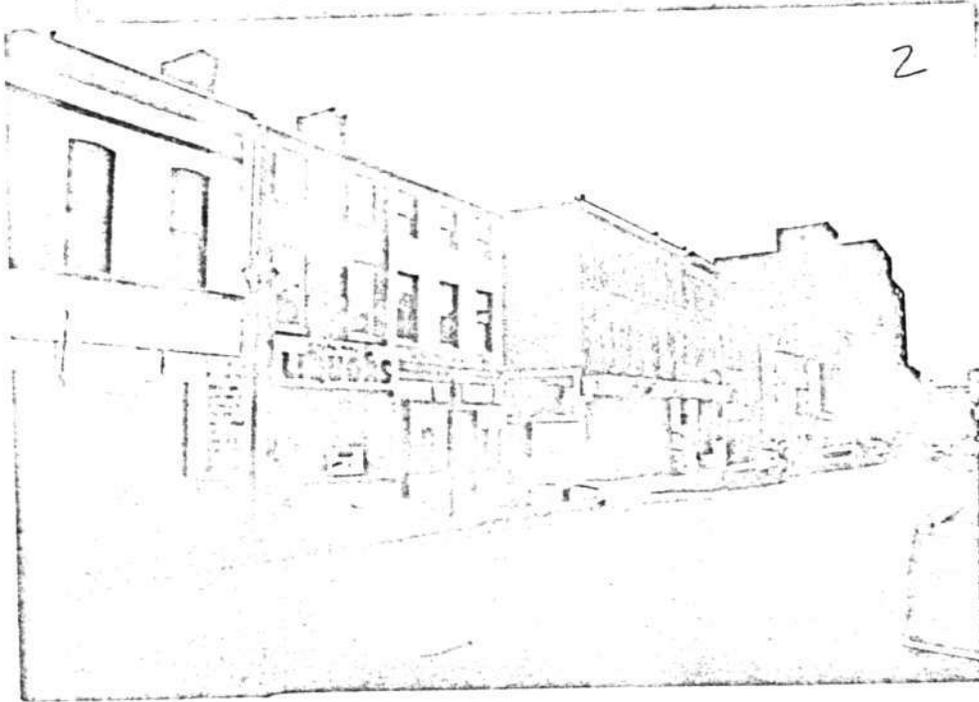
1054 WEST BROMFIELD

1054 West Baltimore Street is an Italianate style, two bay wide, three story high, brick, attached store and residence. Its tripartite, "L" shaped plan consists of the main building, a short hyphen, and a brick, two story high, one and a half bay wide, three bay long backbuilding. Both the main and back buildings have shed roofs. Facade (south elevation) features include a wood shop front, now covered with formstone; a recessed entrance in the west bay; rectangular, wood, double hung windows; and a wood cornice with modillions and molded dentils.

The building was probably built as a Federal style dwelling, and expanded into an Italianate building c.1870. Since then, all first floor partitions have been removed, and the second floor plan has been changed over time. In the twentieth century, a one room addition was built onto the rear of the building, and the storefront was covered in formstone.

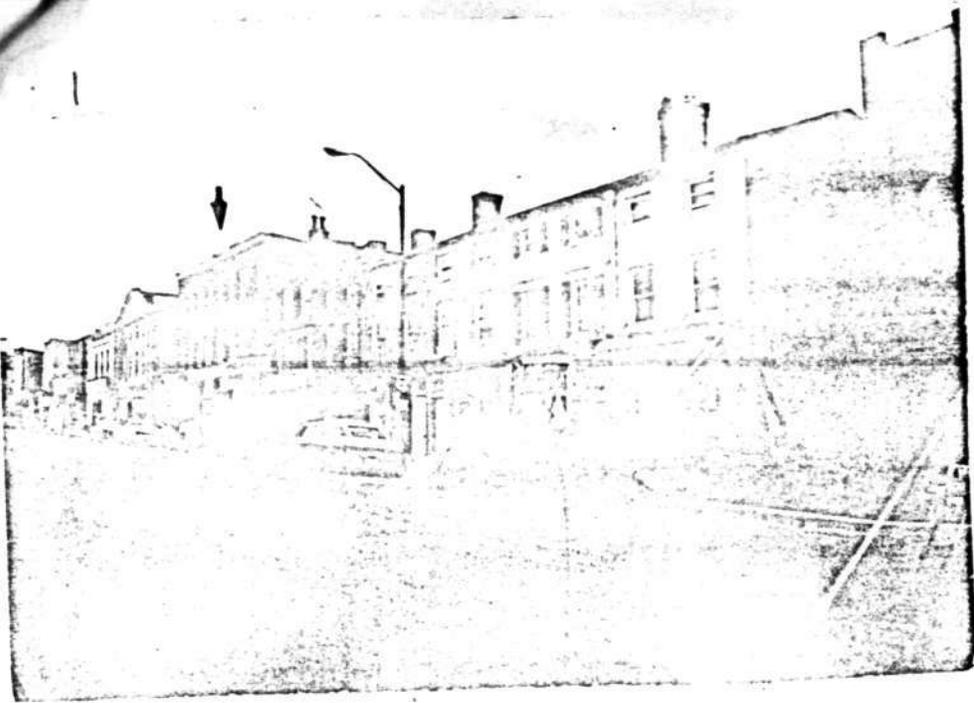
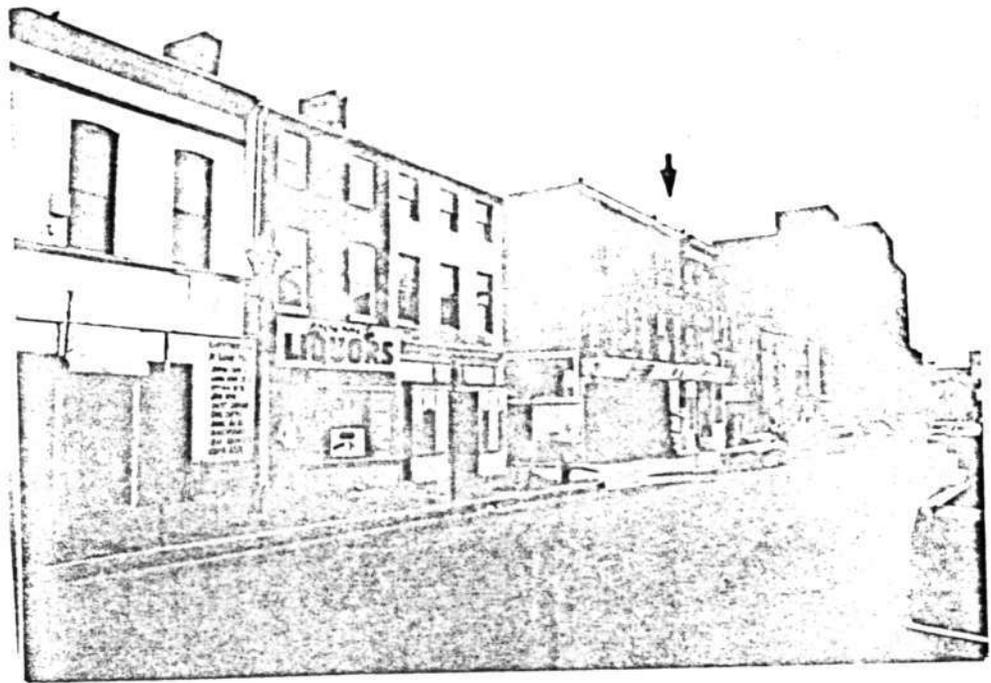
WEST
STIMORE STREET

1056 West Baltimore Street is a late Italianate style, two bay wide, three story high, brick attached residence/shop. It has a rectangular plan; a shed roof; and a one and a half bay wide, four bay long, shed roofed, rectangular, brick backbuilding. Facade (south elevation) features include a decorative wood storefront now covered with formstone; a recessed entrance in the center; one over one, double hung windows at the upper floors; and a thin metal and brick cornice with end brackets and dentils at the roofline.

The building has been altered over time. The stairs may have been relocated, and the second floor plan has been completely rearranged. The rear of the building had a two story, two room frame addition built onto it. Formstone was applied over the storefront.

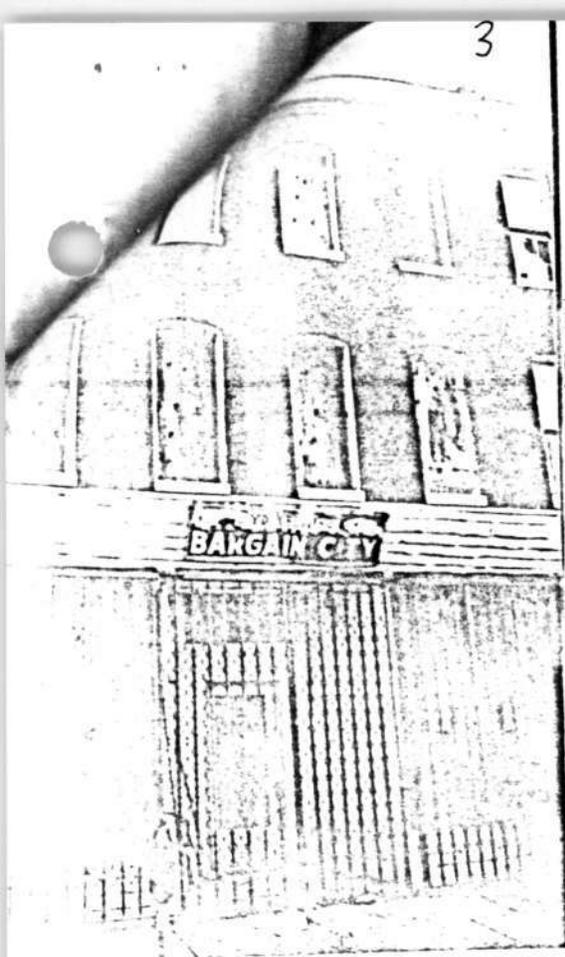
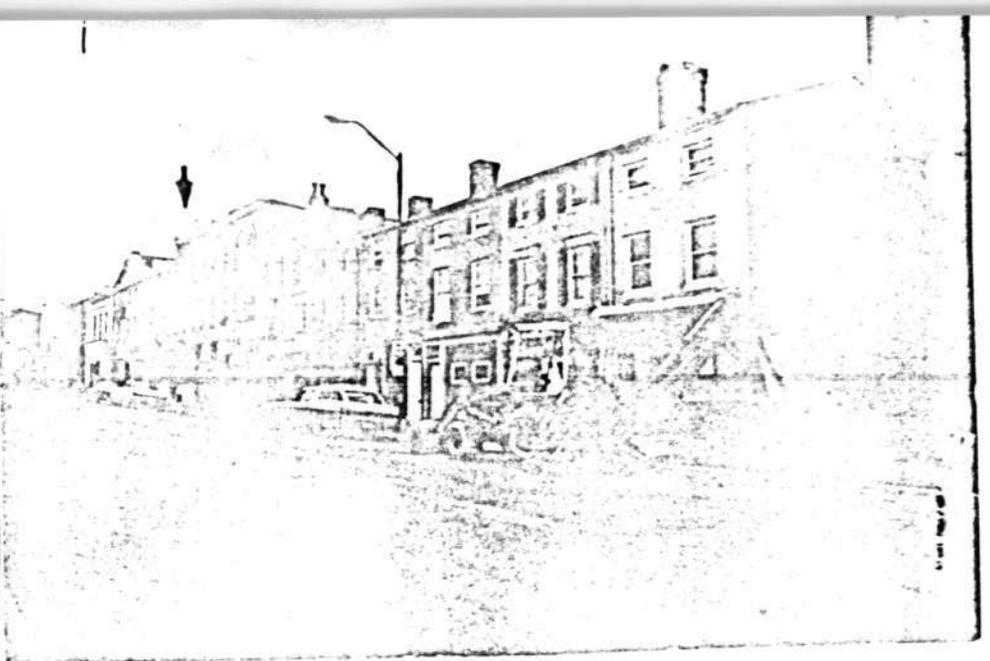
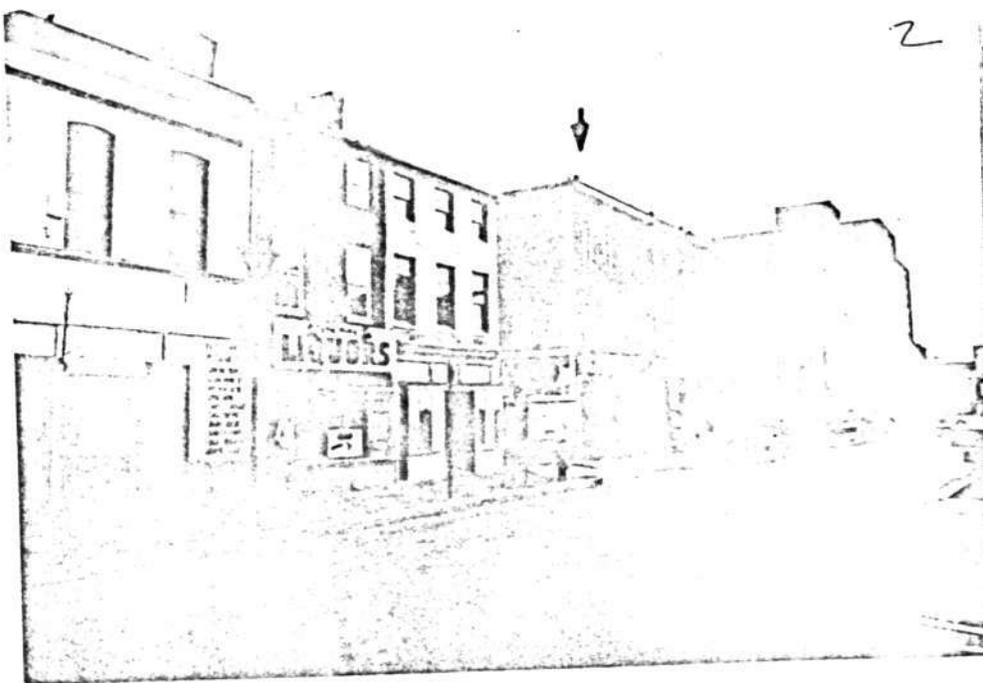
1058-60 WEST

The only changes to the building have been rearrangement of the upper floor plans in the main building and the application of formstone over the storefront.
