POPPLINGTON HISTORIC STUDY

<u>Block</u>	<u>Lot</u>	<u>Address</u>
218	44-36	1020-1038 Hollins Street

HISTORIC PRESERVATION CERTIFICATION
APPLICATION—PART 1

Name/address of Property: 1024 Hollins Street, Baltimore, MD 21223

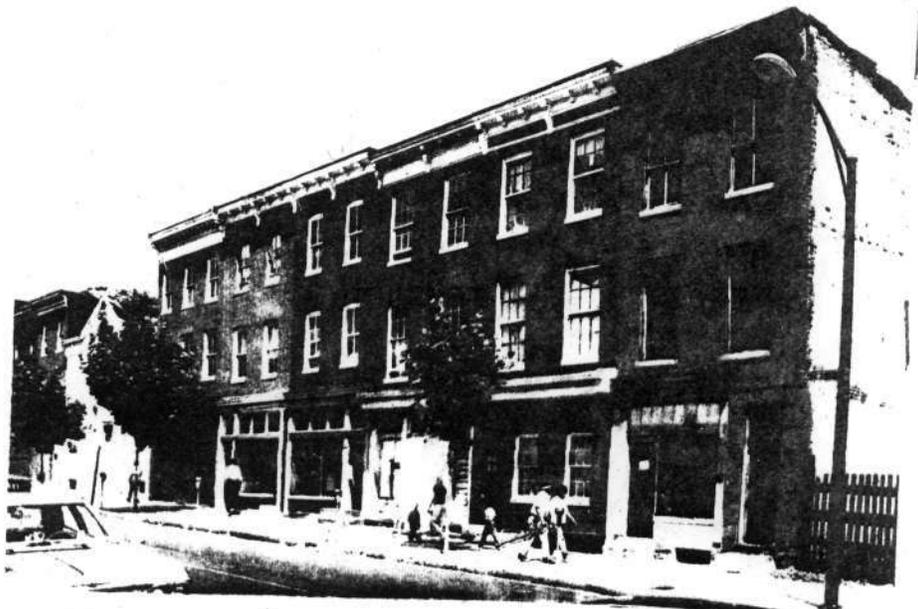
B-2634
1020-1038 Hollins Street
Block 218 Lot 044-036
Baltimore City
Baltimore West Quad.

This is the block of Hollins Street as it approaches the Market from the east. The whole should be rehabilitated. The north side (of concern here) is less old than the south side. In 1851 there were still gaps in the north side which were filled in as the dates given above show.

Numbers 1020-1030 were built into a vacant area next to the little church building. The church is on the Sachse air view of 1868. Numbers 1024-1030 have original shop fronts.

Numbers 1020 and 1030 are vacant, and there is an empty lot east of 1020. Hollins Street dead-ends into McHenry School to the east and the block borders the Market to the west. A few street trees are coming along but more are needed and of larger size. The shops were, no doubt, the influence of the market; would be pleasant if there is the economic possibility for the shops to again be active.
