POPPLETON HISTORIC STUDY

B-2690  
MAG140426905404

<u>Block</u>	<u>Lot</u>	<u>Address</u>
237	1-11	868-884 W. Lombard Street

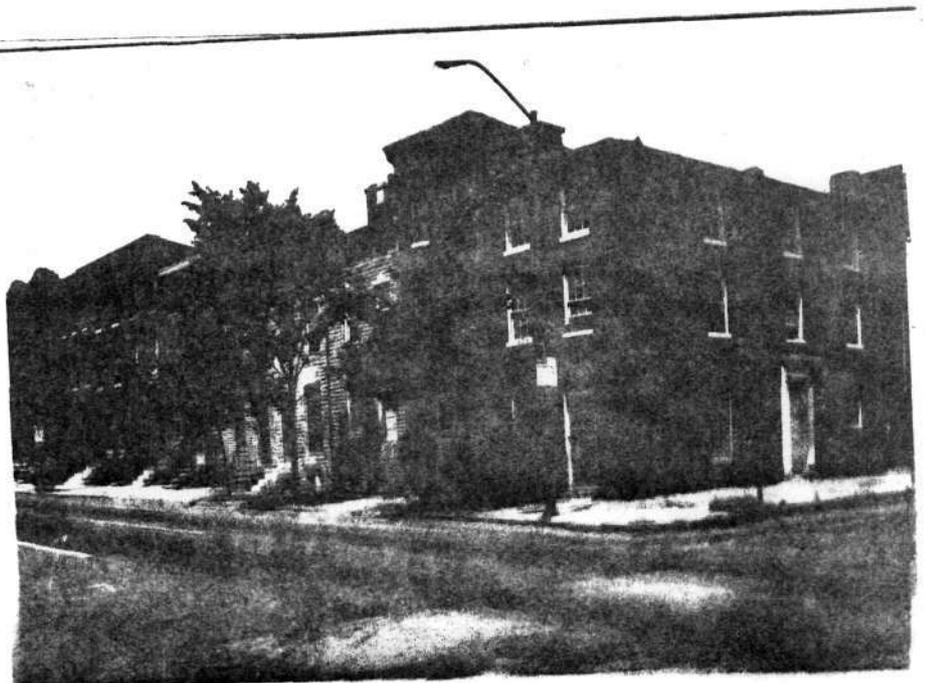
Sachse view of 1869 and 1876 maps show a house set back on lots 882-884. This was presumably demolished, for the 1896 map shows this new building at the building line. Numbers 868 and 872/872½-874 are the oldest in the block; number 868 still has its original character and hipped roof, but the others have been formstoned. Numbers 878-880 are standard 1850's houses, severe cornice, door detailing typical, window basket metal work, good door surround at 880, which is a house of good proportions. Original doors remain at 880 and 878½. Numbers 878-878½ have a cornice in common; 878½ is vacant. The

facades of all except 876 are good, typical houses, though 876 has a fine promenade porch at the rear. Numbers 882-884 though later are serviceable and of reasonable though heavy and undistinguished design with glazed brick facade and stone sills.

Very noisy, one-way street; some good street trees exist; more of same size should be planted. Houses across-street are also good, nice scale and together create a pleasant street except for incredible traffic noise.
