APPLICATION — PART 1
(Pursuant to the Tax Reform Act of 1976)

Address of property: Street 46 E. Montgomery St
City Baltimore County _____ State MD Zip Code 21230
Name of historic district in which property is located: Federal Hill Historic Area

INVENTORY FORM FOR STATE HISTORIC SITES SURVEY

44-46 E. Montgomery St.

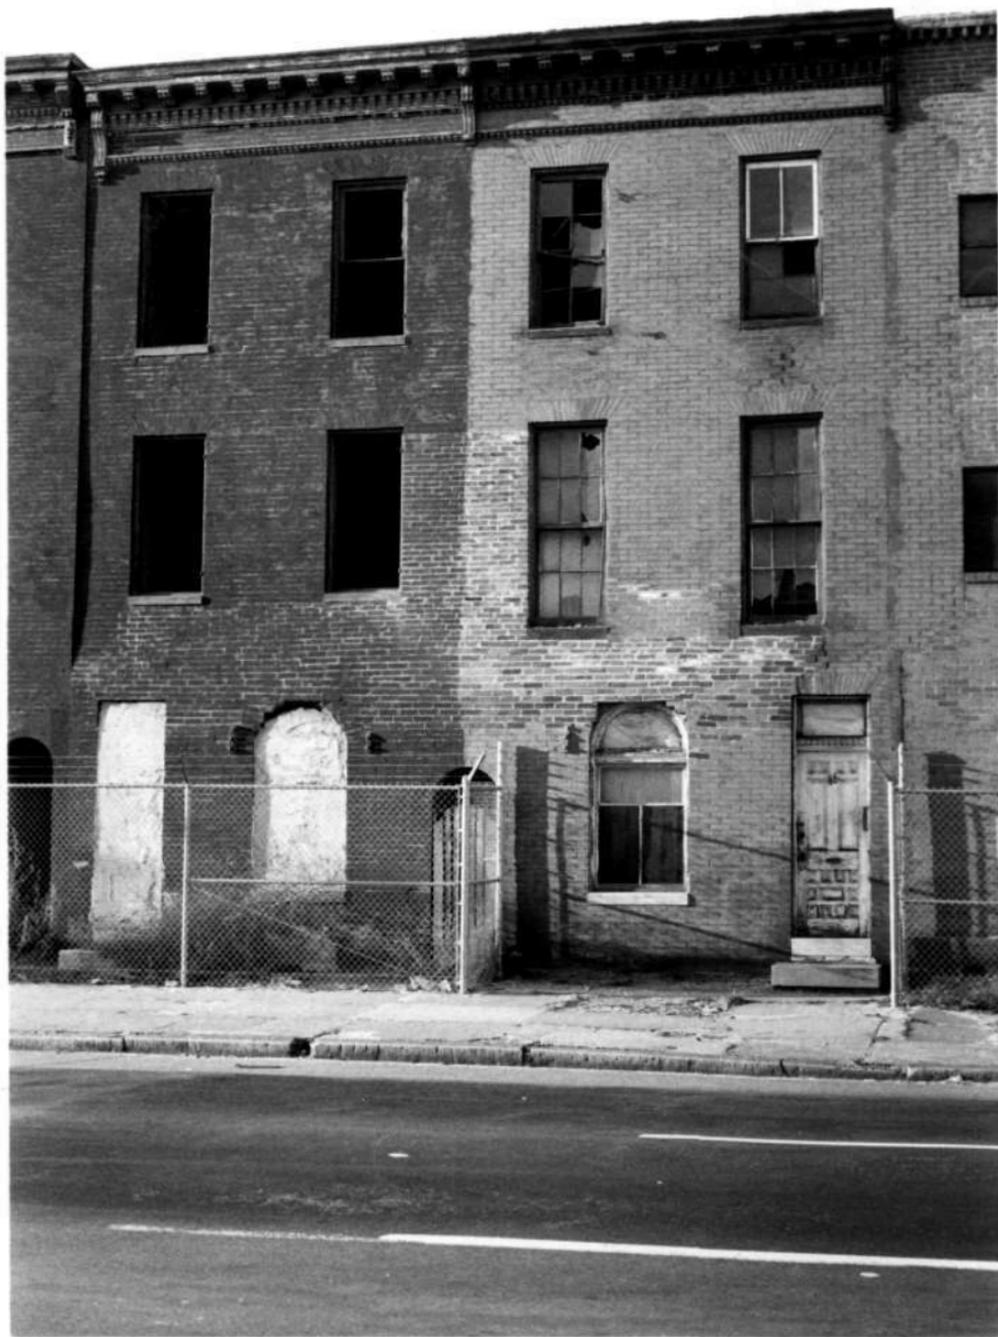
B-3026

This pair of three story brick buildings with shed roof and bracketed wooden cornice form part of a group of similar structures located along this side of Montgomery St. This pair, along with their neighbors, replaced earlier 2 1/2 story houses that had originally occupied the site.

The houses are three stories in height, 15' wide, and occupy lots 69 1/2' deep.* They are constructed in running bond. The shed roof is capped by a wooden cornice of Italianate design that is identical to that of 38 E. Montgomery St. It consists of a deeply projecting crown molding supported by a row of carved modillions. Beneath the modillions there is a row of smaller, vertically oriented, stepped back modillions, above a row of cut-work scallops. Three carved wooden brackets connect the cornice to a lower molding strip decorated with the same cut-work scallops as used in the cornice, thus forming a plain brick freize area. There is a chimney on both the front and back sections of the roof.

The window openings of the second and third floors, and the door opening of 46 E. Montgomery St. have splayed brick lintels and wood sills. The lintel area above the door of 44 E. Montgomery St. have been filled in with brick. The first floor windows are wider than those above and have round arches. The round arches were constructed of stretchers but only a few remain; the window surround is presently partly empty and partly in-filled with brick. The second floor window openings of 46 E. Montgomery St. have been elongated. In both houses there is a considerable amount of in-fill brick between the first and second story openings. All of the openings of 44 E. Montgomery St. are currently empty or plastered over. 46 E. Montgomery St. retains its original sash (except for the sash in the elongated second floor windows). The third floor window openings have 4/4 sash and the second floor openings have 6/6 sash replacing the probably original 4/4. The round arched first floor window is filled with an upper lunette, cut to fit the curve of the arch, separated by a wide molding strip from the lower window which is composed of one horizontally placed panel of glass over two vertical panels. This window has a stone sill. The doorway of 46 E. Montgomery St. has a late, paneled door surmounted by a single light transom. A row of carved block-like designs and a row of cut-work scallops form the lower edge of the transom area. The houses sit on low basements, the entrances being reached by a single wide stone stoop. No coal openings remain, though a filled-in brick area under the first floor window of 44 E. Montgomery St. suggests they once existed. An arched alleyway runs between the two houses.

South elevation
