# HISTORIC PRESERVATION CERTIFICATION APPLICATION — PART 1 (Pursuant to the Tax Reform Act of 1976)

1. NAME OF PROPERTY: 633 & 635 S. Patterson Park Avenue  
Address of property Street: 633 & 635 S. Patterson Park Avenue  
City: Baltimore County: \_\_\_\_\_ State: Maryland Zip Code: \_\_\_\_\_  
Name of historic district in which property is located: Canton National Register Historic District

#2. PHYSICAL APPEARANCE

#3. STATEMENT OF SIGNIFICANCE

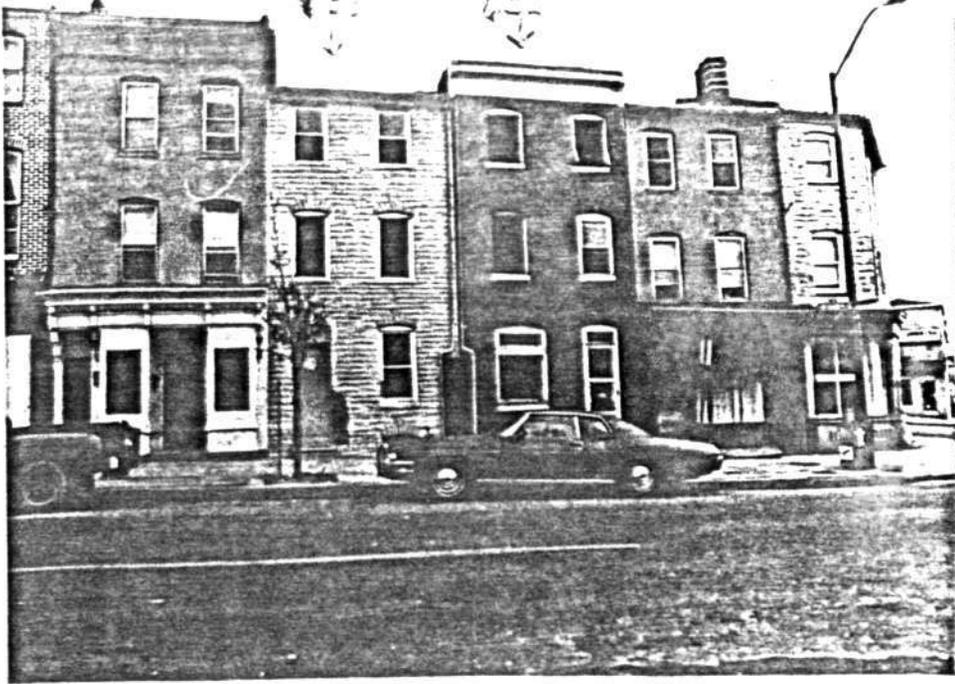
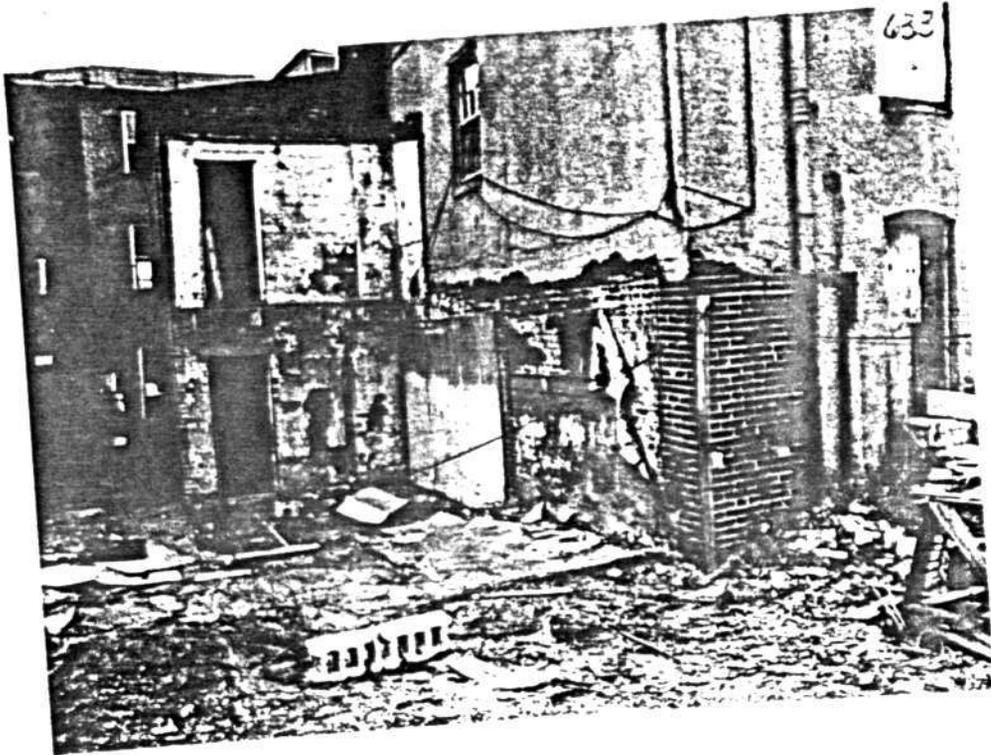
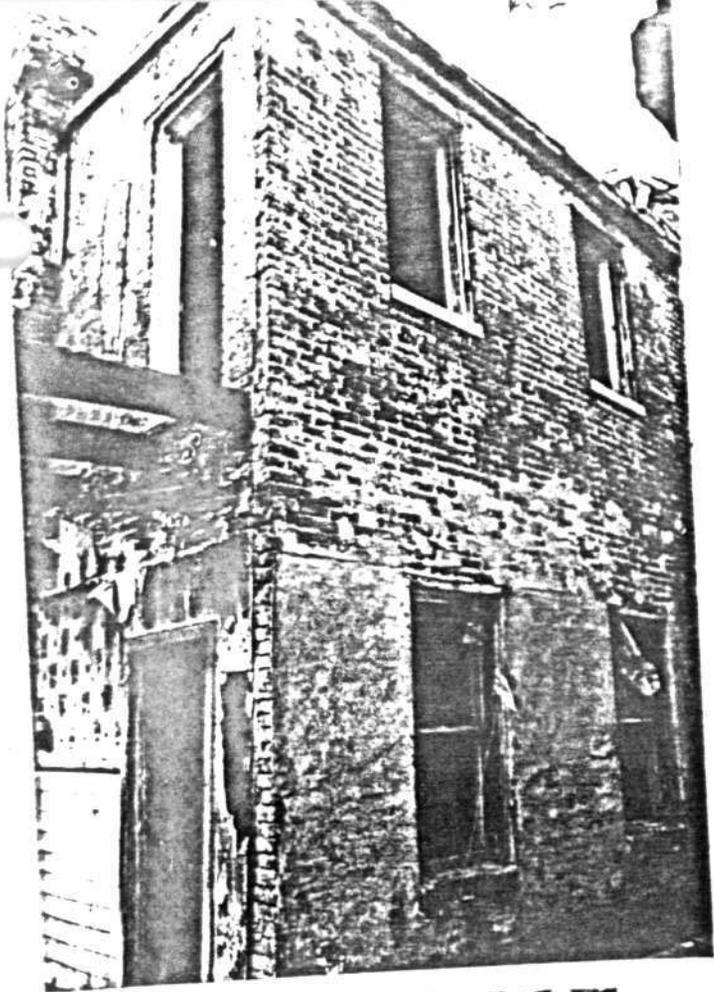
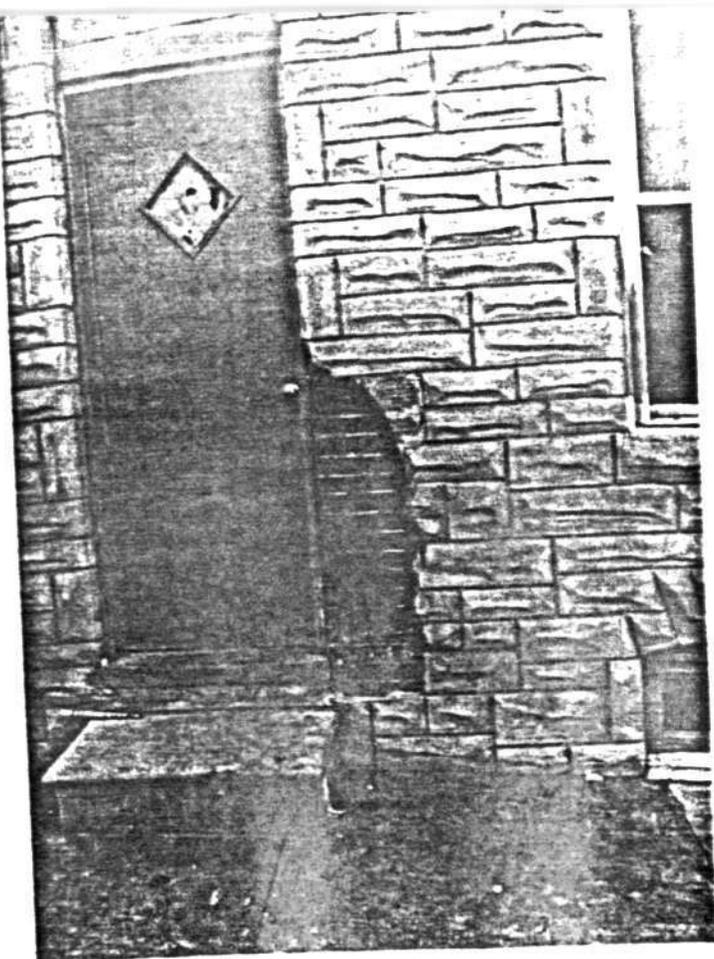
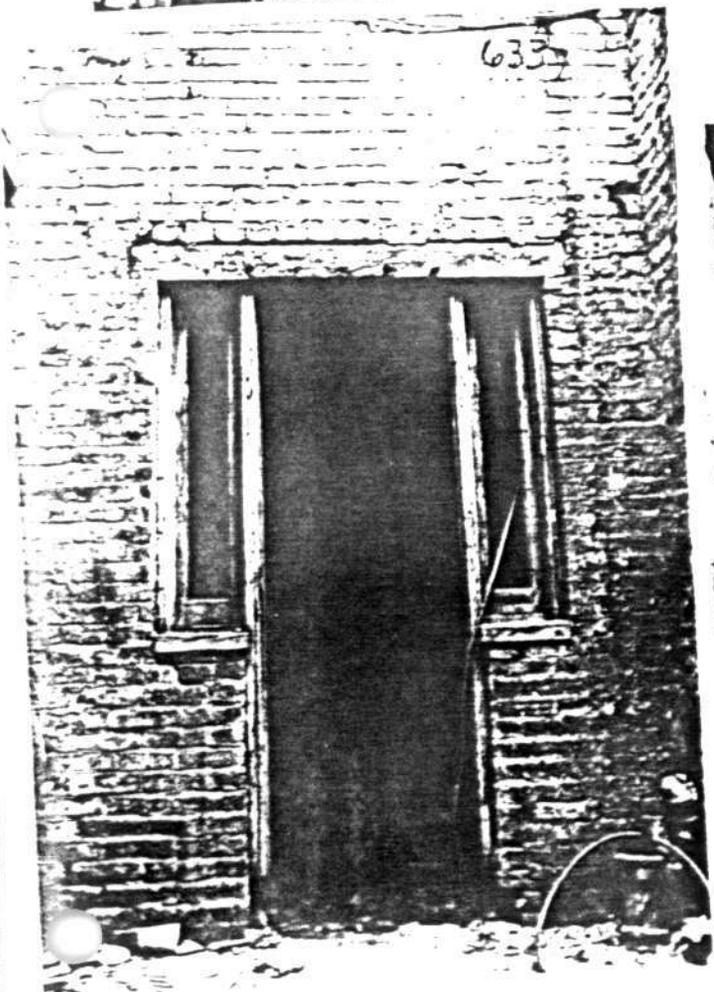
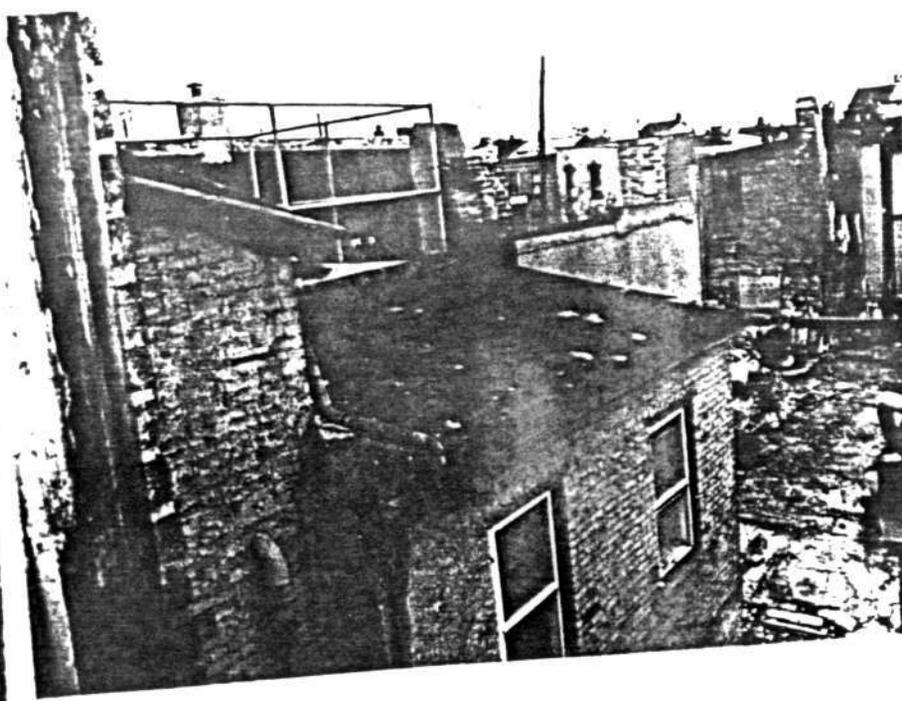
B-3746

The structures are Roman brick row homes with white marble steps, probably built in the mid-nineteenth century. Six thirty-three (633) S. Patterson Park Avenue has formstone covering most of the original brick on the front exterior of the house.

The general character and details of the two residences clearly indicate that they are of the Greek Revival era (1830-1850). The construction system is masonry bearing walls with wood joists. The predominant features of the front facades are sloped roofs; running bond brick work; transoms above the front doors; small rectangular wooden basement windows with scroll sawed tympanum; wood tympanums above all front windows; and a common arched alley-way entrance. The original brick of 635 S. Patterson Park Avenue is visible; it reveals common arched brick lintels and a wood bracketed cornice. The cornice was added sometime after the house was built, probably circa 1850 and is typical of the Victorian era. Both 633 and 635 S. Patterson Park Avenue were built at the same time and it can be assumed that architecturally, the houses are identical.

The side facades are laid in common bond also. The windows are one-over-ones with wooden sills. At the time these properties were purchased by the present owner, the rear of both buildings and most of the interiors had been demolished.

The side entrances to both residences off the common alley-way consist of identically styled doorways with narrow side windows with wooden sills. Six thirty-three (633) S. Patterson Park Avenue is missing this side door; however, six thirty-five (635) reveals a four panel door and a concrete slab door step.

The houses have visible impressions the height of the walls where chimney flues existed prior to demolition. It appears that the kitchens in the rear of both houses were added sometime after the original structures were erected.
