HISTORIC PRESERVATION CERTIFICATION  
APPLICATION-PART 1

1. Name of property: Market News

Address of property: 1305 West Lombard Street

HISTORIC PRESERVATION CERTIFICATION APPLICATION - PART 1  
Description of Physical Appearance

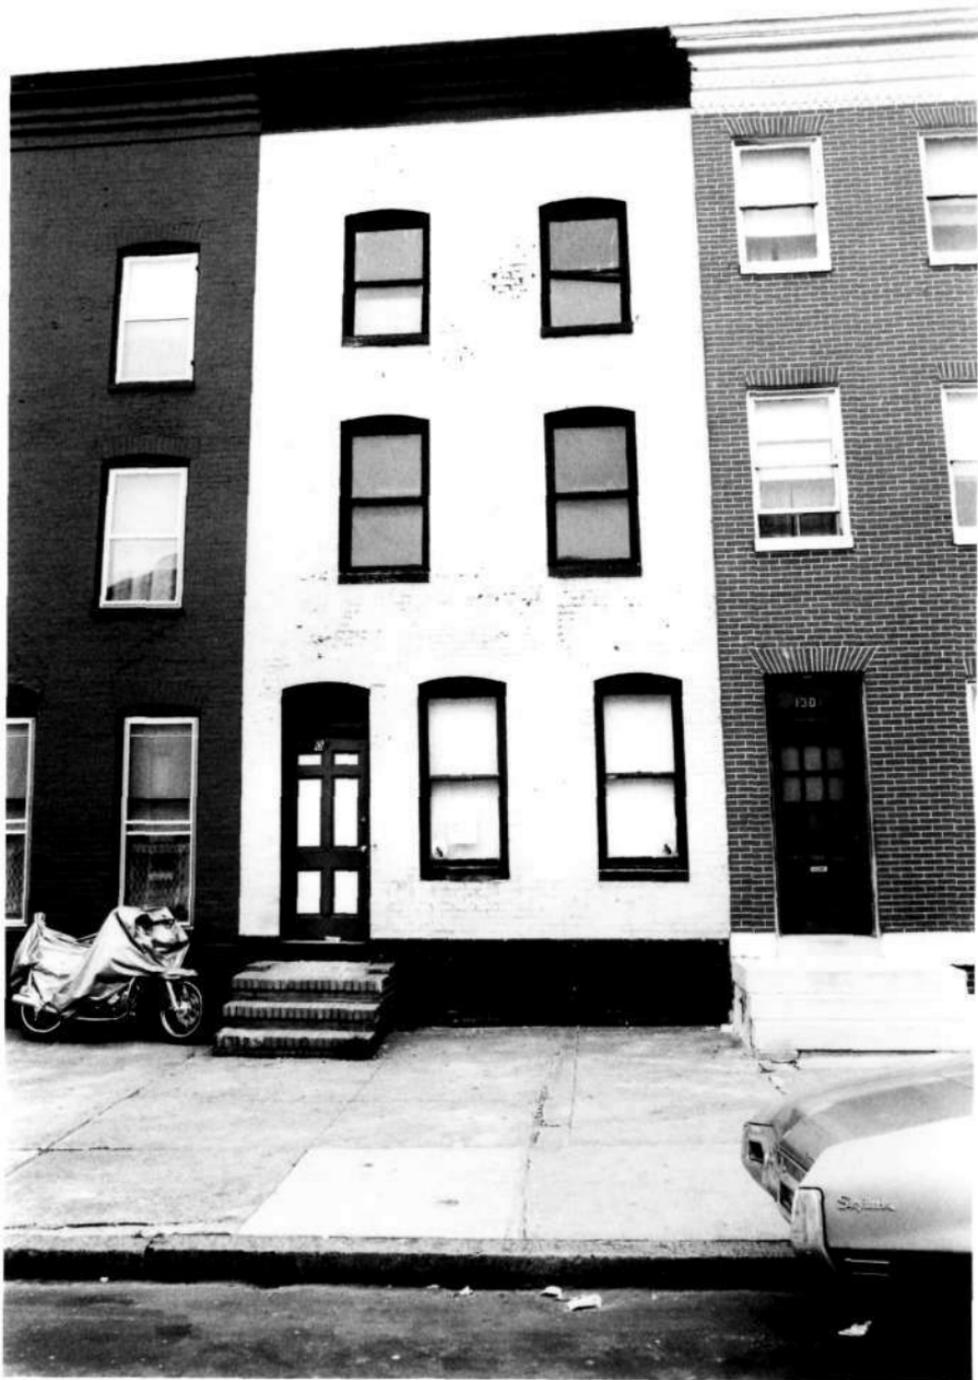
1305 W. Lombard

1305 West Lombard Street is a two bay, three story Italianate rowhouse built above a slightly raised basement. The inset door, in the east bay, has a transom topped by a relieving arch which matches those above the windows. The basement has two small horizontal windows topped by a belt concourse. The 1/1 windows, taller and narrower on the first floor than on the upper two, have flat bottoms. The cornice is flat and plain. The facade is of running bond brick.
