Maryland Historical Trust
State Historic Sites Inventory Form

Survey No. B-4358

historic 418-420 North Howard Street/Augusta Building & Loan
 and/or common Augusta Federal Savings Bank

B-4358
Augusta Federal Savings Bank
418-420 N. Howard Street
Block 0562, Lot 008 (Formerly Lot 010)
Baltimore City
Baltimore East Quad.

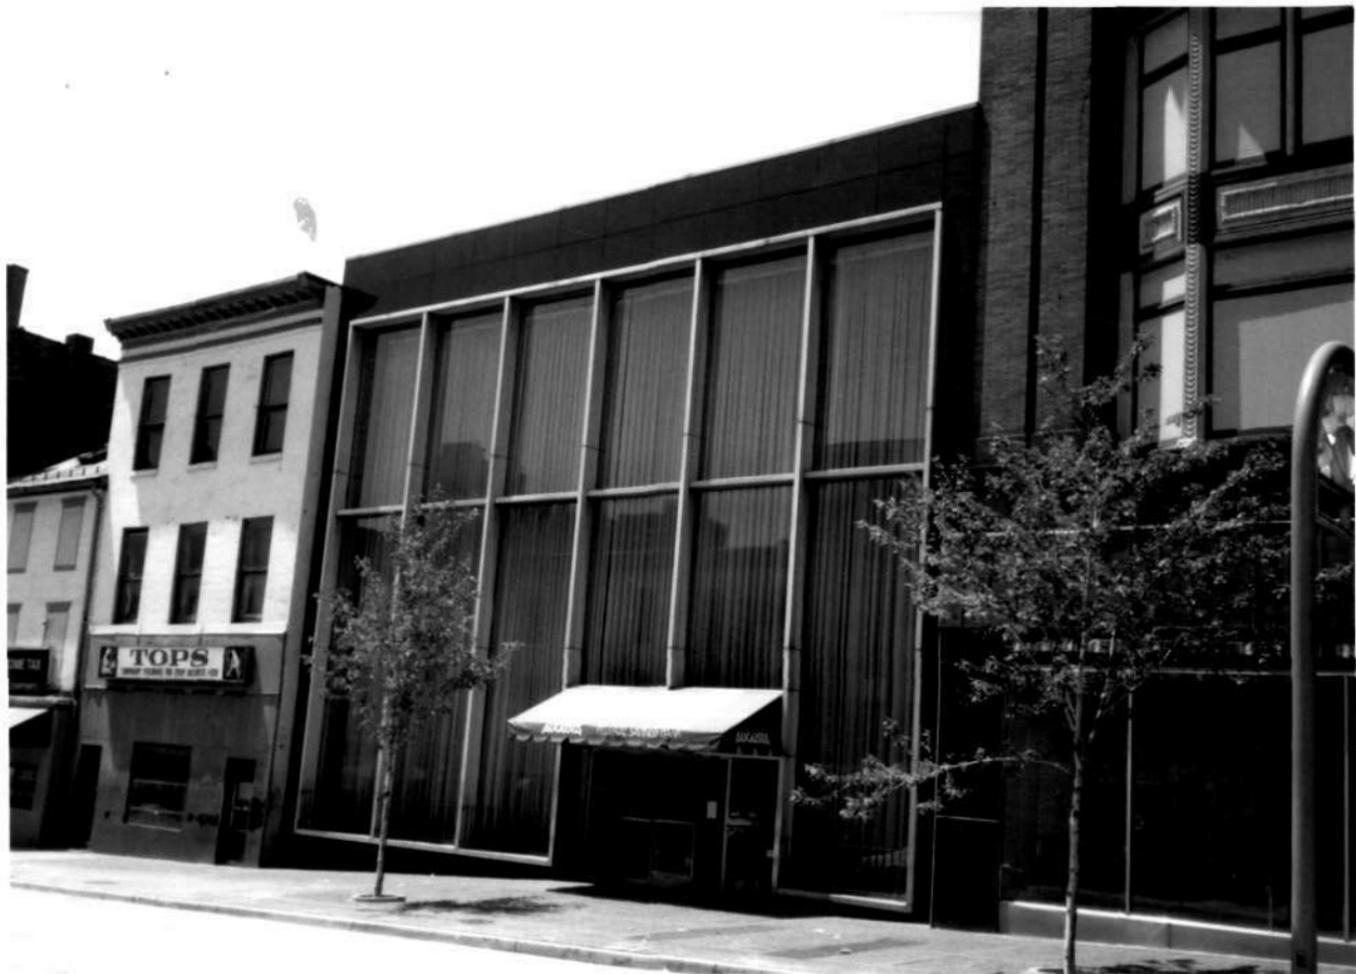
113

This 1957 bank faces east on N. Howard Street and abuts two partywall structures. The enframed window wall design consists of a glass curtain wall surrounded by polished black marble facing at the sides, top, and foundation. The street frontage is 50' and the depth is 120'.

The glass curtain wall is divided into six bays of large plate glass divided by metal mullions. The glass expanse runs from the floor to ceiling of the three story building. The bays are horizontally divided by a row of metal mullions creating a 2/3 to 1/3 height ratio. The lower stories, as represented by the taller section of plate glass, look onto the two-story lobby interior. The upper story, represented by the shorter plate glass windows, demarcates the private banking offices.

The glass double door entrance is in the northernmost fourth and fifth bays. A low iron fence runs in front of the windows at ground level. A date block with "1957" etched on it is position in the lower south corner.

Facade, west elevation

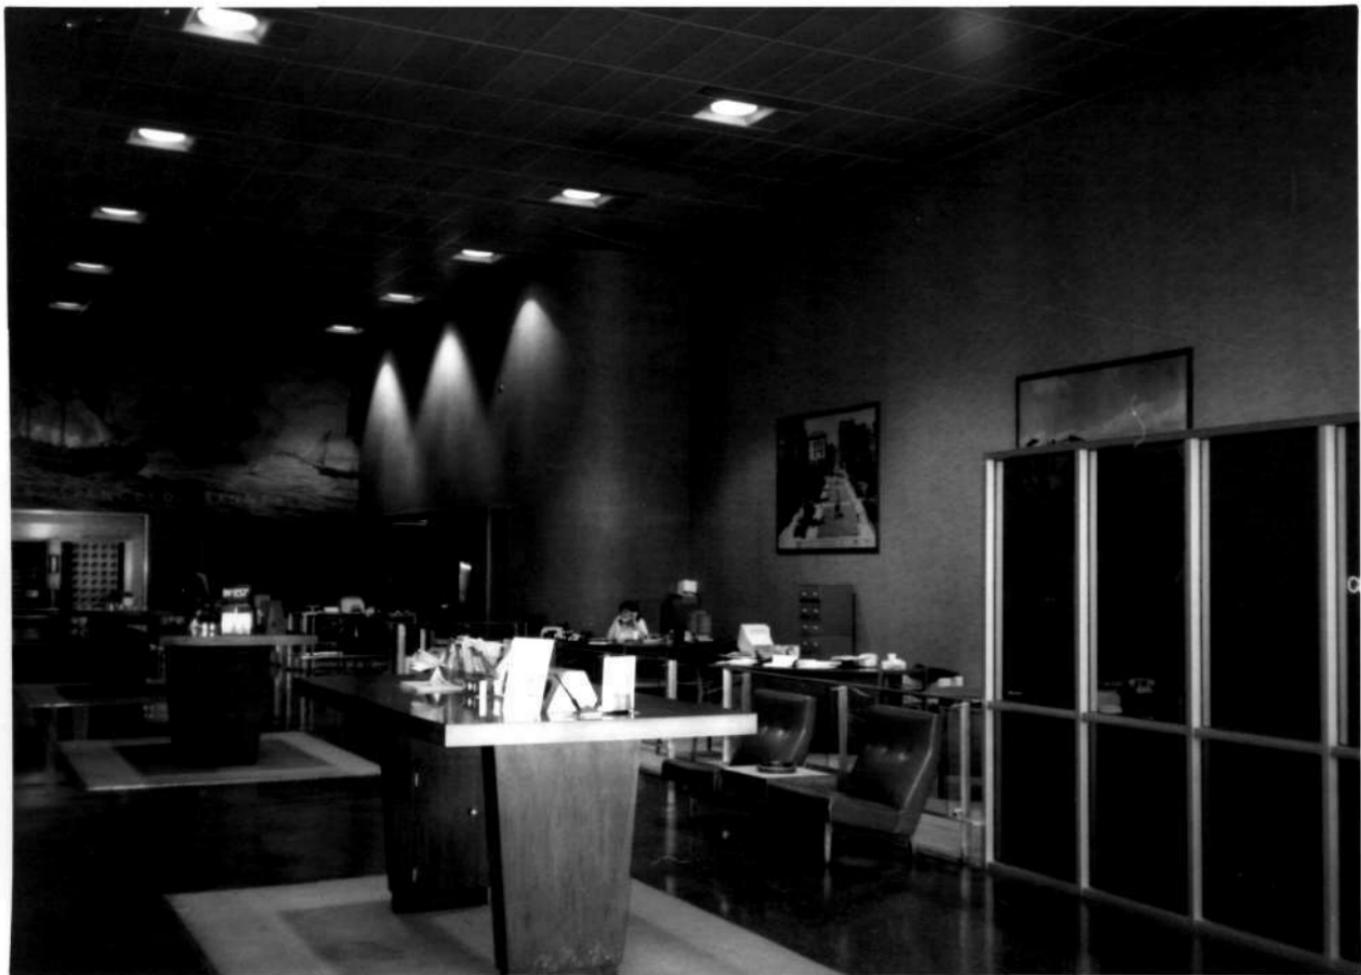
2/3

The interior of the first floor is a large rectangular space rising two stories. The banking floor has a row of teller counters along the south wall, a series of account desks along the north wall, and customer banking counters along the middle of the bank floor.

The glass curtain wall (east) has floor-to-ceiling drapes. The south and north walls are decorated in a gold and sky blue color scheme. The south wall has gold wallpaper on the lower half and blue painting on the upper half. The north wall is painted sky blue from floor to ceiling in the eastern half of the wall; a curved protrusion into the room towards the west wall is entirely covered in gold wallpaper. The west (rear) wall has a mural on the upper level entitled "Birthplace of the Star Spangled Banner" executed by R. Gill in 1957. It depicts the sea battle at Fort McHenry. The lower, floor level contains the bank vault. An office mezzanine on the third story runs along the west wall. A bank employee explained that the furnishings and interior finish are original to the building.

Interior, west & north walls

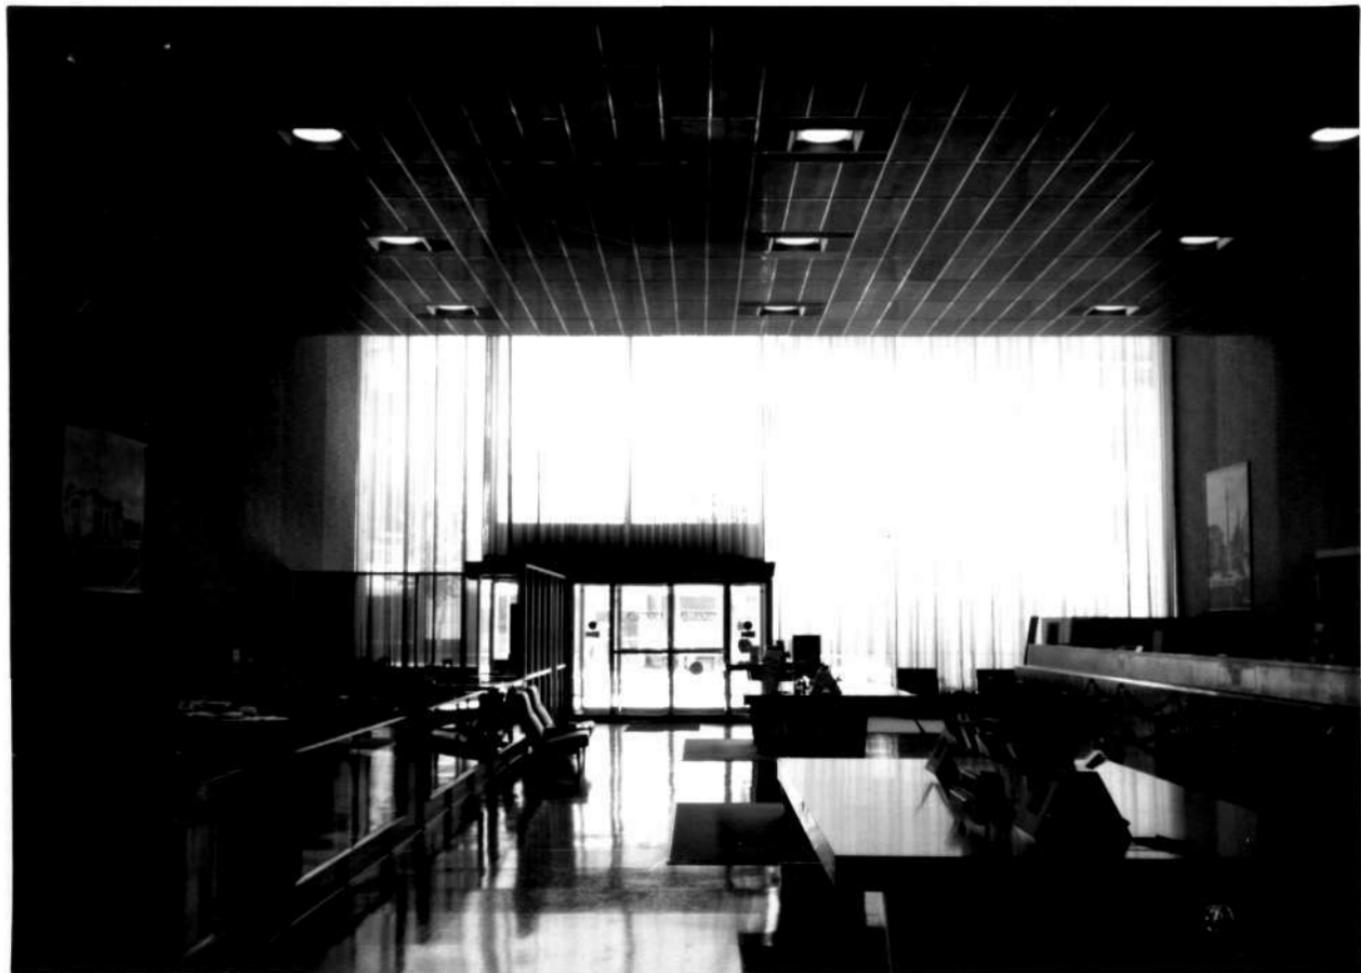
3/3

Interior, east wall
