**Maryland Historical Trust
State Historic Sites Inventory Form**

Survey No. B-4368

historic 704 North Howard Street
and/or common A.T. Jones & Sons Costumers Retail Sales Store

street & number 704 N. Howard Street not for publication
city, town Baltimore vicinity of Seventh congressional district
state Maryland county Baltimore

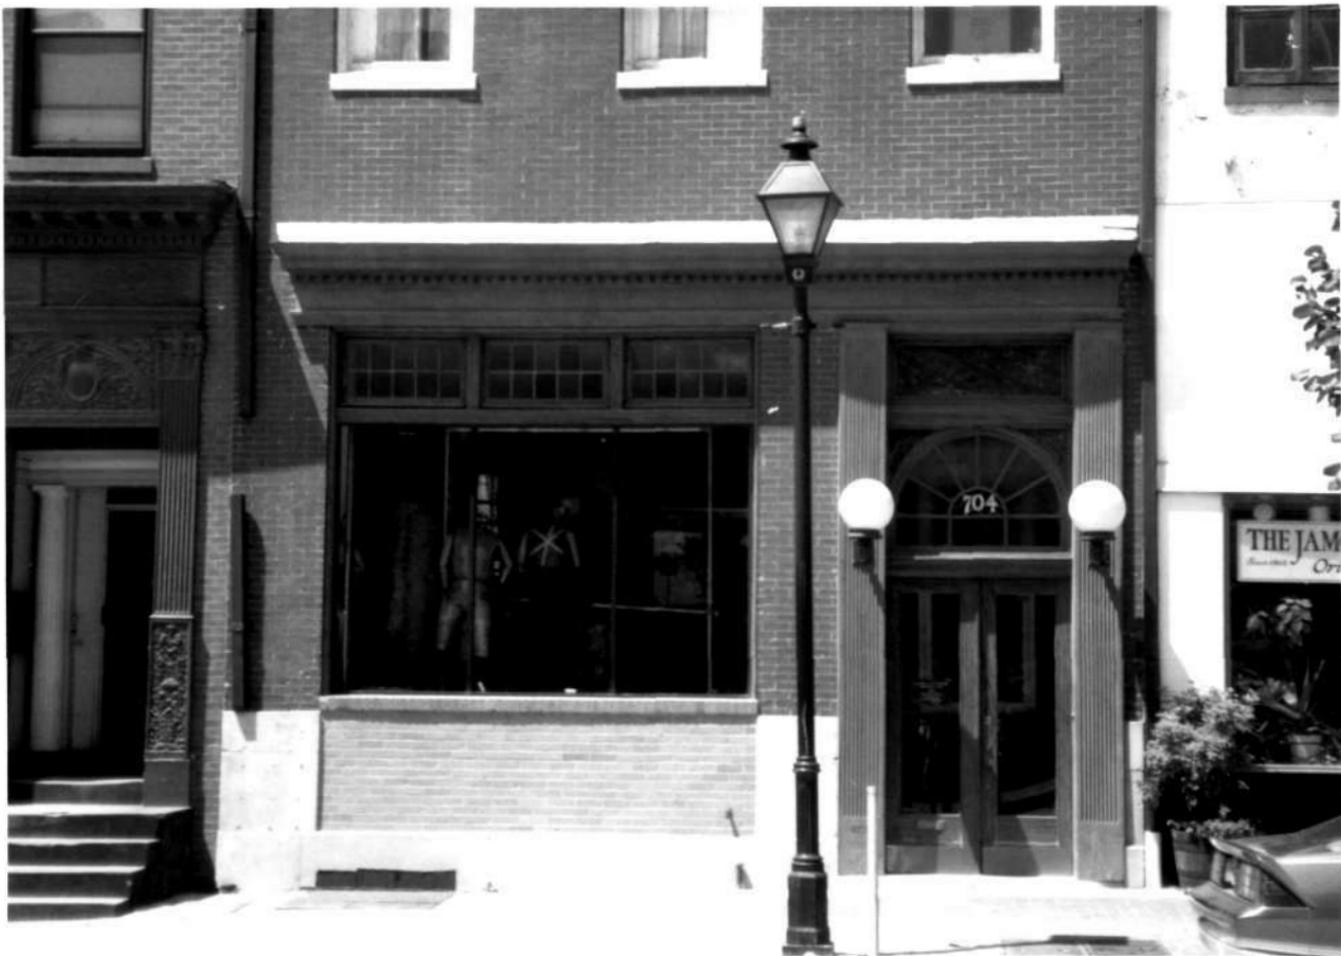
B-4368

The entrance is on the north side of the facade, and it has been altered. The elongated glass double doors have an arched, stained glass transom above with marbleized infill panels. Elongated, fluted pilasters of wood frame the door and transom. A wide cornice runs across the tops of the pilasters and stretches across the width of the facade forming a stringcourse between the first and second stories. The cornice profile consists of an ogee, back band, dentil course, back band and fillet.

The first and second bays of the first story have been altered by the insertion of a large commercial display window. The window is divided into three vertical sections of large panes of glass joined with metal joint seams. Each pane has a hinged ten-light transom with green stained glass.

Facade detail, east elevation
