Survey No. B-4426

B-4426
423 North Eutaw Street
Baltimore, MD
Section 8 Significance
8.1

B-4426
423 N. Eutaw Street
Block 0562 Lot 038
Baltimore City
Baltimore East Quad

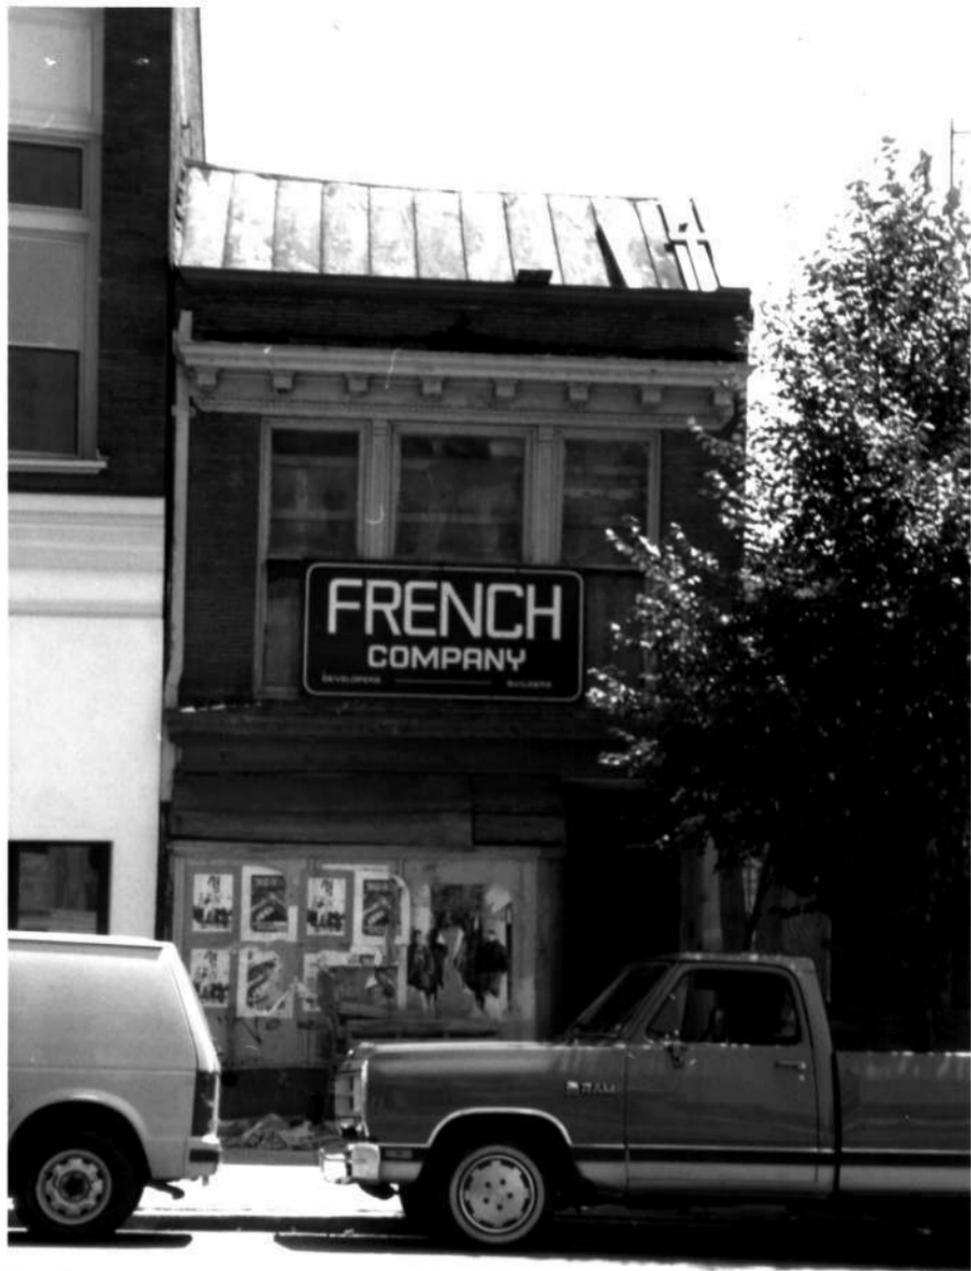
The first story consists of a recessed entrance in the second (south) bay and a boarded up display window in the first bay. The door had a transom. A cornice stretches across the first story facade. Its profile consists of a fillet, ogee, bead, and back band, with an egg and dart molding. This cornice surmounts a simple, flat entablature. The brick is a yellowish-orange Roman brick.

The second story more clearly reveals the enframed window wall design. A tripartite window is centered on the brick wall. The window units consists of a wide 1/1 sash window flanked by narrower 1/1 sash windows. Pilasters divide the windows. The second story is topped by a cornice with a profile of fillet, ogee, bead, back band, a modillion course, and row of egg and dart molding and a row of raised trim.

The parapet wall rises above the second story cornice. This wall is topped with a lesser cornice of fillet, ogee, fillet and egg and dart molding.

Facade, west elevation

This early-nineteenth-century building has been substantially altered. Presently an enframed window wall design of a circa 1900 remodelling, the scale and massing of the building suggests a much earlier construction date of a two-story, two-bay house. The 19th-century gable roof of standing seam tin is visible behind the 20th-century parapet wall. The building faces west on North Eutaw Street and abuts a partywall neighbor to the north and a recently-demolished partywall neighbor to the south. The street frontage is 15'6" and the depth is 61'8". The building is in deteriorated condition, but is scheduled for renovation.
