CUFTON AVE OVER WINDSOR MILL RD

MARYLAND INVENTORY OF HISTORIC BRIDGES
HISTORIC BRIDGE INVENTORY
MARYLAND STATE HIGHWAY ADMINISTRATION/
MARYLAND HISTORICAL TRUST

SHA Bridge No. BC 2502 Bridge name Clifton Avenue over Windsor Mill Road

HAER NO. MD-B-4623

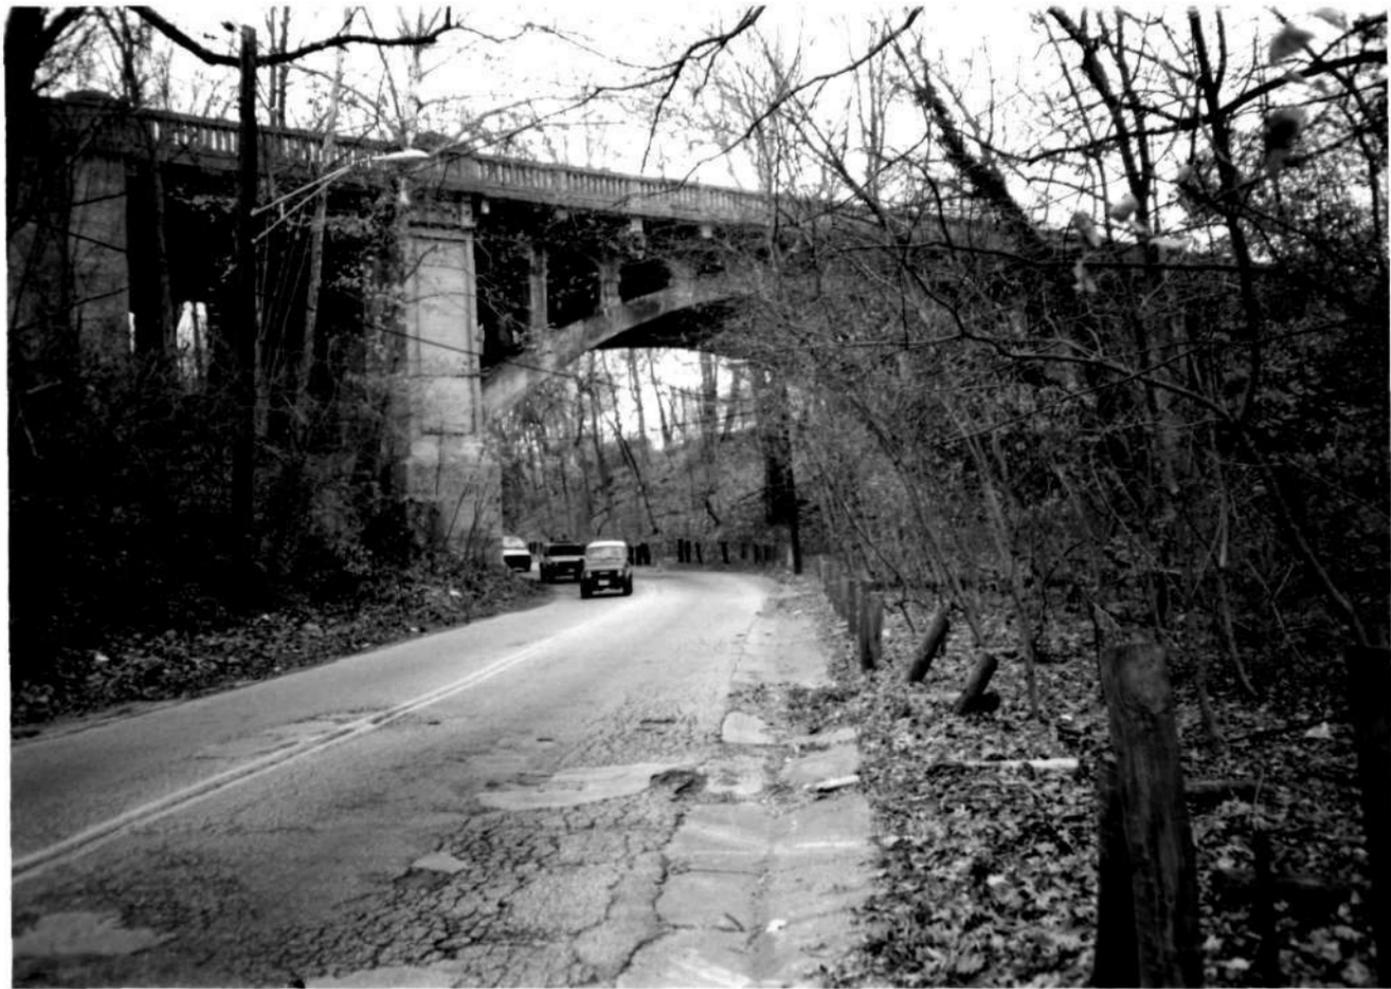
1. B-4623
2. Clifton Avenue
3. Baltimore City, MD
4. Wallace, Montgomery & Associates
5. 12/97
6. MD SHPO
7. Elevation looking east
8. 1 of 6

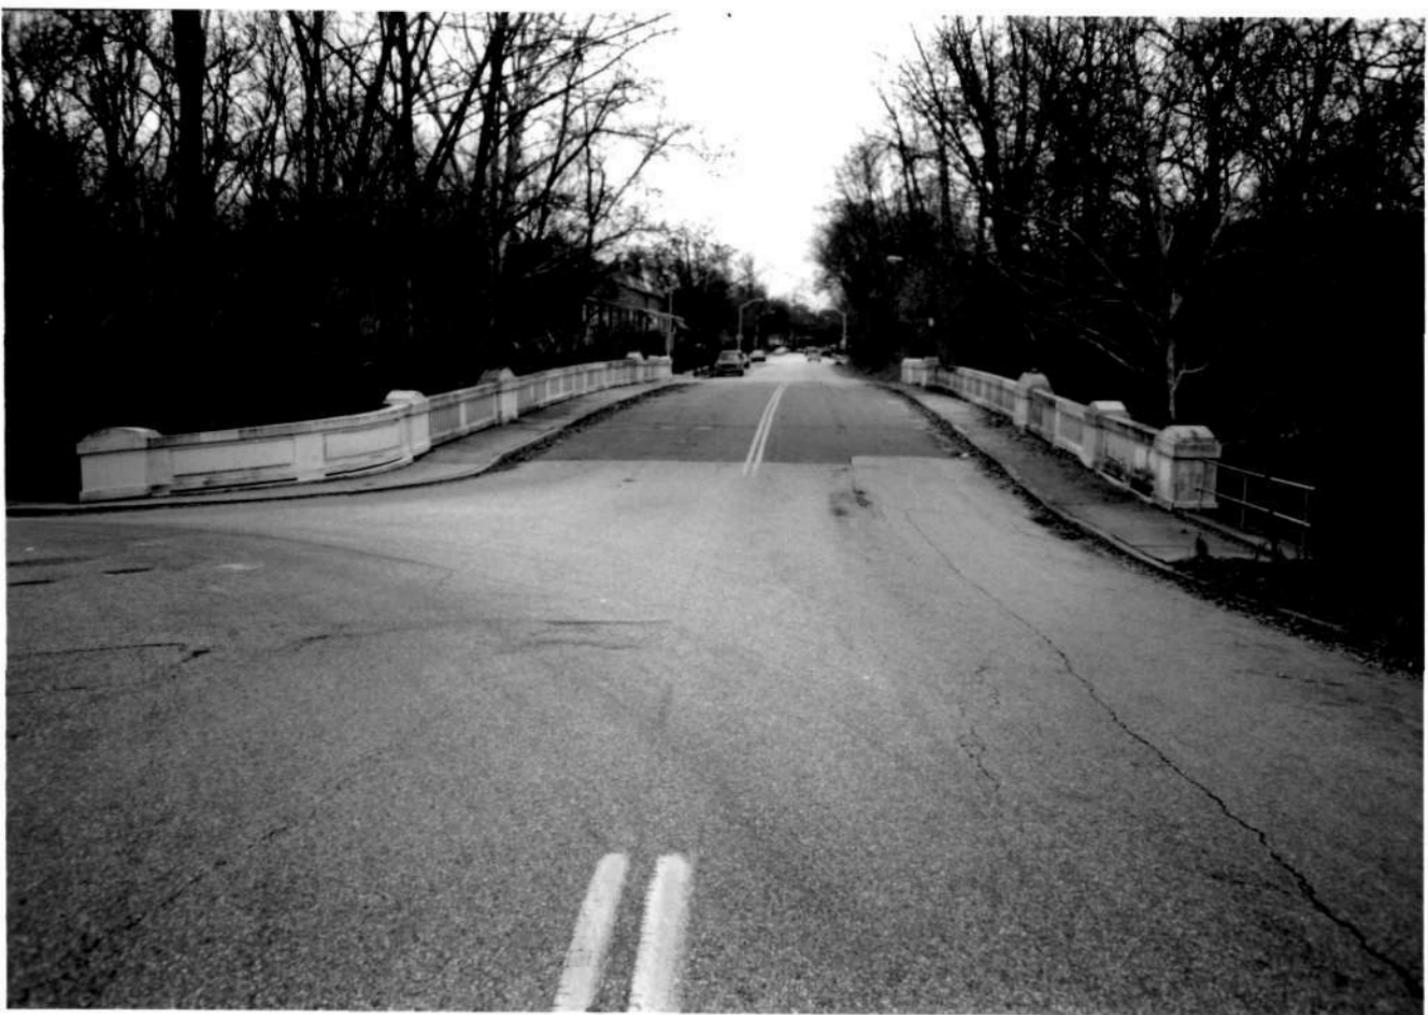
1. B-4623
2. Clifton Avenue
3. Baltimore City, MD
4. Wallace, Montgomery & Assoc.
5. 12/97
6. MD SHPO
7. Looking Southeast
8. 2 of 6

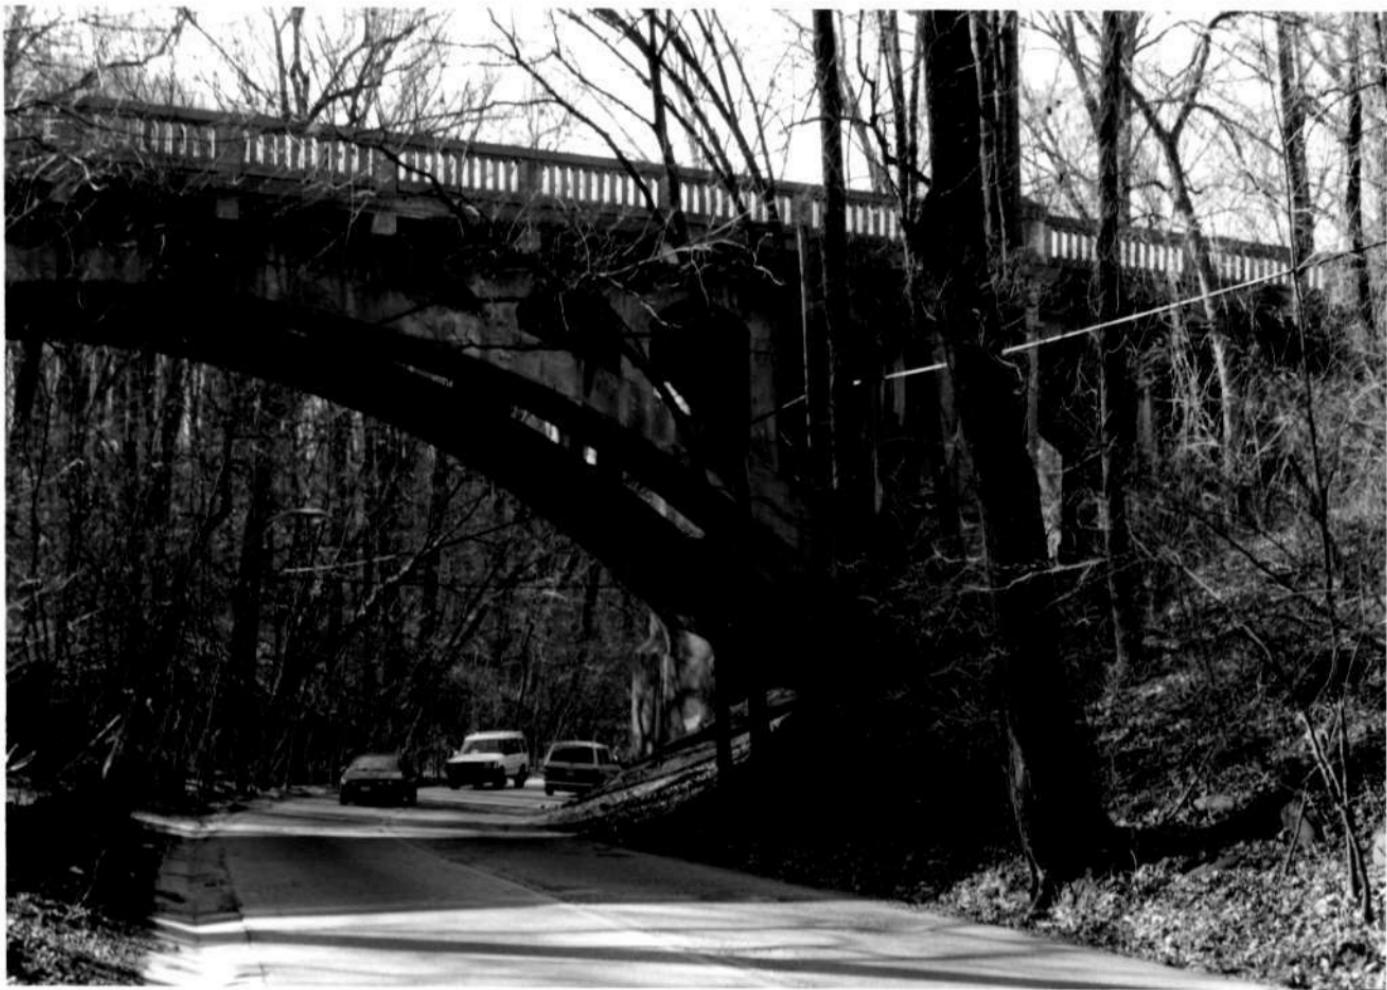
1. B-4423
2. BC 2502, CLIFTON AVE. OVER WINDSOR MILL ROAD
3. BALTIMORE CITY, MARYLAND
4. WALLACE - MONTGOMERY
5. 12/97
6. MDSHPO
7. ELEVATION LOOKING WEST
8. 3 of 4

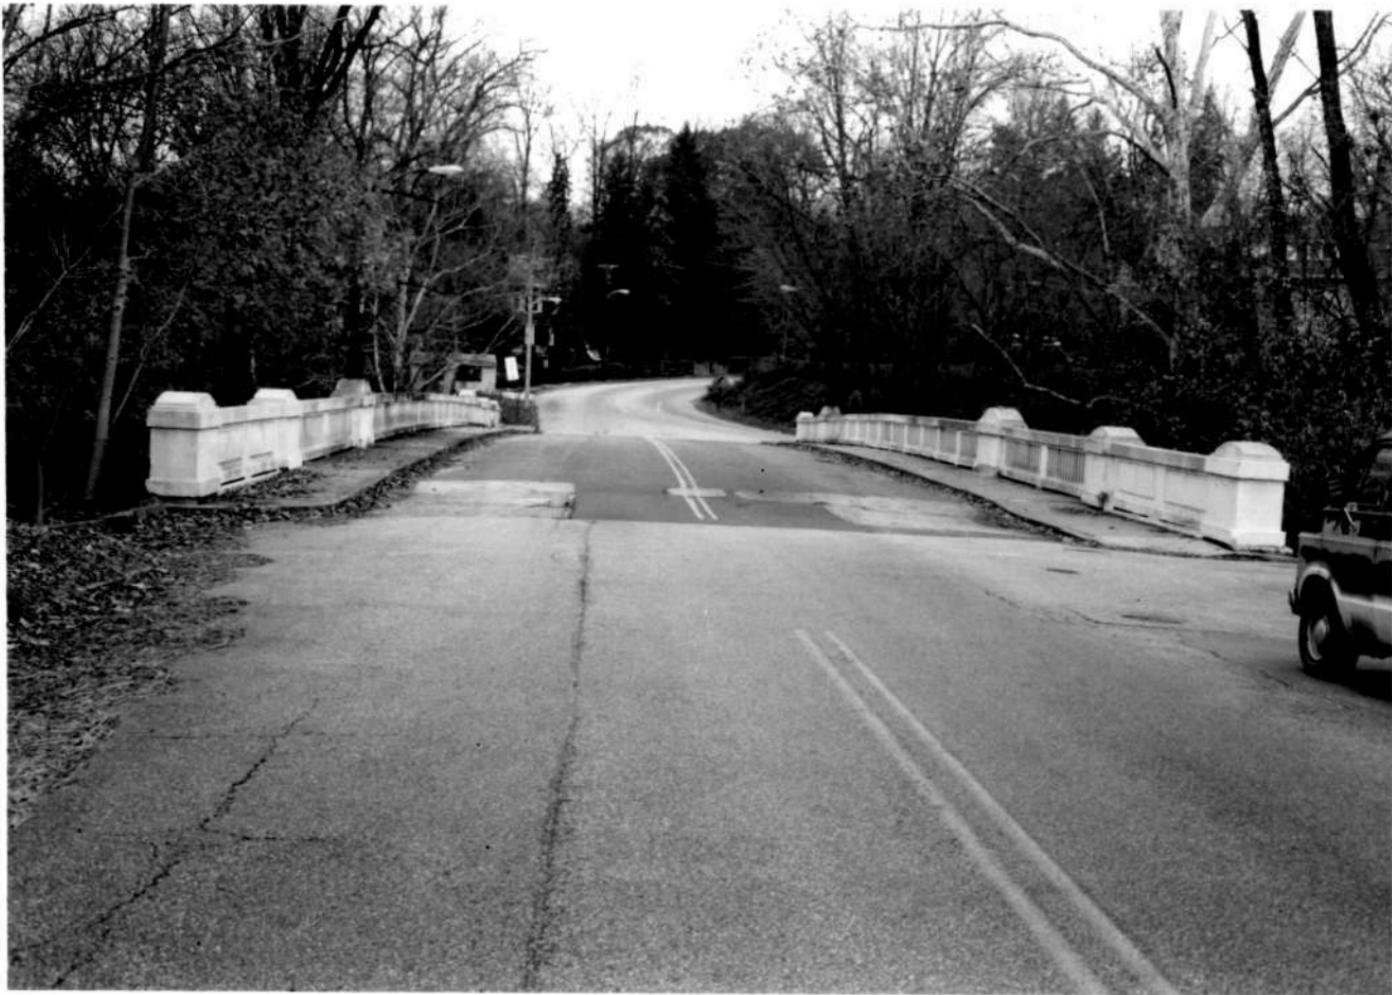
1. B-4623
2. Clifton Avenue
3. Baltimore City, MD
4. Wallace, Montgomery & Assoc.
5. 12/97
6. MD SHPO
7. Looking Northwest
8. 4 of 6

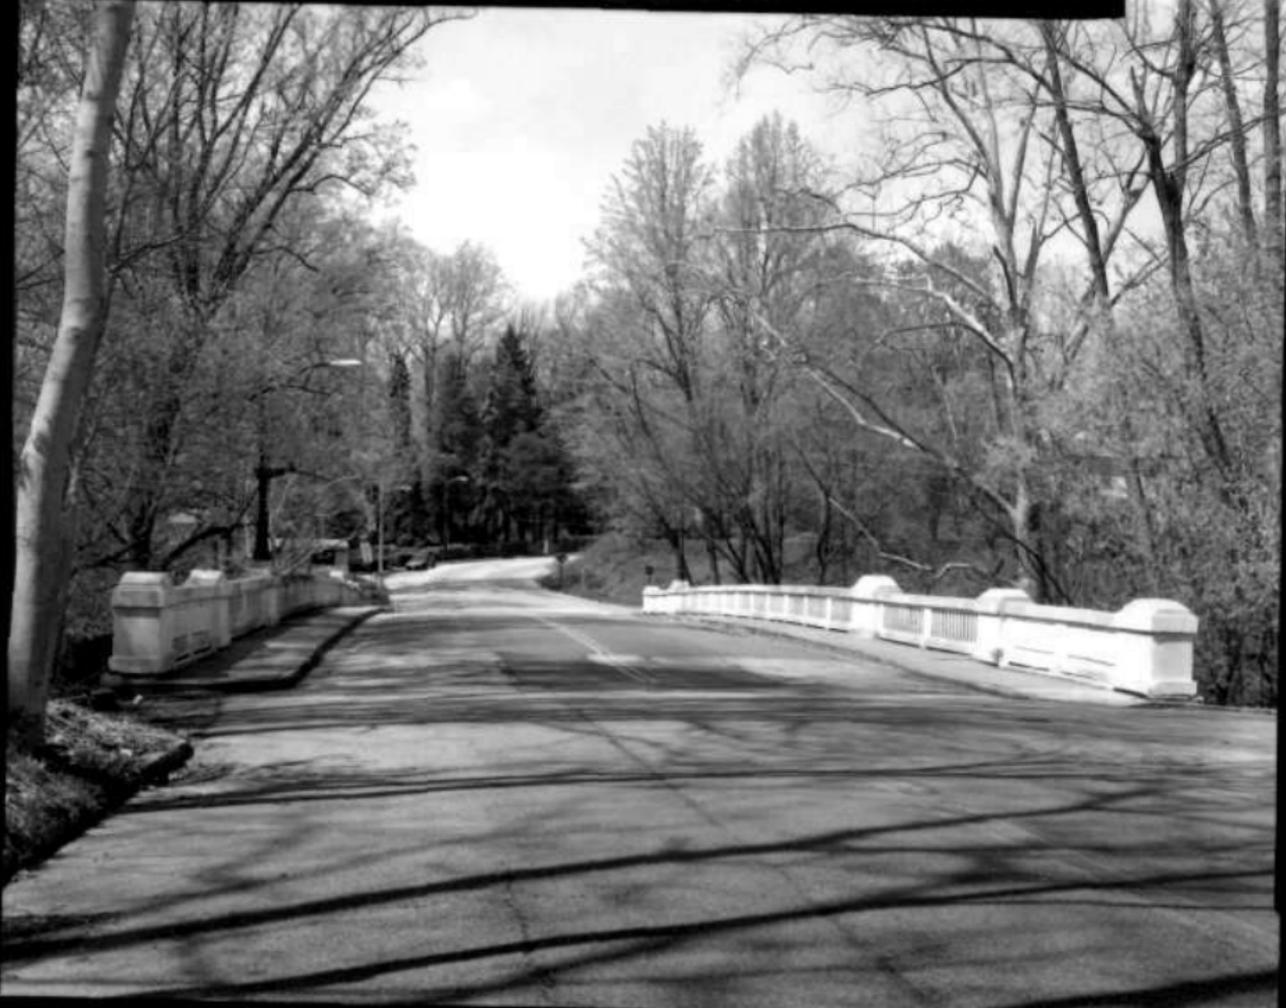
5 OF 21

DECK VIEW, FROM EAST

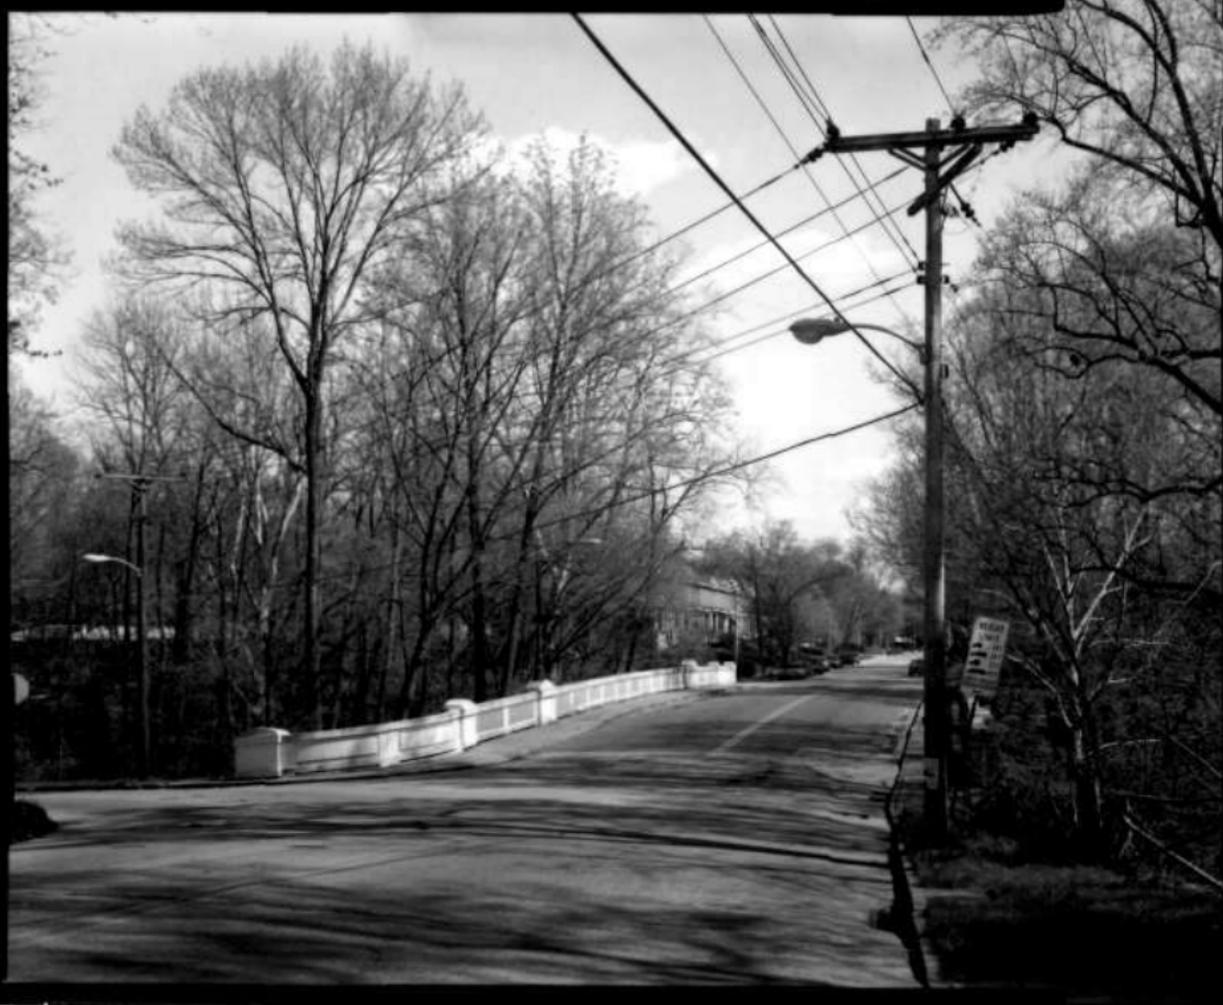
6 OF 21

- MD-B-4623-6 DECK VIEW, FROM WEST, OF CLIFTON AVENUE BRIDGE SHOWING REINFORCED CONCRETE SOLID PANEL AND PIERCED PARAPETS, CONCRETE SIDEWALK, AND BITUMINOUS WEARING SURFACE

DECK VIEW, FROM WEST

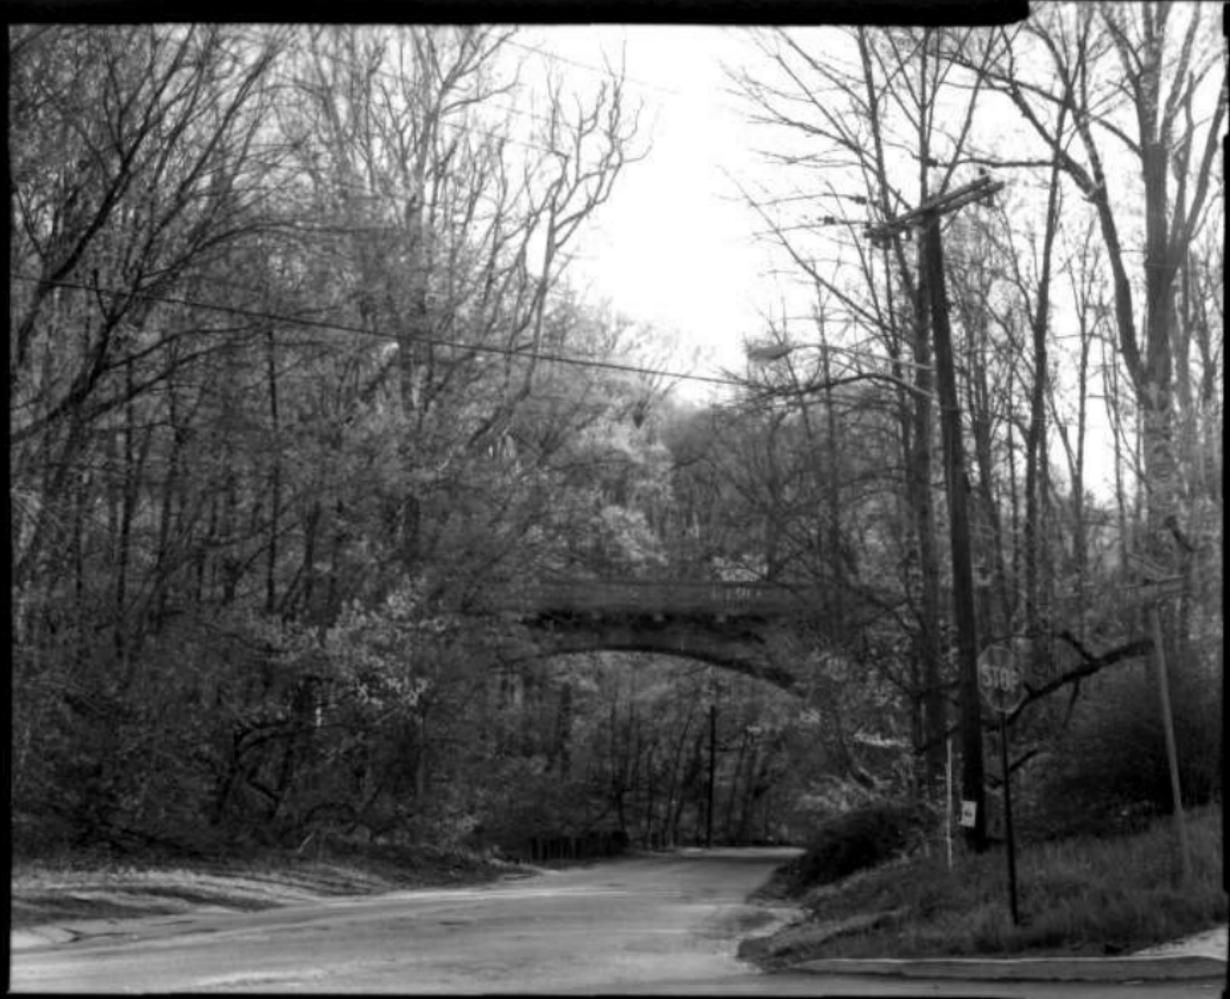
7 of 21

- MD-B-4623-7 NORTH ELEVATION OF CLIFTON AVENUE BRIDGE OVER WINDSOR MILL ROAD

NORTH ELEVATION

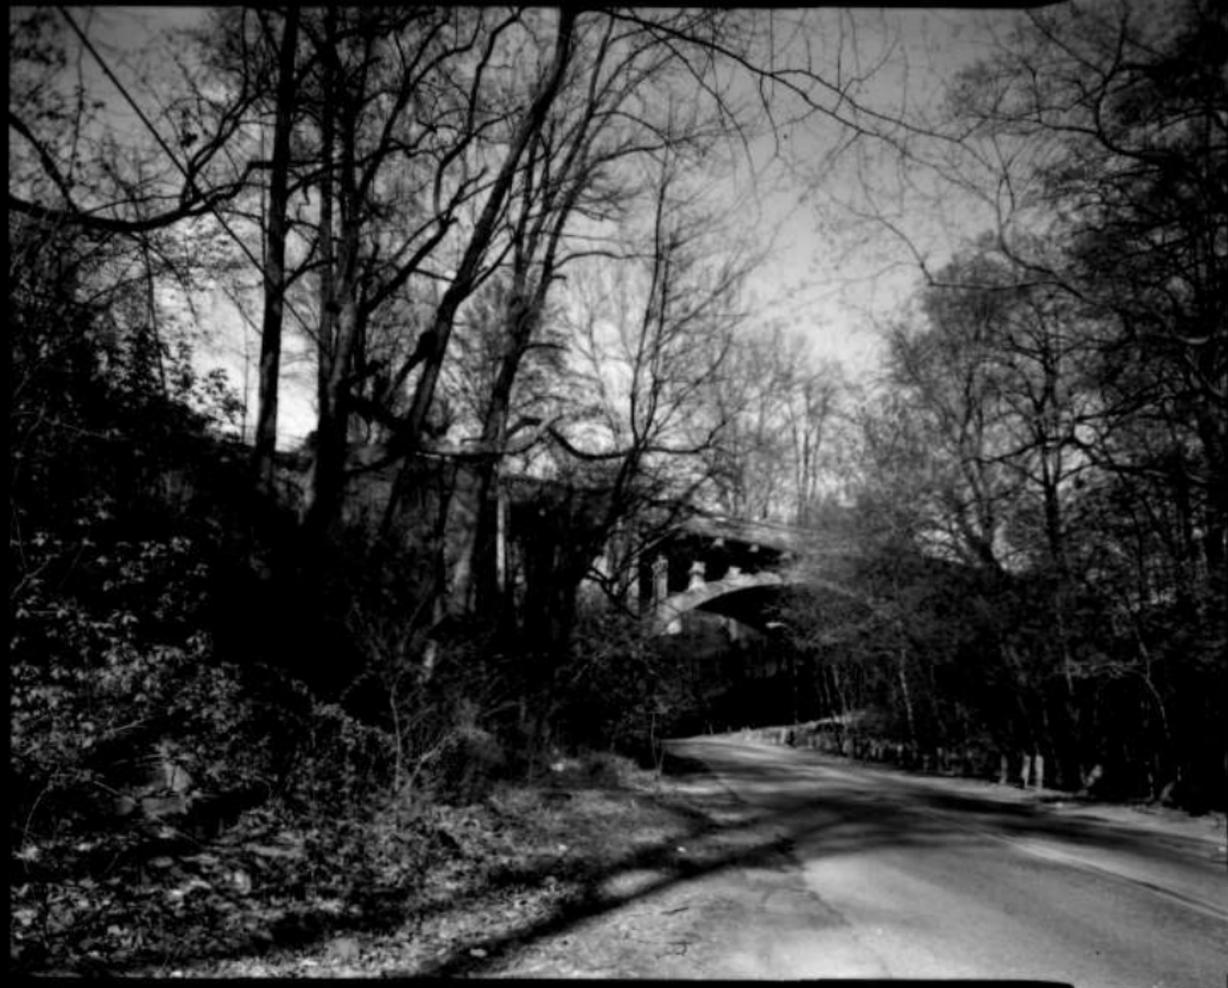
8 OF 21

- MD-B-4623-8 SOUTH ELEVATION OF CLIFTON AVENUE BRIDGE OVER WINDSOR MILL ROAD

SOUTH ELEVATION

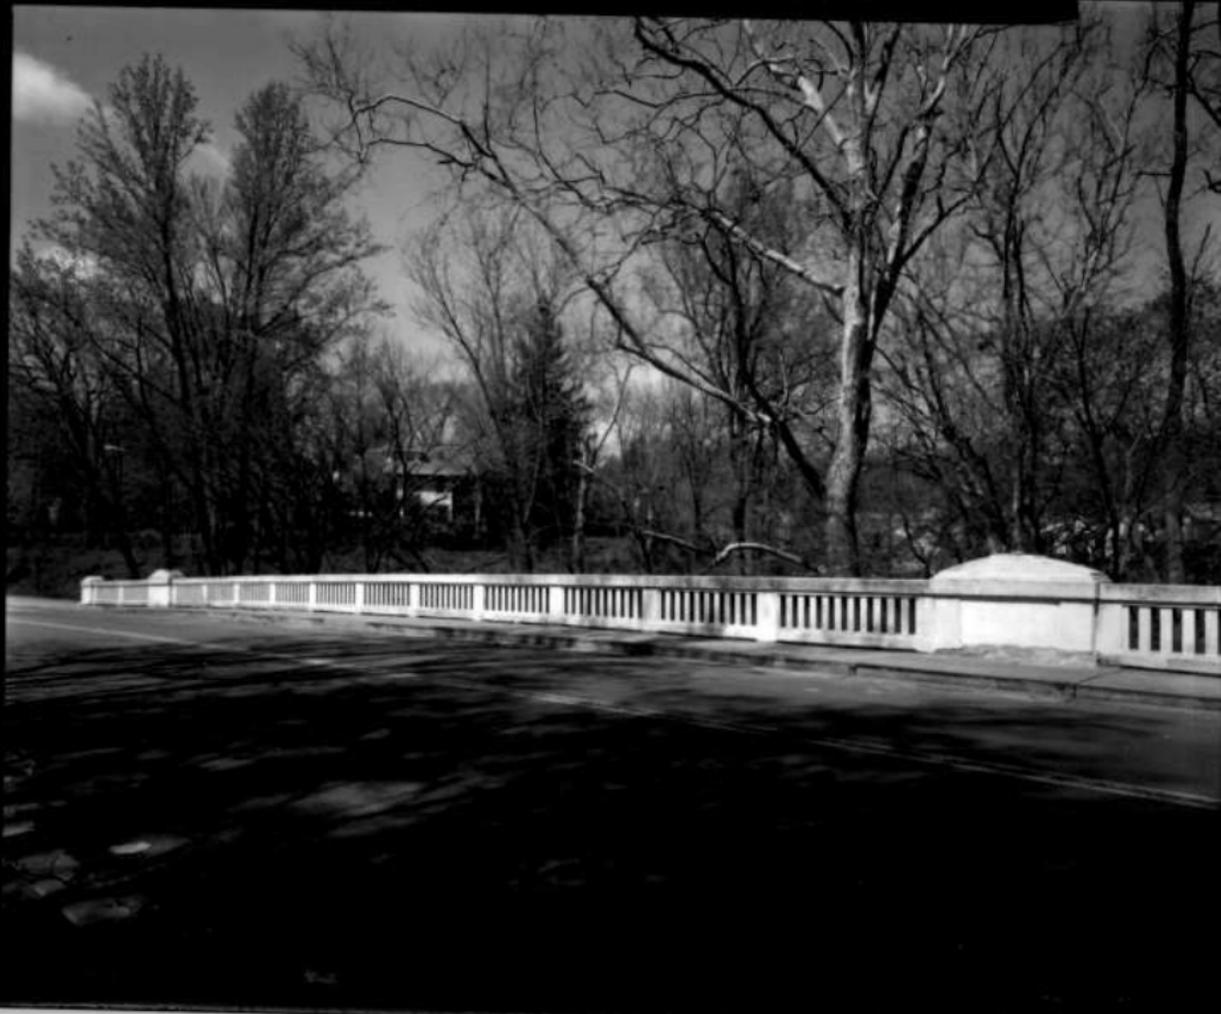
9 of 21

- MD-B-4623-9 DETAIL, FROM SOUTH, SHOWING PIERCED PANEL REINFORCED CONCRETE PARAPET, SOLID REINFORCED CONCRETE SET-BACK BLOCKS, CONCRETE SIDEWALK, AND BITUMINOUS WEARING SURFACE

DETAIL, FROM SOUTH

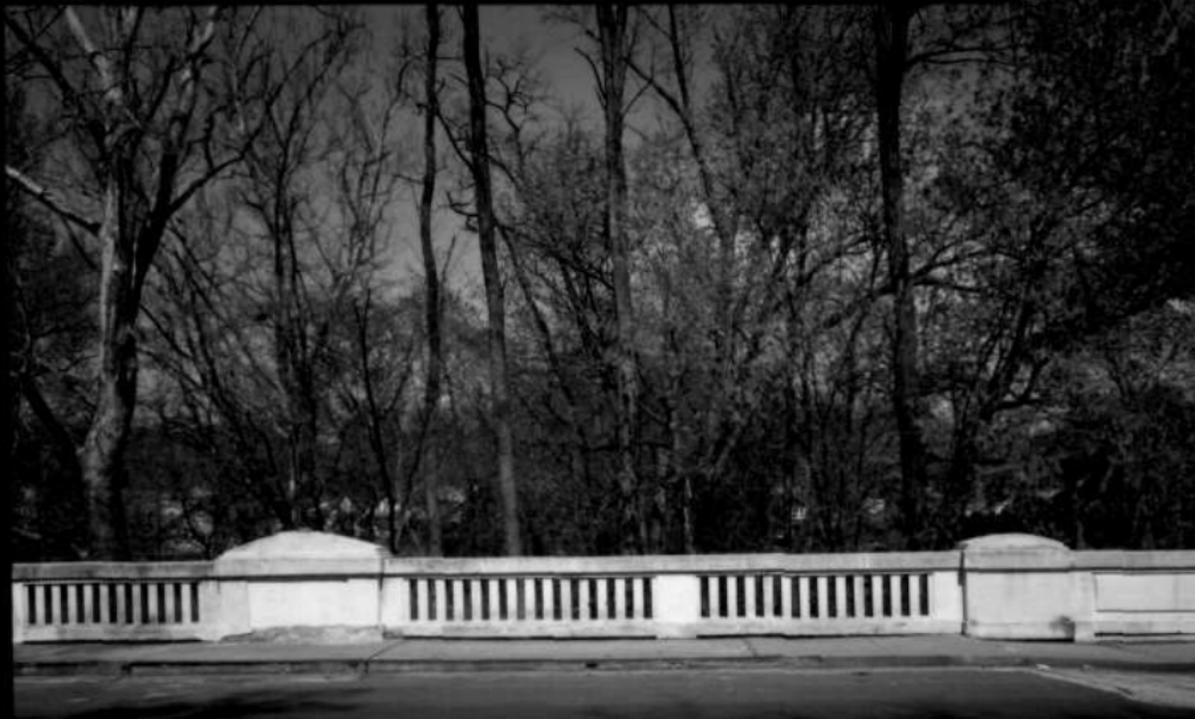
10 OF 21

- MD-B-4623-10 DETAIL, FROM SOUTH, SHOWING PIERCED PANEL REINFORCED CONCRETE PARAPET, SOLID REINFORCED CONCRETE SET-BACK BLOCKS, CONCRETE SIDEWALK, AND BITUMINOUS WEARING SURFACE

DETAIL, FROM SOUTH

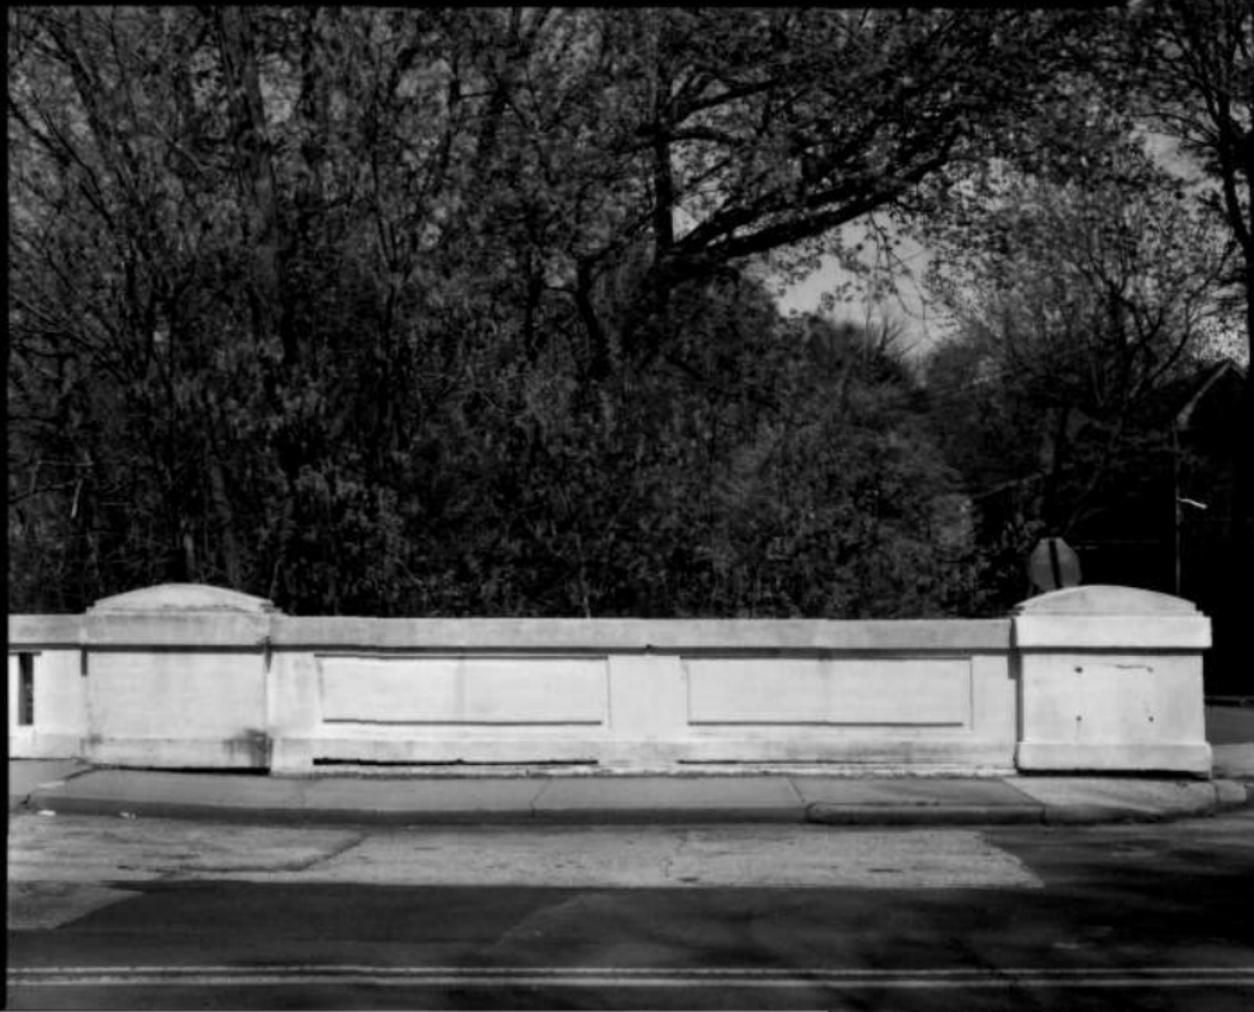
11 OF 21

- MD-B-4623-11 DETAIL, FROM SOUTH, SHOWING SOLID PANEL REINFORCED CONCRETE PARAPET, SOLID REINFORCED CONCRETE SET-BACK BLOCKS, AND CONCRETE SIDEWALK

DETAIL, FROM SOUTH

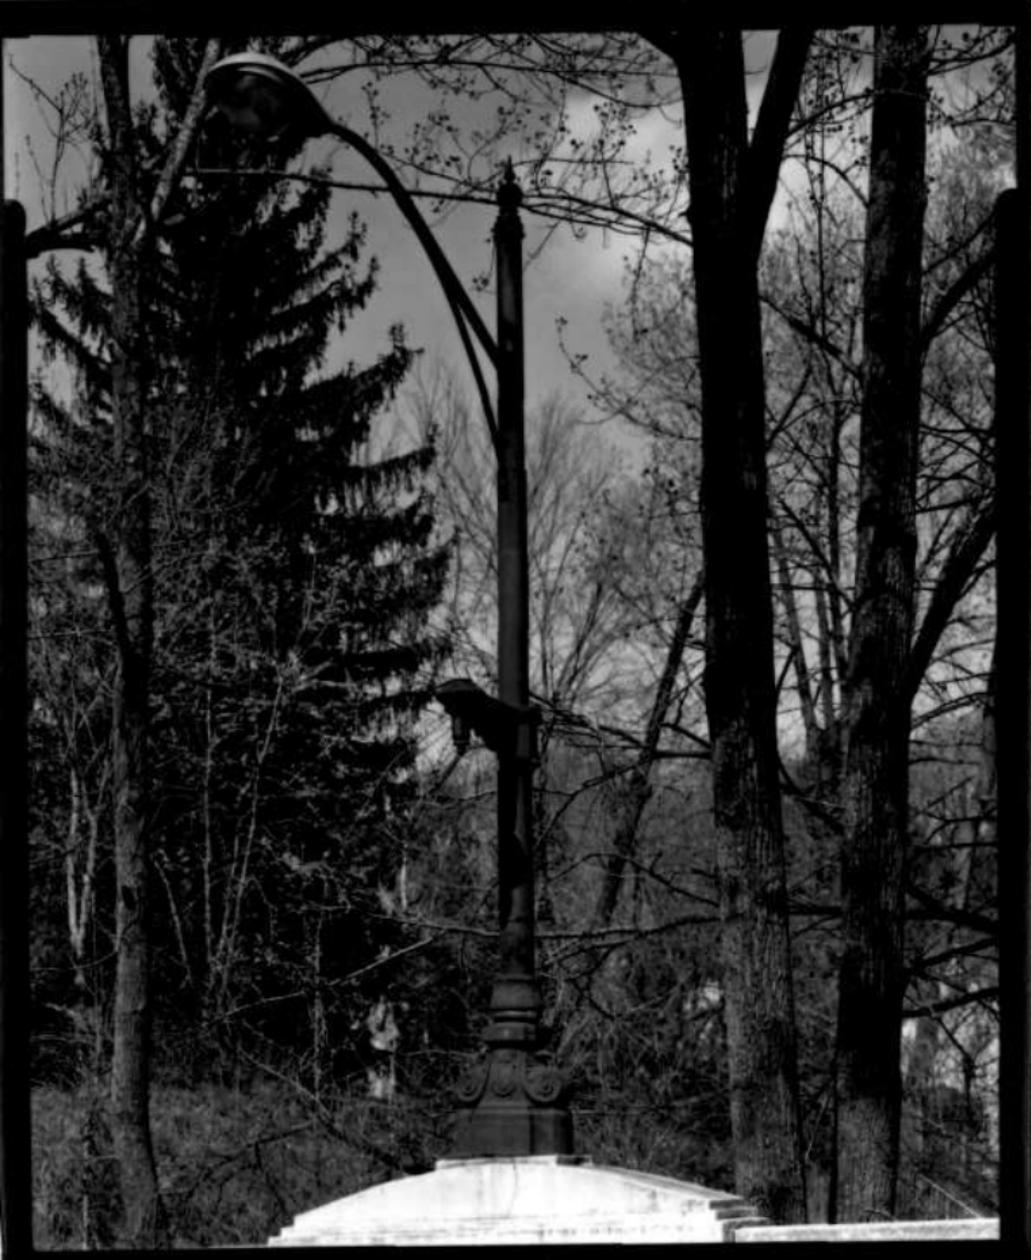
12 OF 21

- MD-B-4623-12 VIEW, FROM SOUTH, OF ORNAMENTAL METAL LAMP STANDARD AND TOP OF SOLID REINFORCED CONCRETE SET-BACK BLOCK

VIEW, FROM NORTH, OF LAND STANDARD

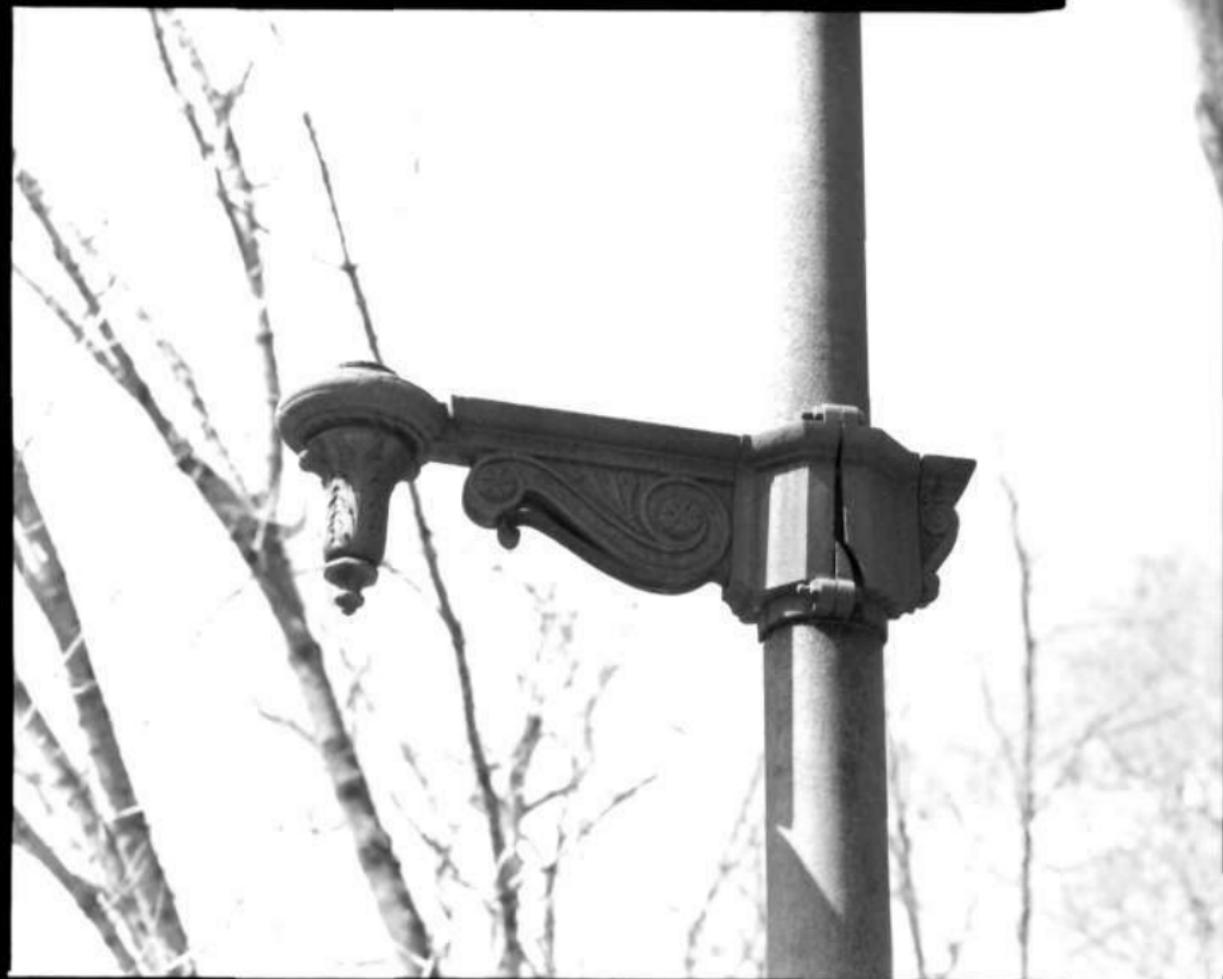
13 OF 21

- MD-B-4623-13 DETAIL, FROM EAST, SHOWING ORIGINAL LAMP SUPPORT OF ORNAMENTAL METAL LAMP STANDARD

DETAIL, FROM NORTH, OF LAMP SUPPORT

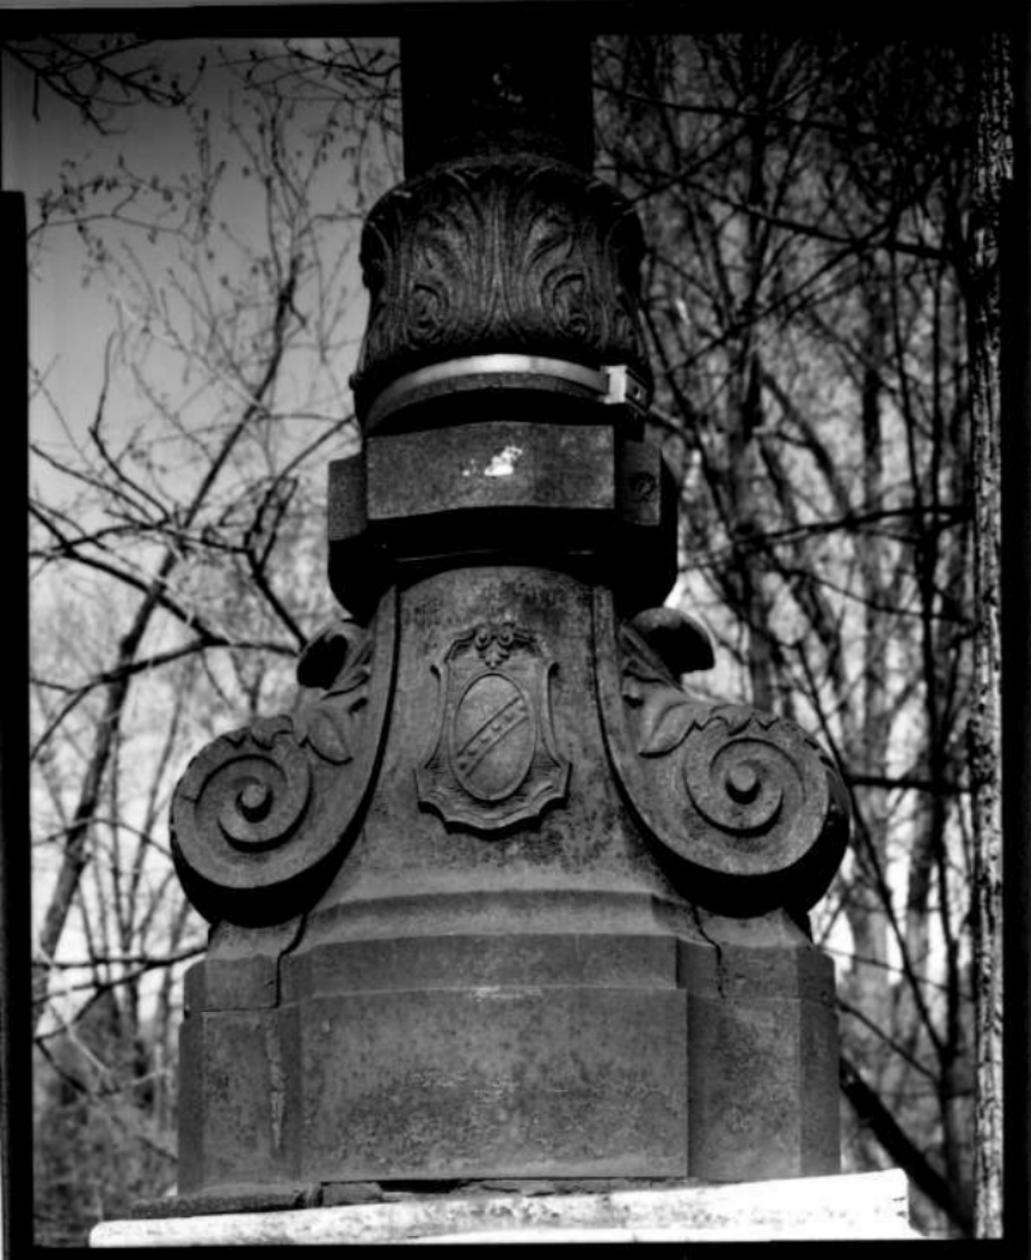
14 OF 21

- MD-B-4623-14 DETAIL, FROM SOUTH, SHOWING BASE OF ORNAMENTAL METAL LAMP STANDARD

DETAIL, FROM NORTH, OF LAMP STANDARD BASE

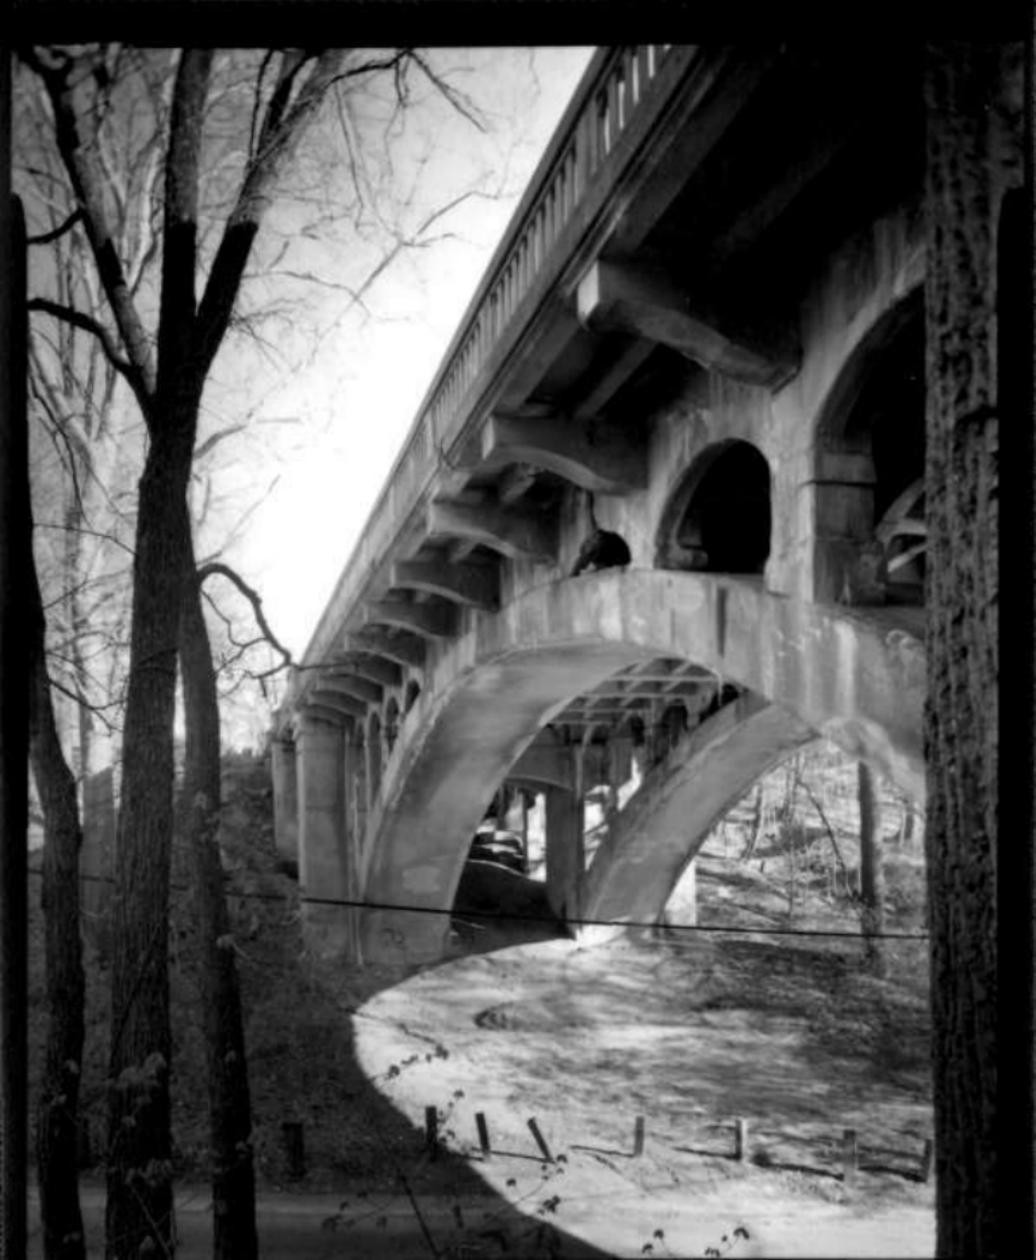
15 OF 21

- MD-B-4623-15 OBLIQUE VIEW, FROM NORTHWEST, SHOWING OPEN SPANDREL REINFORCED CONCRETE ARCHES, UNDERNEATH OF REINFORCED CONCRETE DECK, REINFORCED CONCRETE BEAMS, REINFORCED CONCRETE PIERS, AND SOUTH REINFORCED CONCRETE PARAPET

OBLIQUE VIEW, FROM NORTH WEST

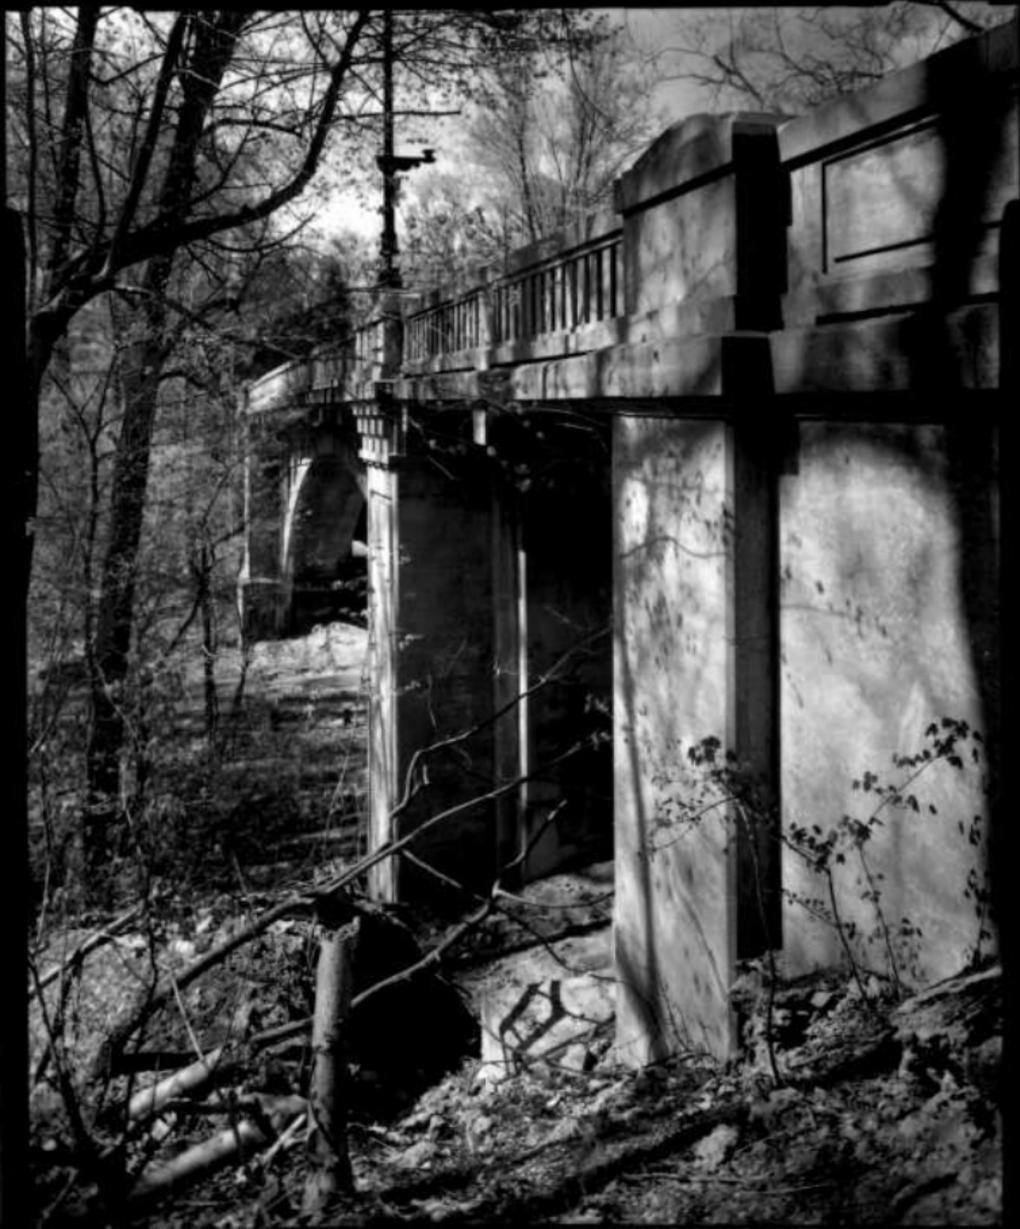
16 OF 21

- MD-B-4623-16 OBLIQUE VIEW, FROM SOUTHEAST, SHOWING EAST REINFORCED CONCRETE ABUTMENT, REINFORCED CONCRETE PIERS, SOUTH OPEN SPANDREL REINFORCED CONCRETE ARCH, SOUTH REINFORCED CONCRETE PARAPET, AND ORNAMENTAL METAL LAMP STANDARD

OBLIQUE VIEW, FROM SOUTHEAST

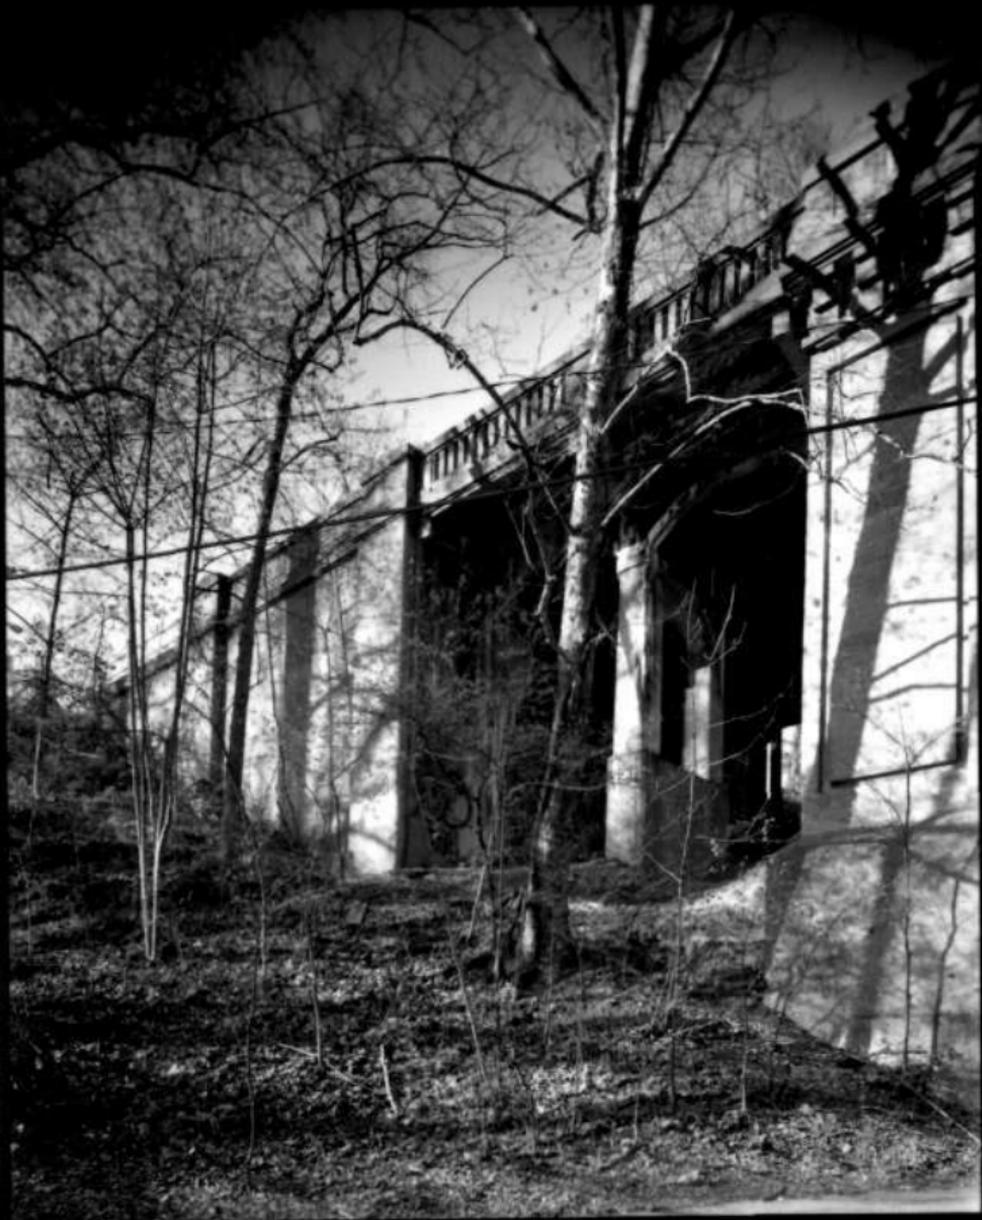
17 OF 21

- MD-B-4623-17 OBLIQUE VIEW, FROM SOUTHEAST, SHOWING WEST APPROACH SPAN, WEST REINFORCED CONCRETE ABUTMENT, REINFORCED CONCRETE INTERMEDIATE PIERS, REINFORCED CONCRETE ARCHES, UNDERNEATH OF REINFORCED CONCRETE DECK, REINFORCED CONCRETE BEAMS, AND REINFORCED CONCRETE PARAPET

OBLIQUE VIEW, FROM SOUTHEAST
