CUFTON AVE OVER WINDSOR MILL RD

MARYLAND INVENTORY OF HISTORIC BRIDGES
HISTORIC BRIDGE INVENTORY
MARYLAND STATE HIGHWAY ADMINISTRATION/
MARYLAND HISTORICAL TRUST

SHA Bridge No. BC 2502 Bridge name Clifton Avenue over Windsor Mill Road

HAER NO. MD-B-4623

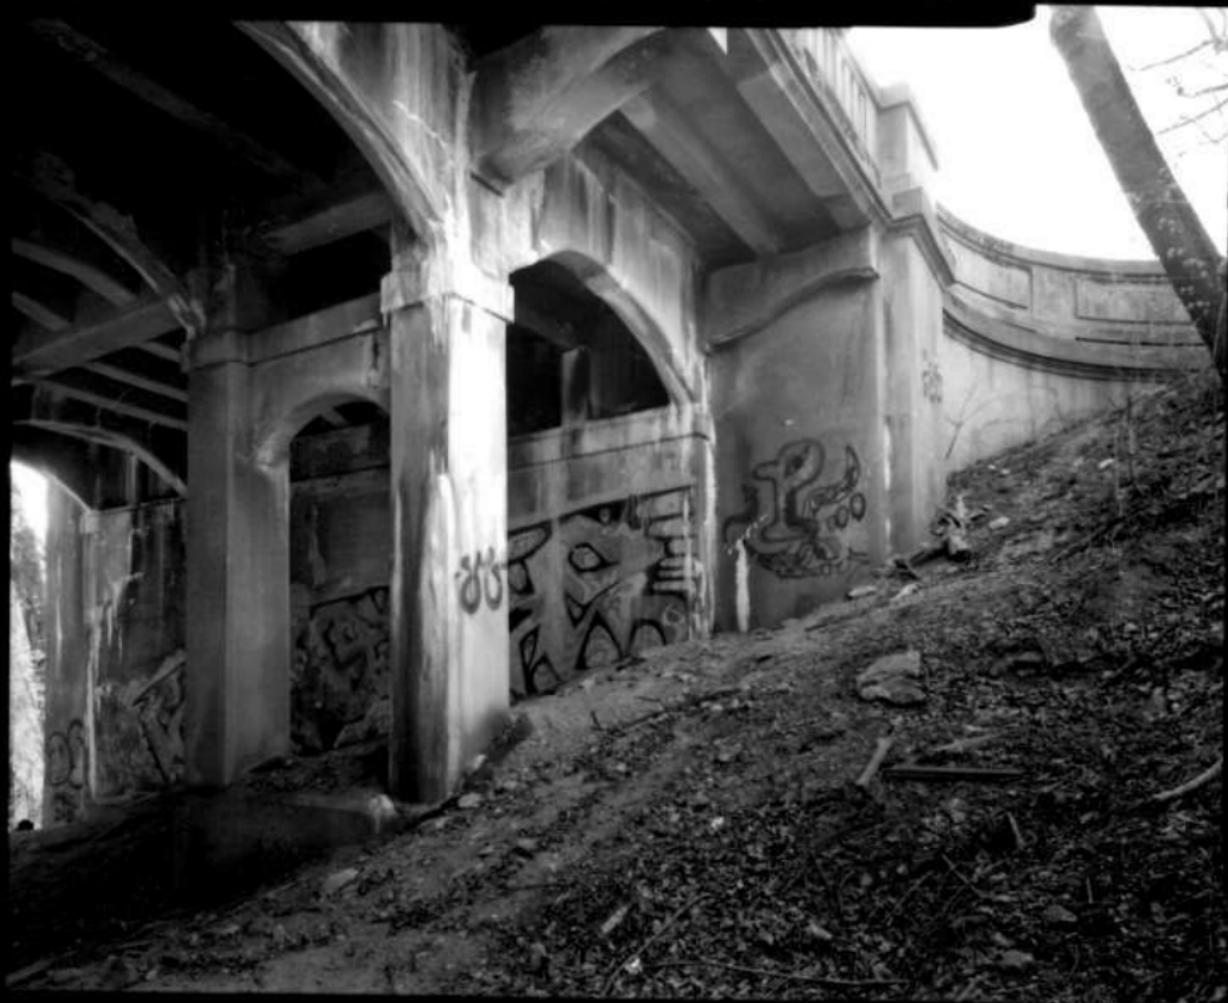
18 OF 21

- MD-B-4623-18 DETAIL, FROM NORTHEAST, SHOWING WEST APPROACH SPAN, WEST REINFORCED CONCRETE ABUTMENT, REINFORCED CONCRETE INTERMEDIATE PIERS, REINFORCED CONCRETE ARCHES, UNDERNEATH OF REINFORCED CONCRETE DECK, AND REINFORCED CONCRETE BEAMS
- MD-B-4623-19 DETAIL, FROM NORTHEAST, SHOWING WEST APPROACH SPAN, WEST REINFORCED CONCRETE ABUTMENT, REINFORCED CONCRETE INTERMEDIATE PIERS, REINFORCED CONCRETE ARCH, UNDERNEATH OF REINFORCED CONCRETE DECK, AND REINFORCED CONCRETE BEAMS
- MD-B-4623-20 DETAIL, FROM EAST, SHOWING NORTH OPEN SPANDREL REINFORCED CONCRETE ARCH, UNDERNEATH OF REINFORCED CONCRETE DECK, REINFORCED CONCRETE BEAMS, AND REINFORCED CONCRETE PIERS
- MD-B-4623-21 DETAIL, FROM EAST, SHOWING OPEN SPANDREL REINFORCED CONCRETE ARCHES, UNDERNEATH OF REINFORCED CONCRETE DECK, REINFORCED CONCRETE BEAMS, AND REINFORCED CONCRETE PIERS

DETAIL, FROM NORTHEAST

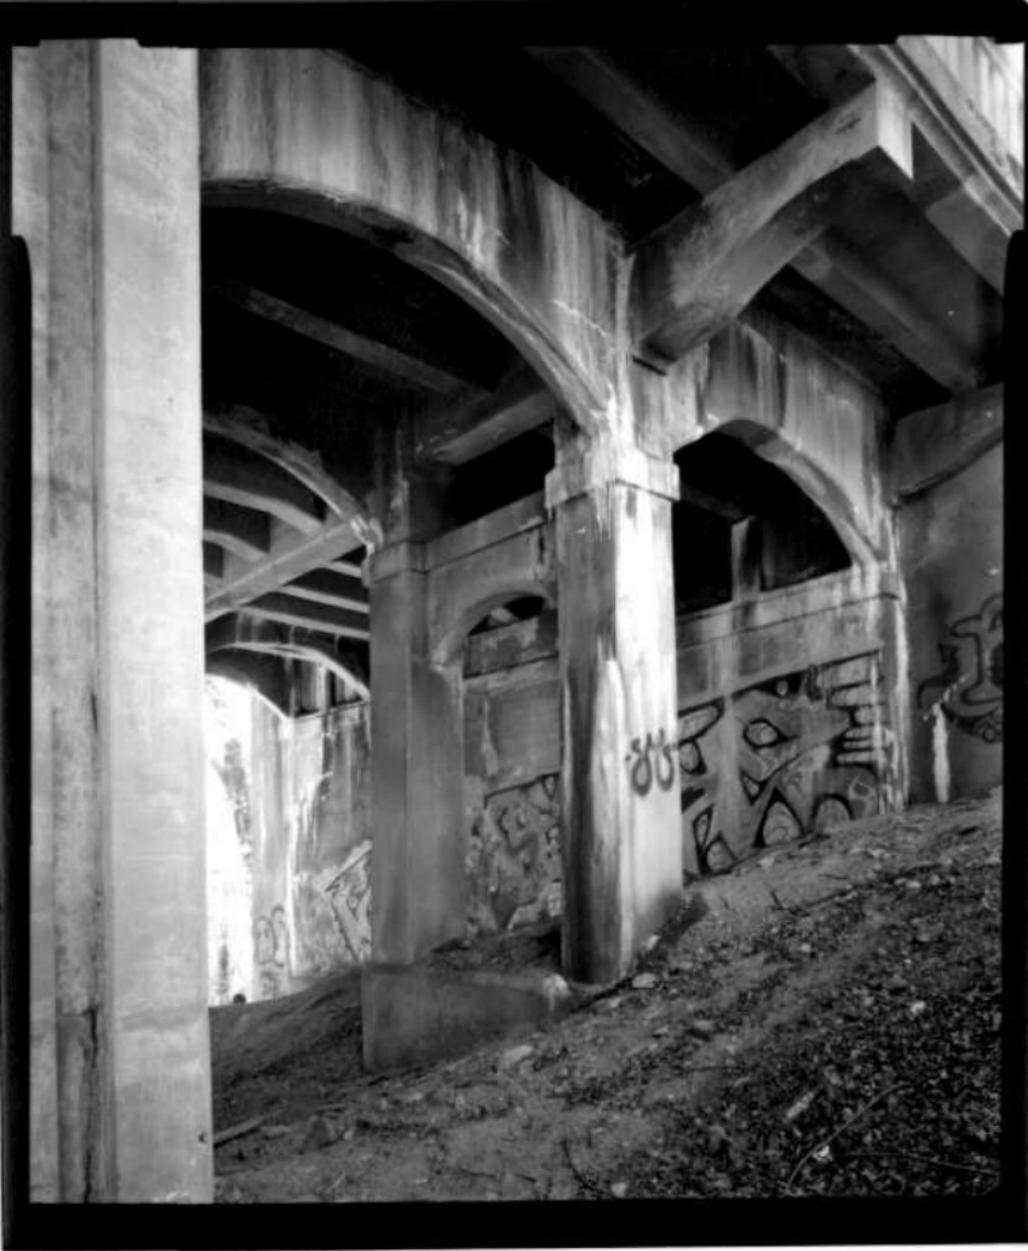
19 OF 21

DETAIL, FROM NORTHEAST
