**MARYLAND HISTORICAL TRUST
NR-ELIGIBILITY REVIEW FORM**

Property Name: Old Frederick Avenue Bridge Abutments Inventory Number: ~~XXX~~ B-5062

Project: Proposed Phase 2 Gwynns Falls Pathway Agency: Maryland State Highway Administration

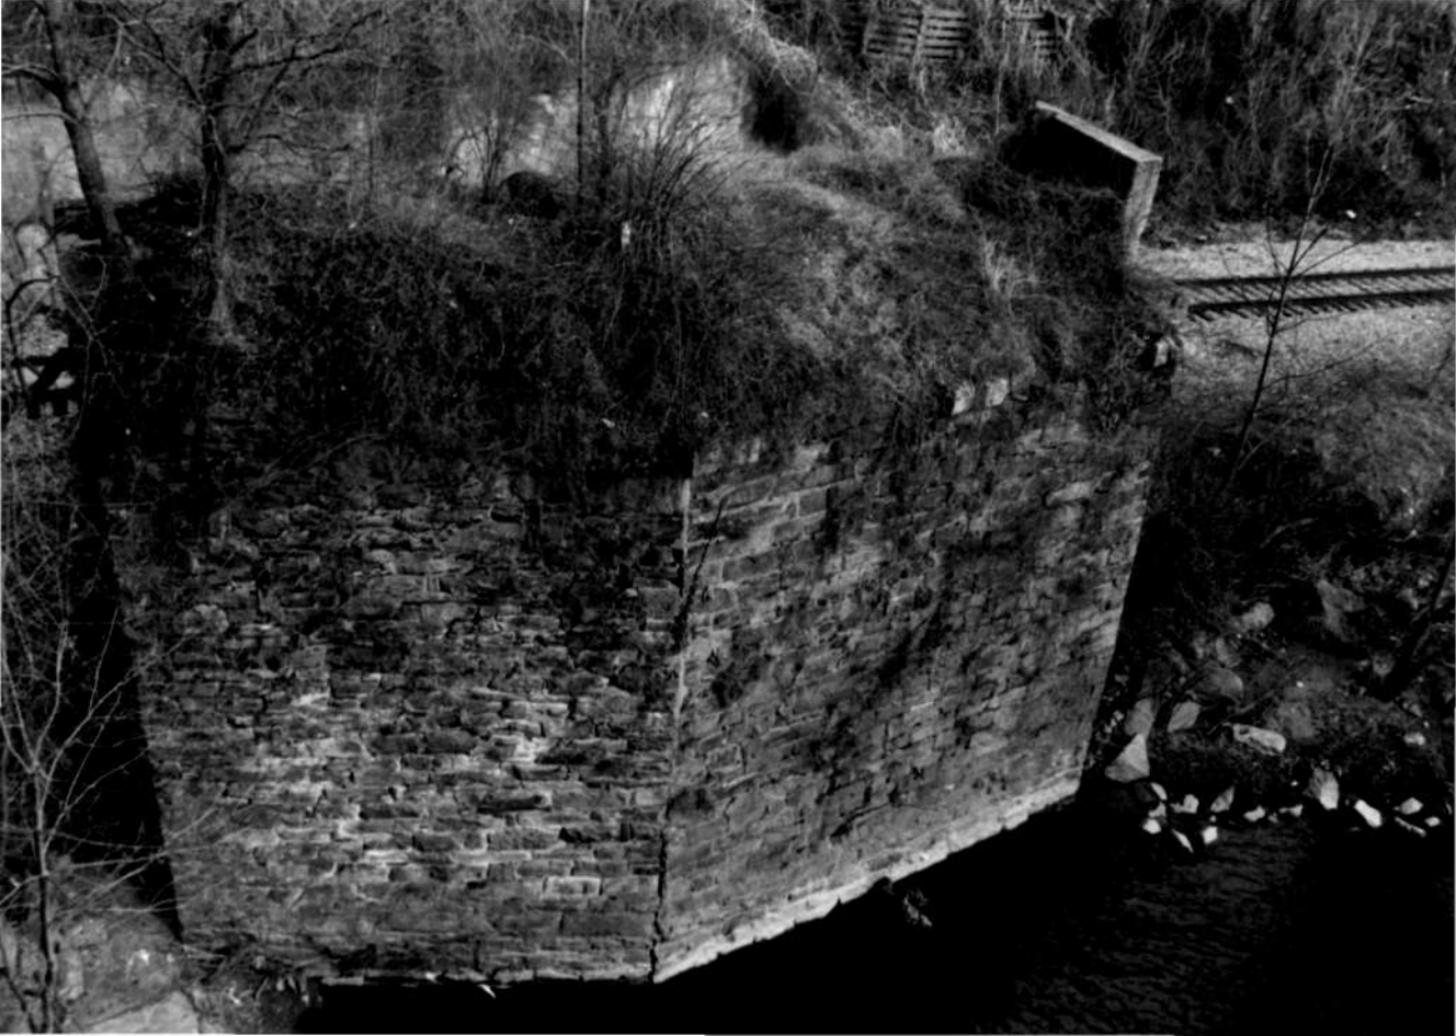
#1 OF 2

The Old Frederick Avenue Bridge Abutments are located on the east and west banks of the Gwynns Falls, south of the Frederick Avenue bridge. In general, the abutments are in a state of ruin. They contain rough-hewn stones of irregular size and interrupted coursing. The walls of the abutments are slightly battered and have a soft mortar. The east abutment is approximately 20 feet in height, while the west abutment remains are scattered over the bank and reach about 5 feet.

EAST ABUTMENT - TAKEN FROM FREDERICK AVENUE
BRIDGE

The overgrowth that obscures the resource has compromised the integrity of the resource. Overgrowth has invaded the resource and its surrounds and has caused pieces of stone and mortar to separate from the structure. The condition of the abutments is poor and is beyond reasonable repair. It has lost integrity of materials due to the loss of substance caused by demolition and weathering. Although the abutments meet the 50-year eligibility criterion, the remains do not have sufficient integrity to be eligible for listing on the National Register of Historic Places.

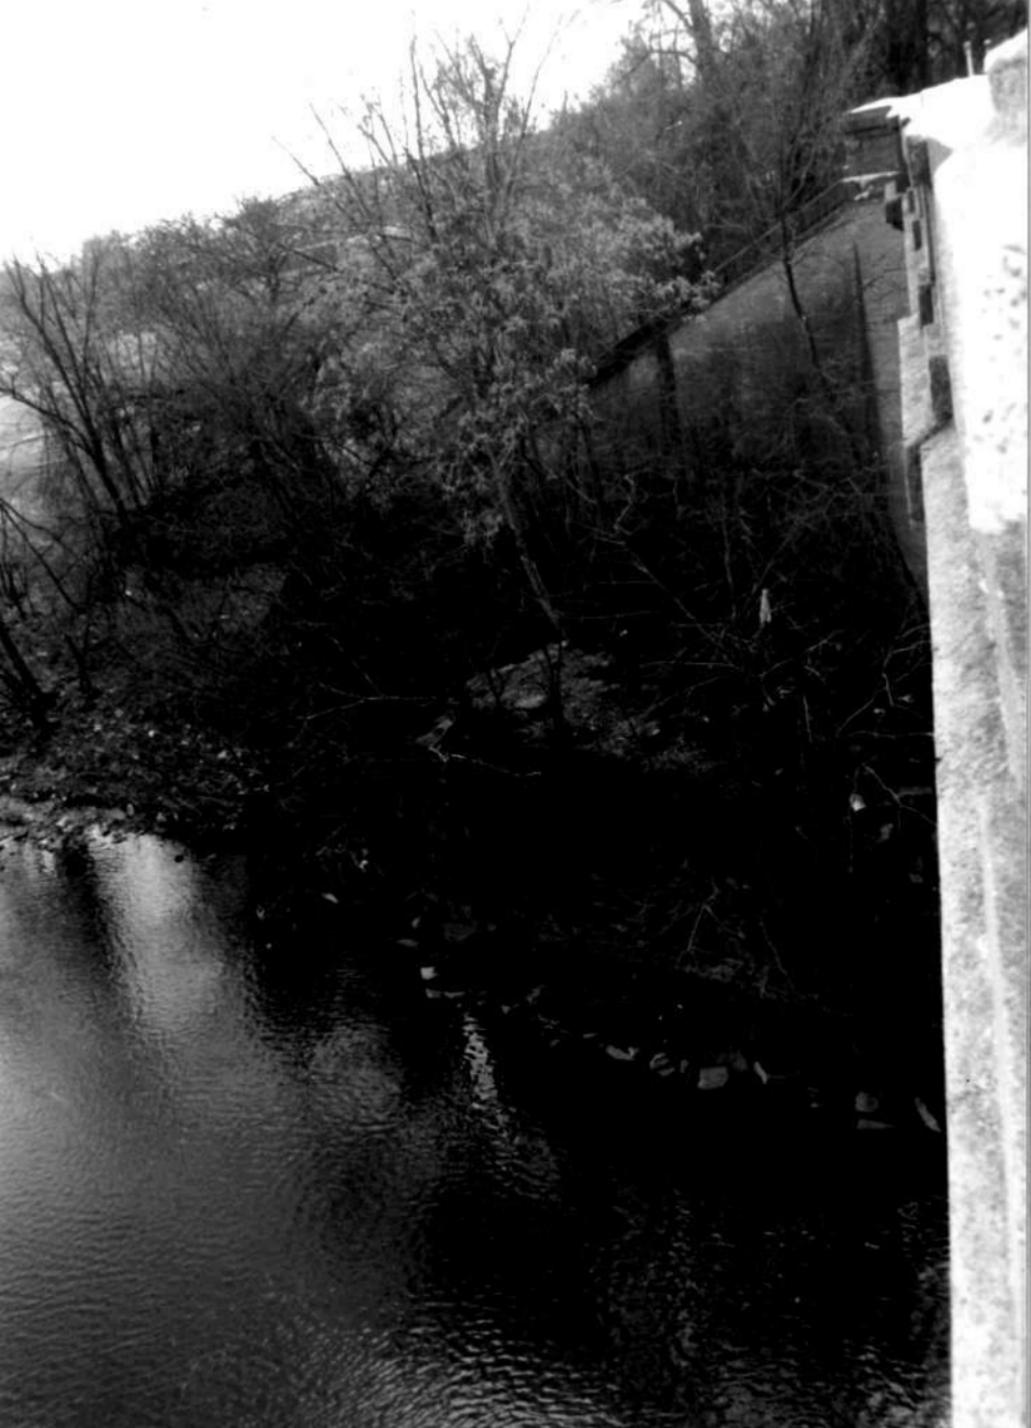
#2 OF 2

WEST APARTMENT PIVOTS TAKEN FROM FREDERICK AVENUE
BRIDGE
