Capsule Summary: East End Auto Garage (B-5077-1)

1717 Henneman Avenue

Maryland Historical Trust Maryland Inventory of Historic Properties Form

Inventory No. B-5077-1

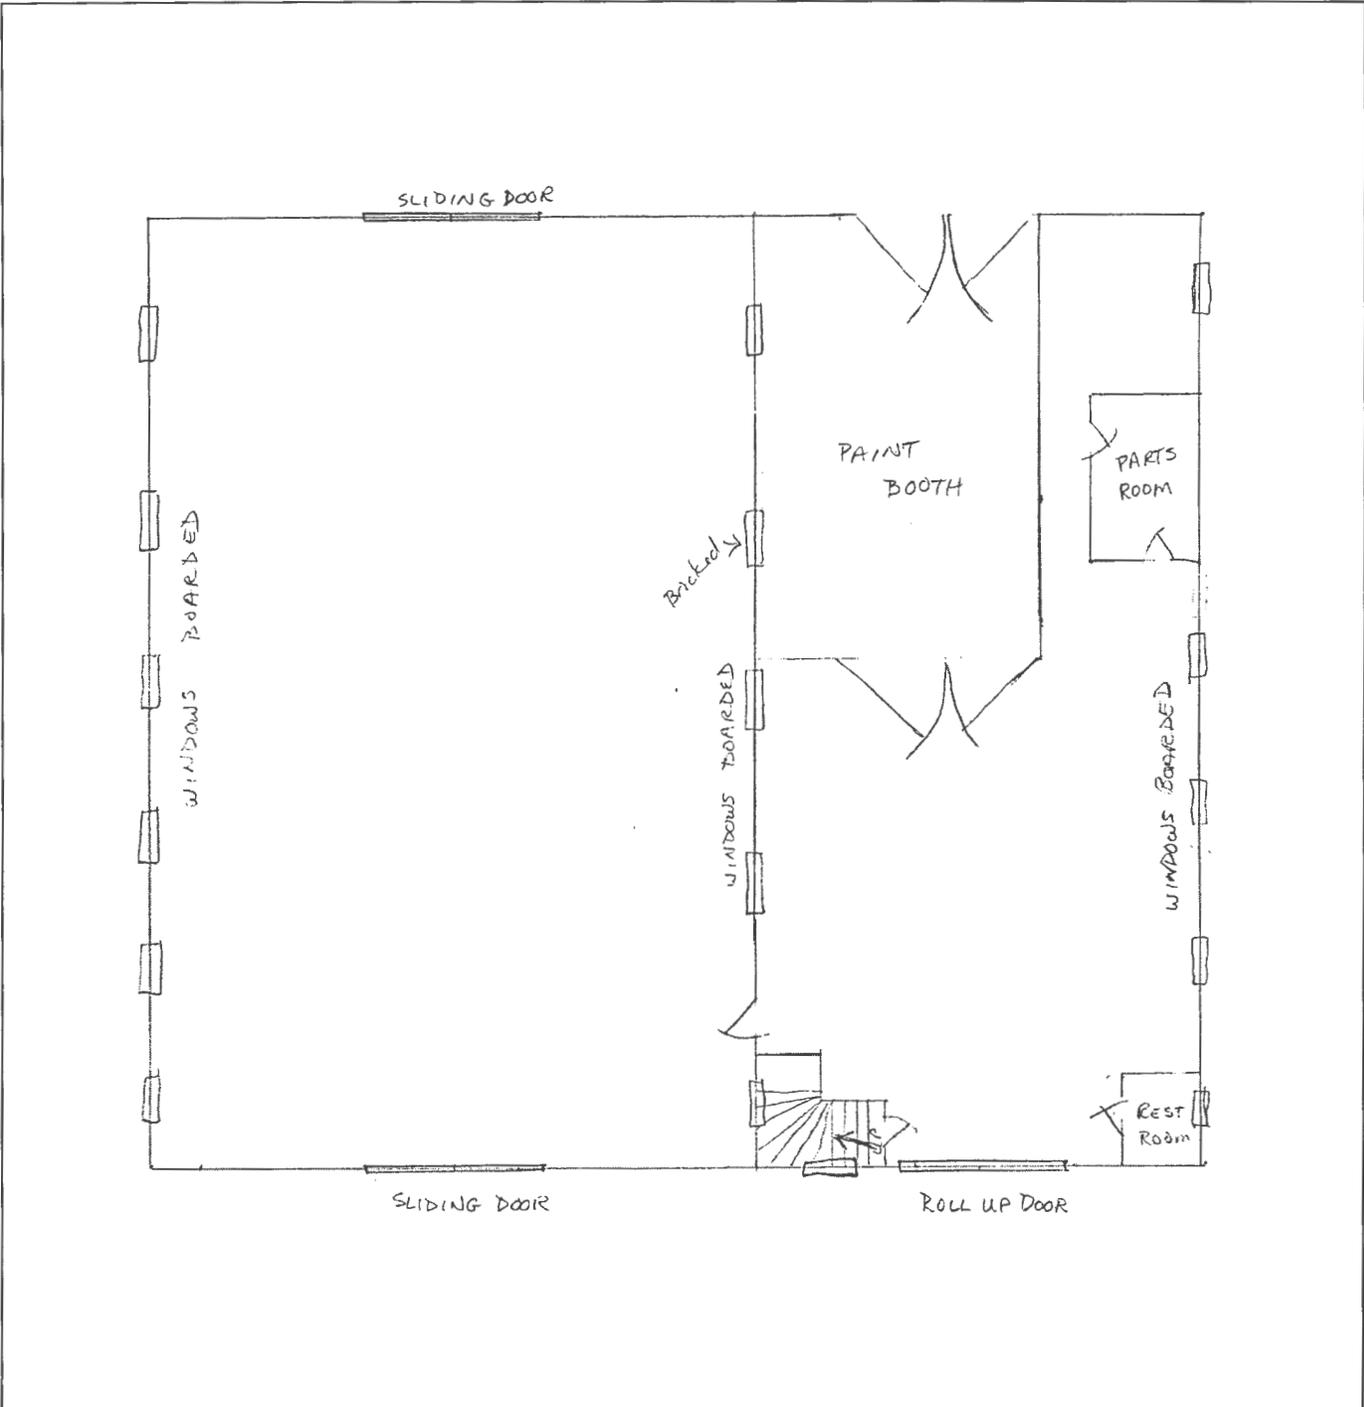
B-5077-1
East End Auto Garage Floor Plan
1717 Henneman Avenue
City of Baltimore
History Matters, LLC
July 2015
Ground Floor

Interior: The building features two adjoining rooms with mostly open floor plans. The two main sections (east and west) are separated by a painted-brick party wall that features a single-leaf wood door and arched window openings that have been blocked with plywood.

With the exception of a limited number of steel support columns, the east section of the garage comprises an uninterrupted floor plan. Finishes in this section include concrete floors, painted brick walls, and an exposed timber-frame ceiling structure with exposed mechanicals. The windows along the east wall feature flat steel lintels and are blocked on the interior with painted plywood.

The west section of the garage is partially open in floor plan, and it features a limited number of iron support columns. A stair to the second floor is located in the northeast corner; a small restroom occupies its northwest corner. The southern portion of the west section comprises a large paint booth, installed within the envelope of the room, and a parts room along the west wall. Both the restroom and the parts room are delineated with drywall. Finishes in the west section include concrete floors, painted-brick and drywall walls, and an exposed timber-frame ceiling structure with exposed mechanicals.

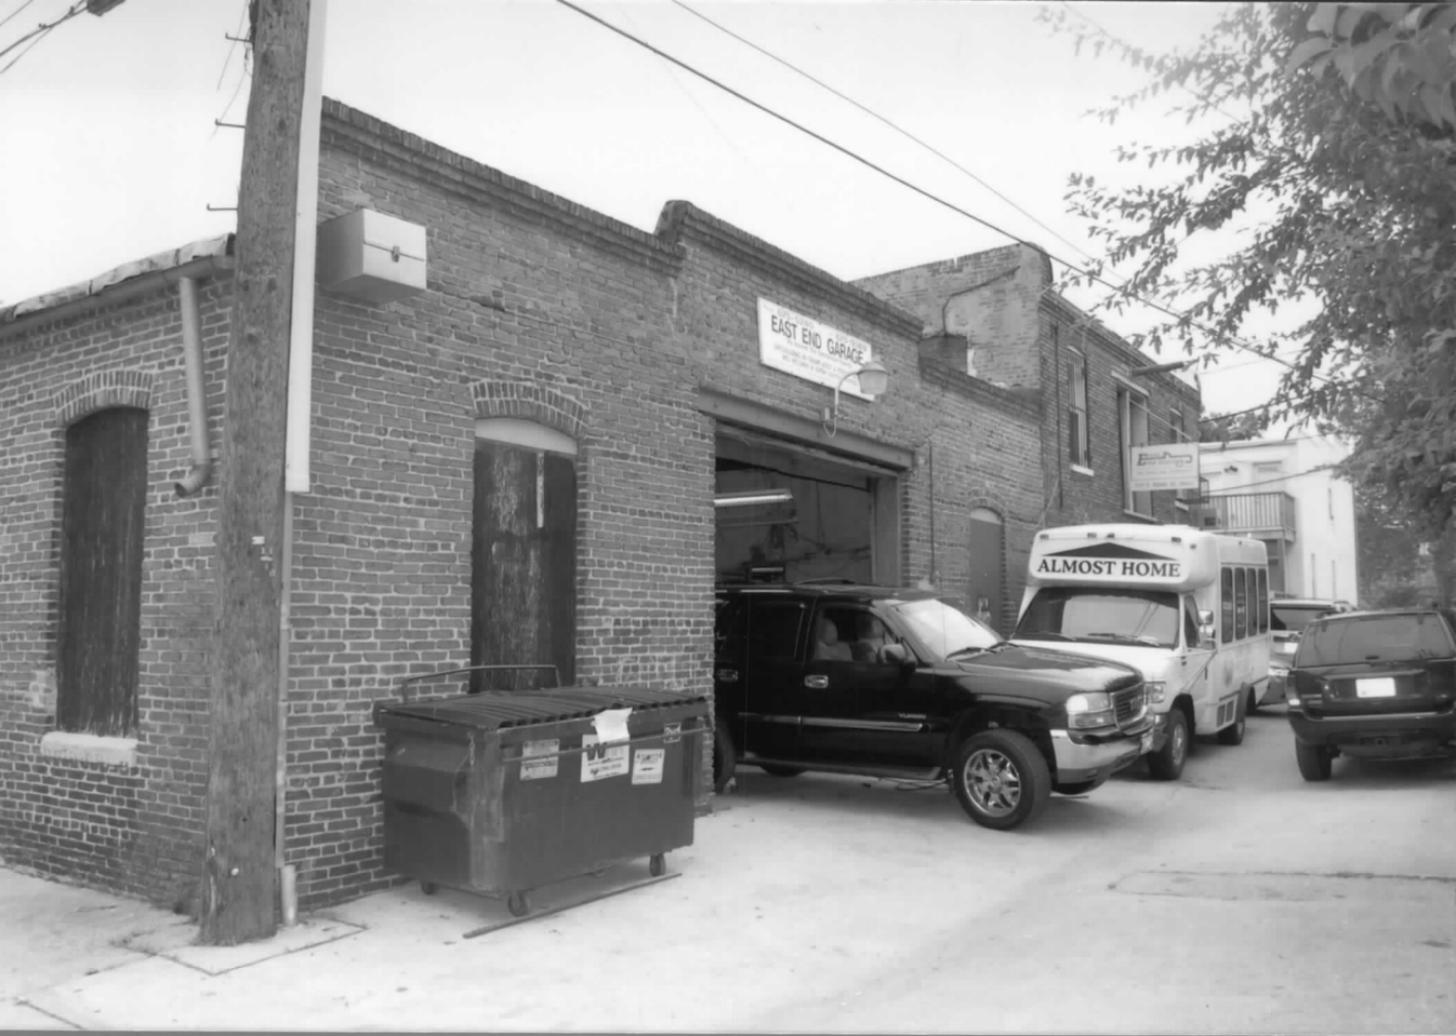
B-5077-1
East End Auto Garage
Baltimore, MD
History Matters, LLC
July 25, 2015
MD STHPO
Nelevation, Looking SW
01/11

The one-story east section of the north elevation is arranged in three bays. A corbelled brick parapet extends across the top of this section, stepping up slightly higher in the center to articulate the center bay. The center bay also features one of the primary vehicle entrances, which comprises two sliding wood doors on a metal track, with 5x3 inset glass in the upper portion of each door. The opening is topped by a flat steel lintel and

flanked by arched-brick window openings that occupy the other two bays on this section. Both windows have been blocked with painted plywood. A commercial sign is mounted above the vehicle opening.

The two-story west section of the north elevation is also arranged into three bays. It features a corbelled brick cornice (flat across all three bays). At the first story, the west section features a vehicle opening with a metal roll-up door in the center bay. The door is flanked by arched-brick window openings in the bays on both sides. The window openings have been blocked with painted plywood. At the second story, the center bay features a loading opening, which has been blocked by painted plywood, and a flat steel lintel with a hoist beam above. The east and west bays of this story each feature an arched-brick window opening with a vinyl one-over-one window.

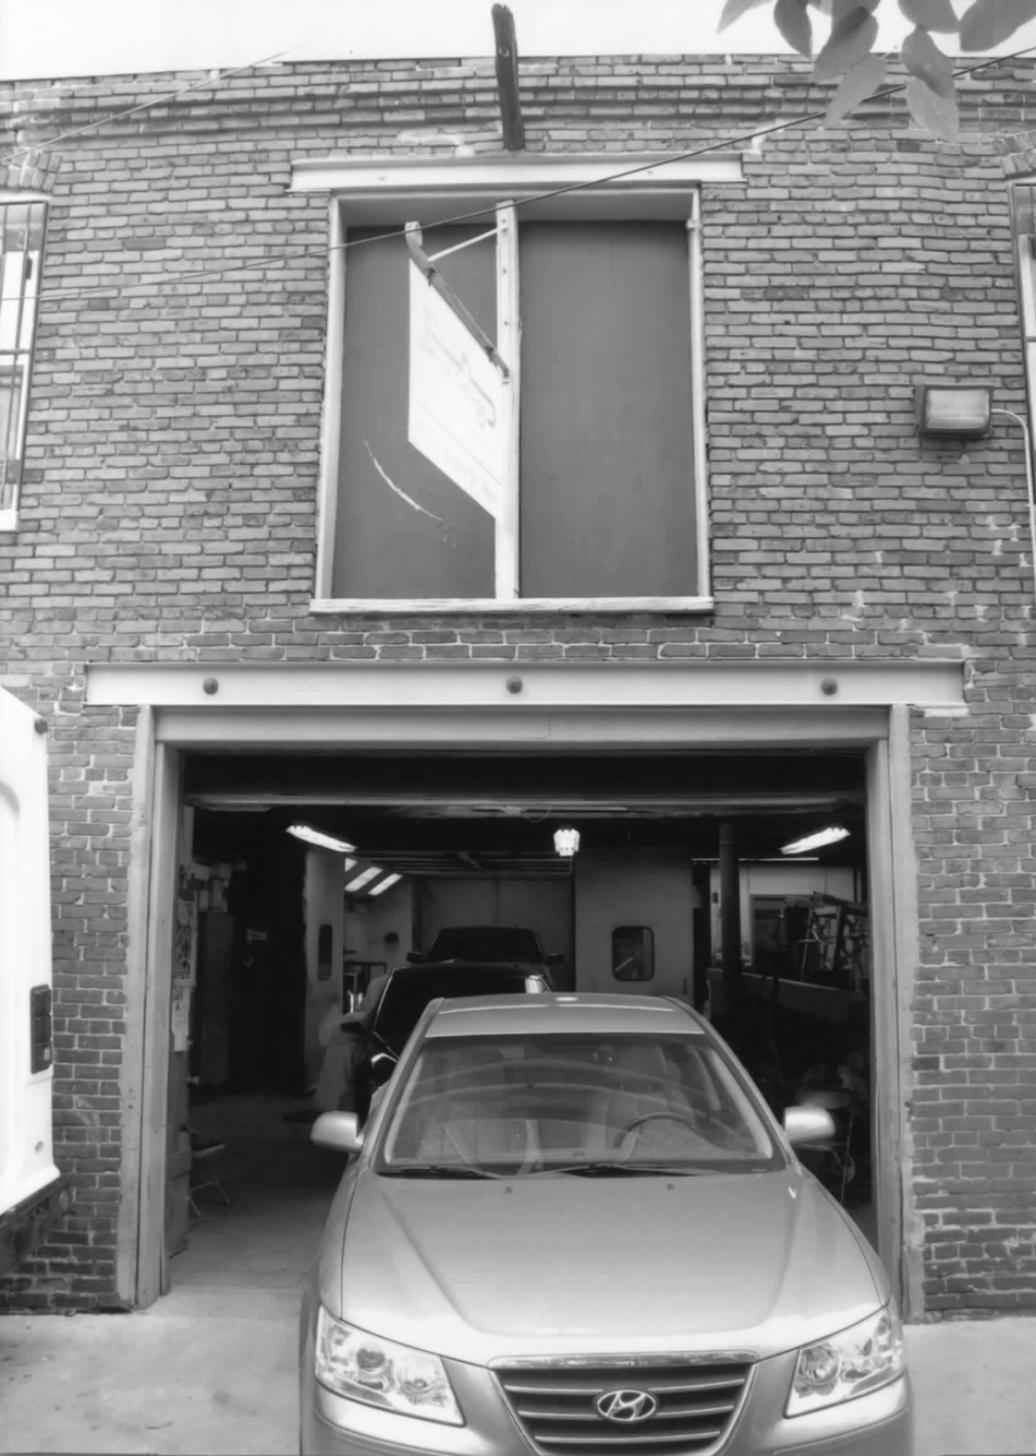
B-5077-1
East End Auto Garage
Baltimore, MD
History Matters, LLC
July 21, 2015
MD SHPO
N elevation, main entrance to
west building, looking S
02/11

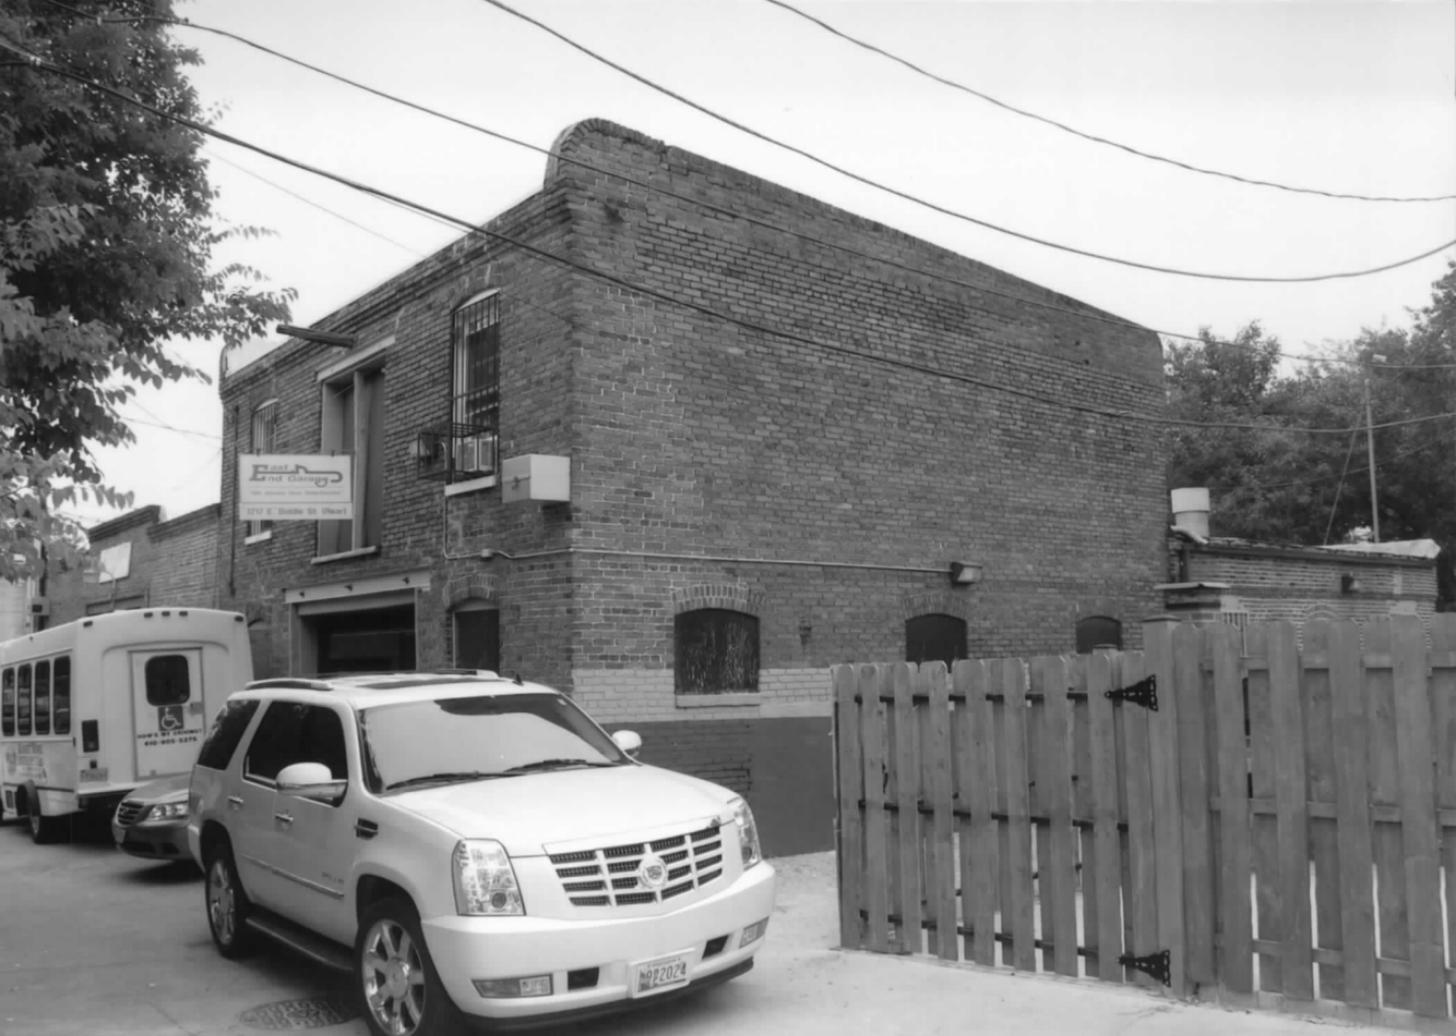
B-5077-1
East End Auto Garage
Baltimore, MD
History Matters, LLC
July 21, 2015
MD SHPO
N+W elevations, looking SE
03/11

The west elevation is divided between the two-story northern section and the one-story rear addition in the southwest corner of the building. The first story in the northern section features three small arched-brick window openings that have been blocked with painted plywood. There is no fenestration on the second story. The brick parapet wall is rounded on the north end and tapers to the south end. The west elevation of the addition features three small arched brick window openings that have been blocked and a brick string-course that runs above the windows.

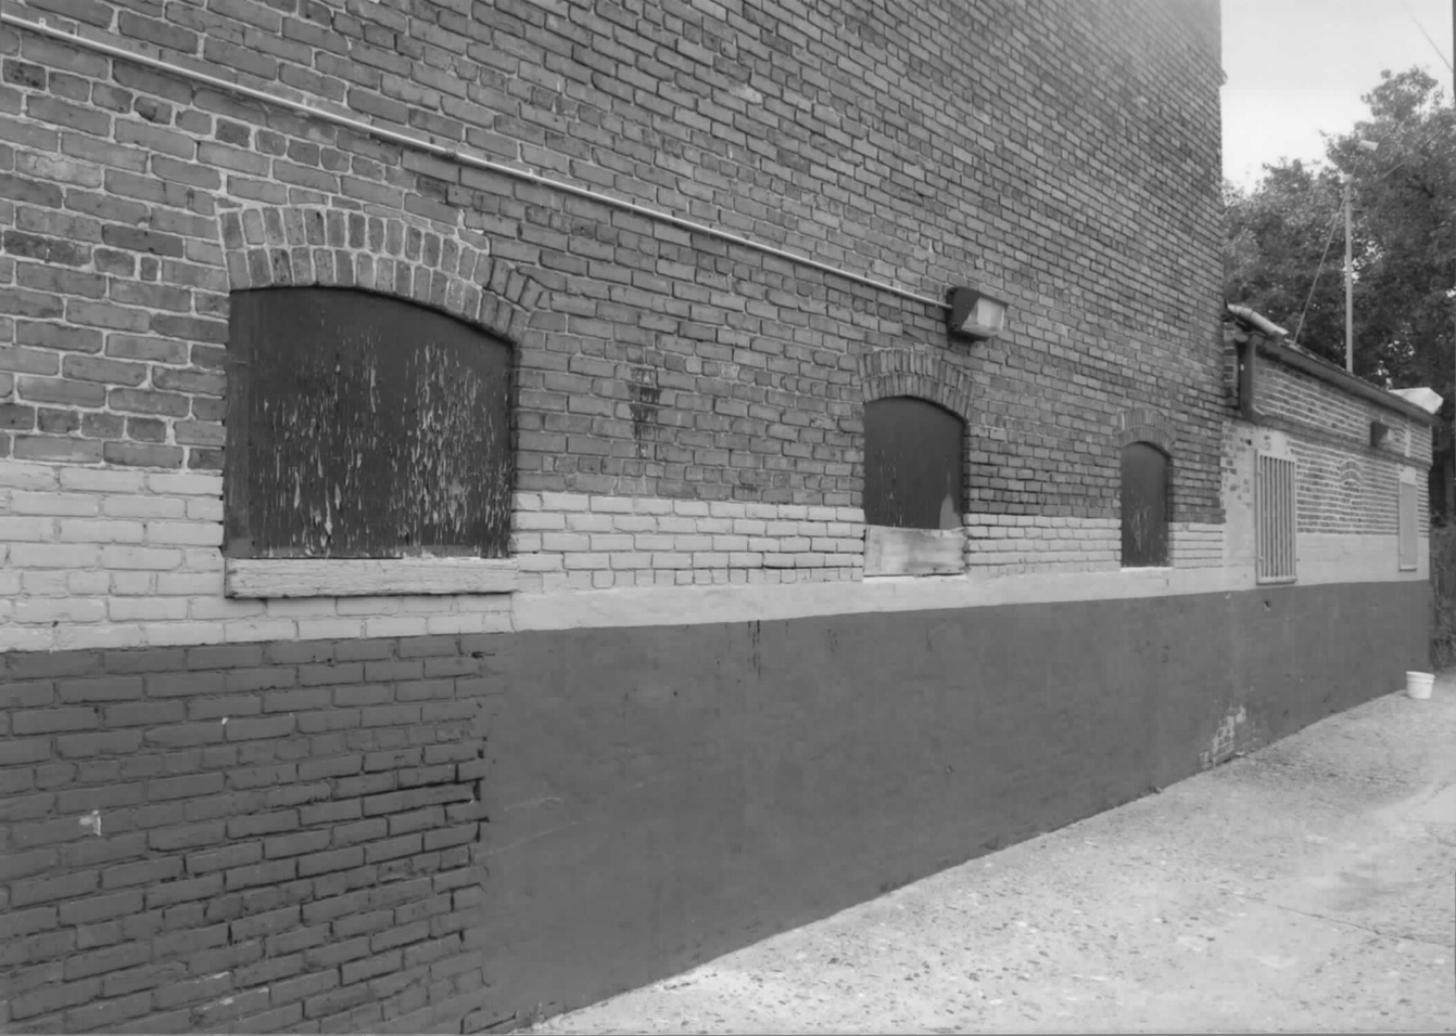
B-5077-1 East End
Auto Garage
Baltimore, MD
History Matters LLC
July 21, 2015
MD STPO
1st story west elevation, looking SE
04/11

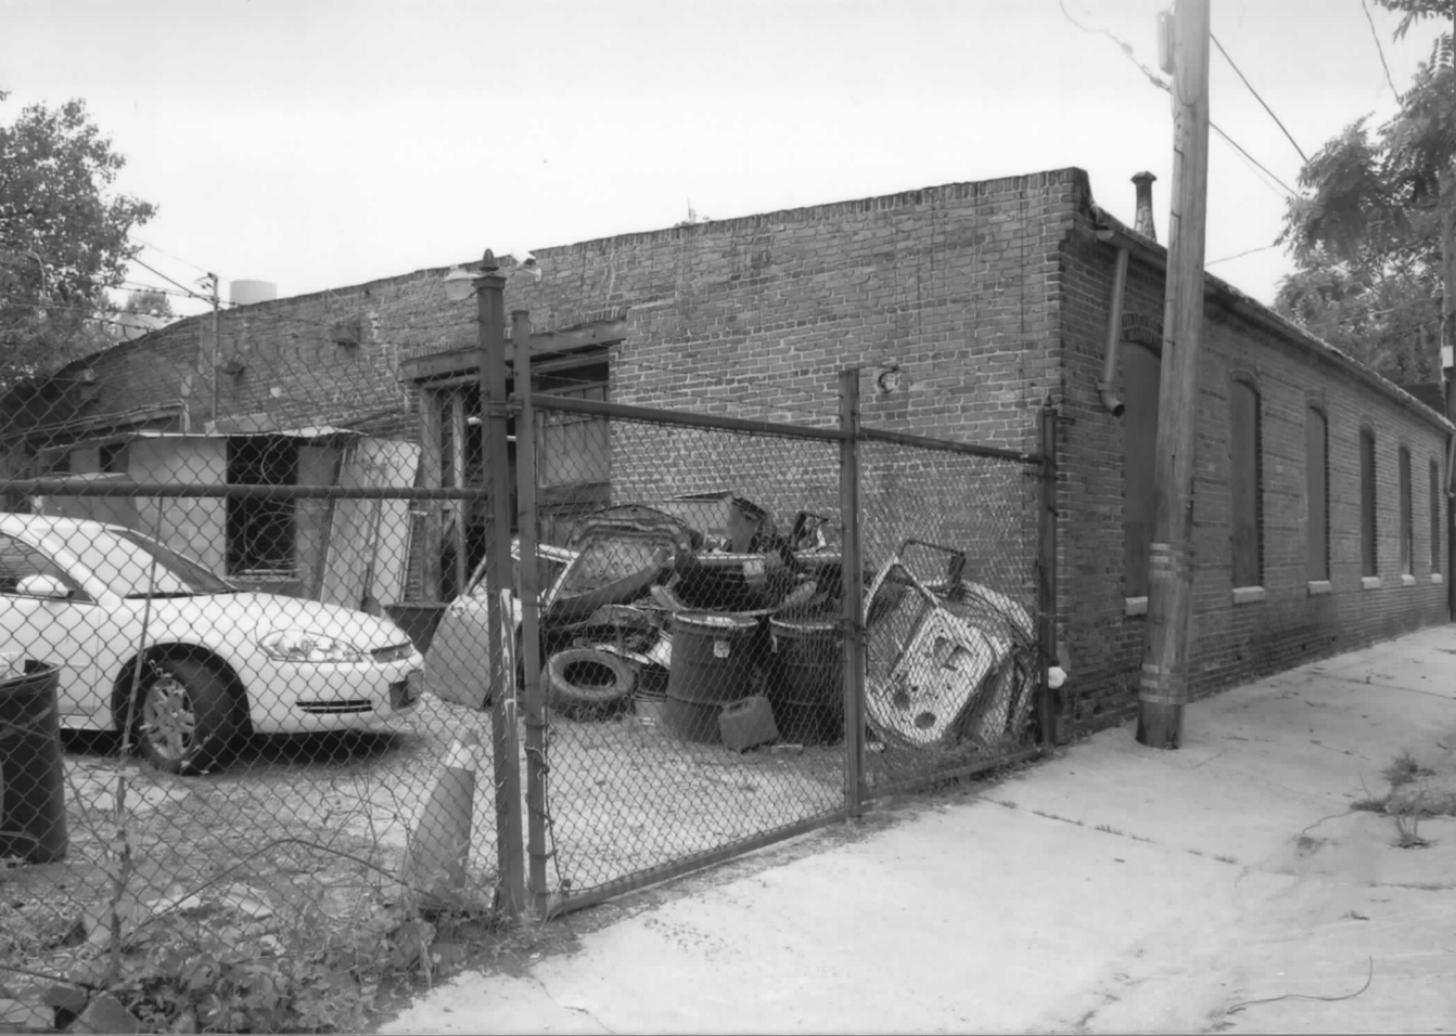
B-5077-1 East End
Auto Garage
Baltimore, MD
History Matters, LLC
July 21, 2015
MD SHPO
S (rear) + E elevations, looking NW
05/11

The south elevation is one story throughout, with a slightly-gabled, unornamented parapet wall. It features two large entrances: the vehicle entrance to the east section features sliding wood doors with inset 5x3 windows and a flat steel lintel; the west vehicle entrance features a rolling metal door and a flat steel lintel. A small concrete shed with a corrugated-metal roof is centered along the south elevation between the vehicle entrances. An arched-brick window opening is located west of the west vehicle entrance; it has been blocked with plywood.

The east elevation is one story in height and features a corbelled brick cornice and six bays of window openings. The openings have arched-brick lintels and stone sills; each window has been blocked with plywood.

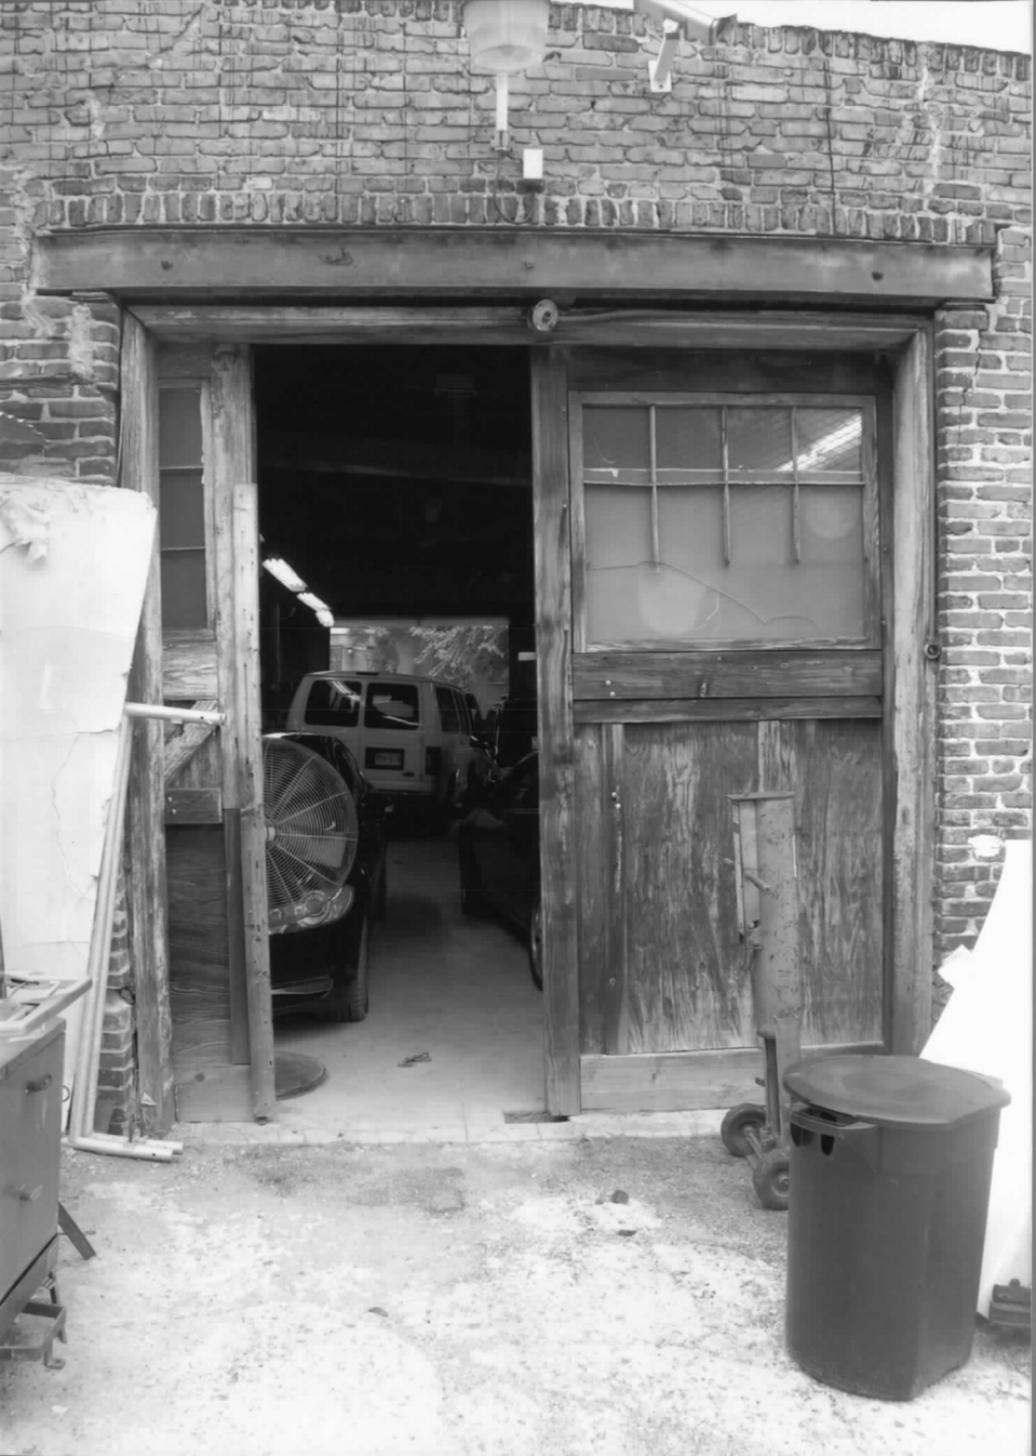
06/11

S (near) elevation, entrance to east
building, looking N

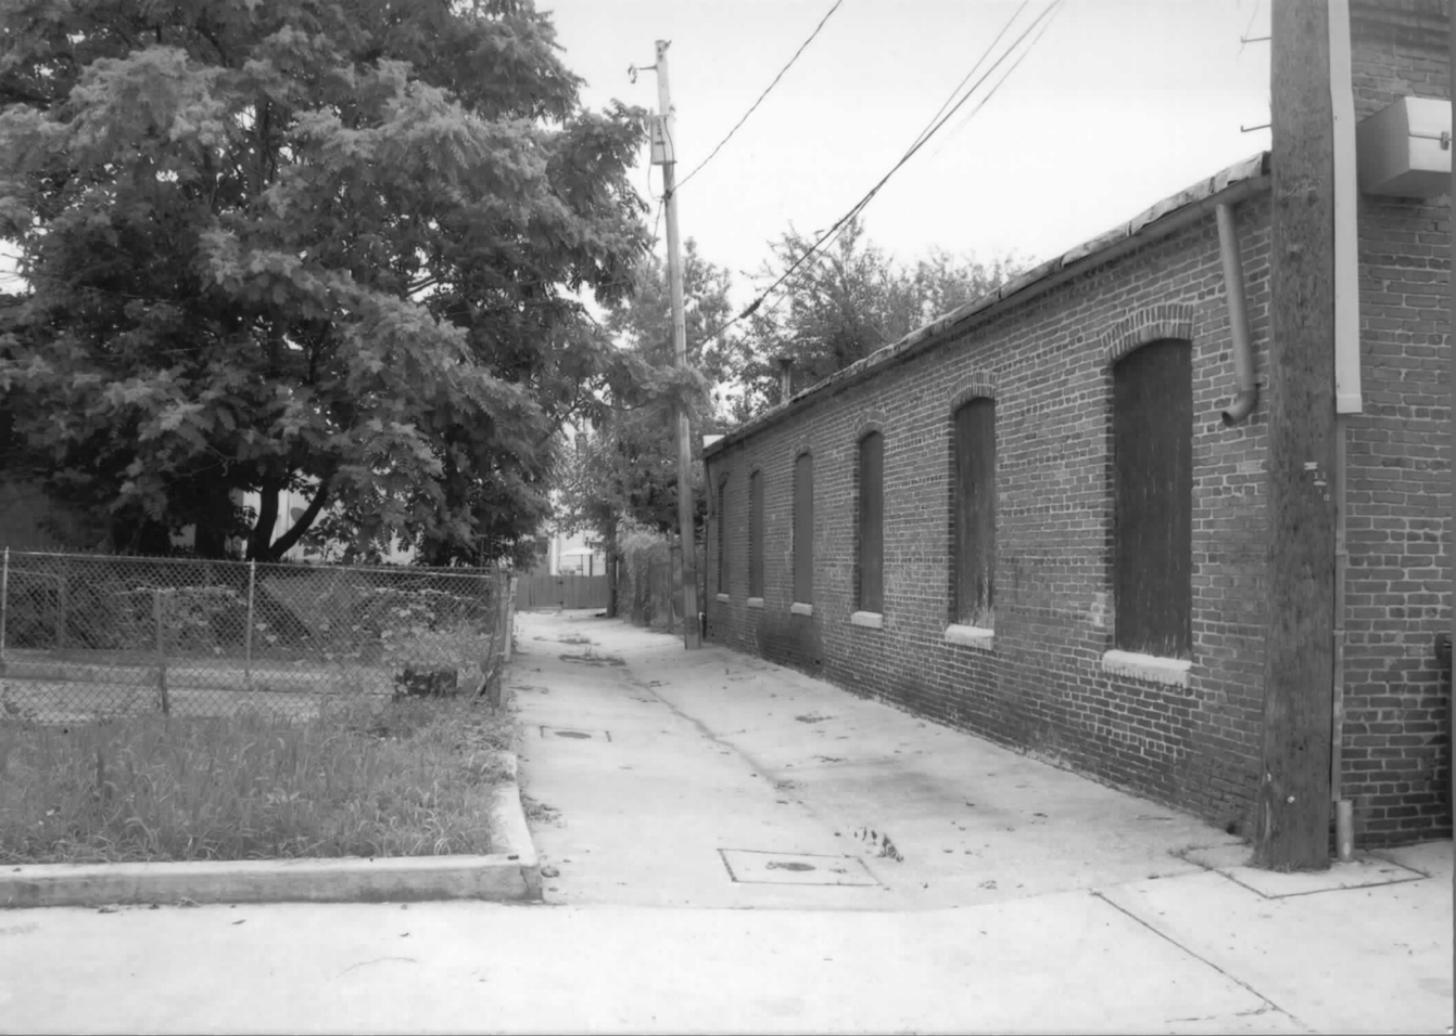
07/11

Elevation, looking SW

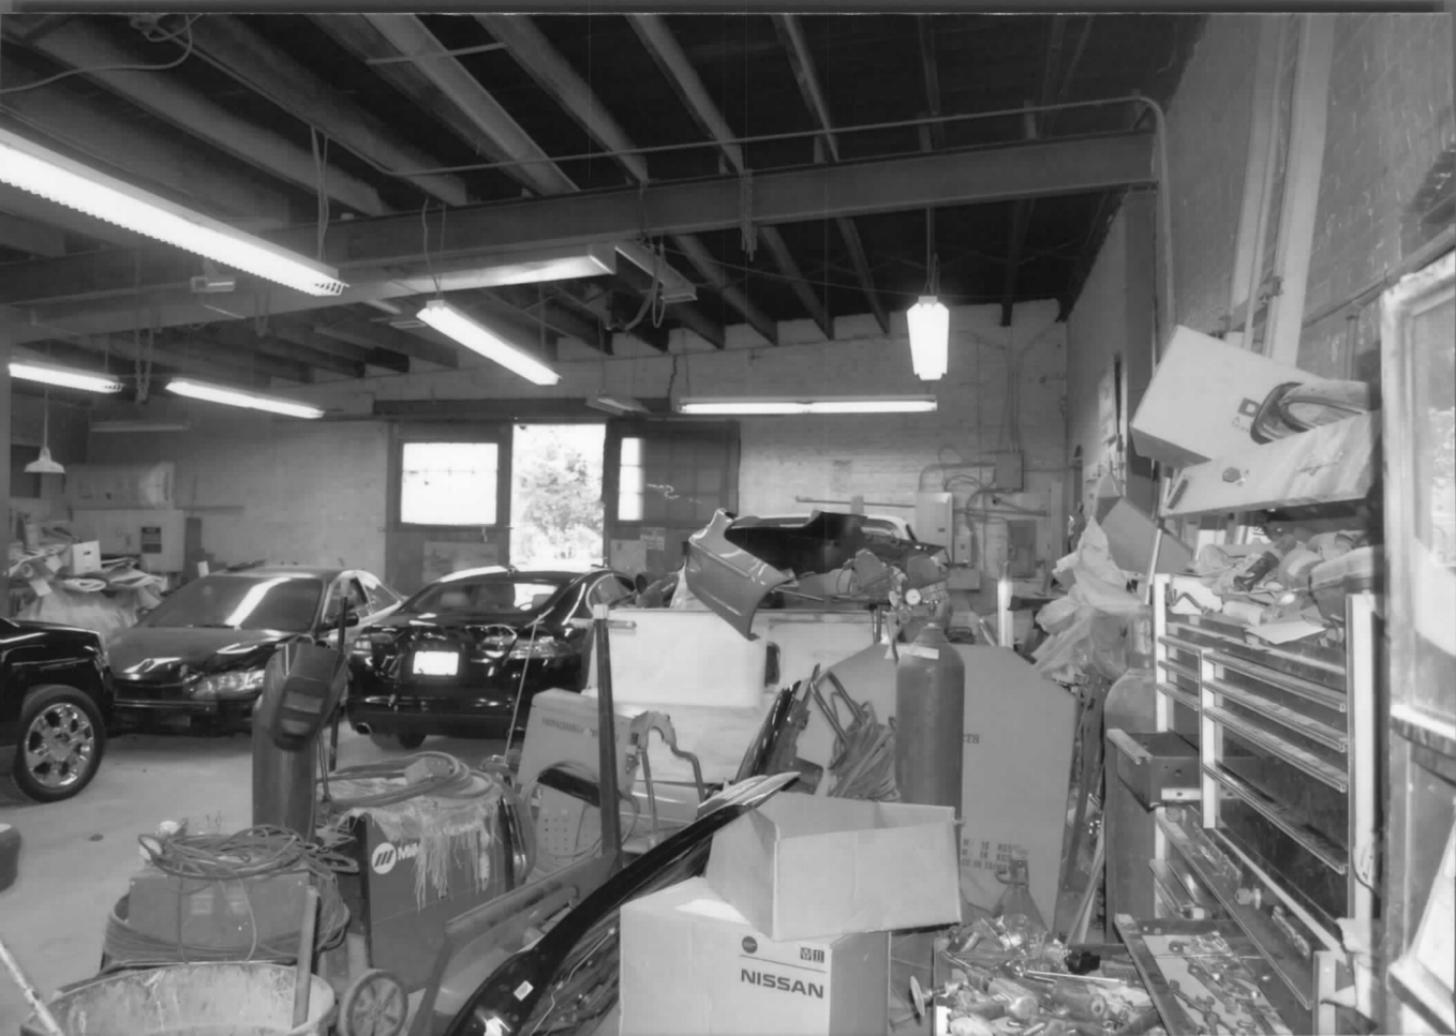
08/11

Interior, east bldg, looking S

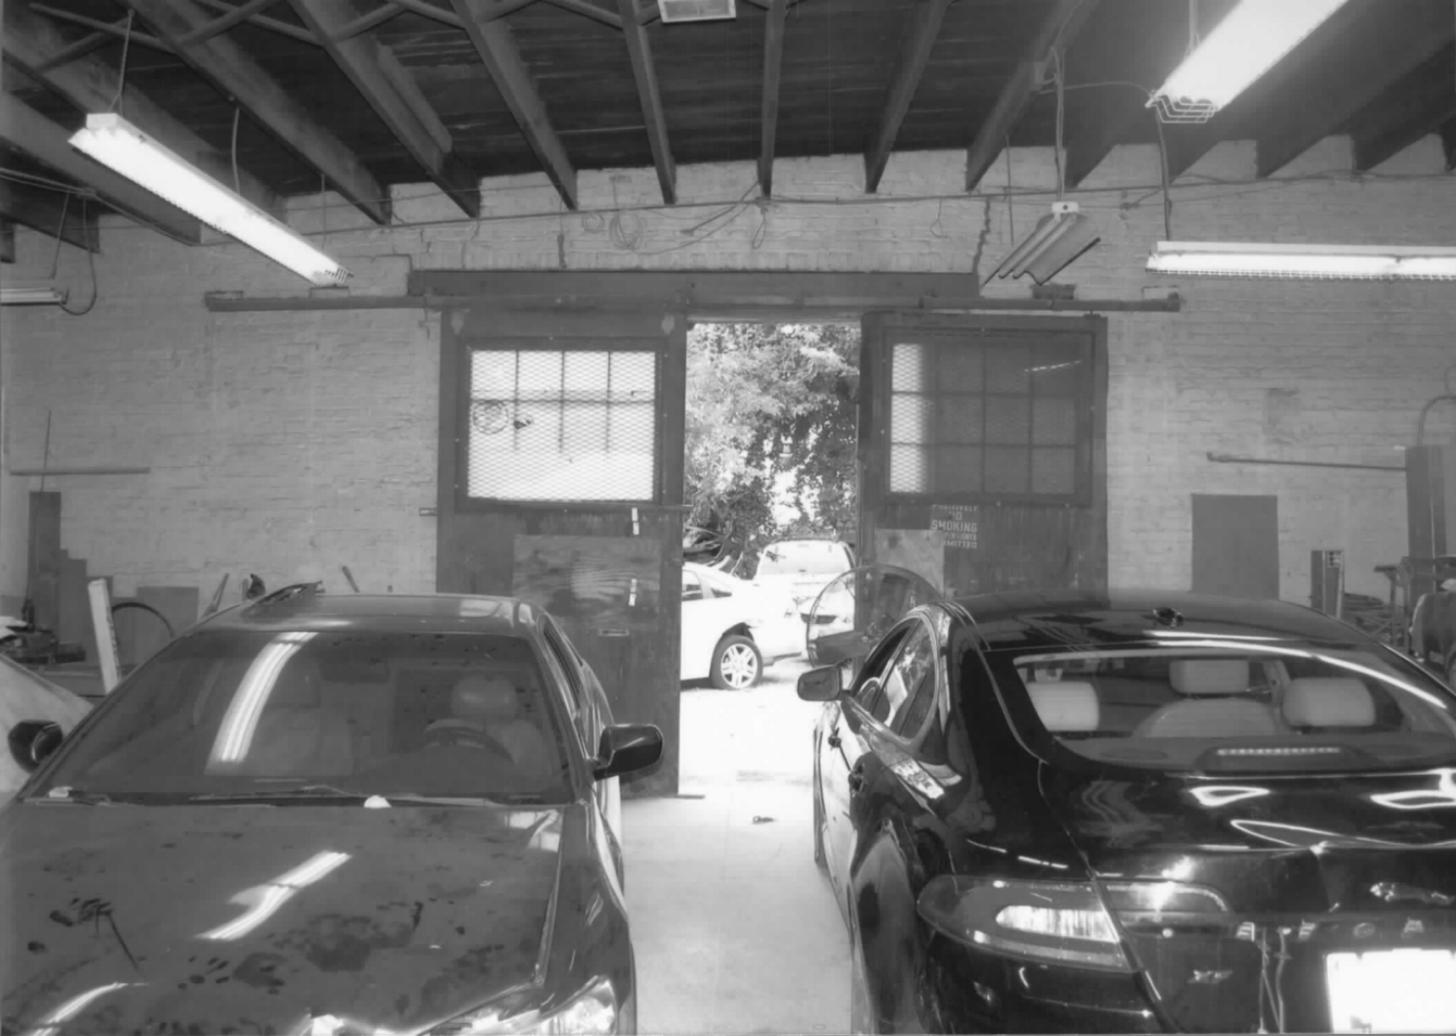
B-5077-1
East End Auto Garage
Baltimore, MD
History Matters LLC
July 21, 2015
MD SHPO
E bldg near (south) entrance,
looking S
09/11

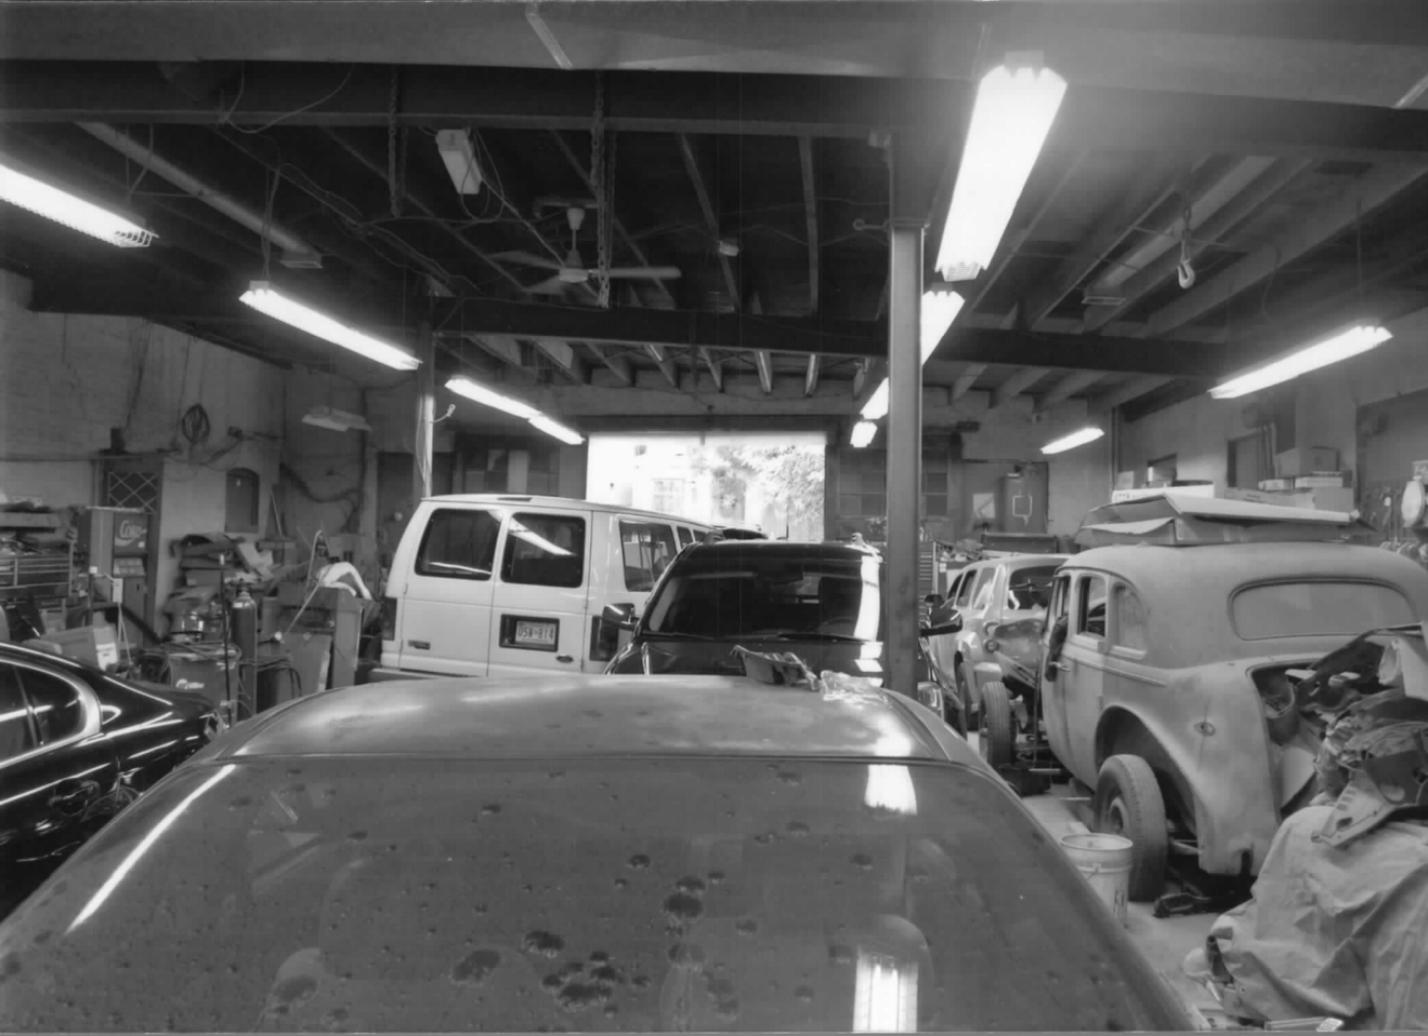
10/11

Interior w/ bldg, looking N to
front entrance

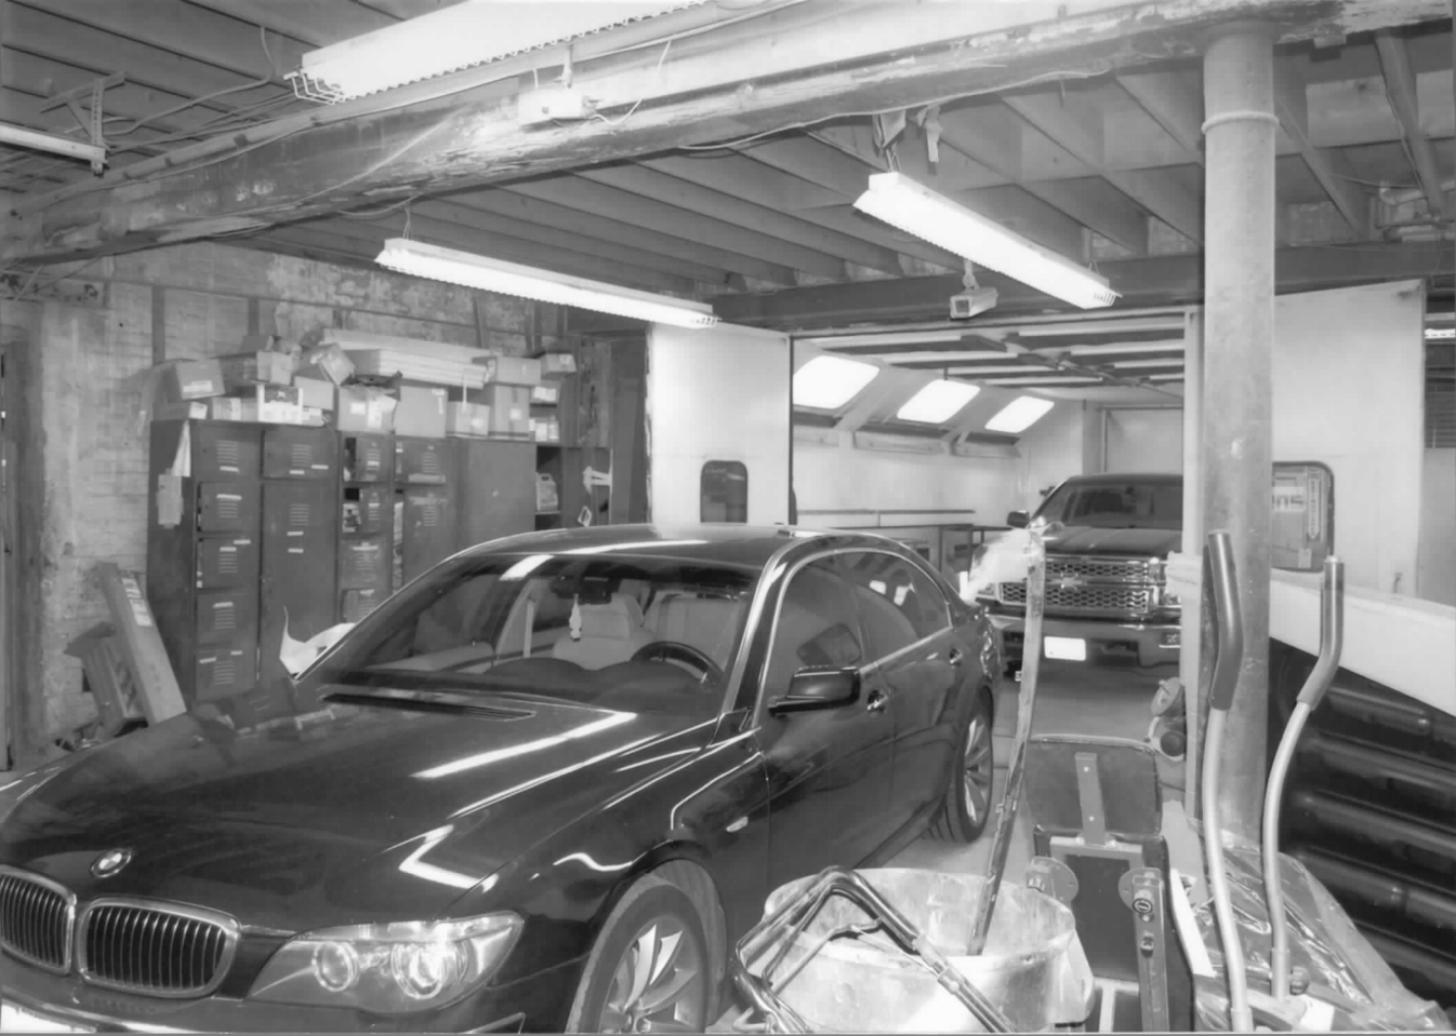
Interior w/ bldg, looking SE to
rear paint booth
