Capsule Summary: Roberts Bros. Fruit Packers (B-5077-5)

1225 North Regester Street

Maryland Historical Trust Maryland Inventory of Historic Properties Form

Roberts Bros. Fruit Packers
Continuation Sheet

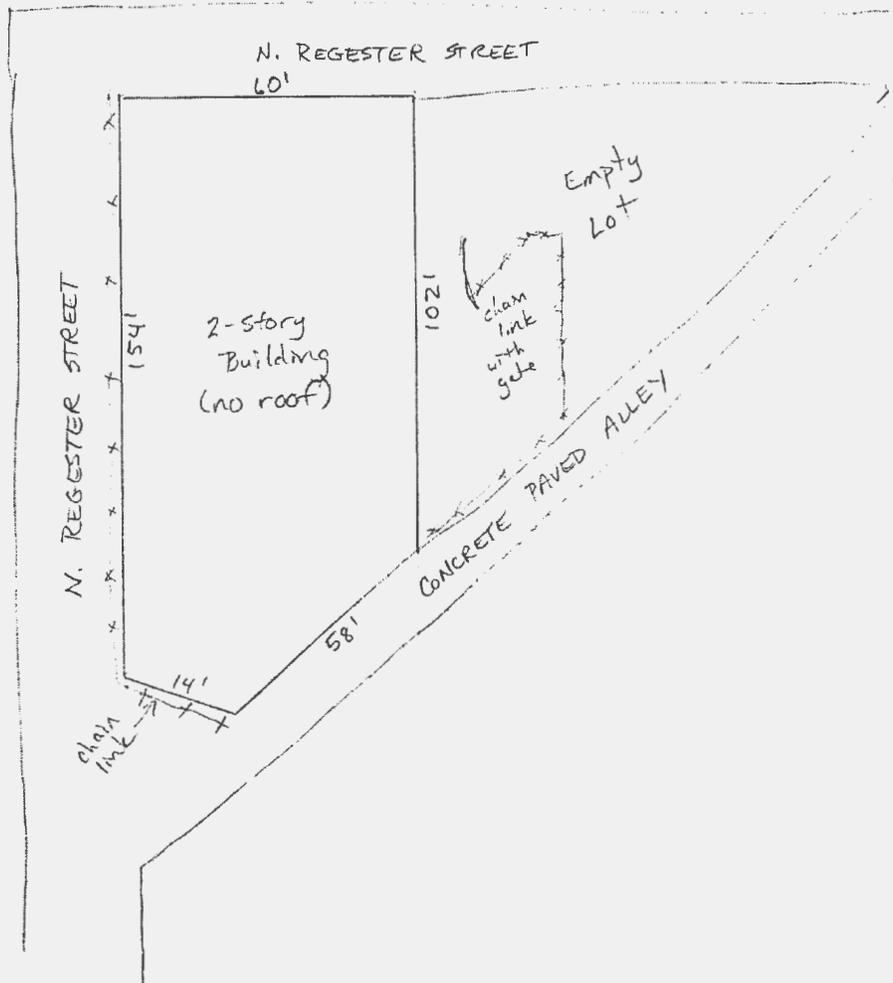
B-5077-5
Robert Brothers Fruit Packers
Site Plan
1225 North Register Street
City of Baltimore
History Matters, LLC
July 2015

Site: The building occupies nearly the entire site, which is part of a triangular plot of land that is bounded by North Regester Street (to the west) and narrow concrete-paved alleys to the north and east. The alley along the east edge of the plot of land extends southwest-northeast, running parallel to North Gay Street. The Roberts Brothers' quadrilateral-shaped parcel occupies the west end of that triangular lot, bound by North Regester Street to the west and the alleys at the north and south edges of the building. The east edge of the parcel runs north-south (parallel to North Regester Street) along the east elevation of the building. The site is enclosed with a chain-link fence along the building's southwest, west, north, and east elevations. The ground level slopes upward from the south toward the north, reaching the bottom sills of the first-story window openings on the north elevation and portions of the east and west elevations. A low retaining wall along the southeast edge of the site mitigates the change in site level between the east and southeast elevations of the building.

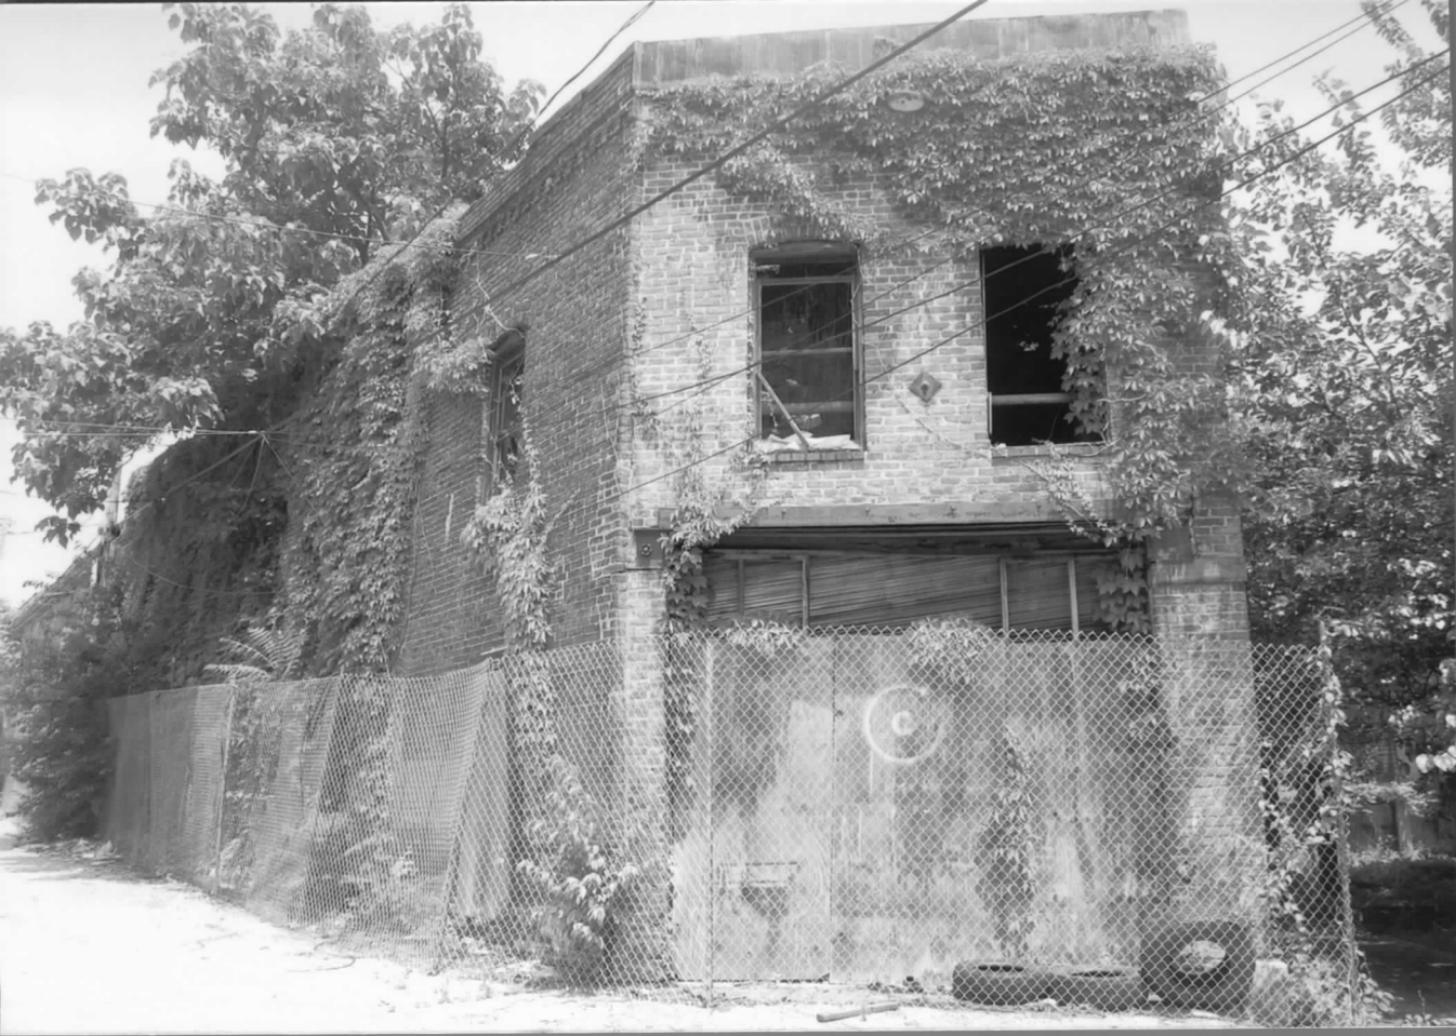
The primary (southwest) elevation, the building's narrowest façade, faces North Regester Street. It features a wide entrance at the first story that spans the width of this elevation. The first story opening on the southwest elevation is sealed with a metal-frame and wood-plank door, with a projecting steel lintel above. The lintel features a rosette-form bolt at one end; no other ornamentation is evident on this elevation. At the second story, the window openings feature brick sills and arched-brick lintels. Remnants of wood sash are present, but the windowpanes in each of the two window openings are missing. A steel tie-rod is centered between the window openings.

B-5077-5
Roberts Bros. Fruit Packers
Baltimore, MD
History Matters, LLC
July 7, 2015
MD SH70
SW (front) elevation, looking NE
01/08

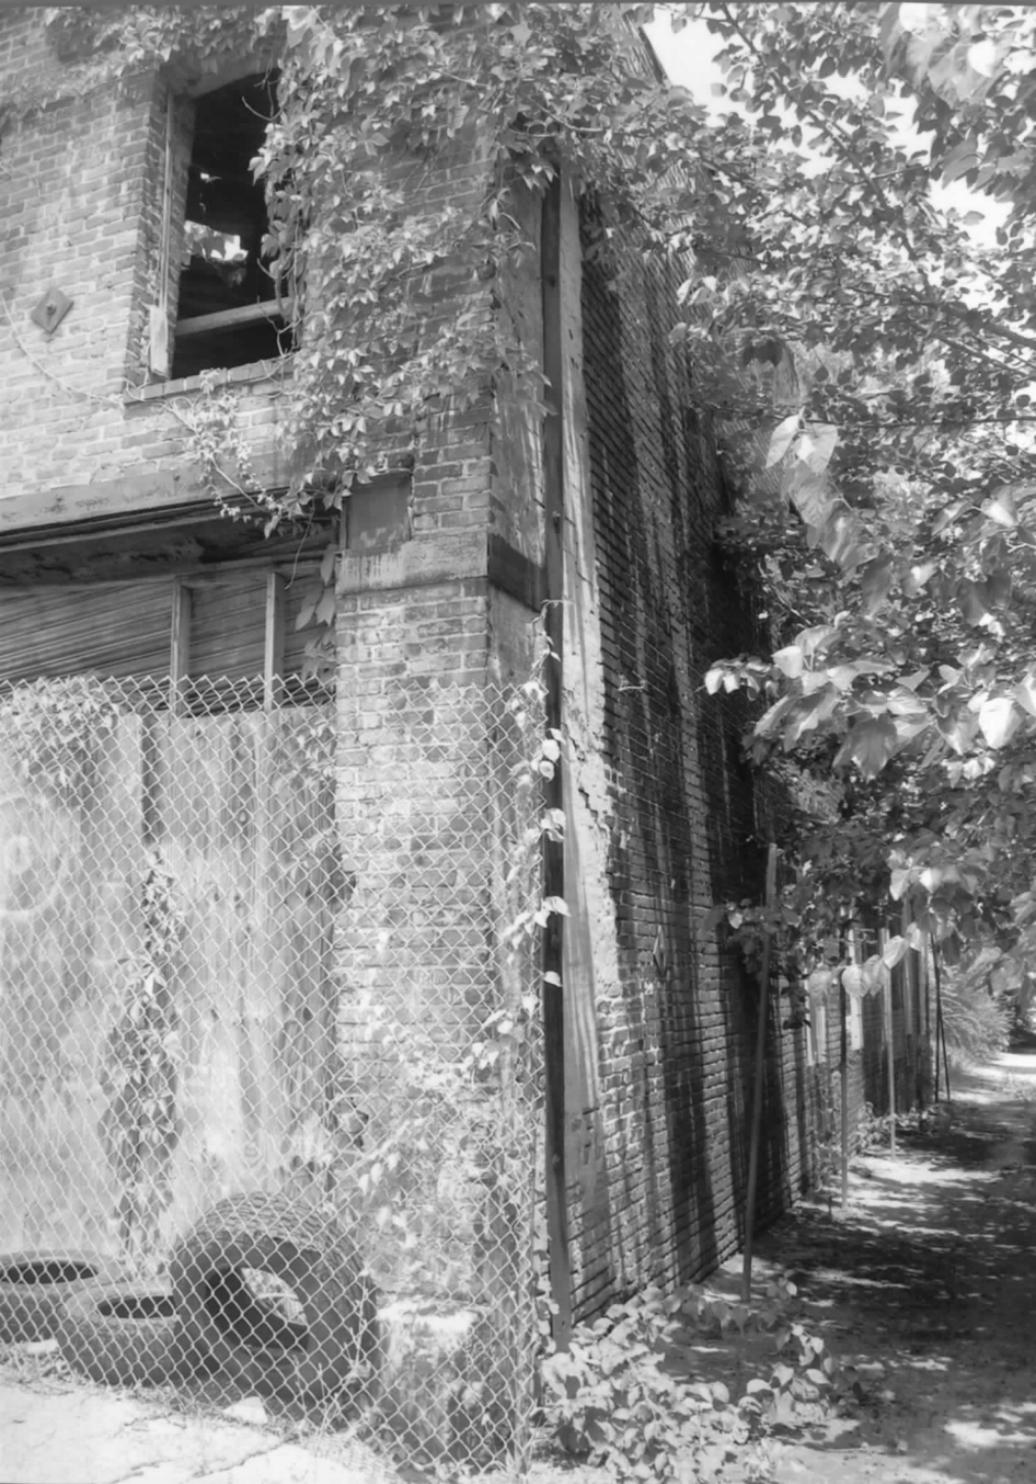
02/08

Part of SW elevation looking NE
along SE elevation

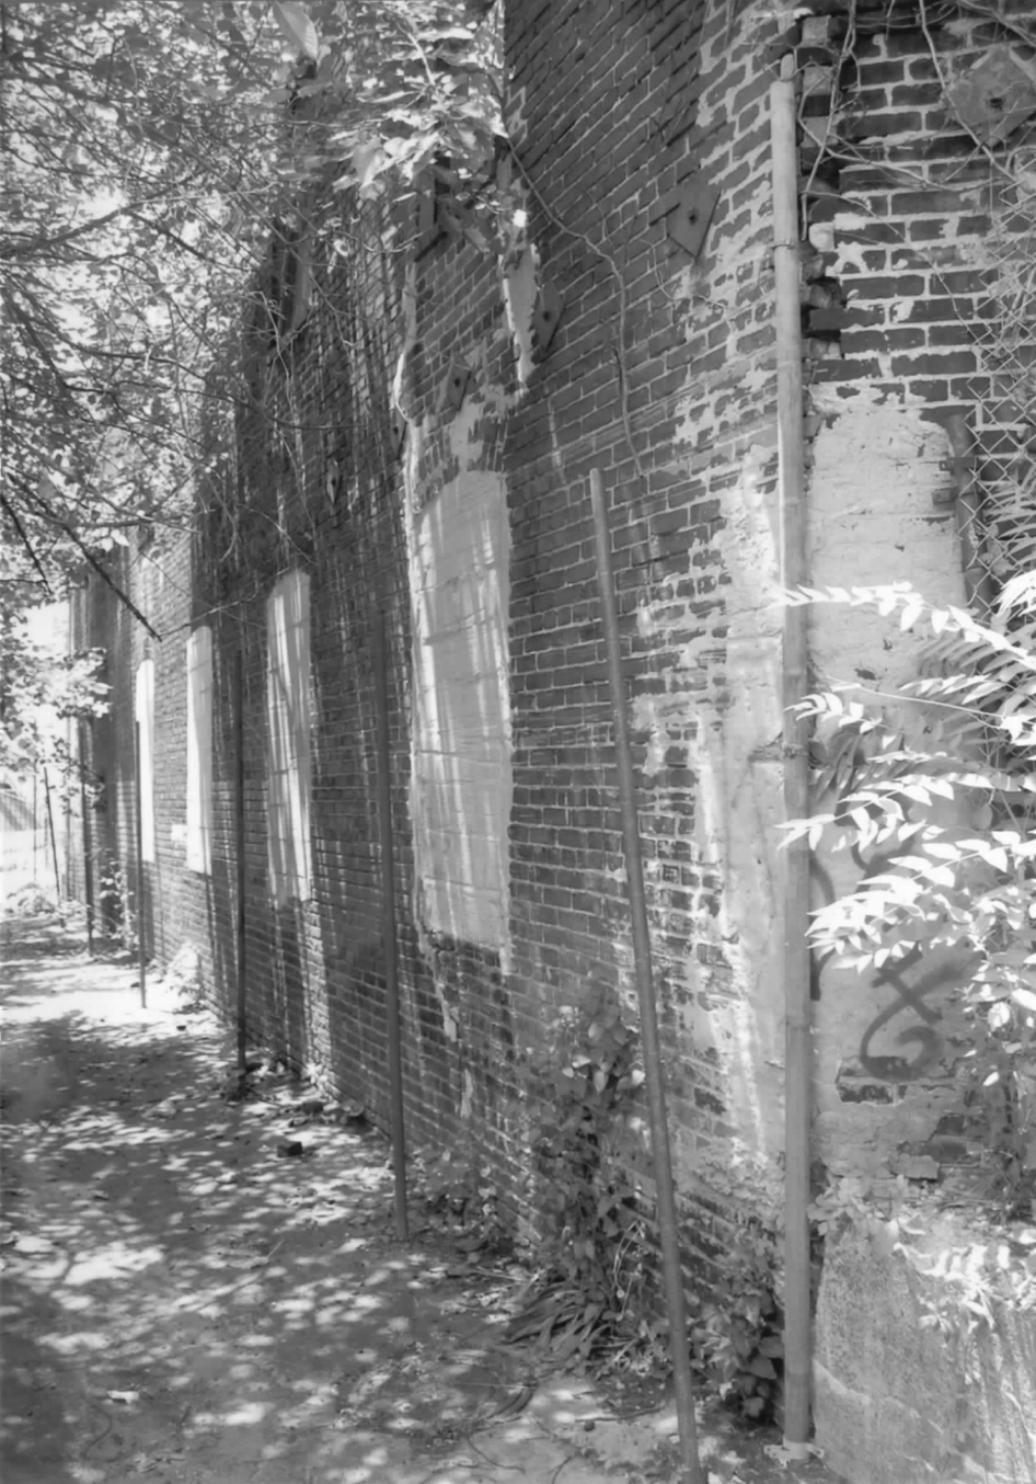
The southeast elevation features five bays of window openings at the first and second stories. On the first story, the window openings feature brick sills and arched brick lintels, and have been infilled with concrete block. On the second story, the windows feature brick sills, arched brick lintels, and sash in poor condition.

B-5077-5
Roberts Bros. Fruit Packers
Baltimore, MD
History Matters, LLC
July 7, 2015
MD SHPO
SE elevation looking SW
03/08

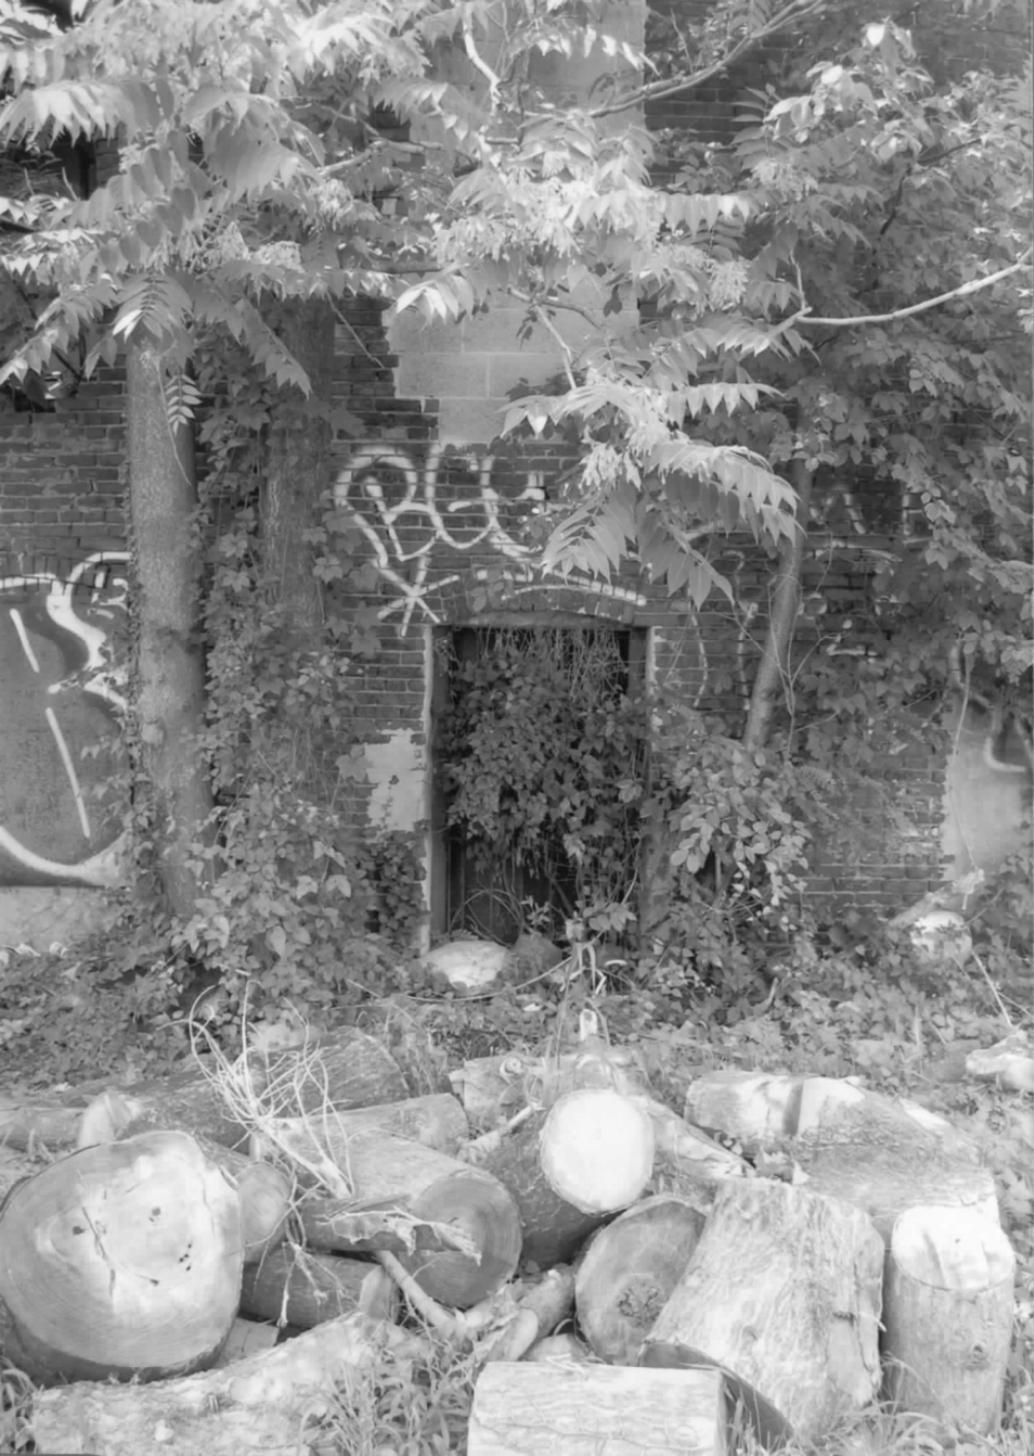
The east elevation features several bays of irregularly-spaced window and door openings at the first and second stories (although many openings are obscured or inaccessible due to invasive vine growth). On the first story, a pedestrian entrance near the southern end of the elevation features a wood-plank door (obscured by growth) and arched brick lintel. The remaining first story bays feature window openings with arched brick lintels; they are flush with the ground, without sills, and have been infilled with concrete block. At the second story, a loading entrance near the north end of this elevation features a brick sill and arched brick lintel; it has been infilled with concrete block. The remaining bays at the second story on the east elevation feature fenestration with brick sills, arched brick lintels, and sash in poor condition.

B-5077-5
Roberts Bros. Fruit Packers
Baltimore, MD
History Matters, LLC
July 7, 2015
MD SHPS
East elevation door, looking W
04/08

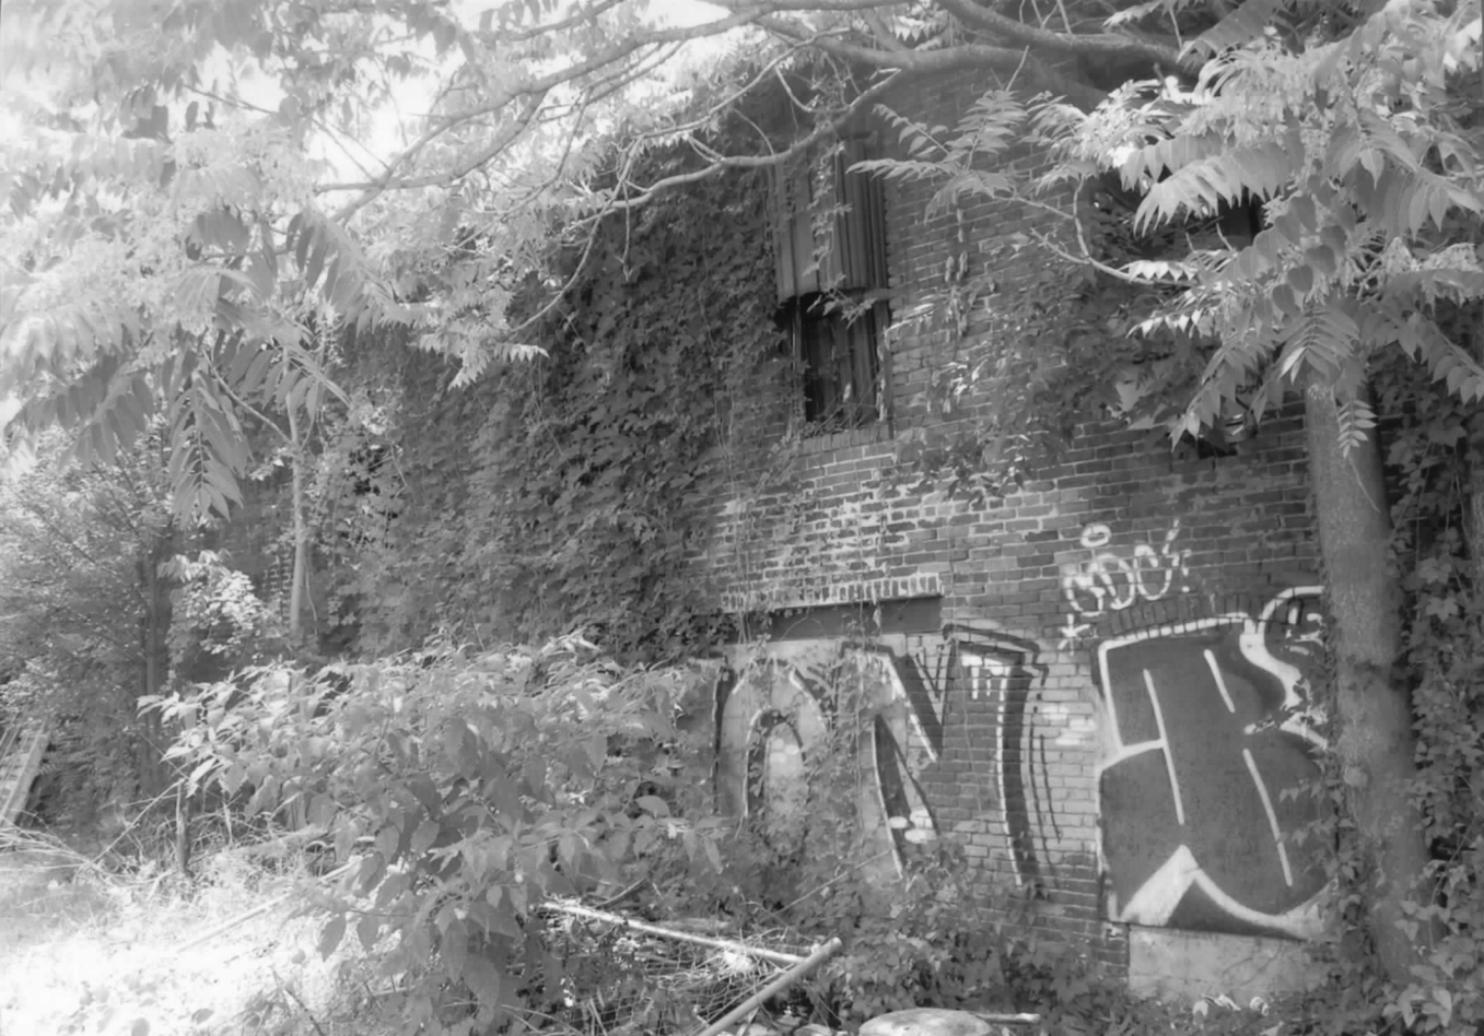
B-5077-5
Roberts Bros. Fruit Packers
Baltimore, MD
History Matters, LLC
July 7, 2015
MD SHPS
East elevation showing graffiti,
looking SW
05/08

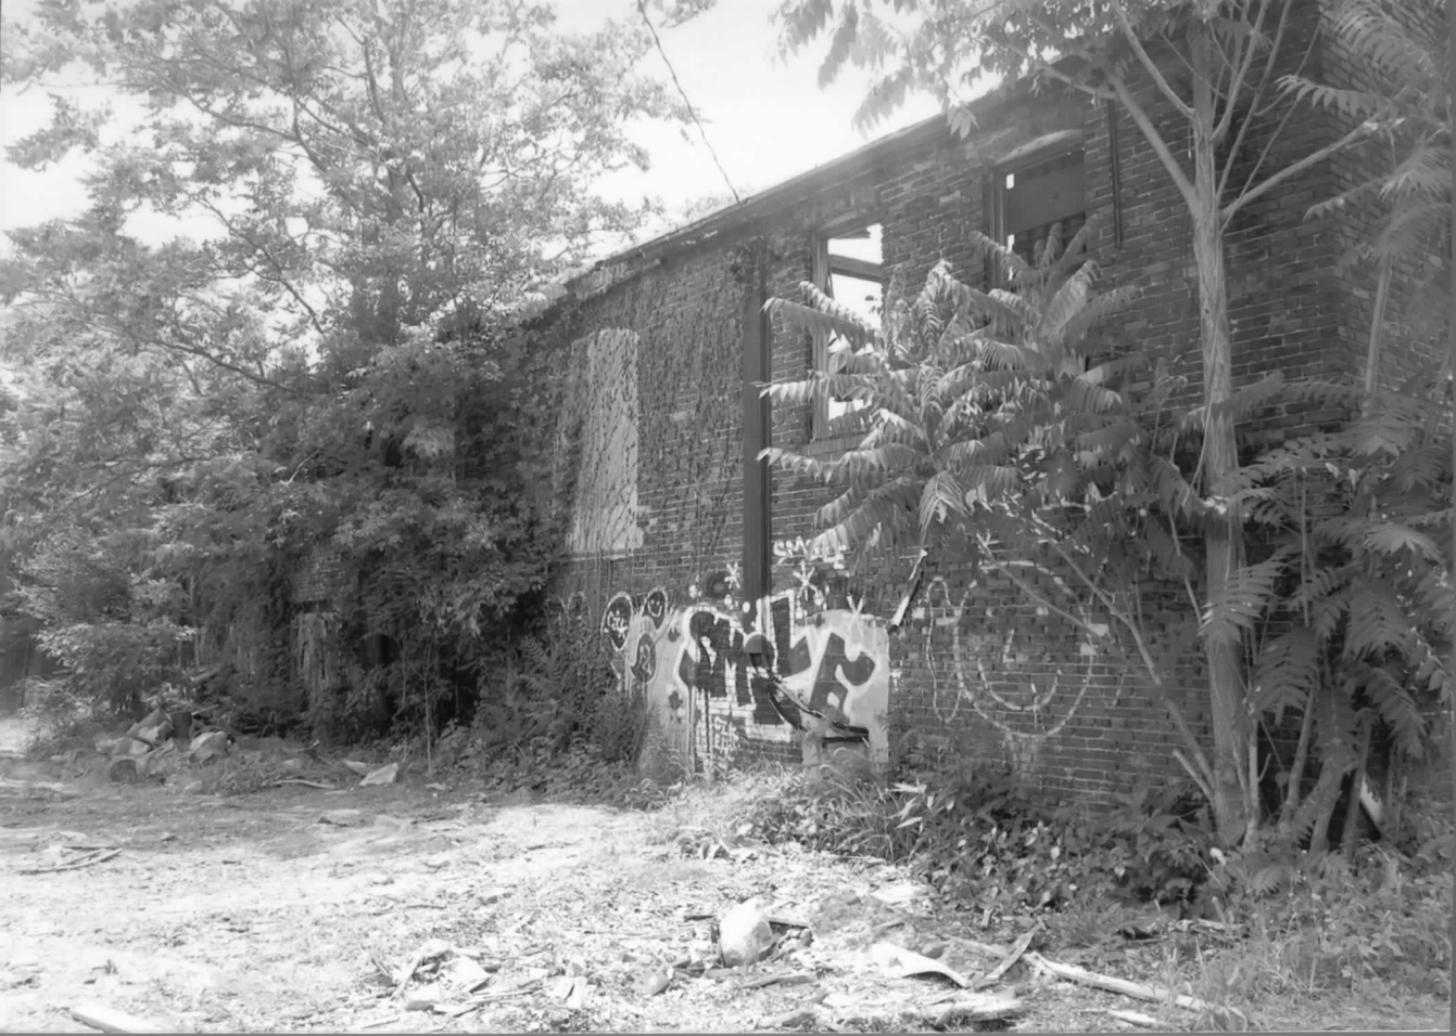
B-5077-5
Roberts Bros Fruit Packers
Baltimore, MD
History Matters LLC
July 7, 2015
MD SHPO
Northern end of east elevation
looking SW
06/08

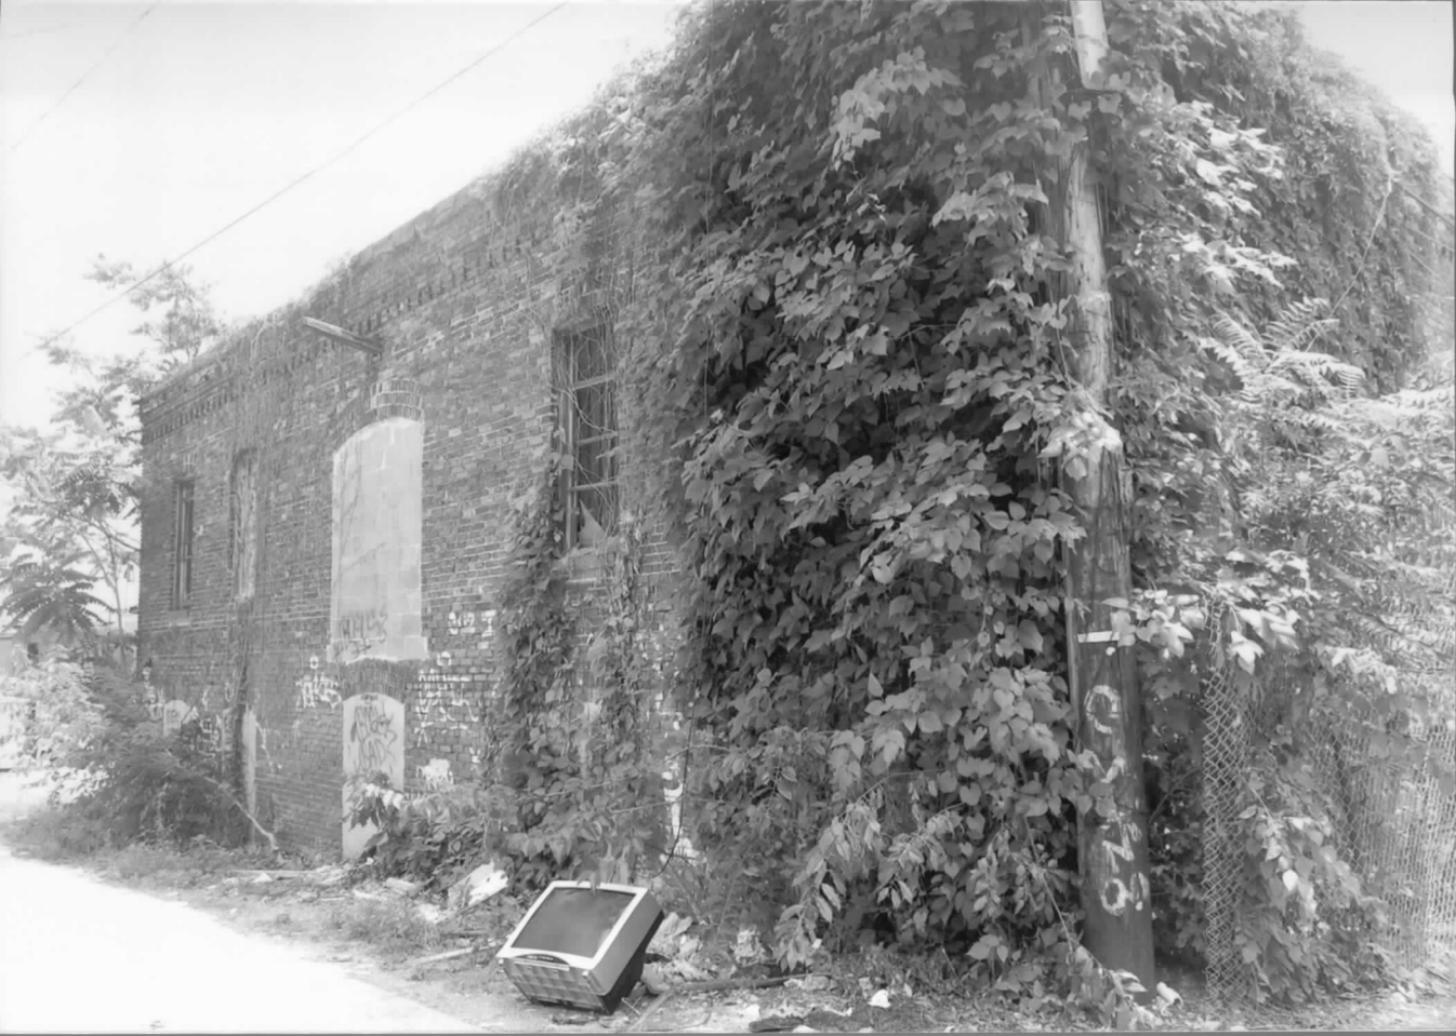
The north elevation features five bays of window and door openings; the westernmost bay is obscured by heavy vine growth. The central bay features a pedestrian entrance at the first story and a loft entrance at the second story, with a projecting hoist beam above the second story. Both the first story and second story entrances have been infilled with concrete block. The other four bays contain window openings with brick sills and arched brick lintels. The first story windows have been infilled with concrete block, while the second story openings feature wood-frame windows in poor condition.

B-5077-5
Roberts Bros. Fruit Packers
Baltimore, MD
History Matters, LLC
July 7, 2015
MD SH70
North elevation, looking SE
07/08

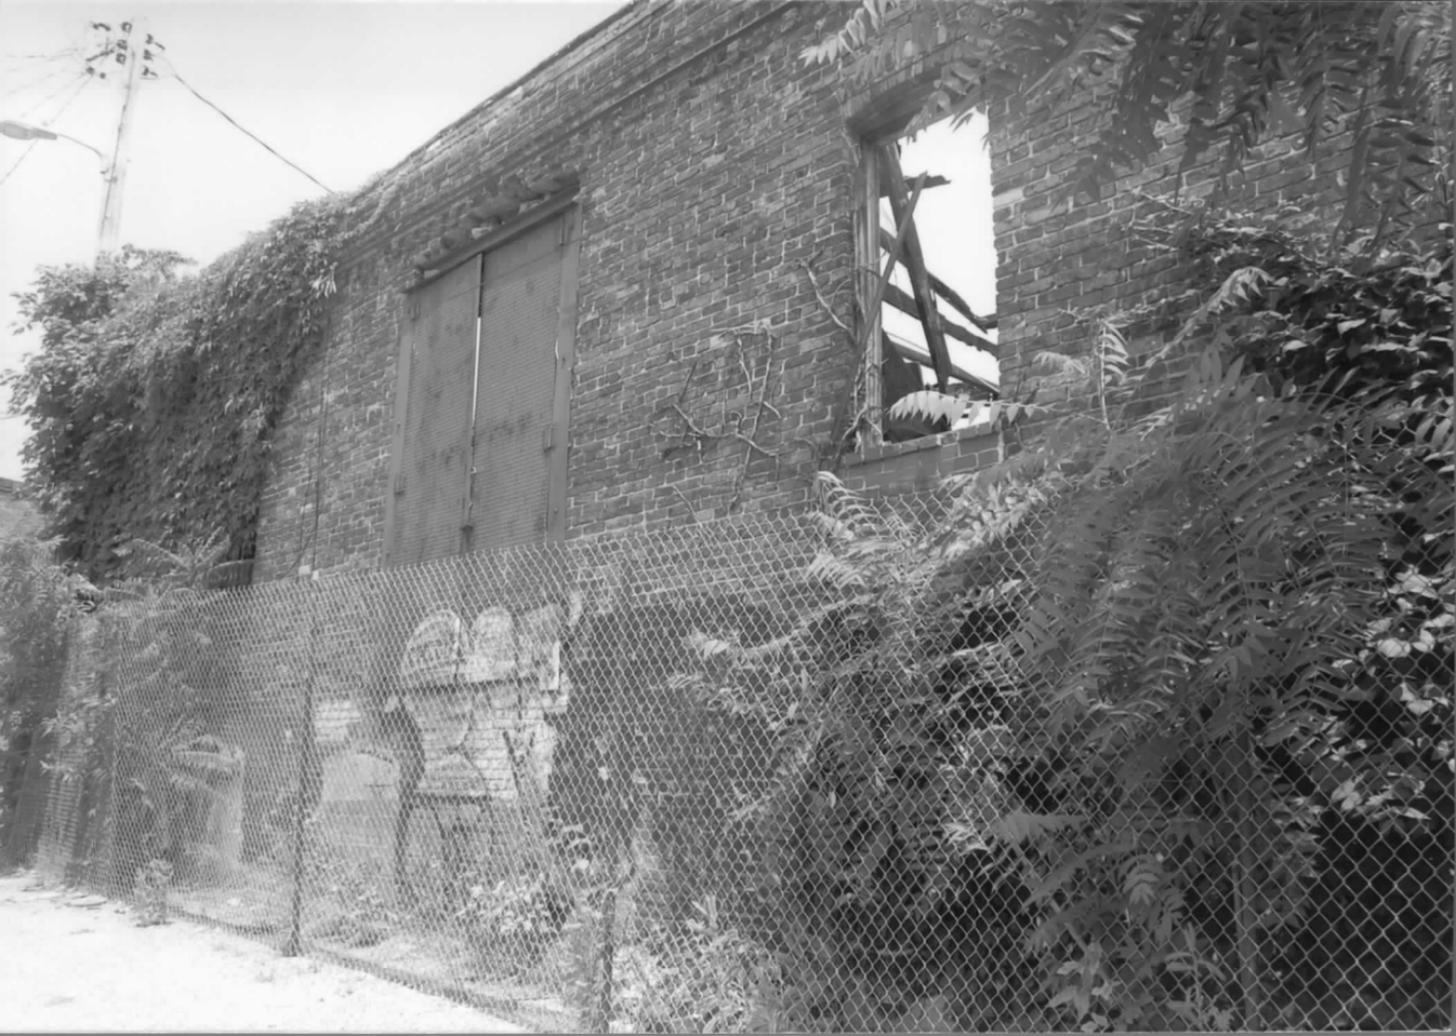
The west elevation extends the depth of the lot along North Regester Street. Large sections of this elevation are obscured by invasive vine growth. At the first story, it features a pedestrian entrance at the southern end, as well as several window openings with arched-brick lintels. All openings at the first story have been sealed or infilled with concrete block. At the second story, the west elevation features two loading entrances that are located in the northern half of this elevation. The southern opening features a brick sill, an arched brick lintel, and a projecting wood hoist beam and pulley above; this opening has been infilled with concrete block. The northern loading entrance features double-leaf steel doors. The remaining bays at the second story on this elevation feature fenestration with brick sills, arched brick lintels, and sash in poor condition.

B-5077-5
Roberts Bros. Fruit Packers
Baltimore, MD
History Matters LLC
July 7, 2015
MD SHPO
North end of west elevation
showing 2nd-story loading dock
looking NE 08/08
