MARYLAND HISTORICAL TRUST WORKSHEET

NOMINATION FORM for the NATIONAL REGISTER OF HISTORIC PLACES, NATIONAL PARKS SERVICE

COMMON: **Goshen**

STREET AND NUMBER: **East side of Butler Road near Belmont Road**

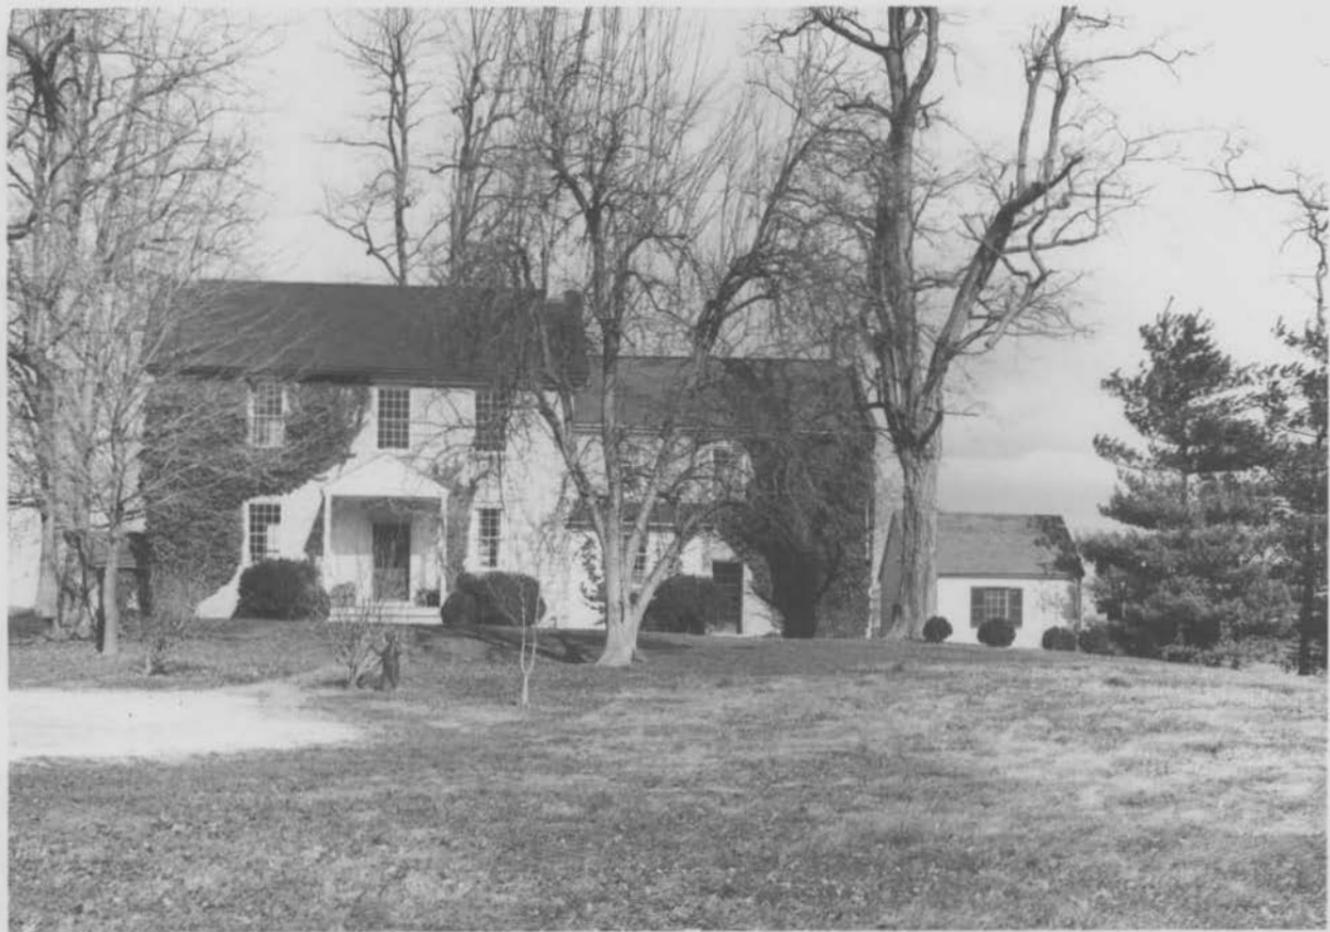
Goshen

SE

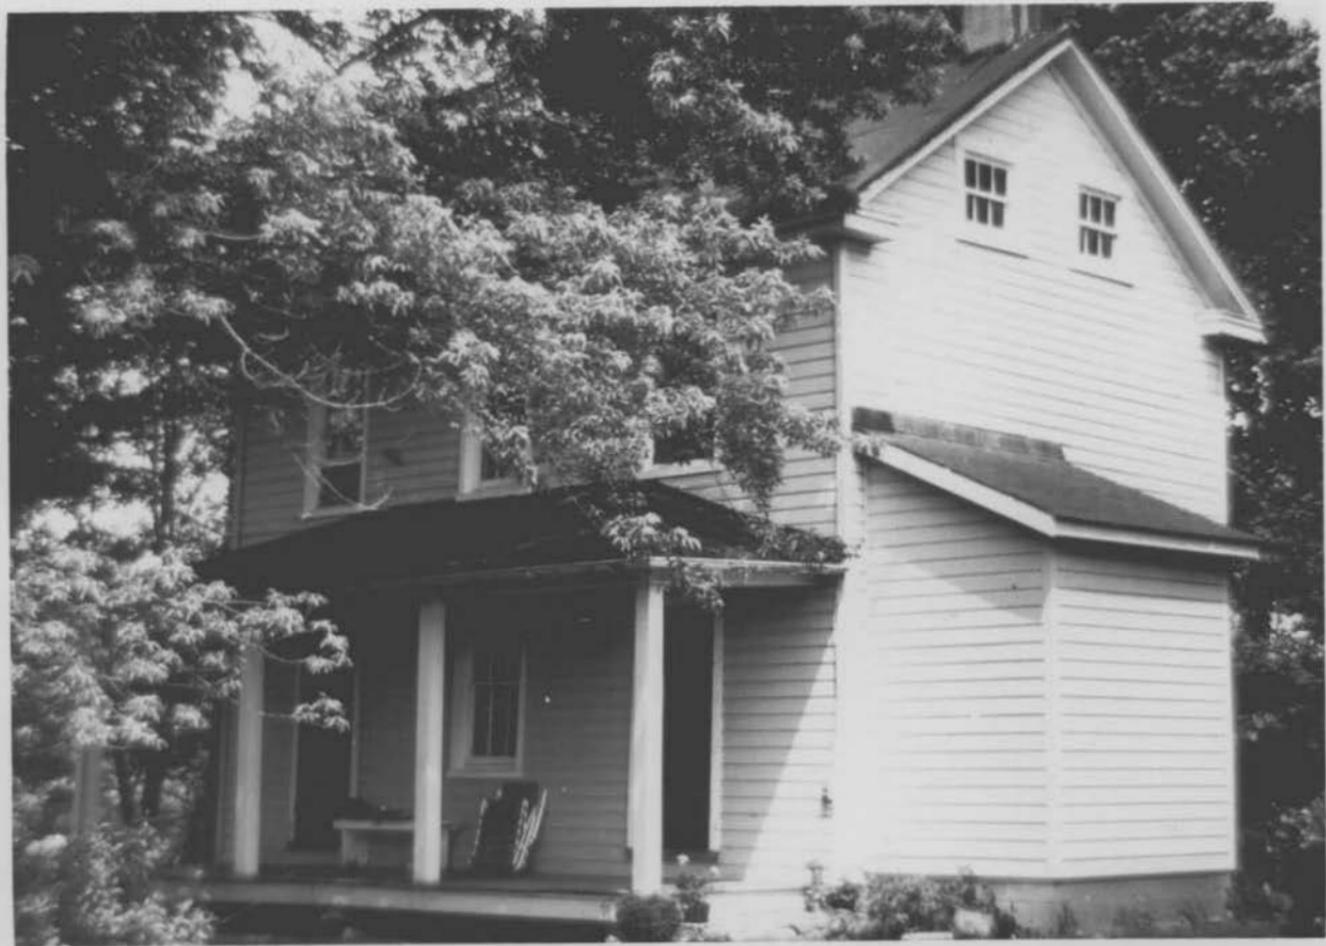
BA-1115  
1975

Further east is a two storey tenant house, three bays in length, of log construction, covered with German siding. It measures, approximately 18 by  $26\frac{1}{2}$  feet. Each end bay of the south front has an exterior door while a 6/6 window is in the middle bay, and in all three bays of the second storey. The north side of the house appears as two bays, each with a single 6/6 window. A one storey hipped roof perch extends across the south front, and a small one storey shed roof frame addition extends to the east. Internally, a large stone fireplace of early

construction heats the larger east room; the west chimney is a single flue. Finishes generally are simple, modern and utilitarian. The tenant house appears in the early lithograph.

Goshen. tenant house  
from southeast

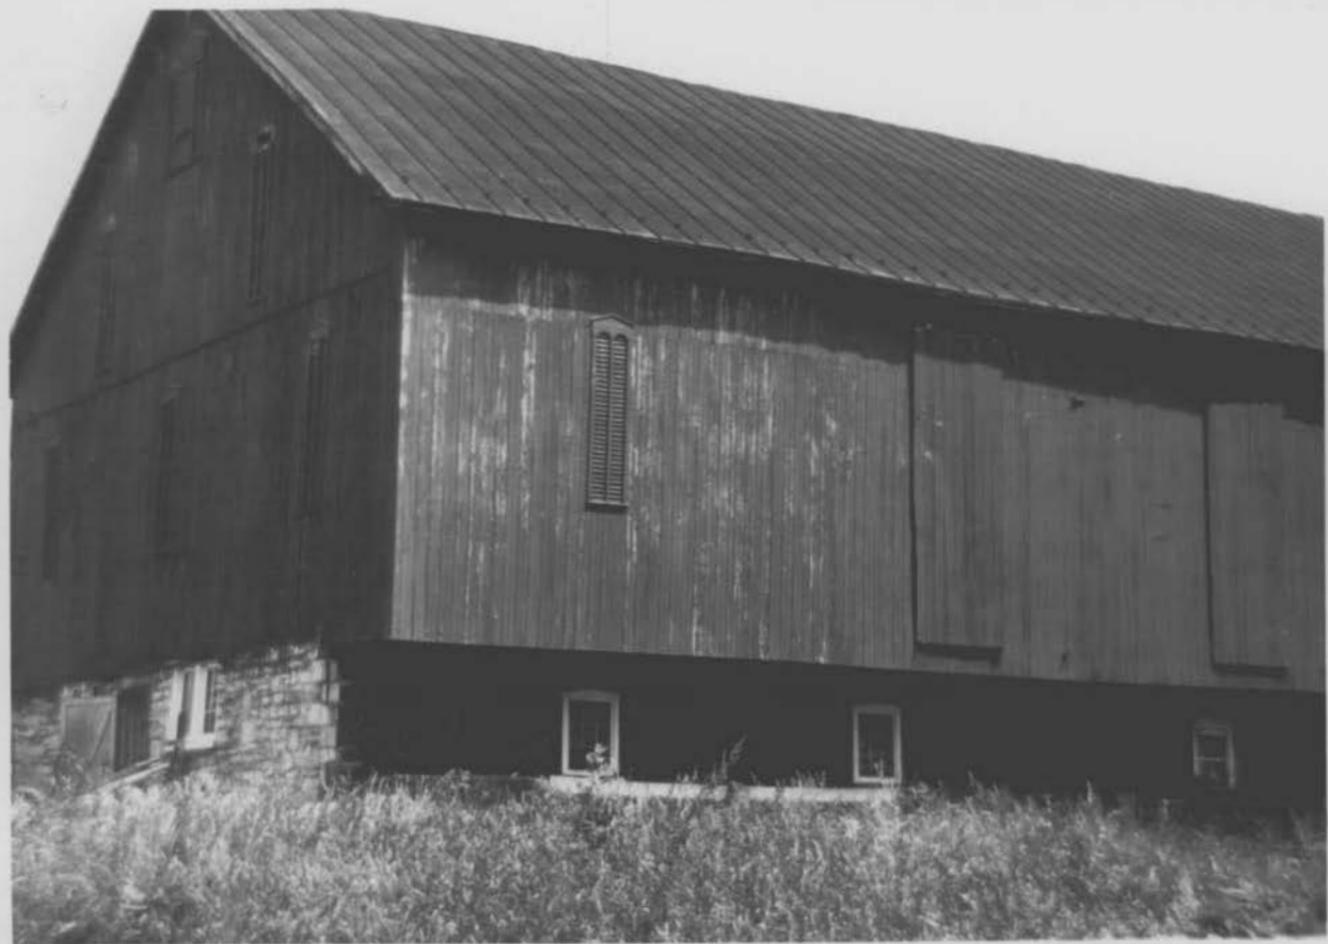
BA-1115 JTW JR  
1975

A large framed barn on a low stone-walled first story, and a framed corn crib stand some distance southwest of the house, and date from the late nineteenth or early twentieth century. A few other farm buildings nearby are later.

Gosken - barn  
from southwest

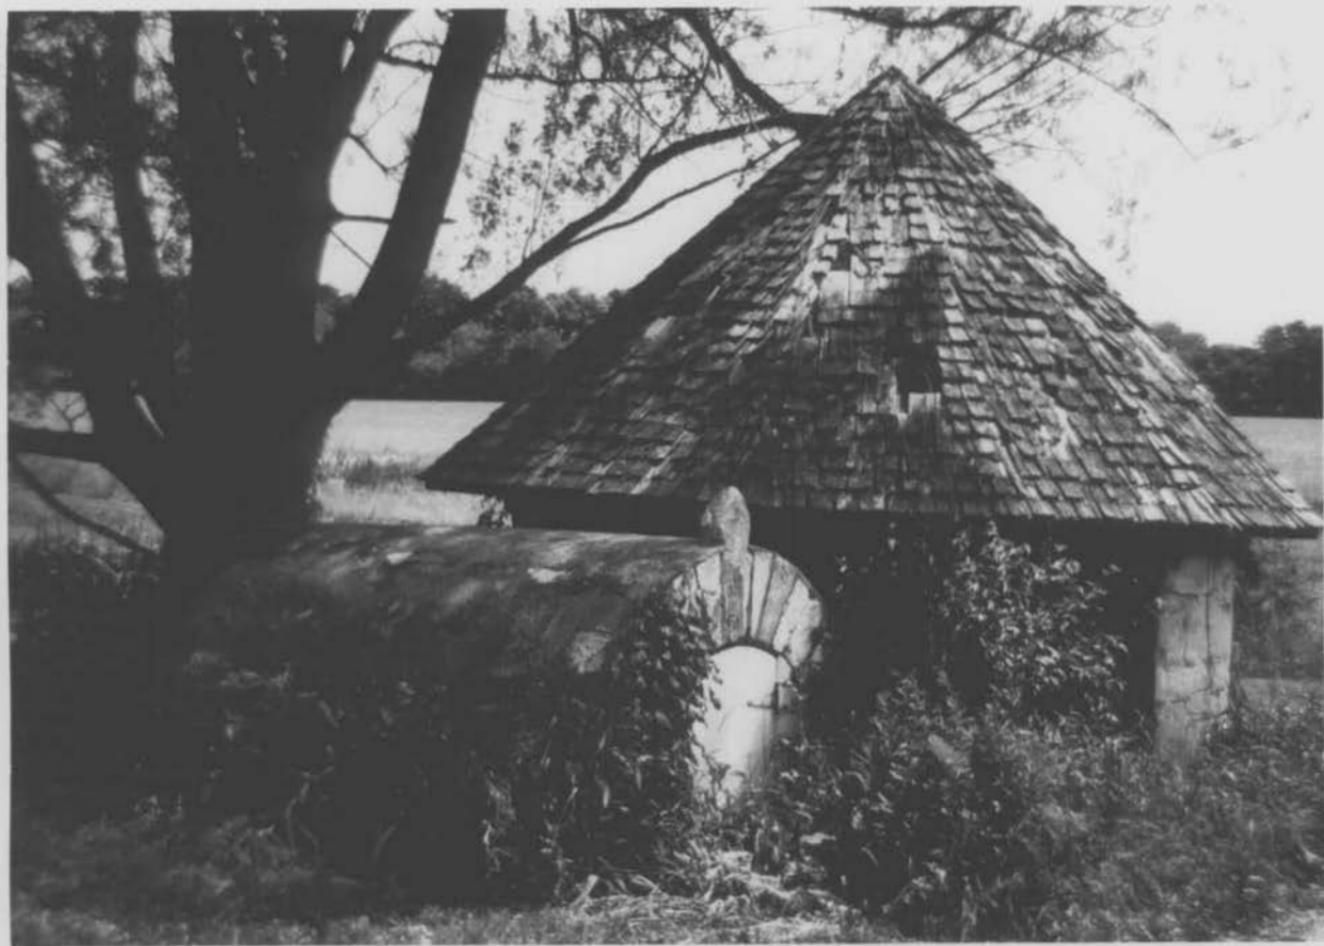
BA-1115

Southeast of the house is a round, stone spring house with a twelve sided steep pyramidal roof. The inside diameter is approximately 12 feet. The top course of stone projects slightly to suggest a corbeled cornice. The entrance is in the south side, through a louvred and paneled door, probably contemporary with the spring house. A small iron-barred window opening east of the door, and another one on the northwest side of the circle admit further light and ventilation. The plastered walls extend rather smoothly into a domed ceiling, the structure of which (stone or lath-and-plaster) is undetermined. A water trough encircles the room.

Immediately west of the round spring house is another stone structure, measuring approximately 7 by 11, containing the actual spring. Its roof is a single barrel vault of stone, an extension of the walls. The keystone above the door projects above the vaulted roof, roughly shaped to form a diamond above the outer surface of the actual vault.

dairy house & springhouse  
from southwest

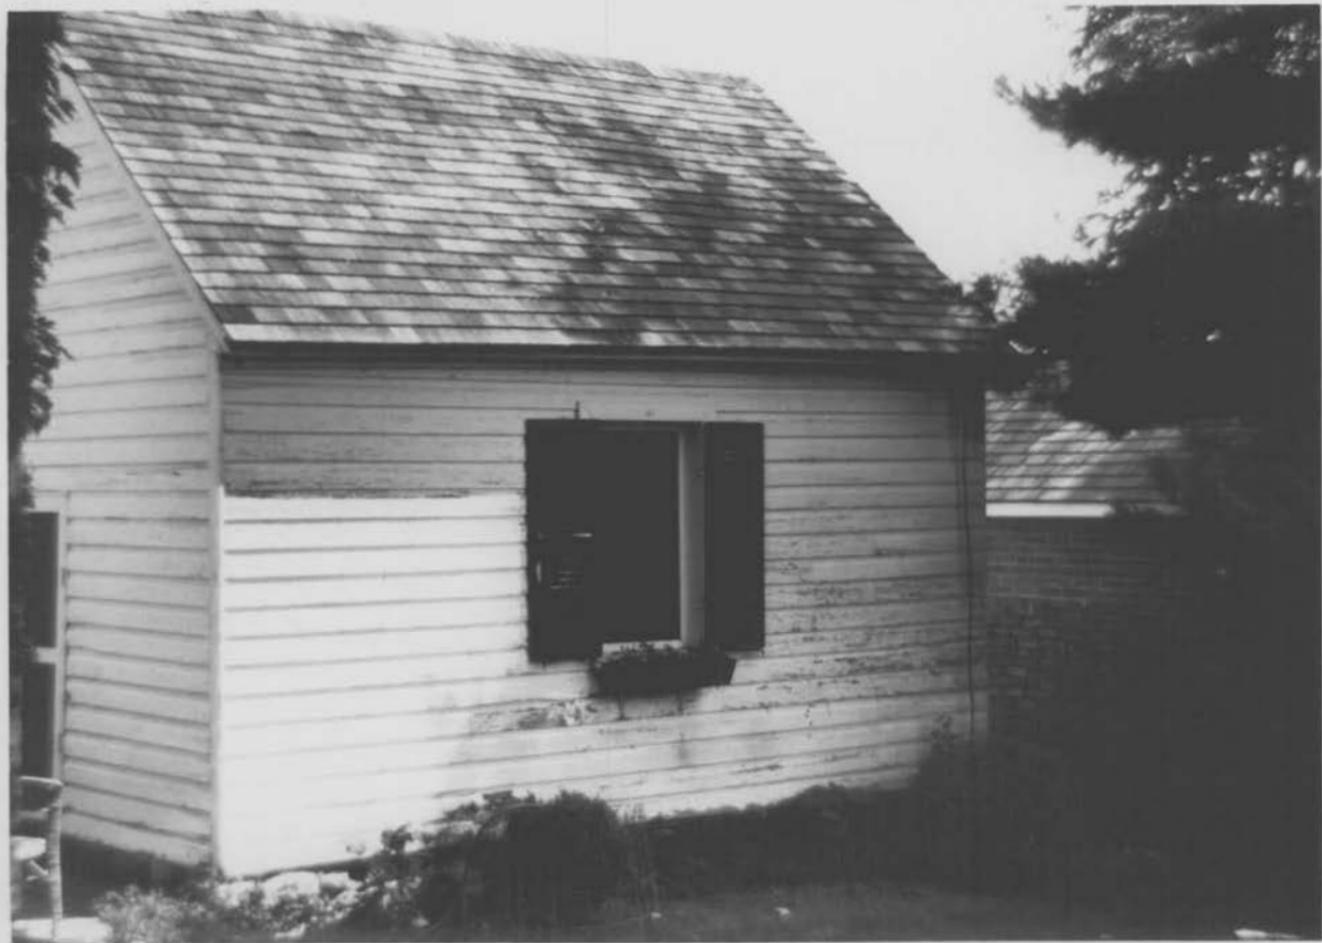
BA-1115

Immediately east of the kitchen is a gable roofed one storey log smoke house, covered with weatherboards; it measures approximately  $14\frac{1}{2}$  by 16 feet. To its east is a brick smoke house, measuring approximately 7 by 12 feet, with a gable roof. The bricks are laid in common bond. Only the log smokehouse appears in the mid-nineteenth century lithograph of the property.

wooden smokehouse

from southwest
