MARYLAND HISTORICAL TRUST WORKSHEET

NOMINATION FORM for the NATIONAL REGISTER OF HISTORIC PLACES, NATIONAL PARKS SERVICE

COMMON: Andor Farm BOHS #113 and Tenant House

AND/OR HISTORIC: Leaferts Lodge

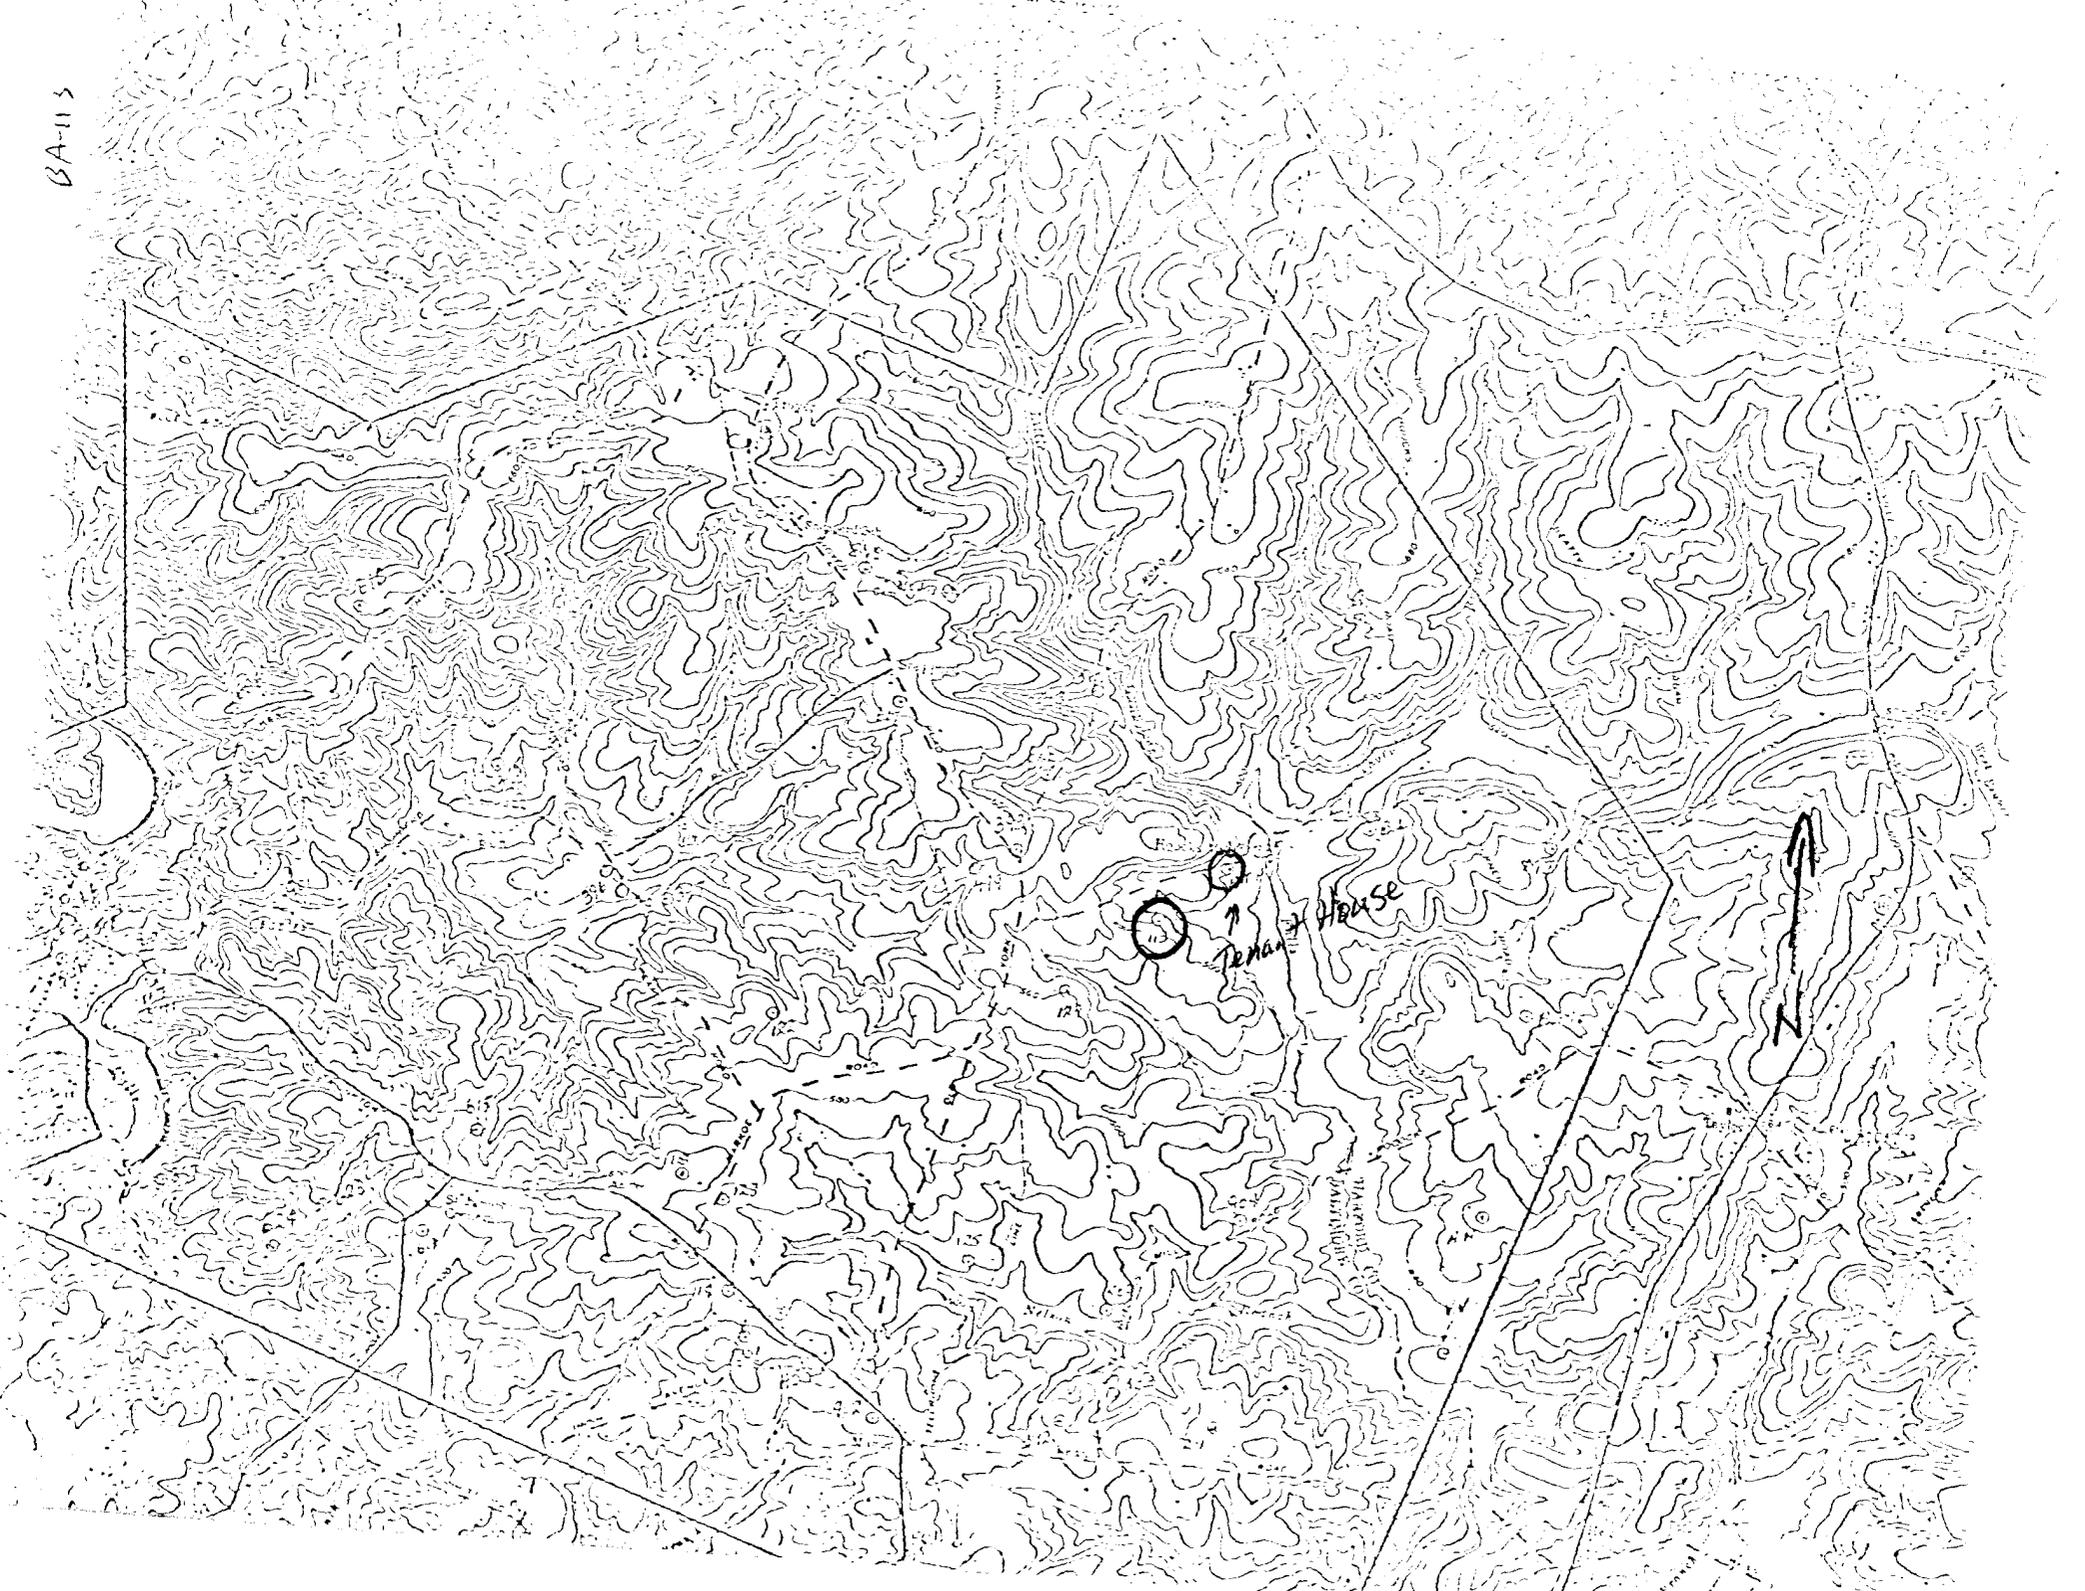
BA-113

1. NAME			
COMMON: Andor Farm		and Tenant House	
AND/OR HISTORIC: Loafers Lodge			
2. LOCATION			
STREET AND NUMBER: Hutchins Mill Rd., 0.2 miles woutheast of Houcks Mill Rd.			
CITY OR TOWN: Monkton			
STATE: Maryland	CODE	COUNTY: Baltimore	CODE
3. PHOTO REFERENCE			
PHOTO CREDIT: R.M.N. Crosby, M. D.			
DATE OF PHOTO: January 1975			
NEGATIVE FILED AT: Maryland Historical Trust 21 State Circle, Annapolis, Md.			
4. IDENTIFICATION			
DESCRIBE VIEW, DIRECTION, ETC.			
South (front) facade

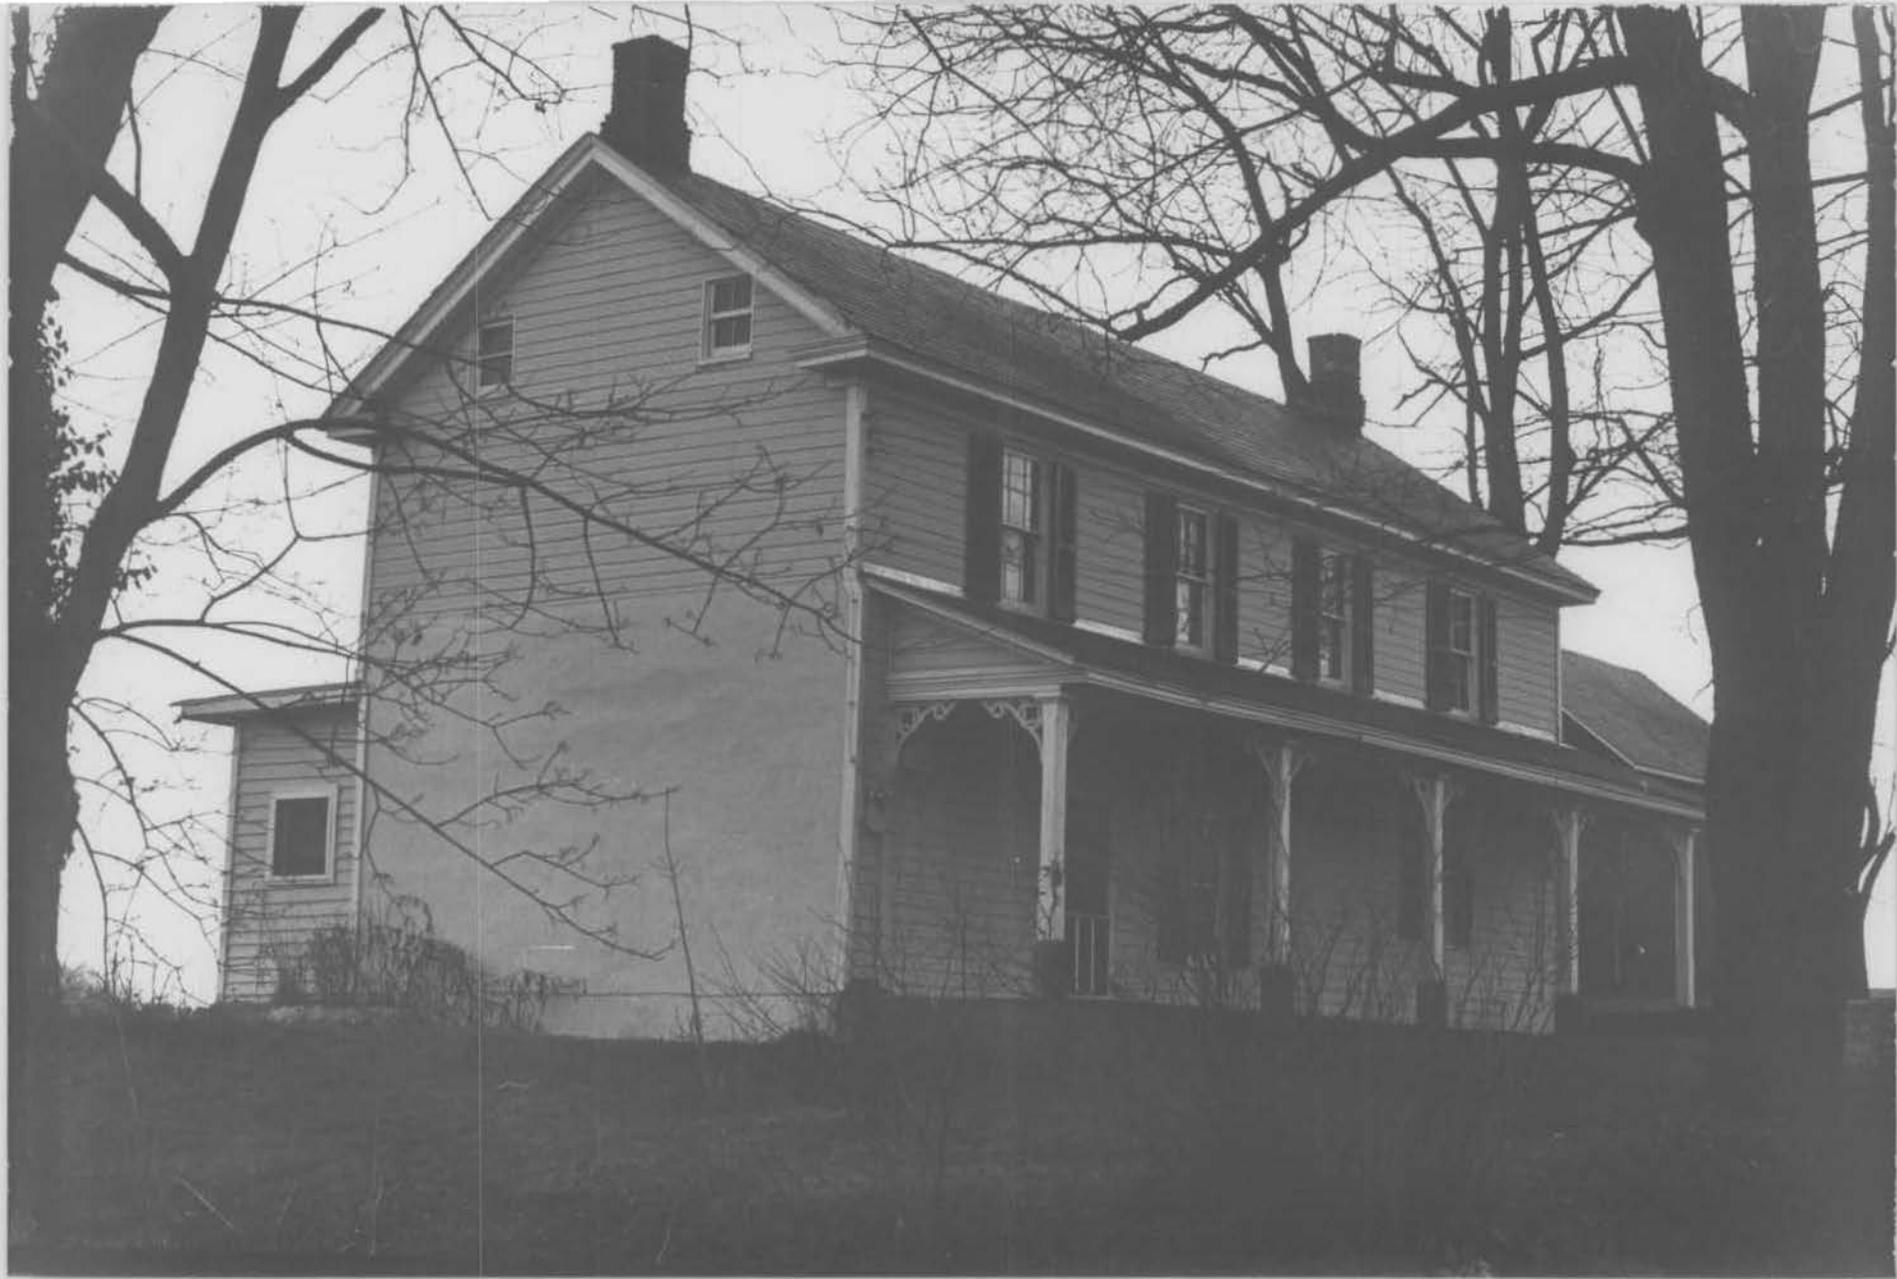
ANDOR FARM TENANT HOUSE

Andor Farm Tenant House

South (front) facade

Tenant House

The Tenant House on Ander Farm is of wood construction, two storeys high, its length divided into two sections, each coincidental in profile, and roofline, but with varying floor levels. Exterior walls are covered with plain weatherboards and the house faces the road on its north side. A one-storey shed-roofed porch extends across both the north and south facades. A third section, now removed, stood on foundations still apparent at the east end.

The westerly section, with its floor levels slightly higher than those of the easterly section, is three bays in length, with a door in the middle bay of both the north and south sides. Windows are 6/6, with architrave trim. A single flue chimney rises from the west gable end. The easterly section is also three bays in length, with similar fenestration. A single flue chimney rises from the east gable end, and the east end of the first storey is stuccoed. At the north east corner, the north facade of the second storey is noticeably recessed from the plane of the wall in the first storey. The porch, extending the entire length of the house, masks the off-set condition west of the corner.
