BA-1203

TURNER MILL DWELLING - Before 1850 - 204 Dairy Road, 0.15 mile west of York Road. Small, 2-story frame house in vernacular style, painted white, located east of the mill. Under the composition shingle covering is a log house according to statement by late owner Stuart Roser. Gable roof, good condition. House first appears on 1875 plat of Miss Georgetta C. Turner's property (in special bound volume of plats in clerk's office, Towson). House and mill were both on Lot No. 4. In a

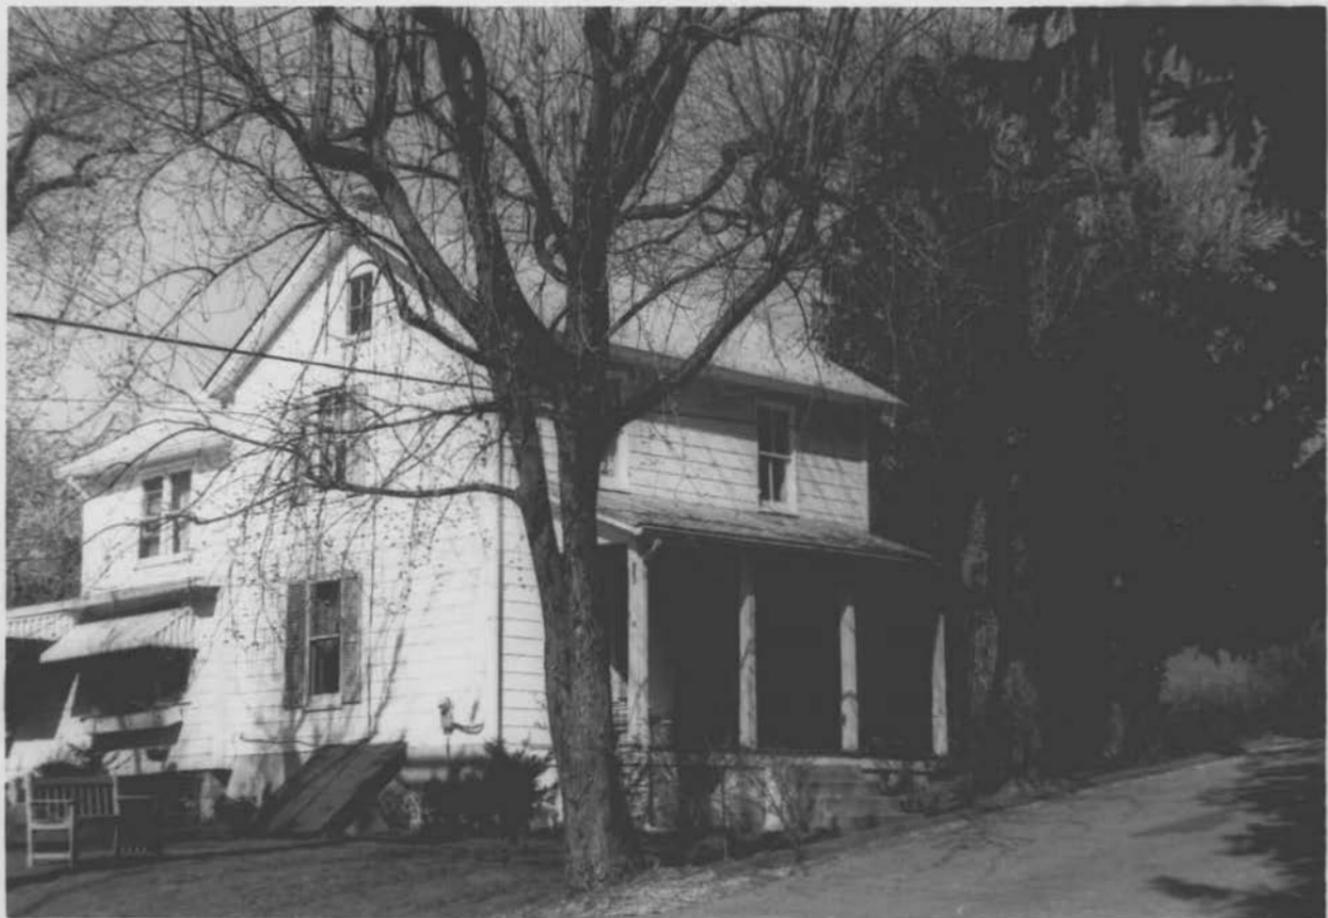
Turner Mill Dwelling BA 1203
Baltimore County, Maryland
John McGrain March 1980
Neg Located at MHT
House from SW
Photo 1 of 11

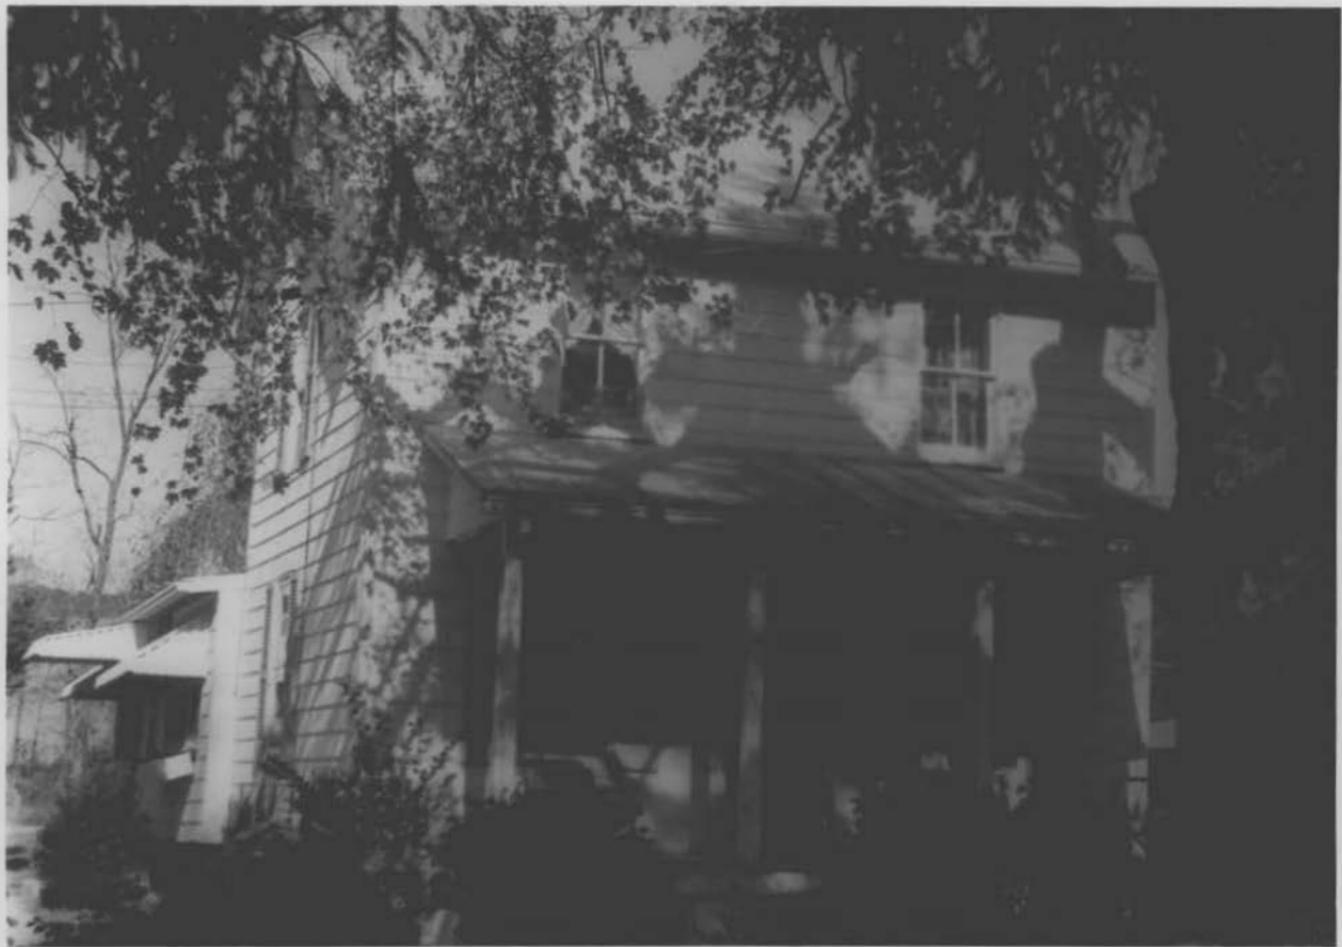
Turner Mill Dwelling BA 1203
Baltimore County, Maryland
John McGrain October 1980
Neg Located at MHT
House from south, main facade
Photo 2 of 11

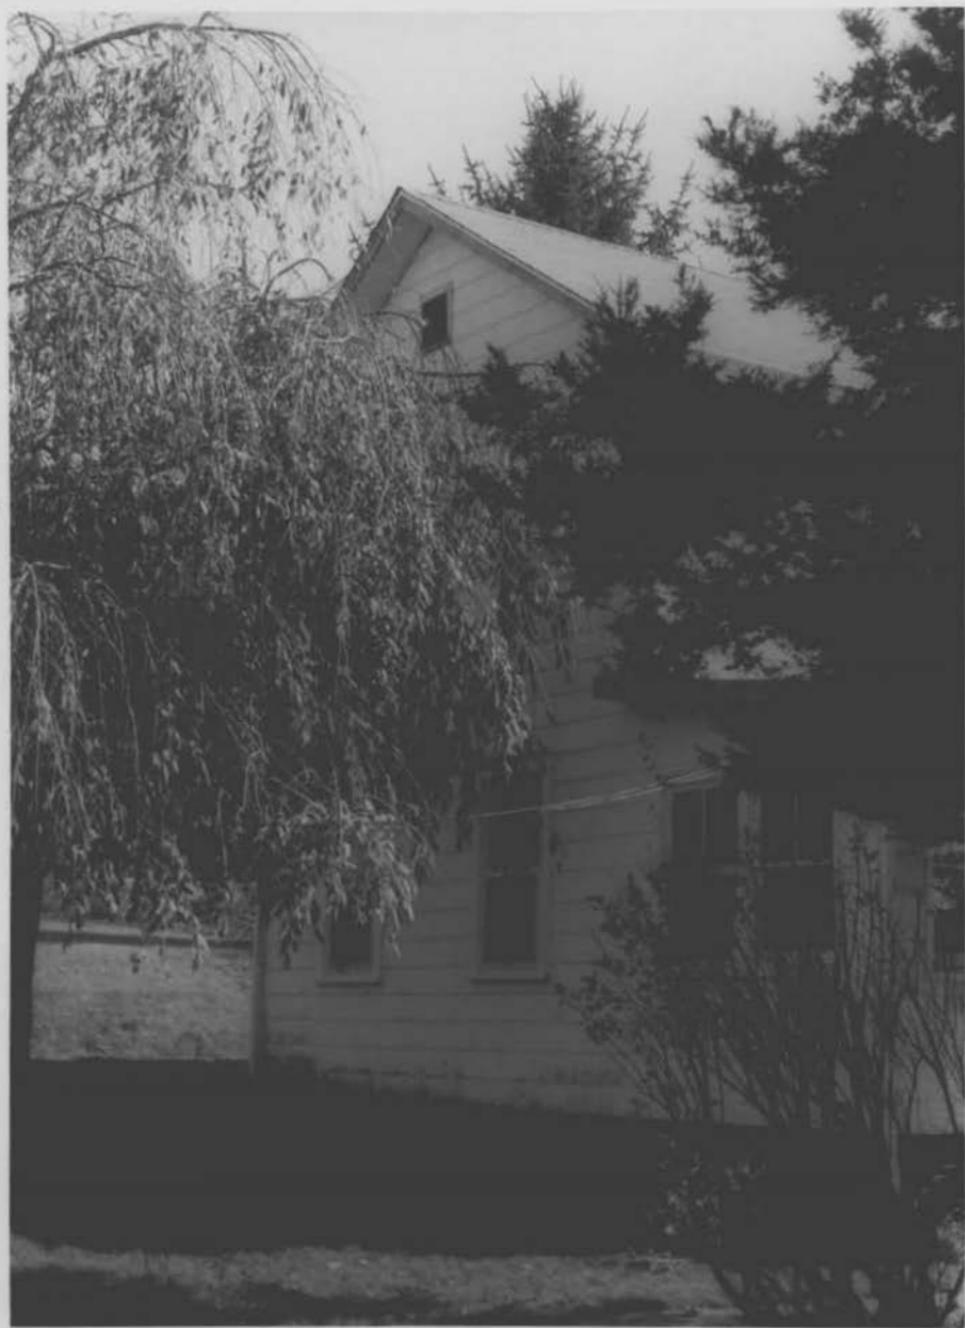
Turner Mill Dwelling BA 1203
Baltimore County, Maryland
John McGrain, October 30 1980
House from SW
Neg Located at MHT
Photo 3 of 11

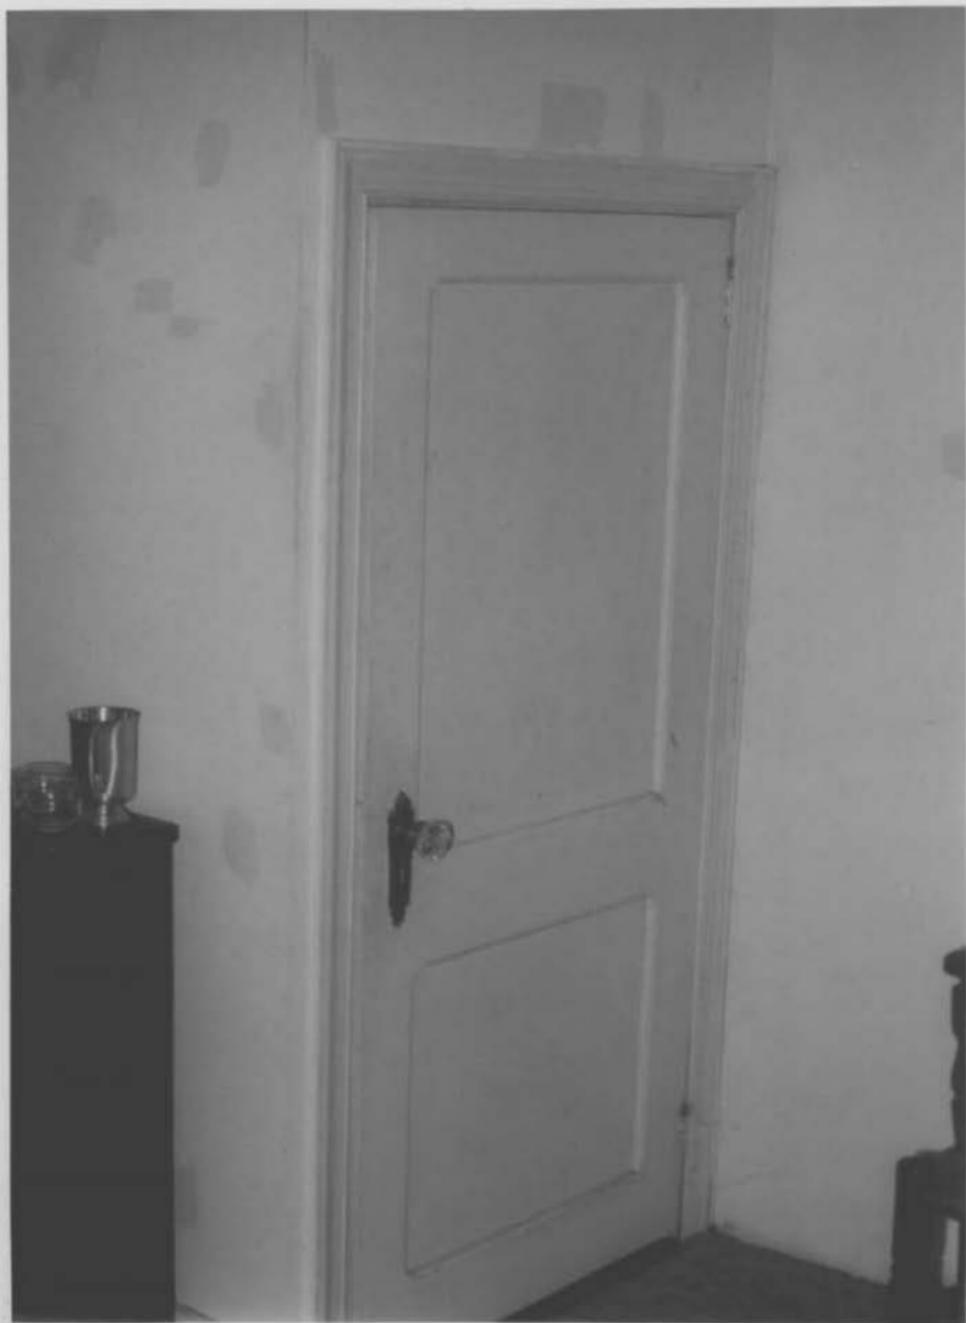
Turner Mill Dwelling BA 1203
Baltimore County, Maryland
John McGrain October 30 1980
Neg Located at MHT
Living room, unusually low closet
door
Photo 4 of 11

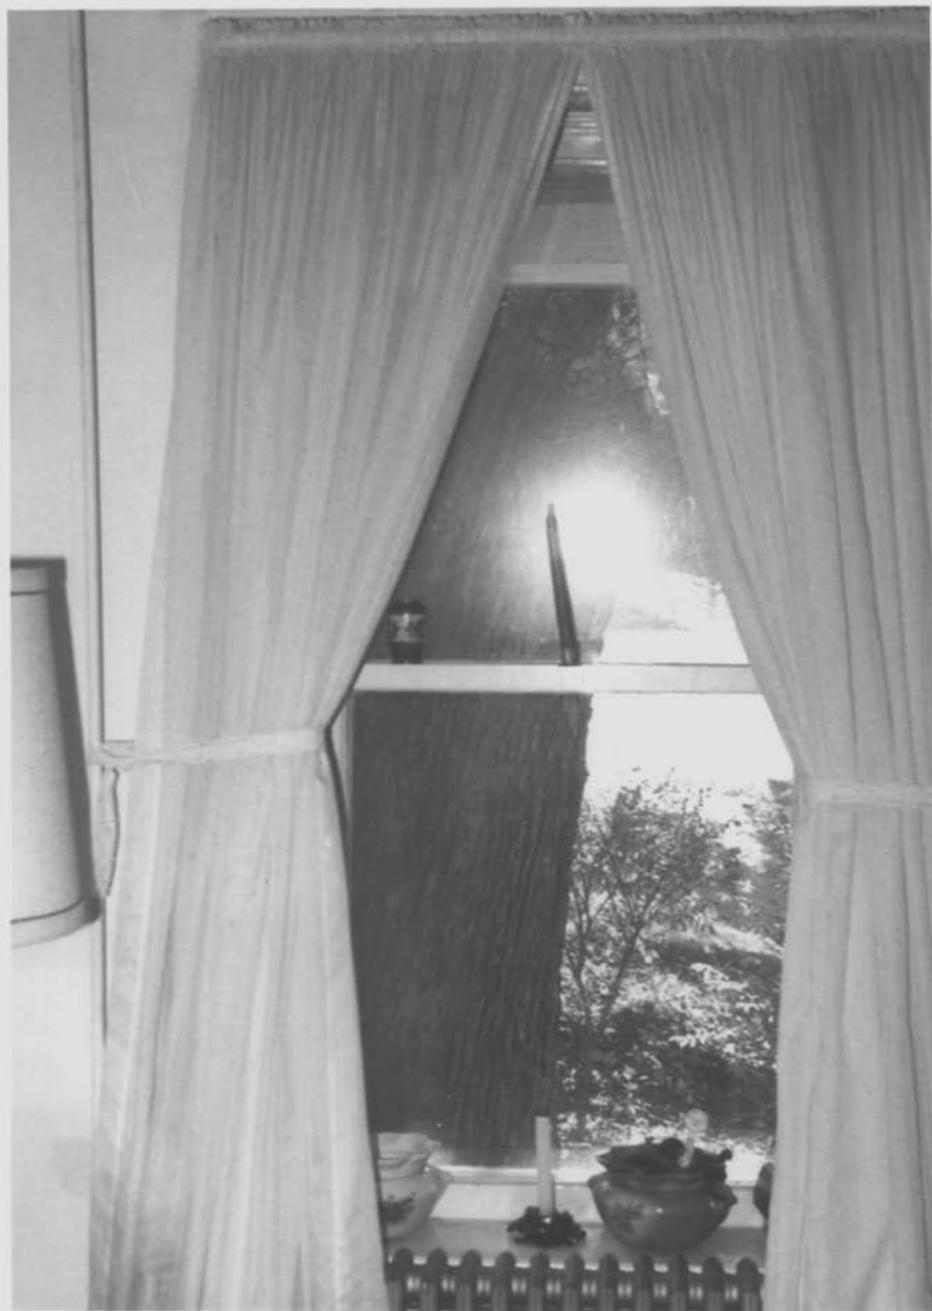
Turner Mill Dwelling BA 1203
Baltimore County, Maryland
John McGrain October 30 1980
Neg Located at MHT
Living room, west window
Photo 5 of 11

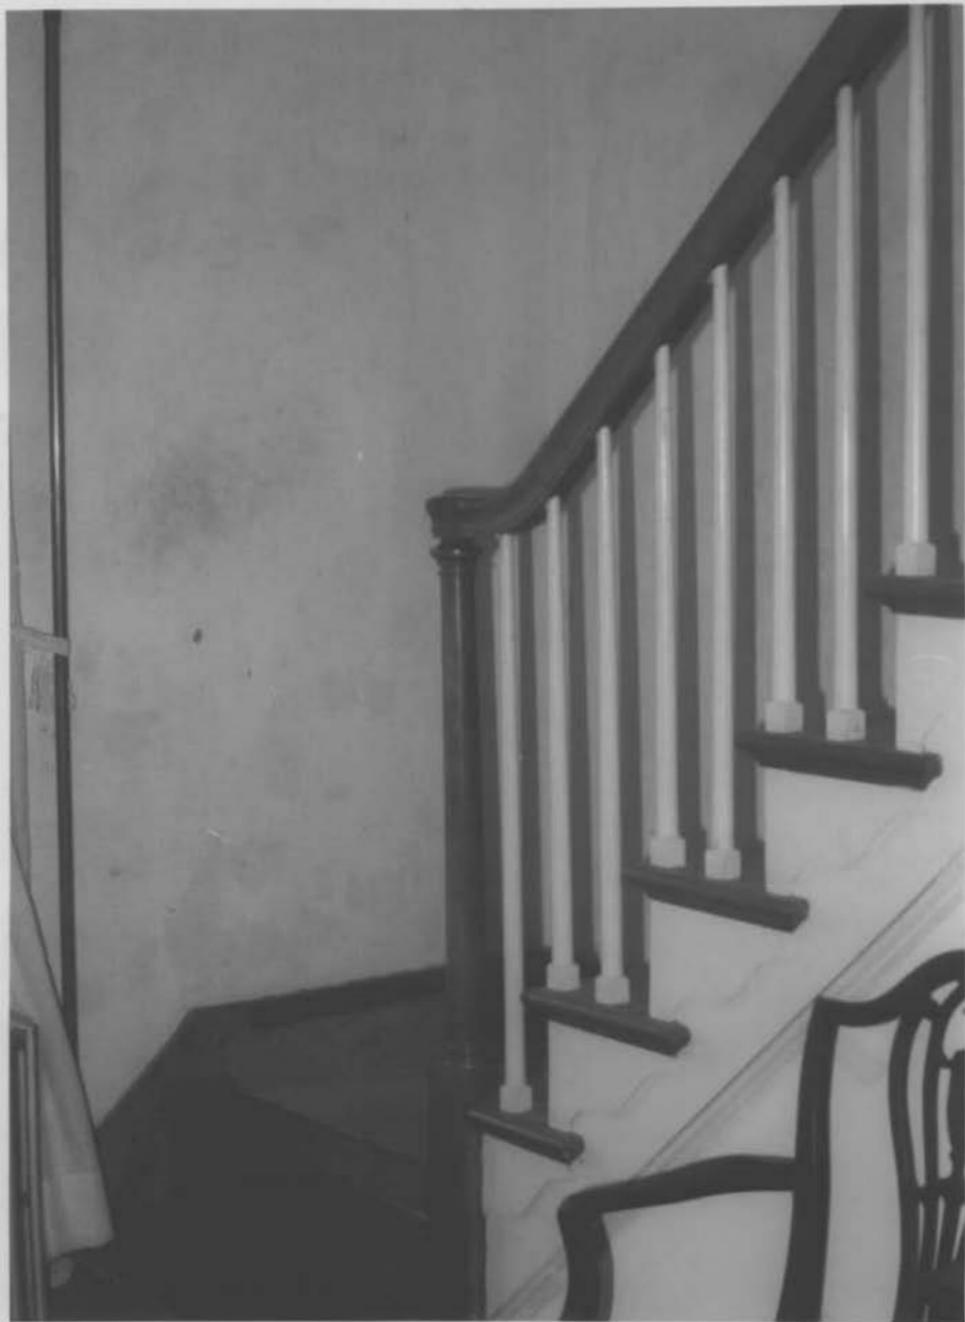
Turner Mill Dwelling BA 1203
Baltimore County, Maryland
John McGrain October 30, 1980
Neg Located at MHT
Living Room, stairway landing
Photo 6 of 11

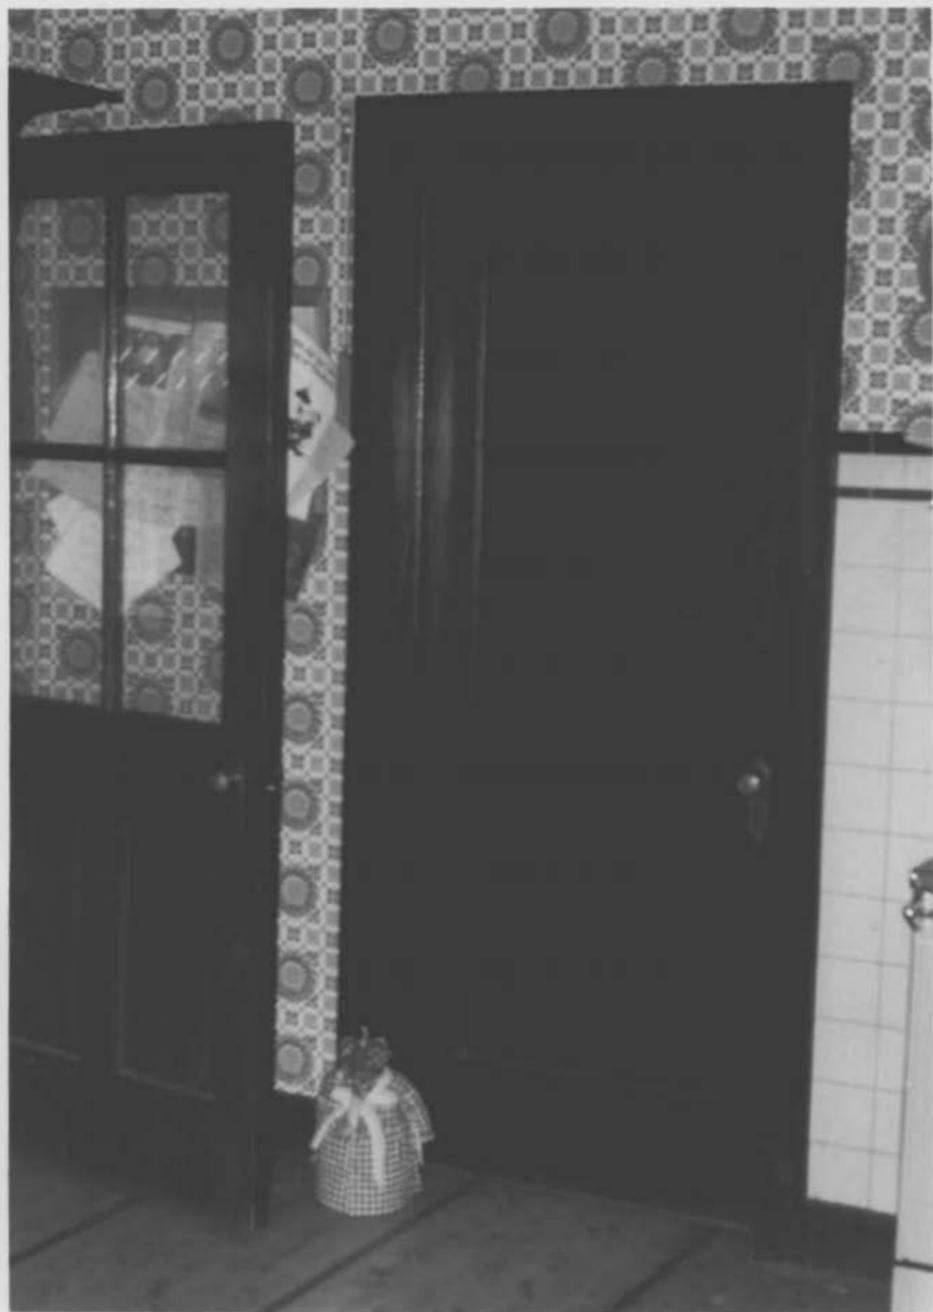
Turner Mill Dwelling BA 1203
Baltimore County, Maryland
John McGrain October 30 1980
Neg Located at MHT
Kitchen, doors to enclosed porch and
to utility room
Photo 7 of 11

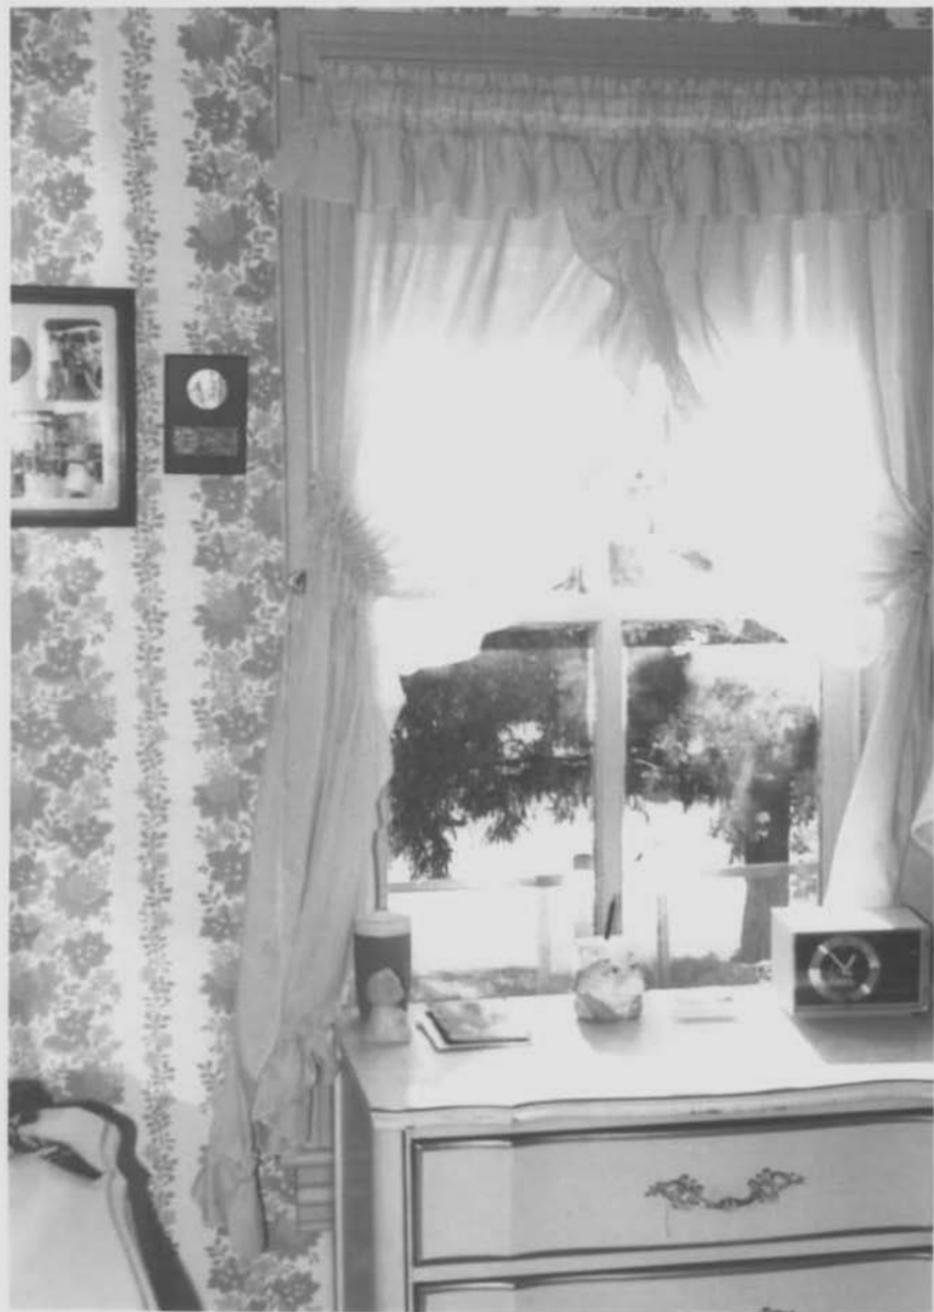
Turner Mill Dwelling BA 1203
Baltimore County, Maryland
John McGrain October 30 1980
Neg Located at MHT
Second story, front-west room,
 typical window frame
Photo 8 of 11

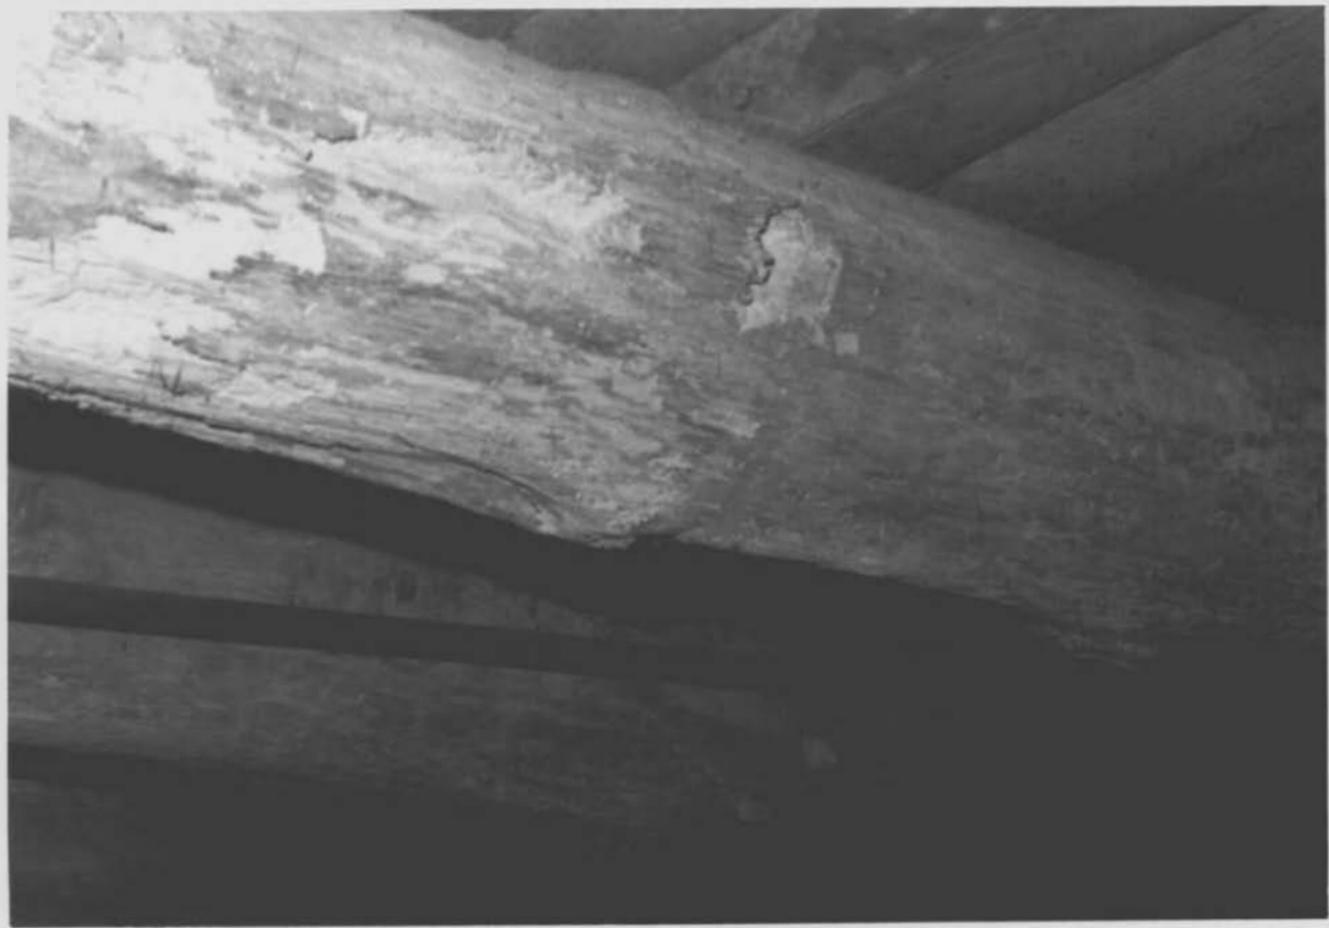
Turner Mill Dwelling BA 1203
Baltimore County, Maryland
John McGrain October 30 1980
Neg Located at MHT
Rough-hewn joists in basement
Photo 9 of 11

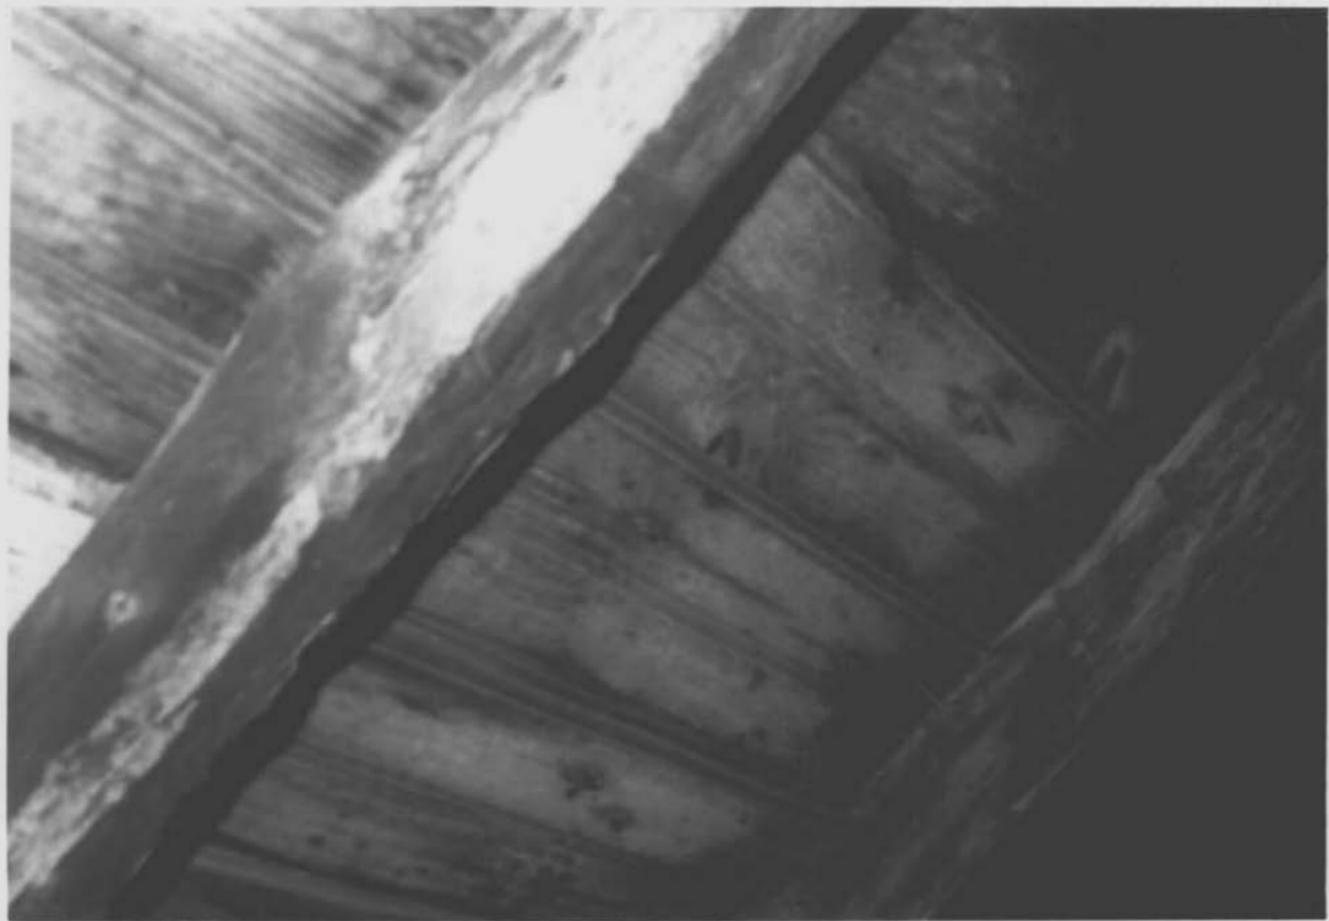
Turner Mill Dwelling BA 1203
Baltimore County, Maryland
John McGrain October 30 1980
Neg Located at MHT
Attic, hand-hewn rafter in original
 main block
Photo 10 of 11

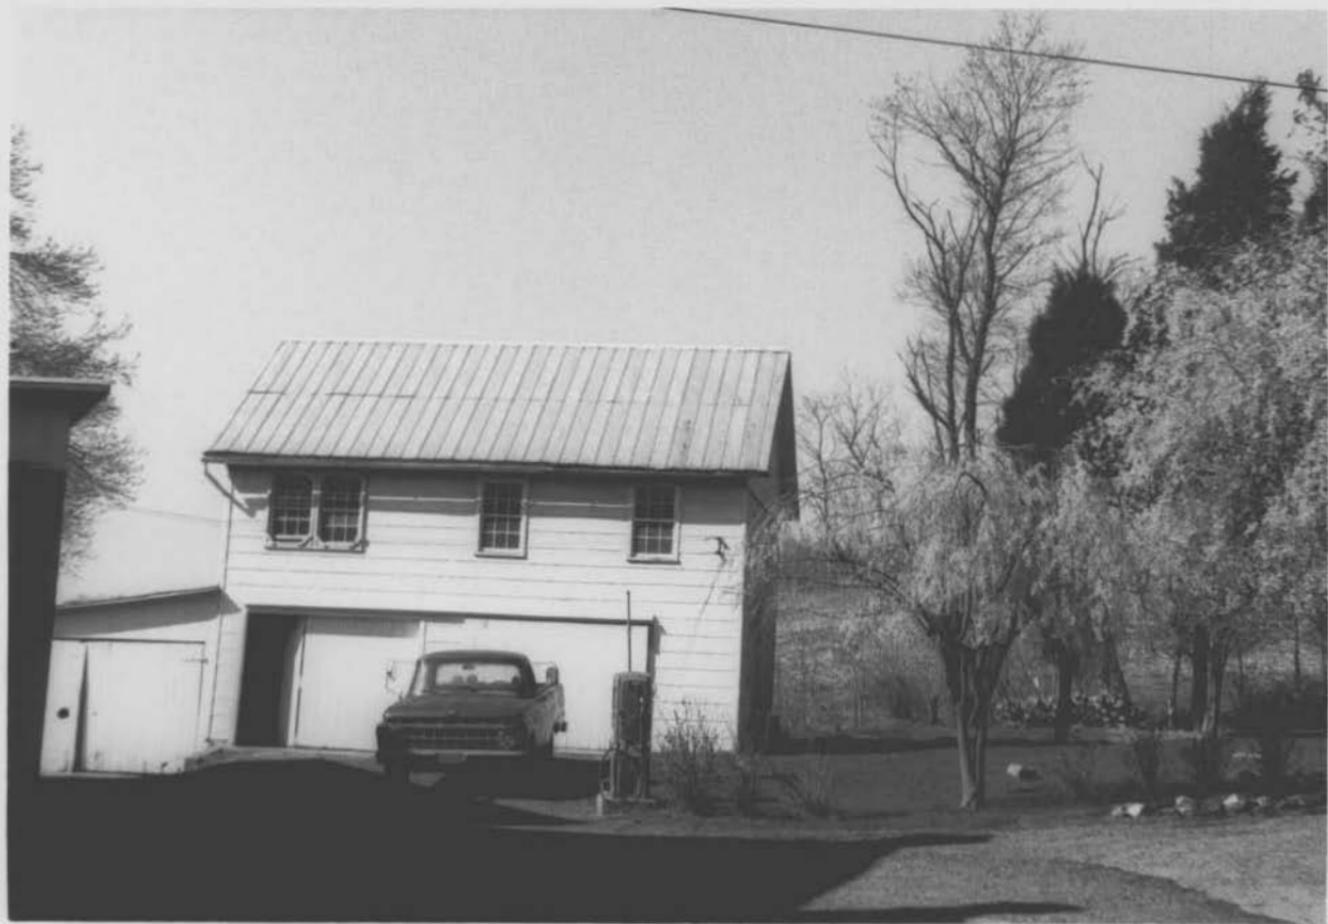
Turner Mill Dwelling BA 1203
Baltimore County, Maryland
John McGrain March 1980
Neg Located at MHT
Frame stable from S
Photo 11 of 11
