Property Name: Philip Reister House Survey Number: BA-1270

**FIELD REPORT**

**Date:** February 15, 1995  
**Project:** Reisterstown Residence

Subject STRUCTURAL INSPECTION & REPORT

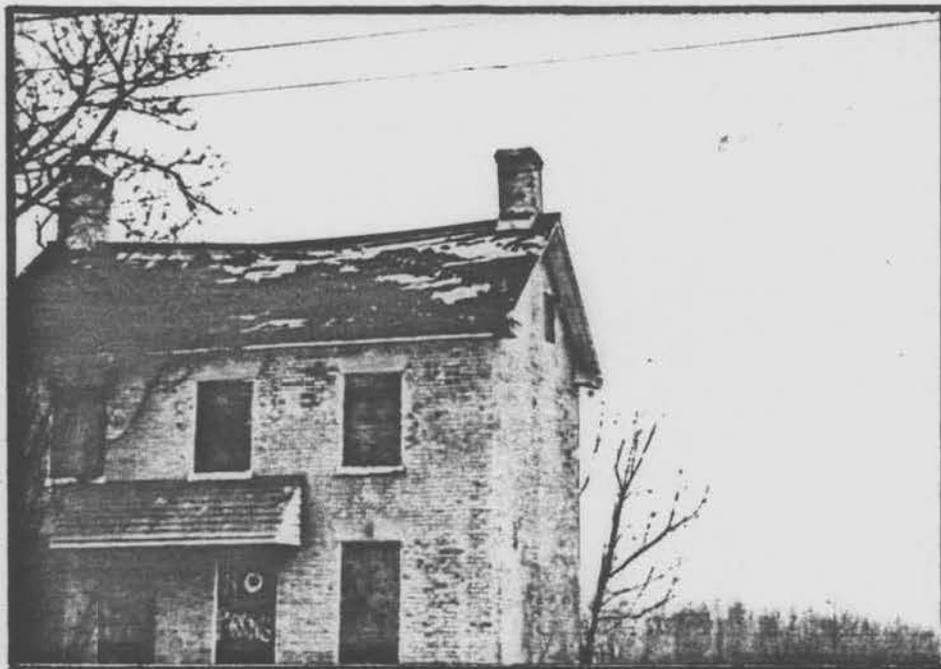
Reisterstown Residence 2-3-95-004  
Westminster Pike & Reisterstown  
Front (East) Elevation

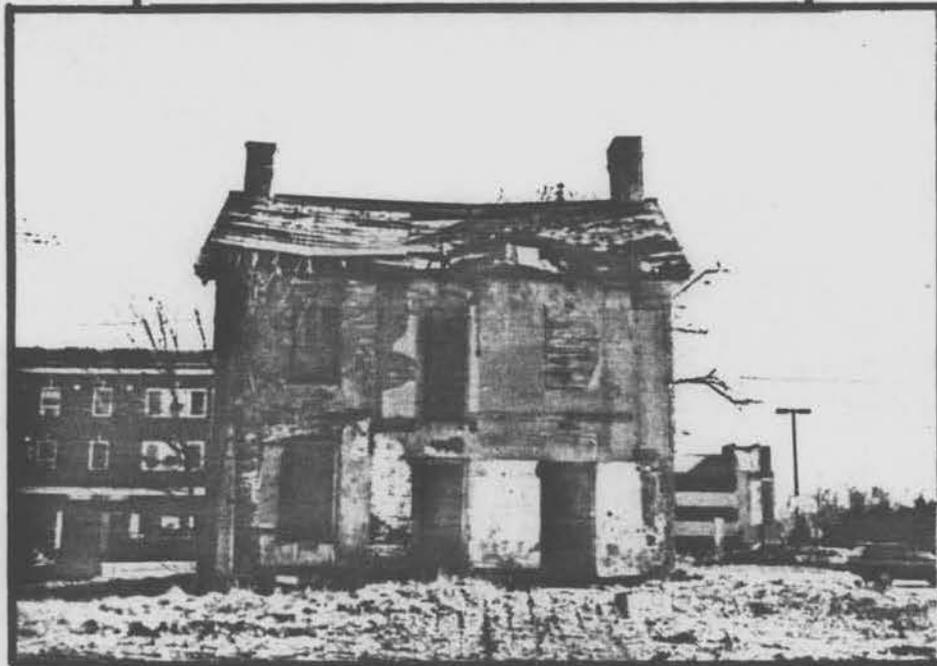
Reisterstown Residence 2-3-95-004  
Westminster Pike & Reisterstown  
Rear (West) Elevation

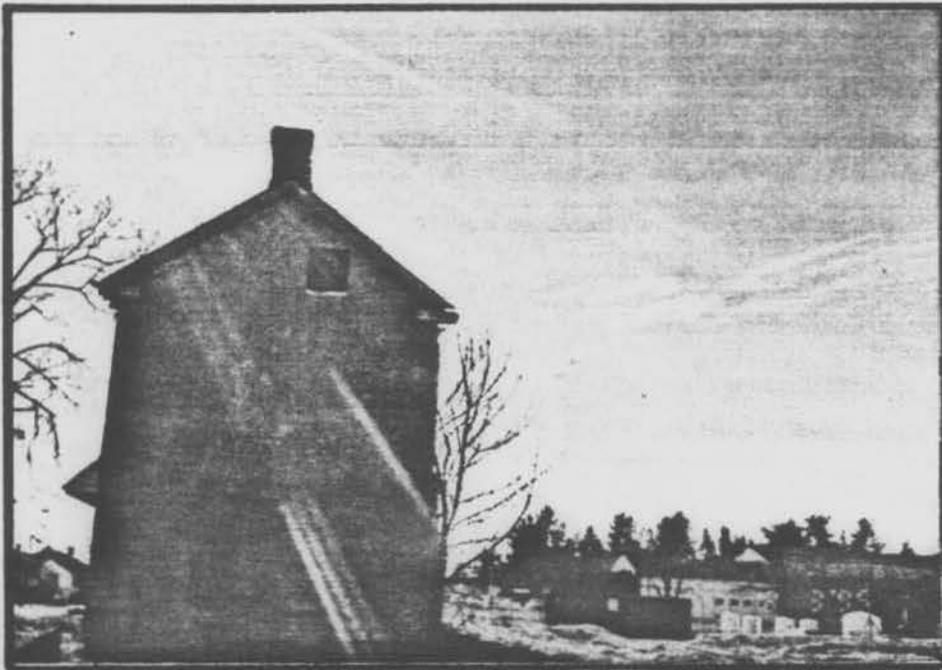
Reisterstown Residence 2-3-95-004  
Westminster Pike & Reisterstown  
Side (North) Elevation

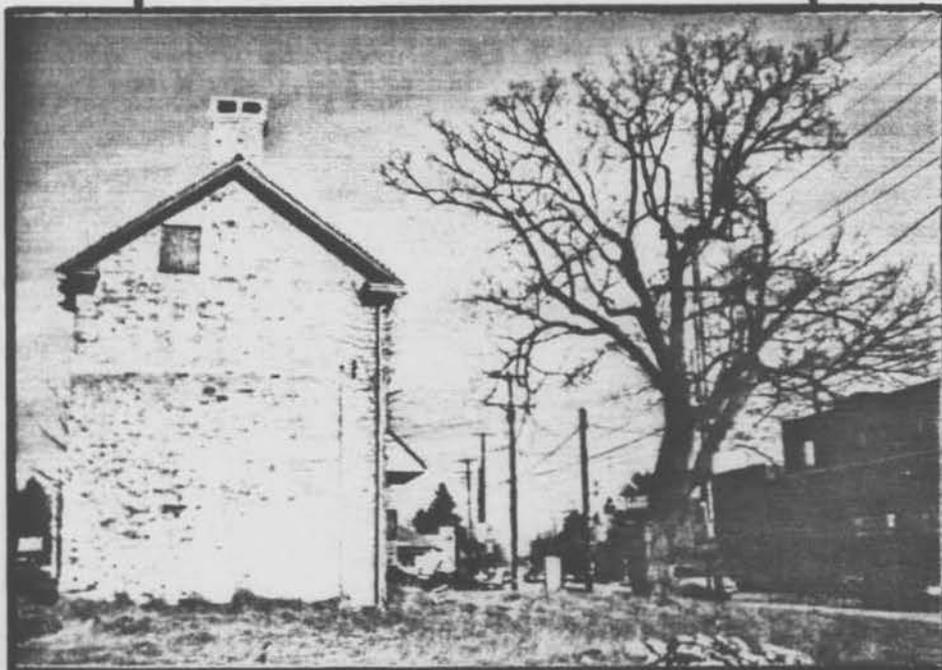
Reisterstown Residence 2-3-95-004  
Westminster Pike & Reisterstown  
Side (South) Elevation

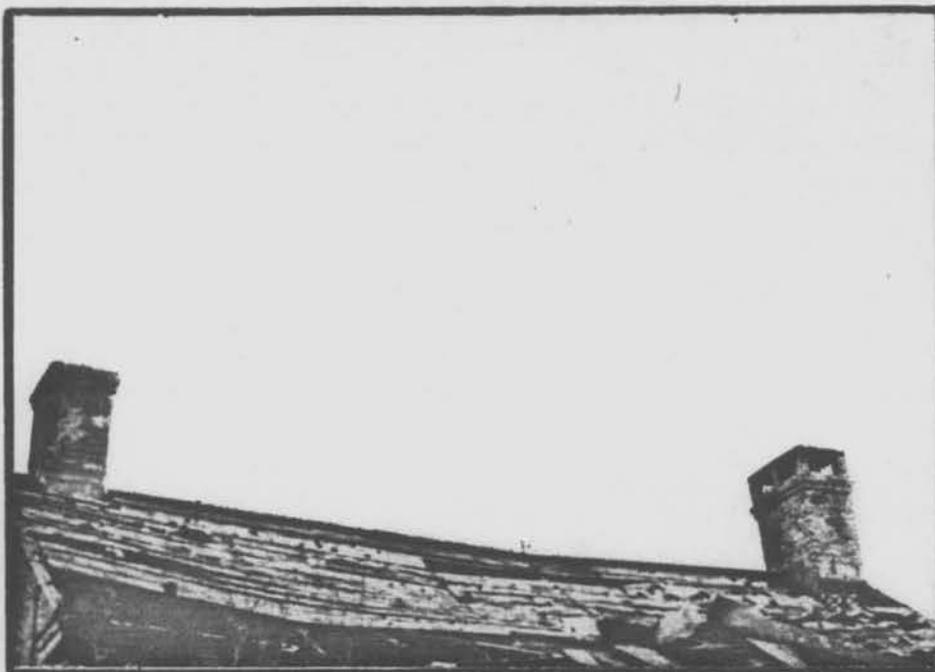
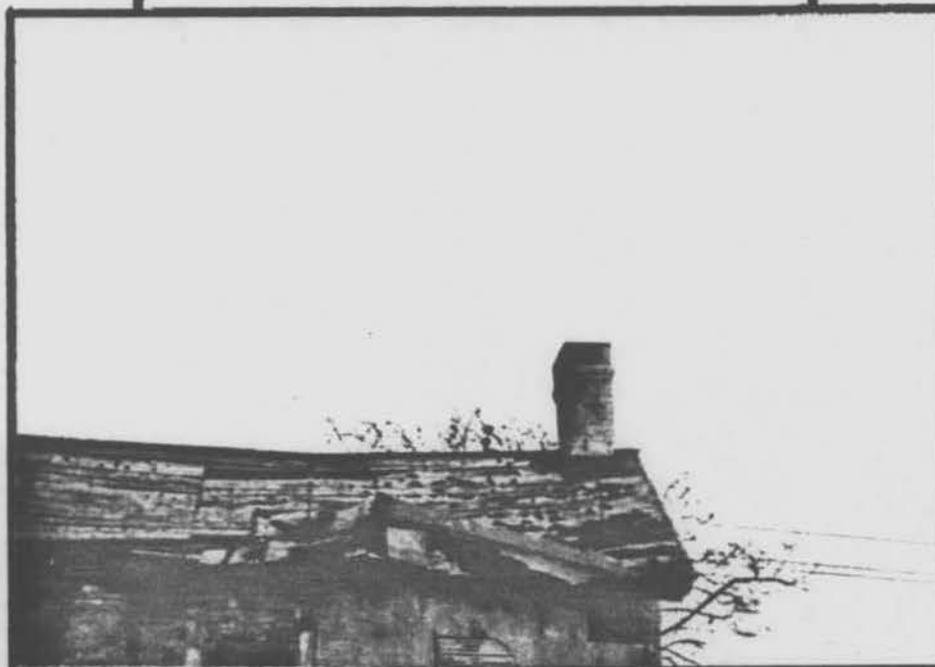
6. The wood roof system has extensively collapsed and is either partially supported by the exterior brick walls and/or deposited onto both the second and first floors. See photographs of these conditions.

Reisterstown Residence 2-3-95-004  
Westminster Pike & Reisterstown  
Deteriorated Roof System and  
Brick Chimney

The building should be immediately razed to prevent entry by the general public and other unauthorized personnel. As this report indicates I was able to enter all areas and levels of this building to collect data.

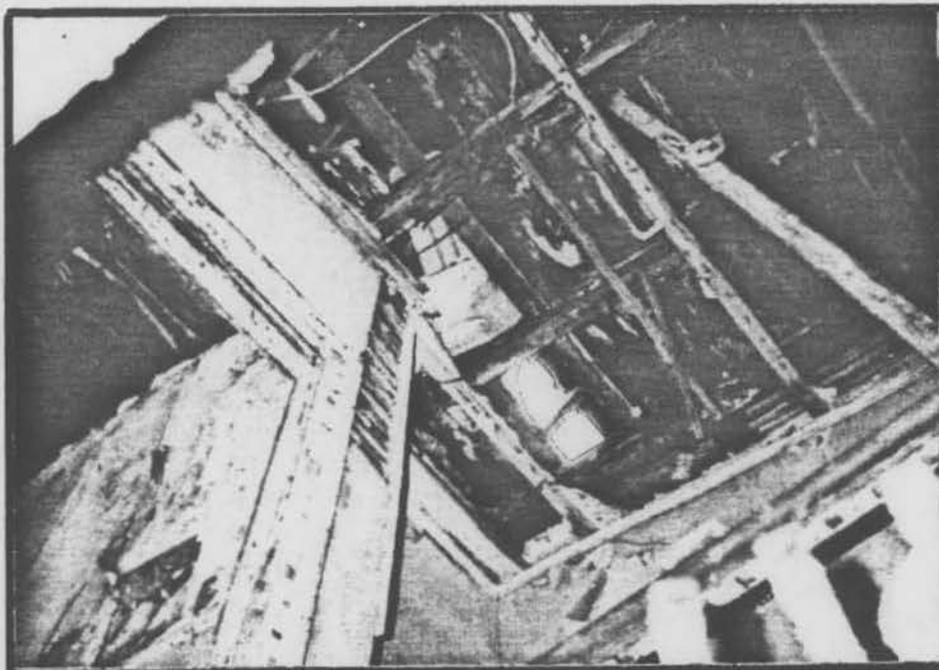
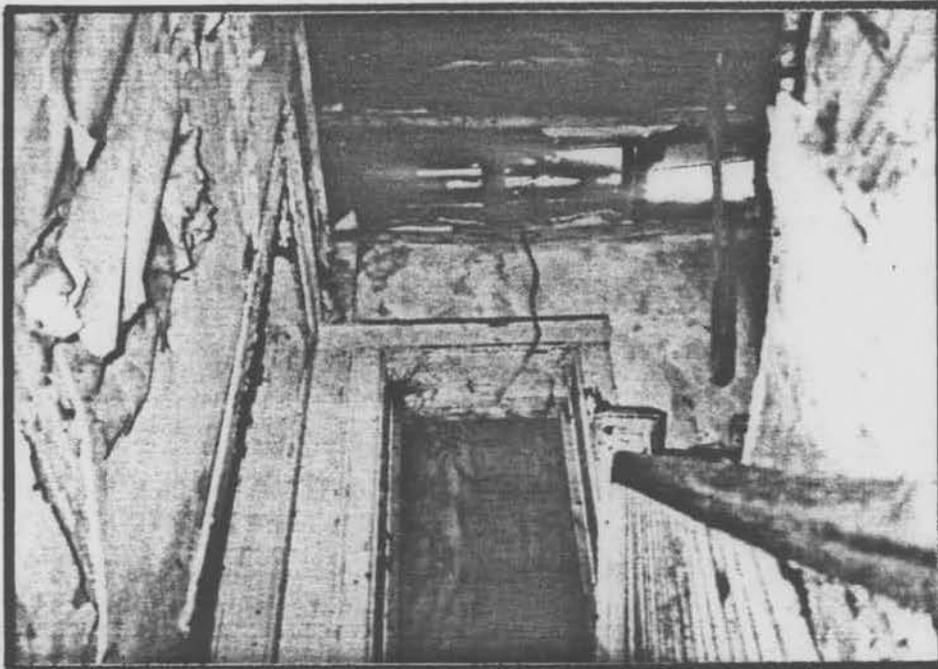
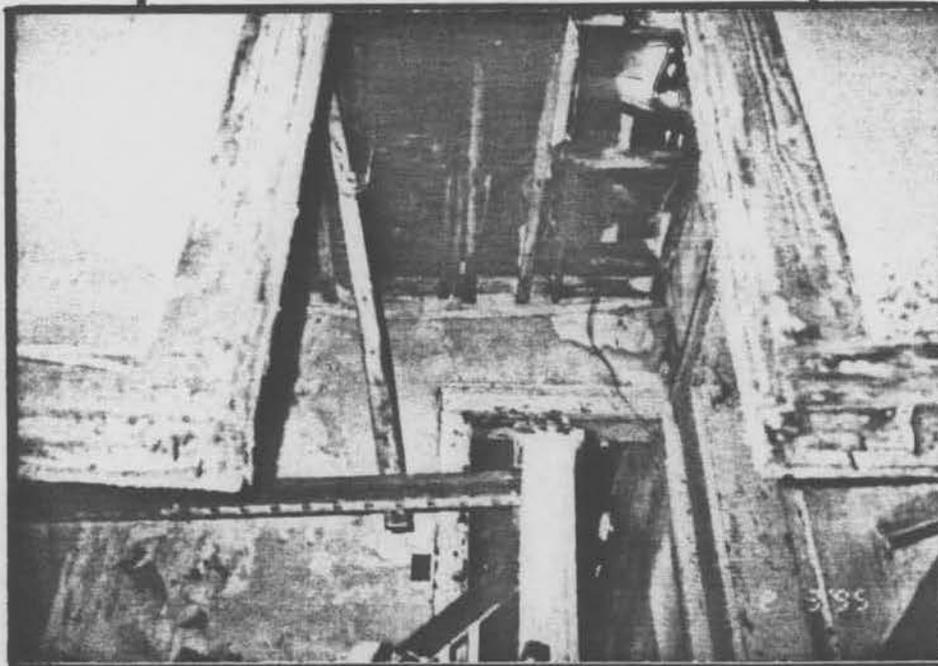
5. The second floor wood framing and ceiling system has extensively collapsed and is either hanging from the second level and/or deposited onto the first floor. See photographs of these conditions.

Reisterstown Residence 2-3-95-004  
Westminster Pike & Reisterstown  
Deteriorated and Collapsed  
2nd. Floor and Roof System

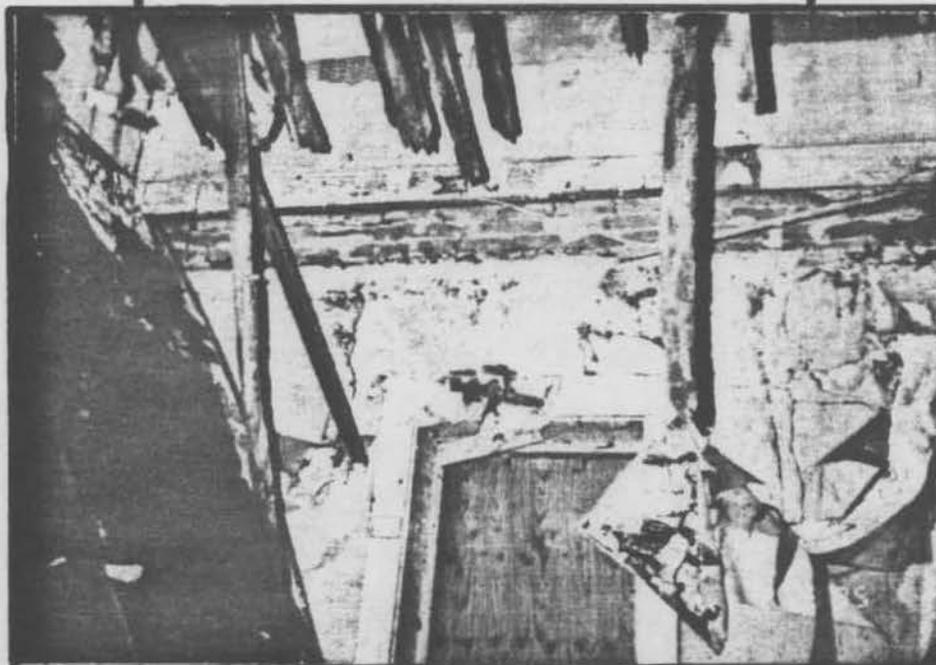
Reisterstown Residence 2-3-95-004  
Westminster Pike & Reisterstown  
Deteriorated Interior Wall  
East Side 2nd. Level

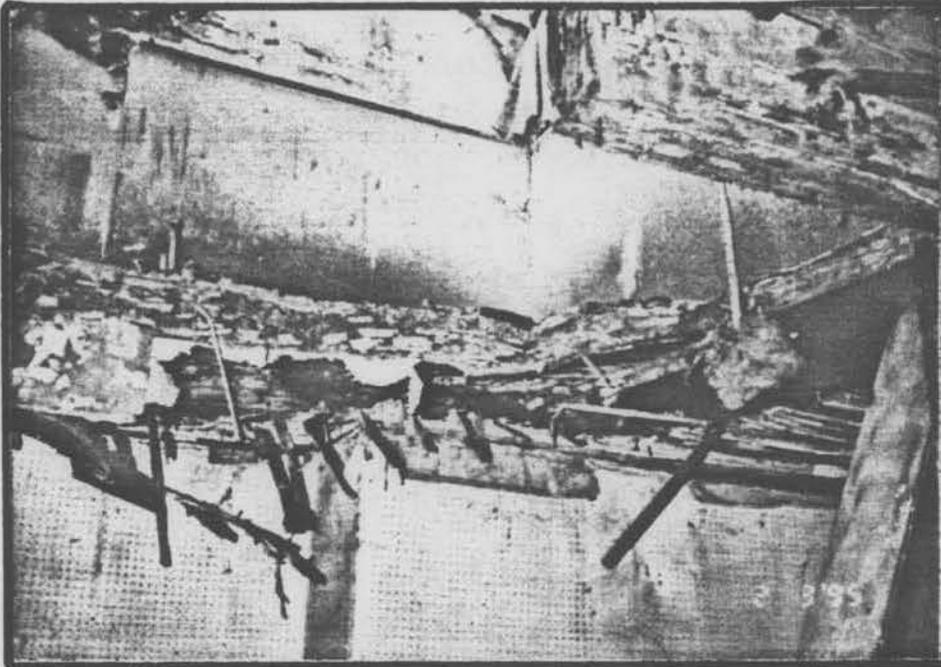
Reisterstown Residence 2-3-95-004  
Westminster Pike & Reisterstown  
Deteriorated and Collapsed  
2nd. Floor Framing System

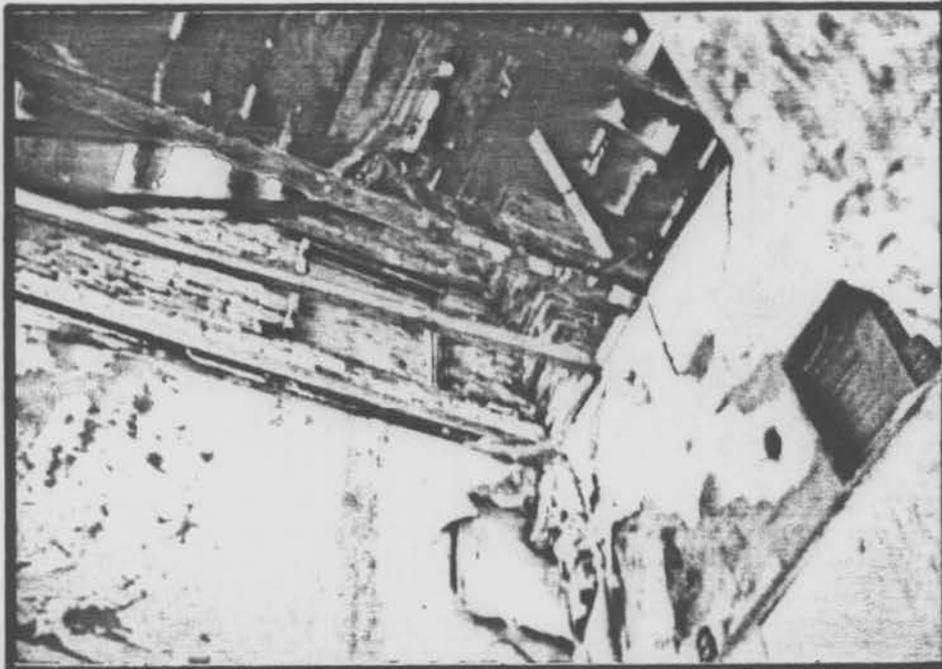
7. The exterior superstructure walls are approximately 8" thick. Some of the exterior brick surfaces have been painted and/or parged. The pargeting is in various stages of deterioration. Mortar within the brick joints is in fair to poor condition with many voids, loose, sandy and easily removed with a steel awl. The wall is cracked and bulging at several locations. The brick chimneys which extend above the roof level are in various stages of deterioration with missing mortar and tilting when viewed with binoculars.

Reisterstown Residence 2-3-95-004  
Westminster Pike & Reisterstown  
Deteriorated Interior Brick North  
Wall 2nd./ Attic Level

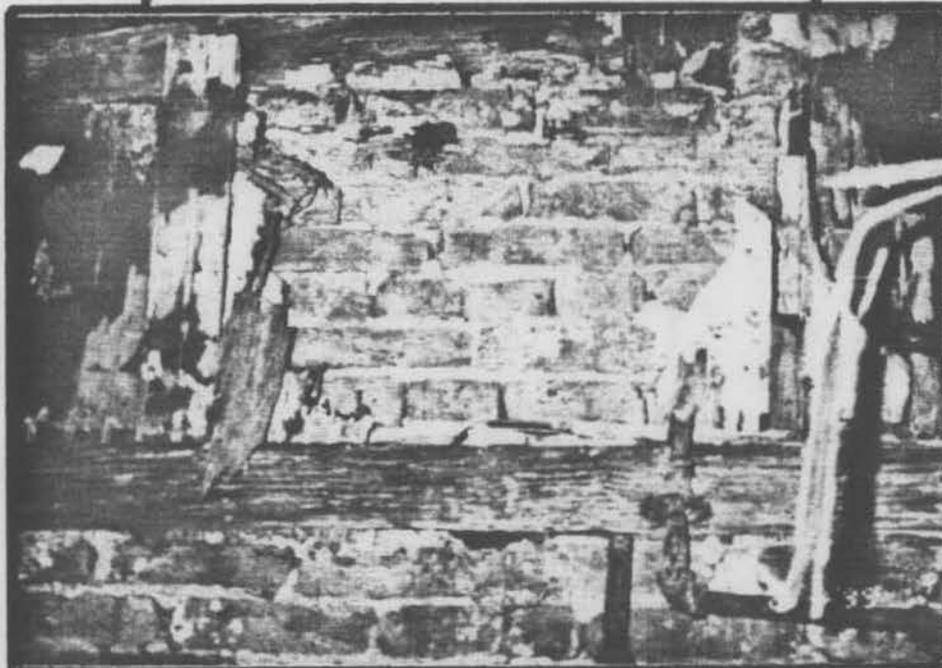
Reisterstown Residence 2-3-95-004  
Westminster Pike & Reisterstown  
Deteriorated Interior Brick West  
Wall (Center) 2nd. Level

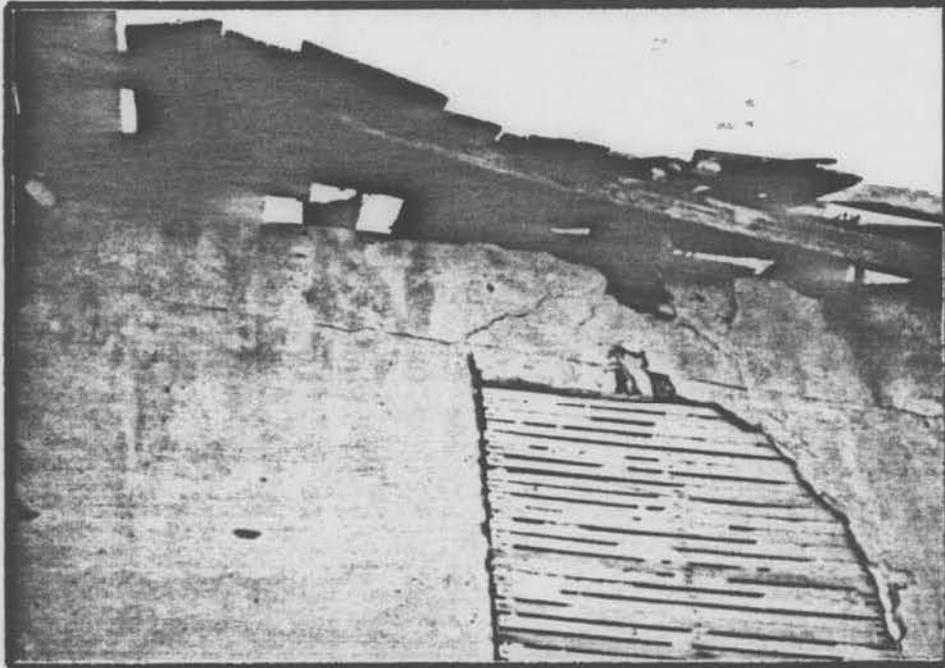
Reisterstown Residence 2-3-95-004  
Westminster Pike & Reisterstown  
Deteriorated Parqueting West Wall  
South Corner 2nd. Level

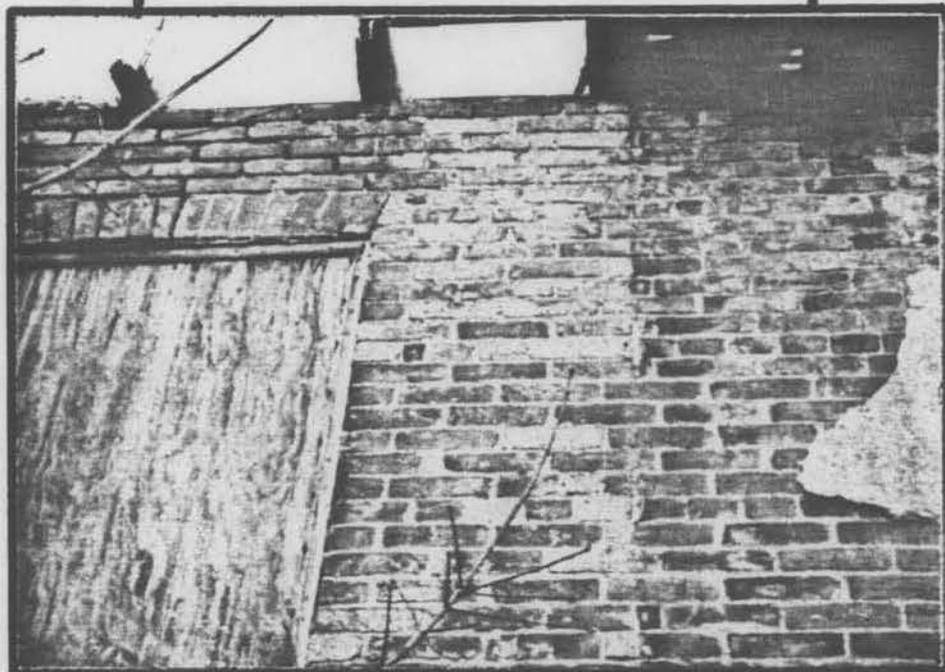
Reisterstown Residence 2-3-95-004  
Westminster Pike & Reisterstown  
Deteriorated Exterior Brick West  
Wall (Center) 2nd. Level

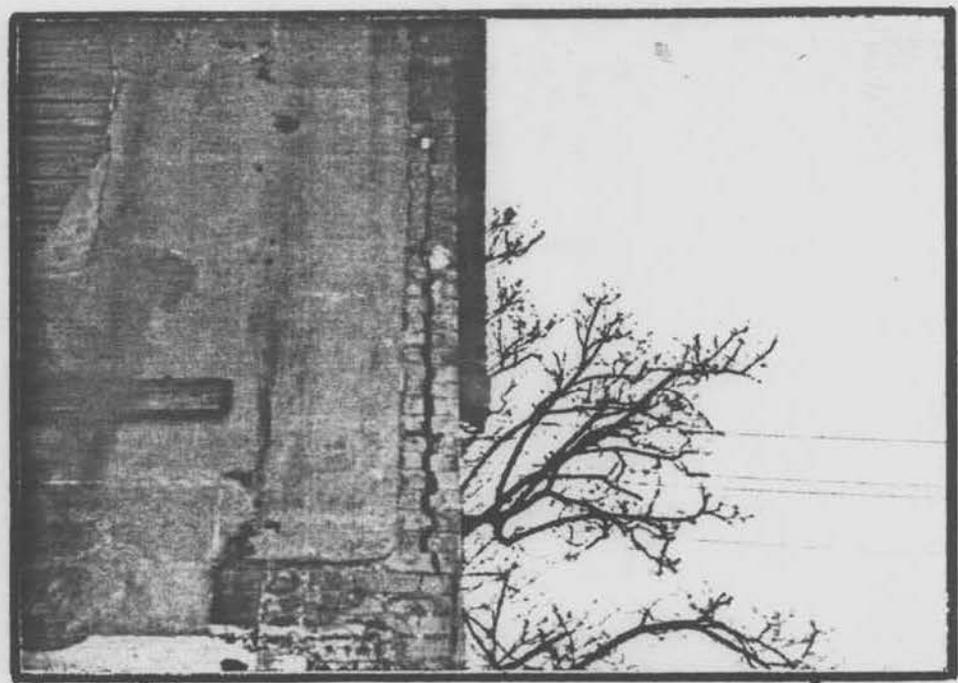
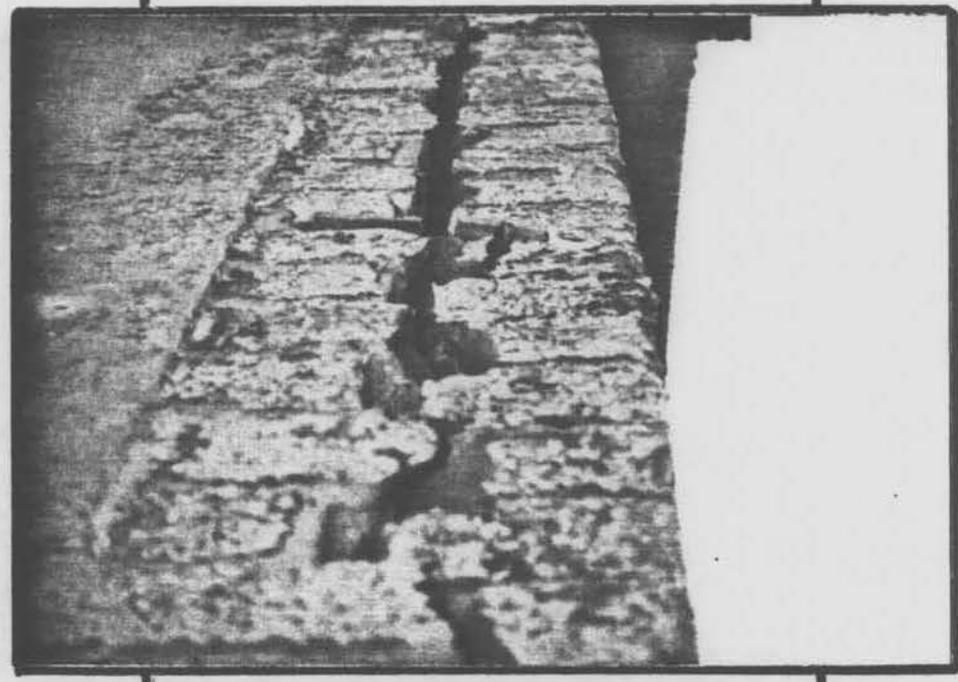
Without a complete roof and floor system to provide lateral stability and the present deteriorated conditions of the superstructure walls, these walls are in a very unstable and unsafe state.

Reisterstown Residence 2-3-95-004  
Westminster Pike & Reisterstown  
Cracked West Wall South Corner

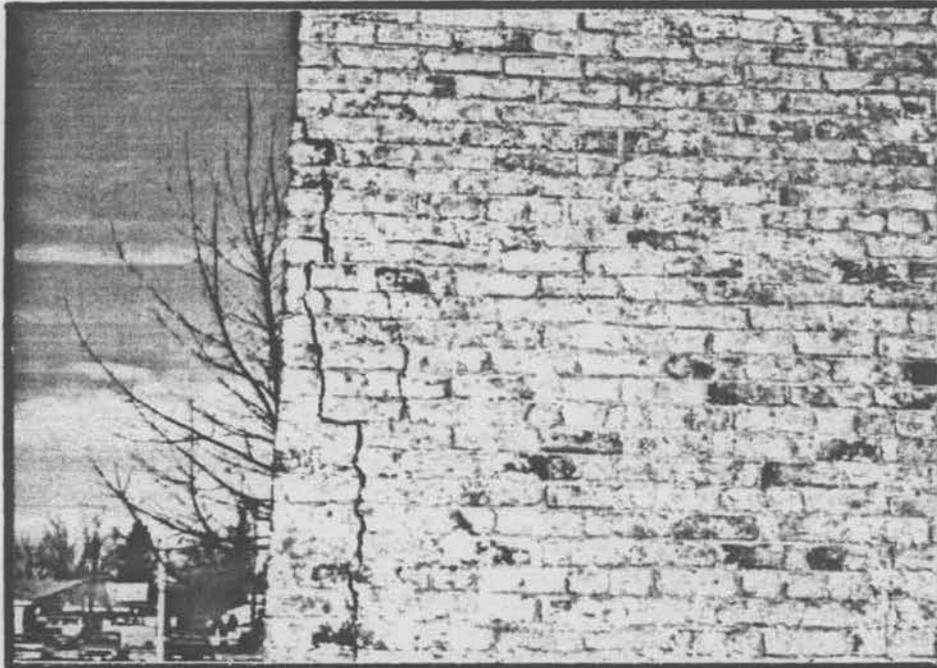
Reisterstown Residence 2-3-95-004  
Westminster Pike & Reisterstown  
Cracked South Wall West Corner

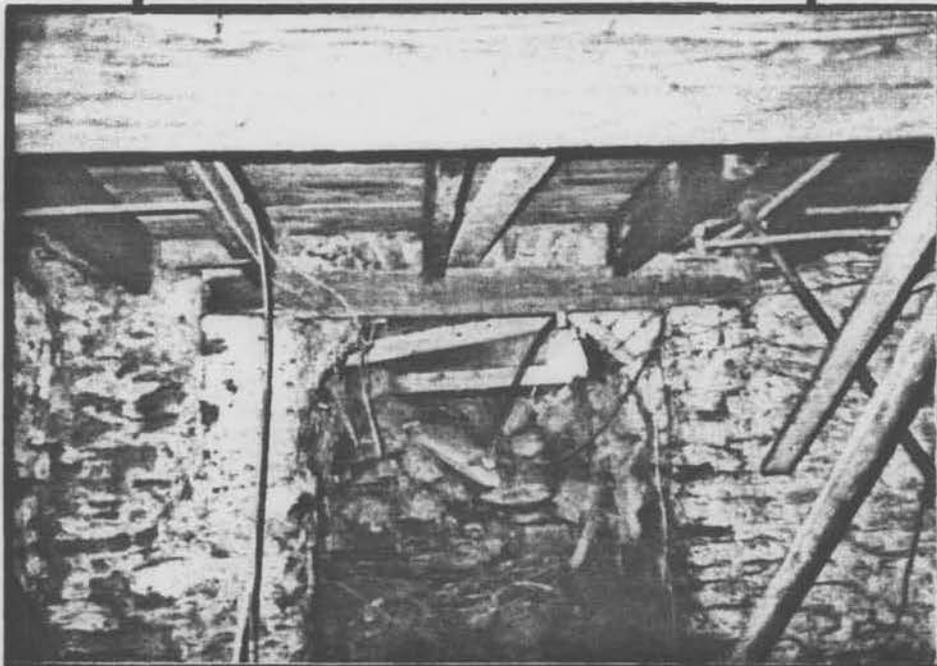
2. The residence has a full basement approximately 4'-6" below exterior grade with two areaway entries on the rear (west side) and a small basement window on the north side east end. The areaway stone walls have partially caved in. Basement floor appears to be concrete/masonry, the condition of the floor slab could not be determined due to the excessive debris on the floor. See photographs of these conditions.

Reisterstown Residence 2-3-95-004  
Westminster Pike & Reisterstown  
Areaway Foundation Walls  
West Side South End

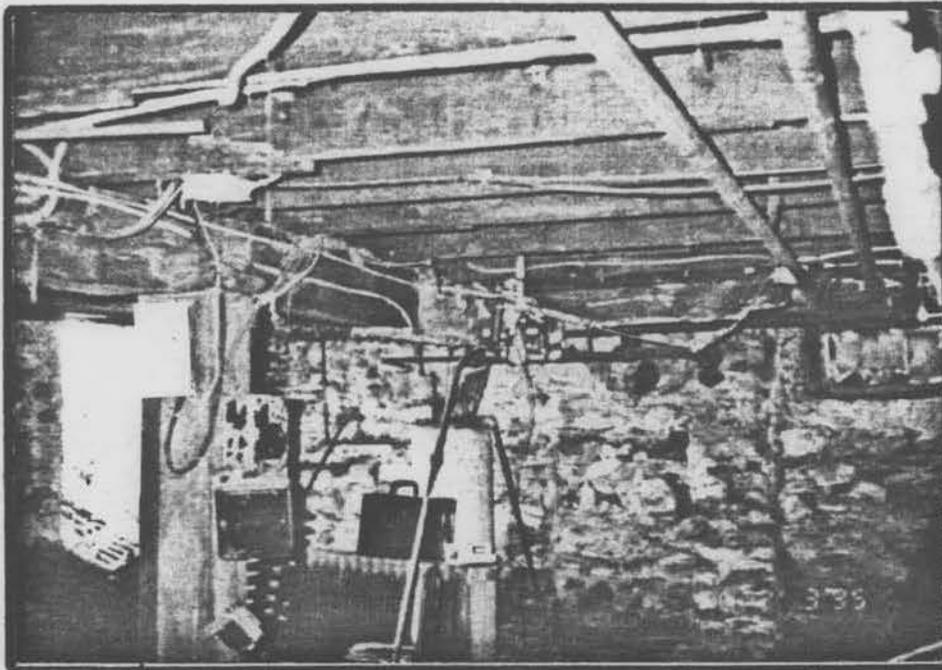
3. The foundation walls are +/- 18" thick rubble stone approximately 6' high. Mortar within the stone joints is in poor to very bad condition with many voids, loose, sandy and easily removed with fingers and/or steel awl.

4. First floor framing is 2"x 8" full size wood joists at +/- 24" o.c. spanning front to rear. The joists span approximately 7'-4" from exterior stone foundation walls to an interior wood girder. The girder is a 8"x 8" full size wood member spanning side to side. The girder spans approximately 13' from exterior stone foundation walls to an interior wood post. The wood post consist of a full size 6"x 8" and a 2"x 8" nailed together. The wood joists and girders appear in fair to good condition with no visible signs of distress. The first floor sub-flooring is full size 1"x 8" with a second layer of 1"x 3" flooring. The two layers of wood flooring are separated by 2"x 3" wood subpurlins. The sub-flooring appears in very poor condition with signs of warping, sagging, buckling and mildew.

Reisterstown Residence 2-3-95-004  
Westminster Pike & Reisterstown  
North Foundation Wall and  
First Floor Framing

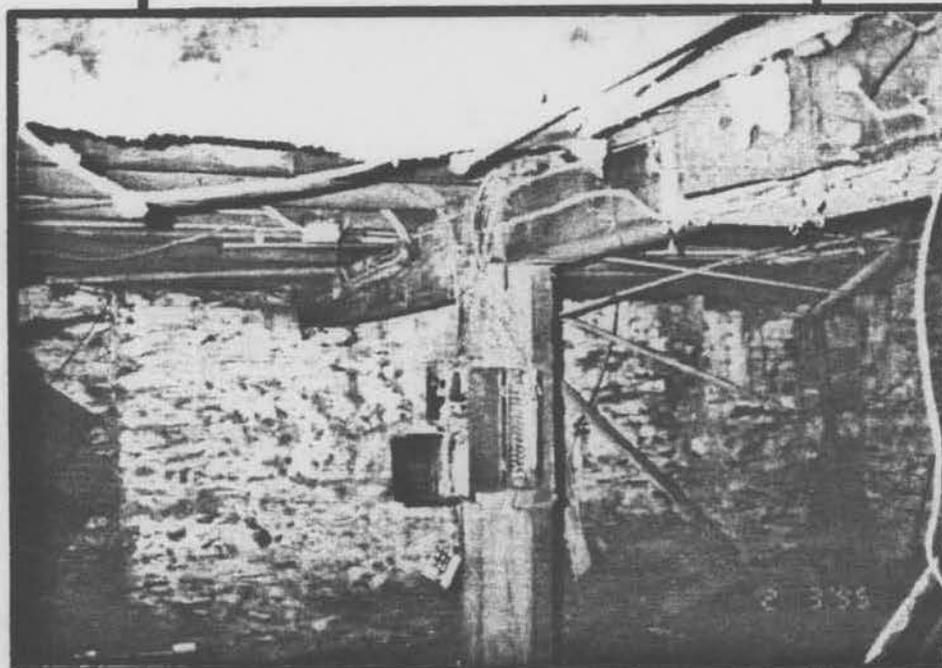
Reisterstown Residence 2-3-95-004  
Westminster Pike & Reisterstown  
South Foundation Wall and  
First Floor Framing
