BA-142
English Consul Mansion
2820 Oak Grove Road
Halethorpe vic.
c. 1831-36.
Private

The English Consul Mansion is located at 2820 Oak Grove Road in southwestern Baltimore County, Maryland. The house is a 2 ½-story, five-bay by two-bay structure with a rubble stone foundation. The southwest and northeast walls are frame with weather boards that are covered by later asbestos shingles, and the northwest and southeast walls are stuccoed brick. The gable roof has a northwest-southeast ridge, and has standing seam metal. There are interior parged chimneys on both ends. The house currently faces southwest toward the road, though the original orientation was apparently to the northeast. On the southwest elevation, the center bay has a door with two tall, pyramidal panels with a four-light transom above it. Flanking the door are wide, plain pilasters and sidelights of two-over-two double hung sash with wood sills. There is a pediment above the door, but the top half is cut off by the porch soffit. This is a one-story, one-bay porch with a gable roof that has a northeast-southwest ridge, and standing seam metal. There are two large brick piers supporting the porch roof. The northeast elev

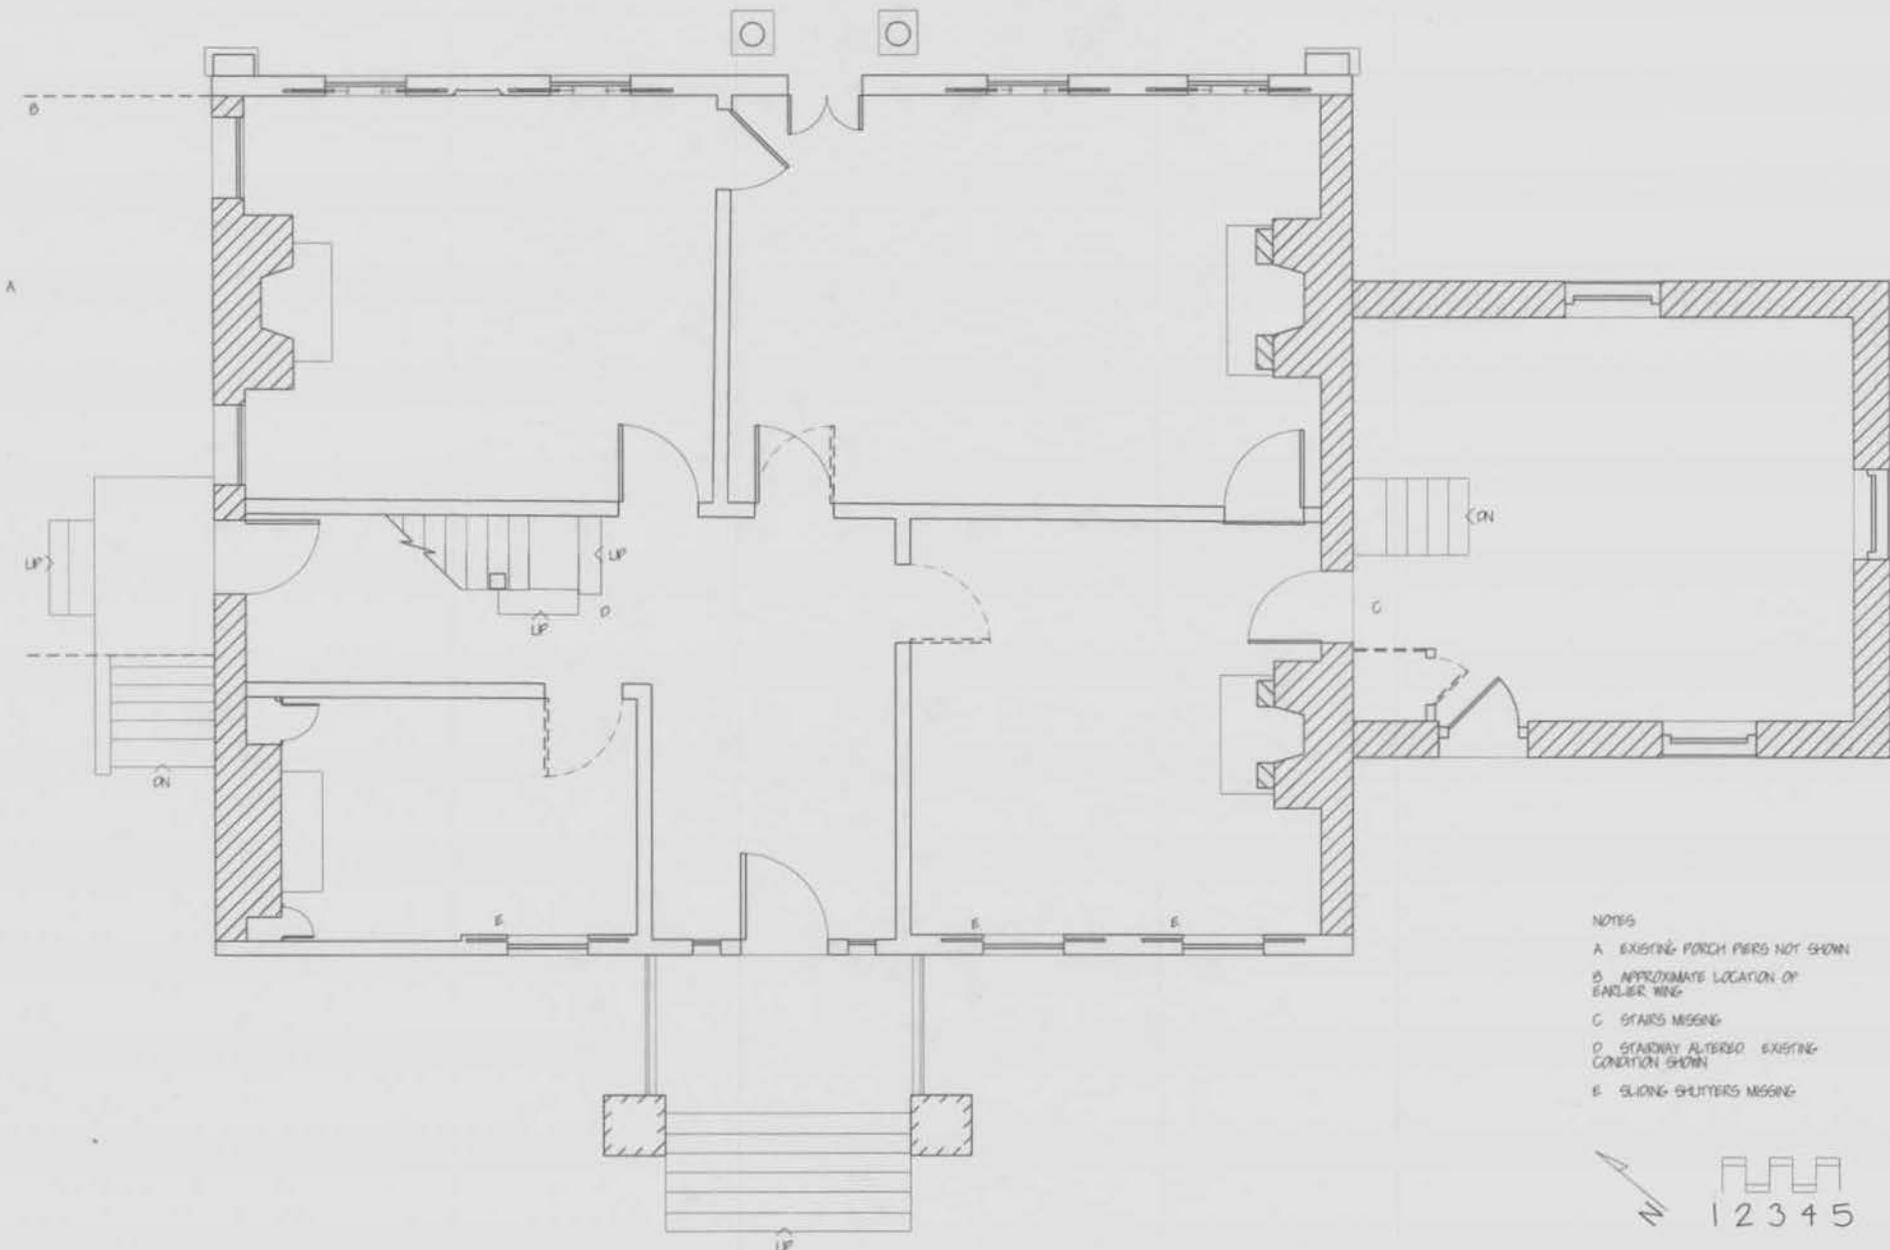
- NOTES
- A. EXISTING PORCH PIERS NOT SHOWN
 - B. APPROXIMATE LOCATION OF EARLIER WING
 - C. STAIRS MISSING
 - D. STAIRWAY ALTERED. EXISTING CONDITION SHOWN
 - E. SLIDING SHUTTERS MISSING

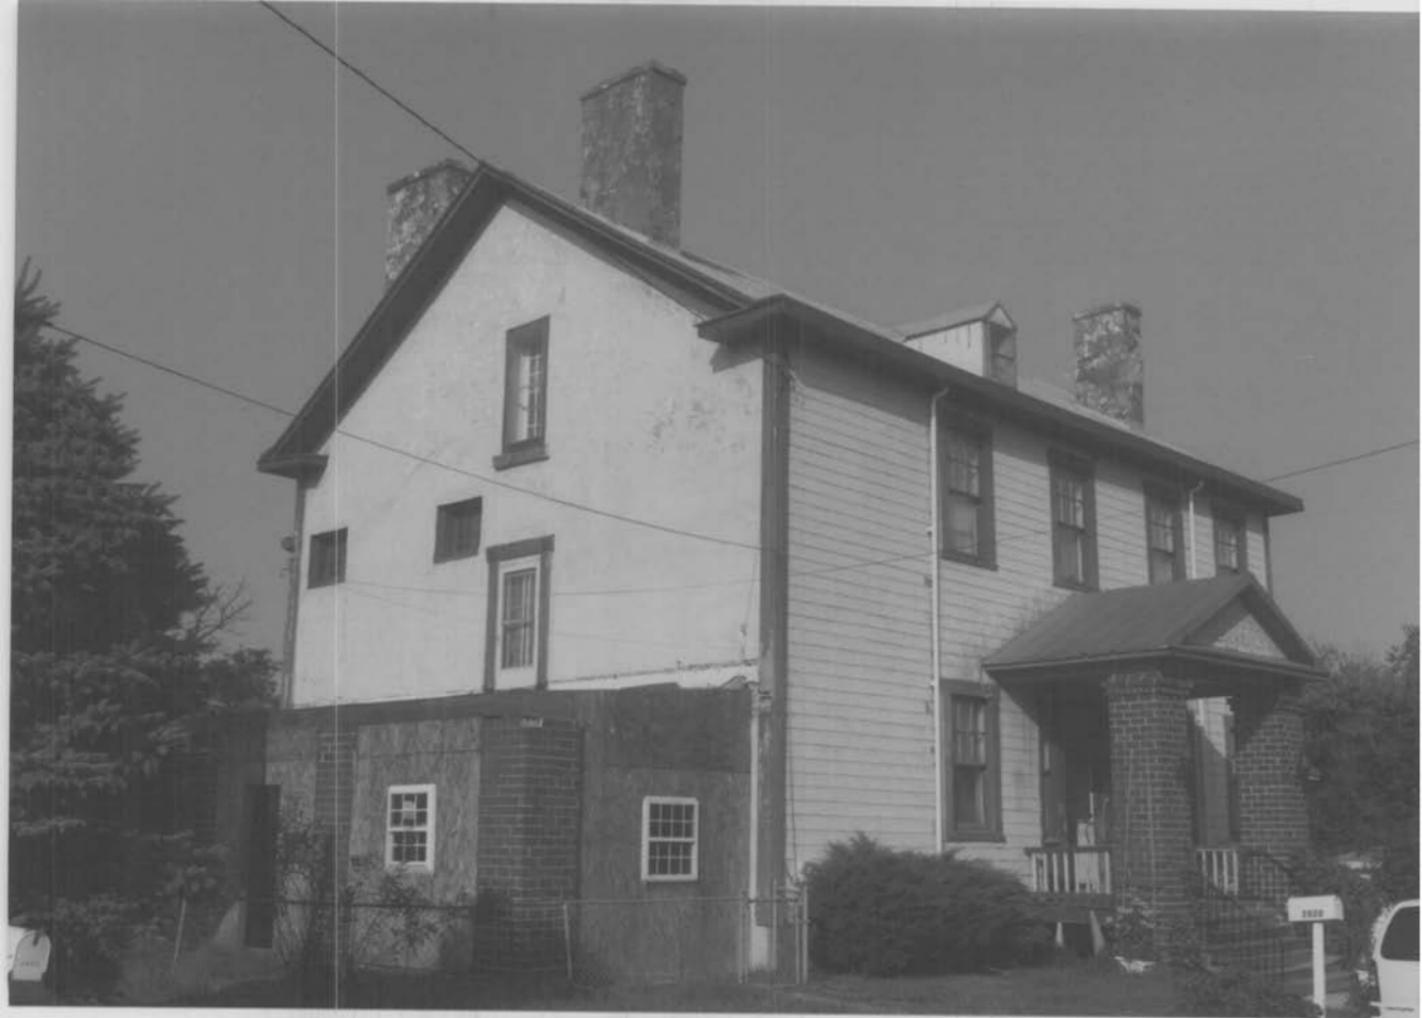
1/11

Northwest & Southwest EUS

On the southwest elevation, the west bay of the foundation has what appear to be two one-light casement windows. The center bay has a three-over-three double hung sash with a wood sill. Brick is used around the opening, and is toothed into the stone. The south-center and south bays are not visible. On the first story the west bay has no opening. The west-center bay and the two south bays each have a six-over-one double hung sash with a wood sill and plain head cut wood trim. The window trim laps over the weatherboards beneath it. The center bay has a door with two tall, pyramidal panels that have quirked Greek ovolo panel moulds and a large vertical bead down the center of the door. The transom bar has a quirked Greek ovolo, with a four-light transom above it. Flanking the door are wide, plain pilasters and sidelights of two-over-two double hung sash with wood sills. Below each sill is a sunk, flat panel with a quirked bead panel mould. There is a pediment above the door, but the top half is cut off by the porch soffit. This is a one-story, one-bay porch with a gable roof that has a northeast-southwest ridge, and standing seam metal. There are two large brick piers supporting the porch roof, with the bricks set rowlock on the bull. There are square vertical balusters and a moulded handrail. New aluminum soffit covers beaded-edge-and-center boards. The gable end of the porch has wood shingles alternating between square butts and paired saw tooth butts in each course, with each course staggered so that the square butts lap the saw tooth pair and vice versa. The second story has no opening in the west bay and typical six-over-one sash in the other four bays. There are plain corner boards and a box cornice.

The northwest elevation has a one-story porch the width of the house supported by four wide brick piers like those on the southwest porch. Between these piers is frame infill with wafer board sheathing, a door opening in the center, and a six-over-six aluminum sash in the ends. This infill construction was never completed. The foundation has a window opening near the north corner. North of center is a window opening with a four-light sash that has architrave with a broken field, a beaded interior edge, and is mitered at the corners. In the center of the foundation is a brick porch with two concrete steps on the northwest, and steps down to the cellar on the southwest that lead underneath of the porch. The side cheek wall to these cellar steps is brick. The first story has two windows set north of center, each with two eight-light casement windows. The center bay has a door with six lights over two panels, and one panel on each jamb and on the soffit. The panels have sunk fields and quirked Greek ovolo panel moulds. The symmetrical architrave has two beads in the center, with a fillet on each side that is flanked by a small bead on each side of the fillet. One plain corner block survives, though it may not be original. Just above the window and door opening height are three pockets in the brick wall, one near the north corner, one in line with the southwest end of the porch, and a third centered between these. The pockets suggest a wing attached to this elevation. Between the first and second stories are French doors in the center with new head cut trim. To the north of these doors are two casement windows identical to those on the first story. There is a ghost on the wall of a gabled roof eave that aligns with the pockets in the first story. The ridge of this roof was just below the eave cornice line of the main block of the house. The eaves of this wing roof were around the same height as the lintel of the French door between the first and second stories. The southwest wall of this wing was set just southwest of this door, and the northeast wall was near the northeast wall of the main block. Between the second story and the attic are French doors with a plain frame and a sill that is covered with metal. The raking eaves have a deeply overhanging box cornice with narrow boards on the soffit.

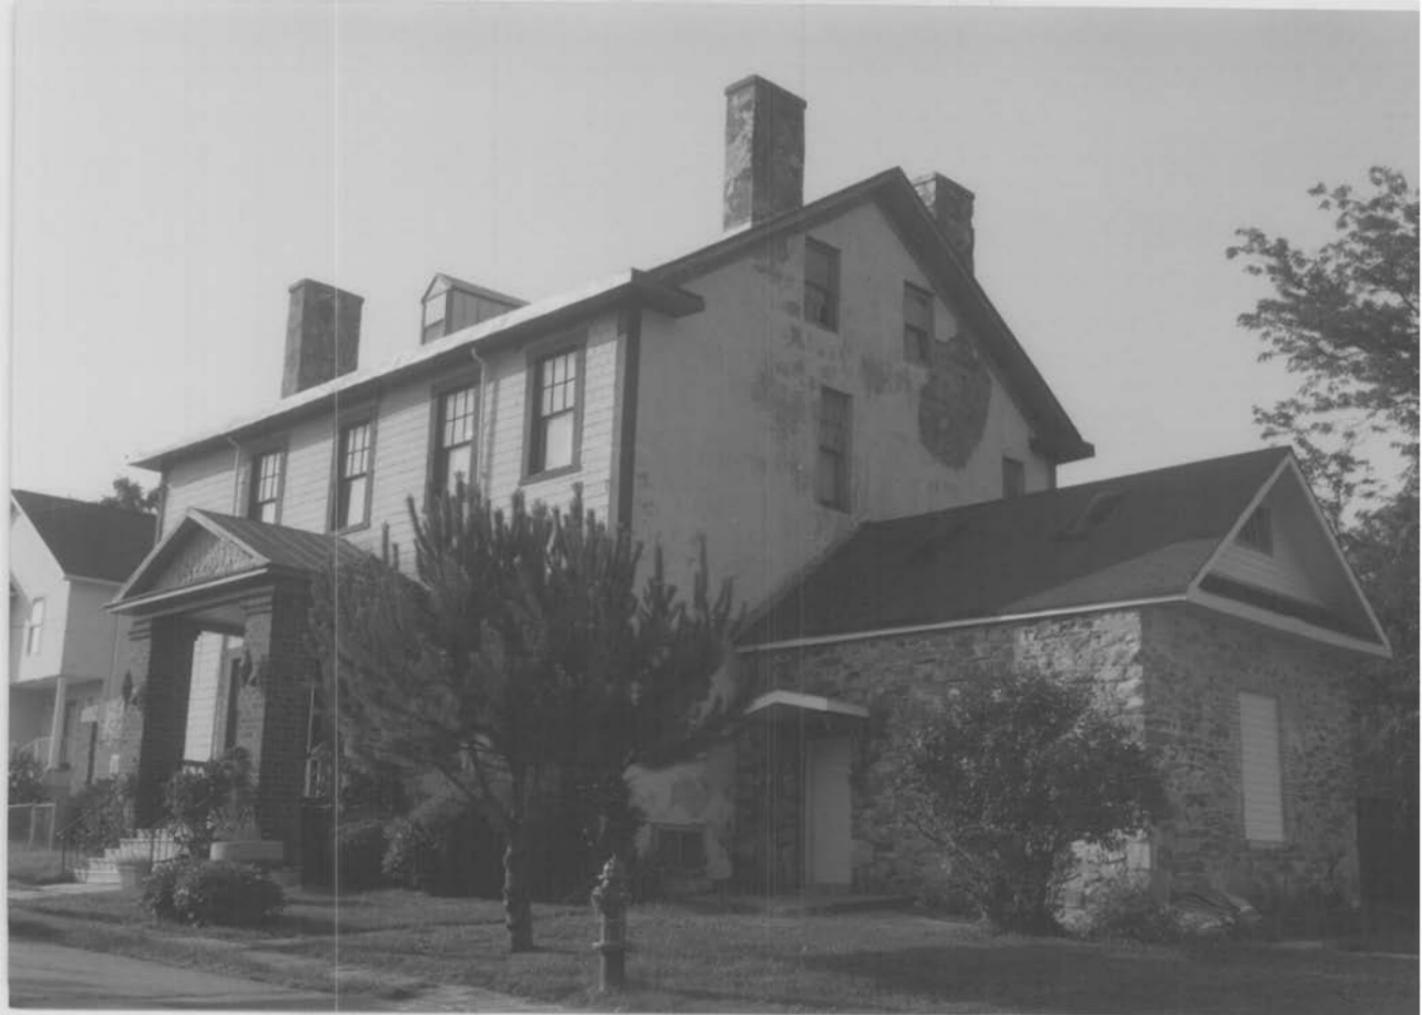
2/11

Southwest, southeast elevs

The southeast elevation of the main block has a three-light sash in the foundation, south of the wing. The stucco on this wall retains the ghost of the original wing cornice profile, which projected far from the wing wall. The second story of the main block has a six-over-one sash set just south of center, and another near the east corner. The gable end has two six-over-six sash and the raking eave is the same as on the northwest elevation. Some of the rough casting is missing, but some retains faint scoring lines that create the appearance of ashlar stone.

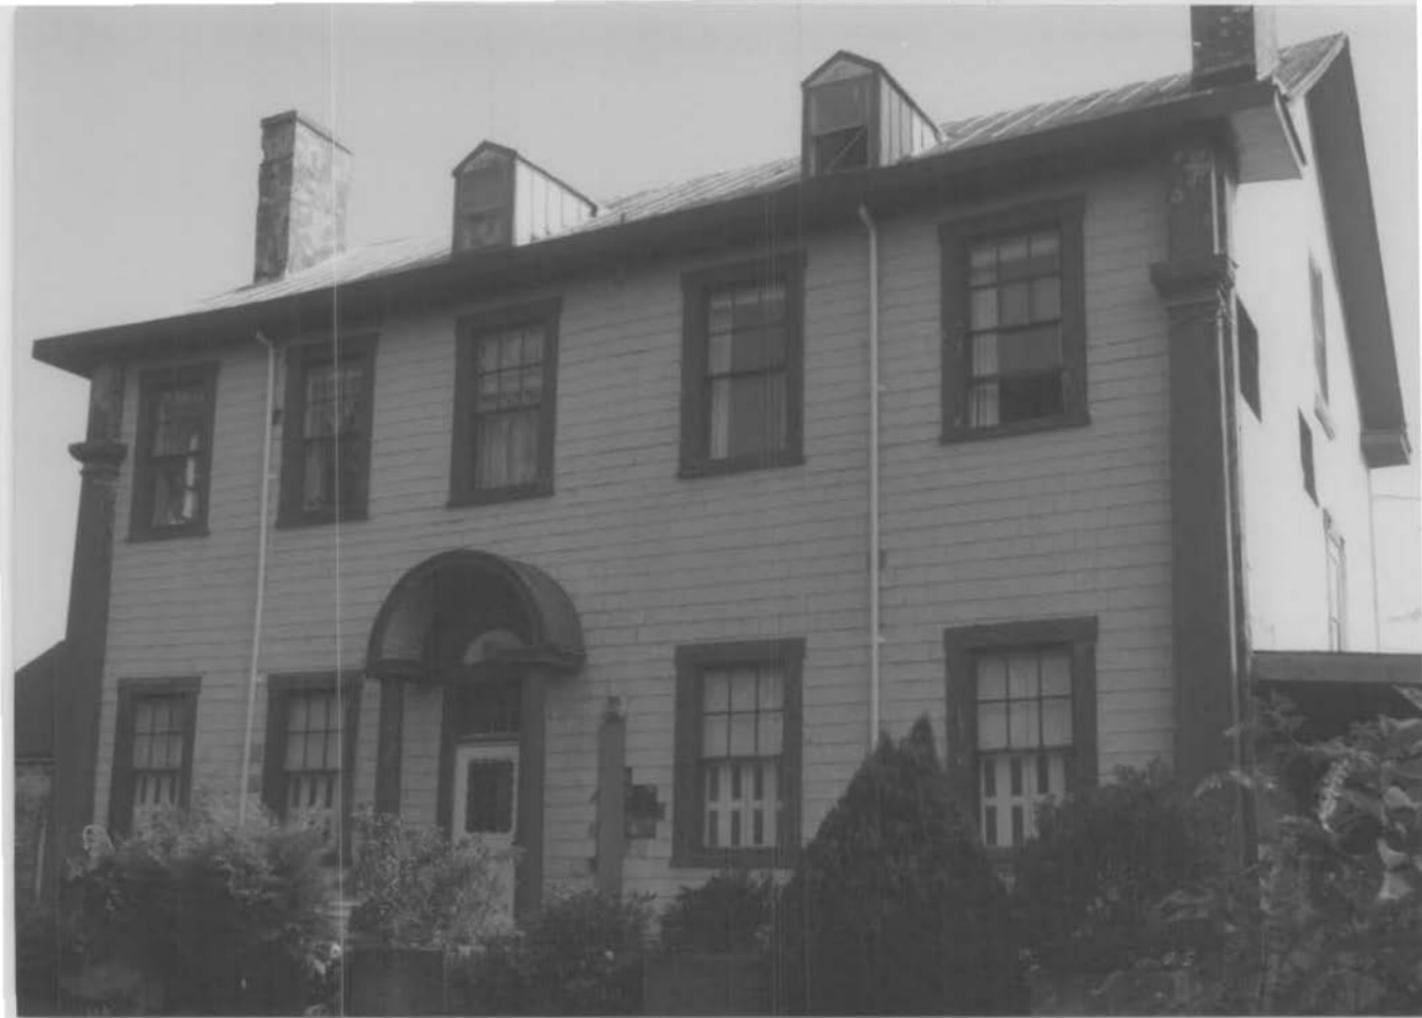
3/11

Northeast cku

The northeast elevation has asbestos shingles over top of weatherboards that are fastened with cut nails. Both corners have a colossal pilaster with a Greek ovolo moulding on the capital, and entablature blocks. In the center of the first story is a pair of

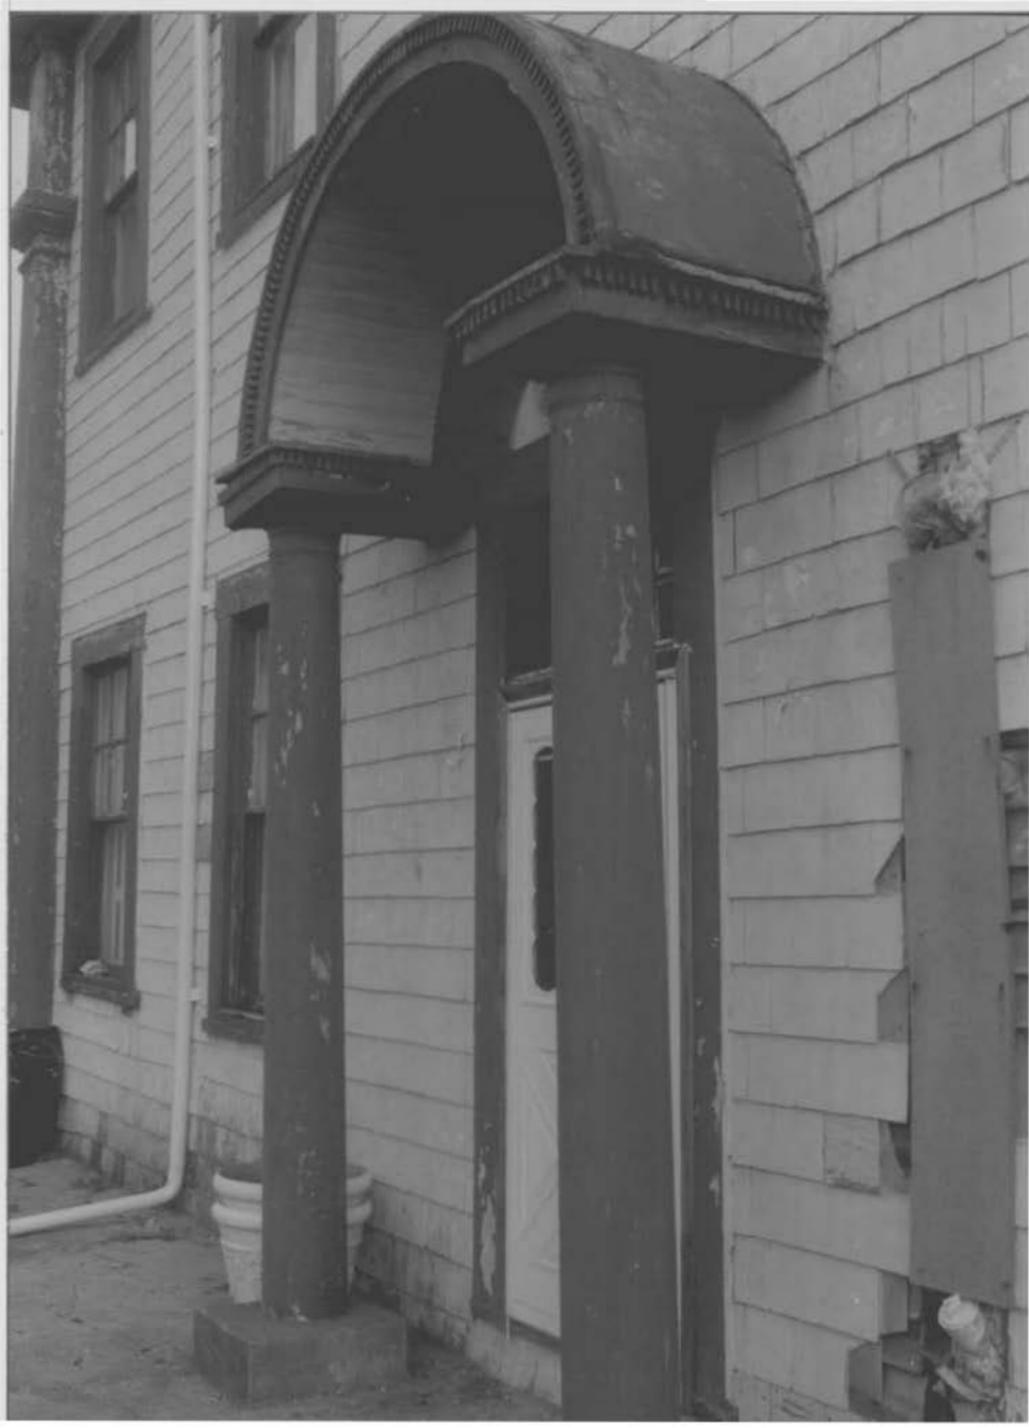
4/11

Northeast elev. - door pediment

French doors with eight lights over one panel, and a two-light transom. There are freestanding wood Doric columns with concrete plinths and short impost blocks with dentils. The columns support a semi circular arched hood with dentils and a soffit of narrow, beaded-edge boards. On the wall above the transom, inside of the hood, is a blind wooden fanlight with irregularly spaced battens and long, narrow dentils. The four end bays have six-over-one double hung sash with head cut trim and wood sills. Beneath the exterior window trim the window frames have a double bead. The second story has five typical six-over-one sash and there is a box cornice of all new wood. There are two dormers, one between the east-center and center bays and the other over the north-center bay. They are gabled and have one-over-one sash. There is an internal gutter system in the roof. On the northeast side of the house is a large concrete porch with parged brick end walls that are topped by old paving blocks made of fired clay, and are eight inches square. There are also square paving stones to the north side of the porch that are brownstone and are approximately 1 foot, 9 inches square.

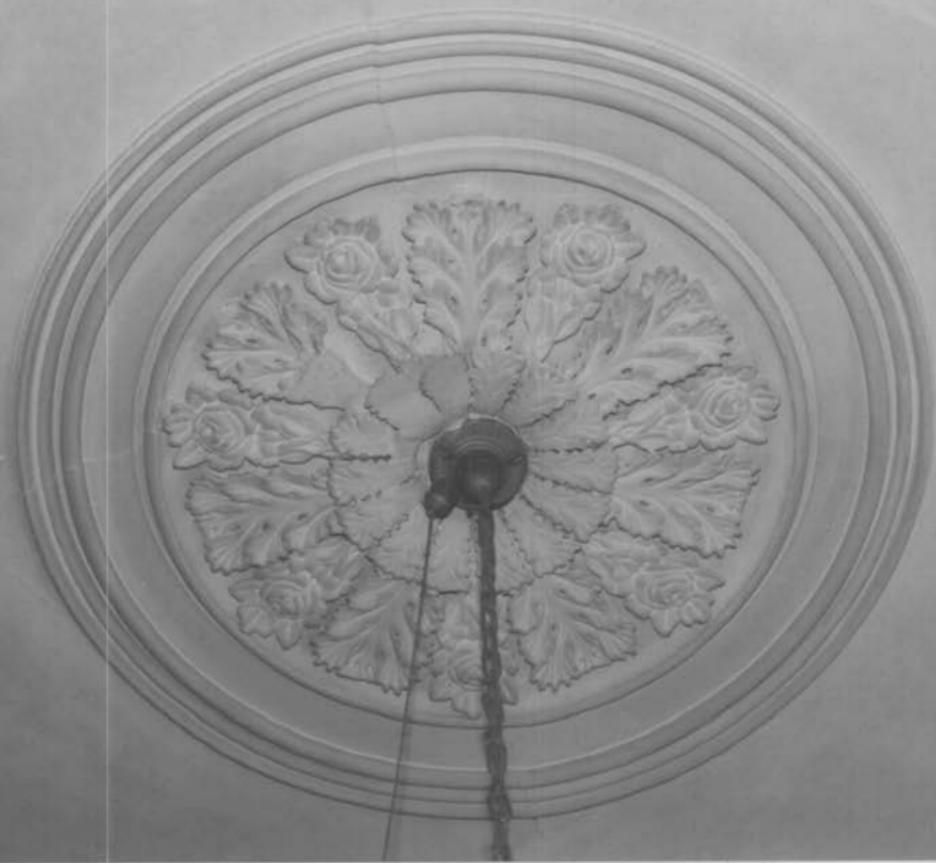
5/11

1st sty passage ceiling medallion

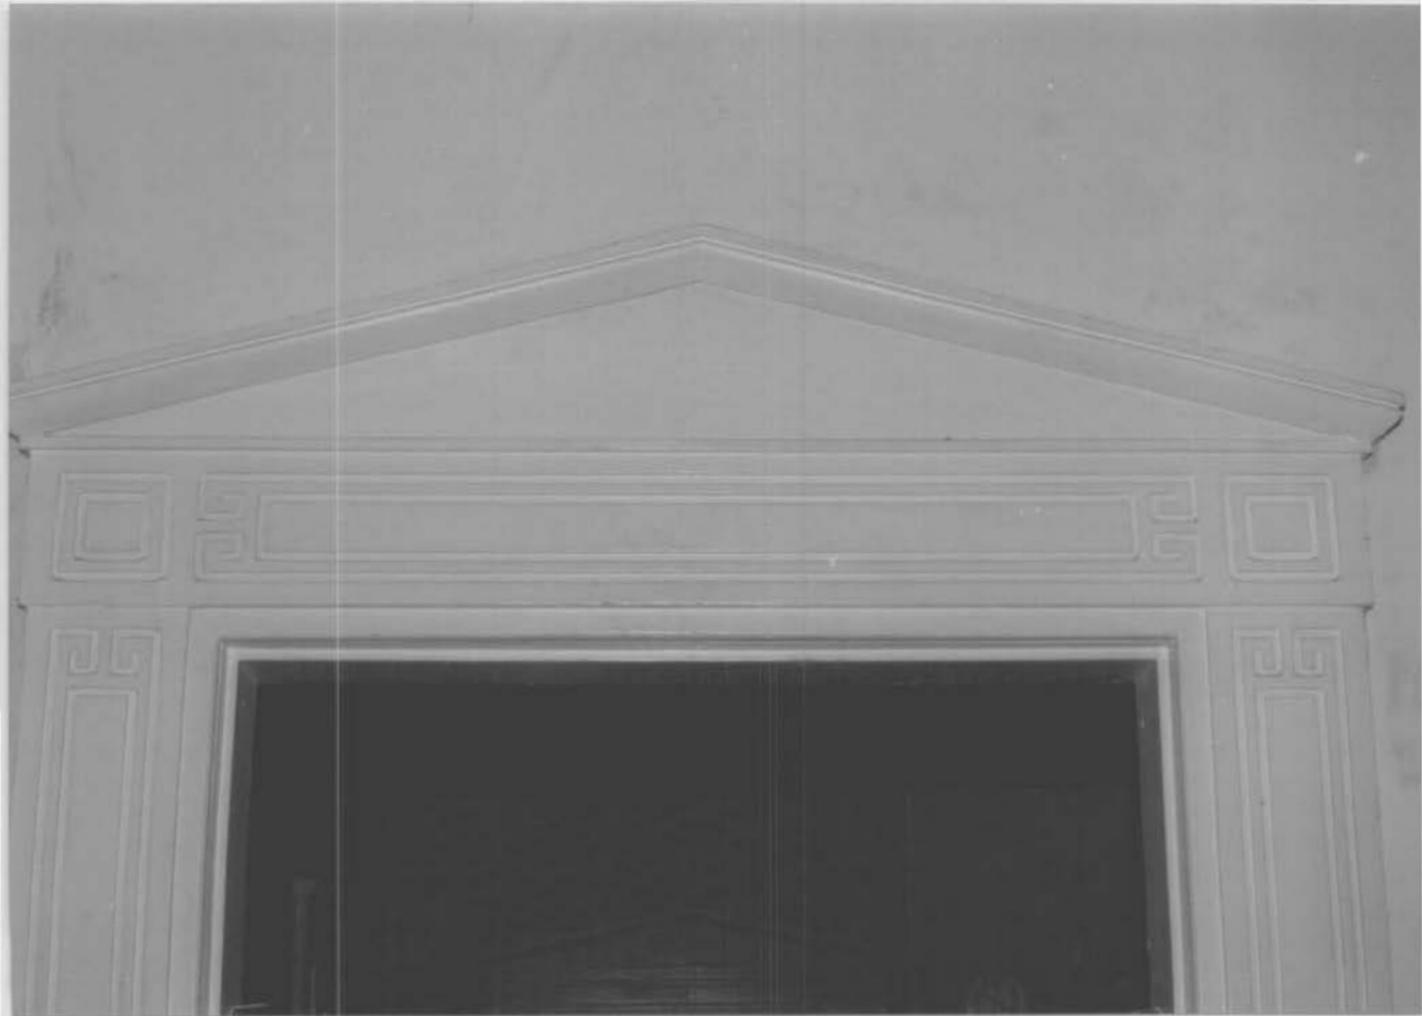
6/11

1st sty passage door architrave

modern lock that replaces a mortise lock. All of the doors have this same architrave and pediment. There is a run plaster cornice with a Greek cavetto at the bottom, a bead, a Greek ovolo, and on the ceiling an ovoid flanked by fillets. There is a plaster ceiling medallion with an inner row of small acanthus leaves and an outer row that alternates between acanthus leaves and rosettes with foliage. Outside of this is a ring of three beads. The stair hall is off the northwest side of the passage, with a dogleg stair that ascends along the northeast wall, with a landing at the northwest end. The bottom of the stairway has been altered with a landing and steps on the southeast and southwest sides of this landing constructed of 2 ¼-inch-wide boards. There is a boxed newel post and tapered round balusters. The handrail is completely round. The sawn stair brackets are in a Vitruvian wave pattern. The stairway does not have a complete cornice, but only has the ovoid and fillets on the ceiling. On the northwest wall, under the stairway, is a door with six lights over two panels. Some of these lights still have quirked Greek ovolo panel moulds. The door has a new lock and two cast-iron butt hinges. There is a powder room built into the west corner under the stairway. There is a doorway on the landing with typical architrave and a pair of French doors with 12 lights each. There are two steps up to this doorway. The first story ceilings are 12 feet, 6 inches high.

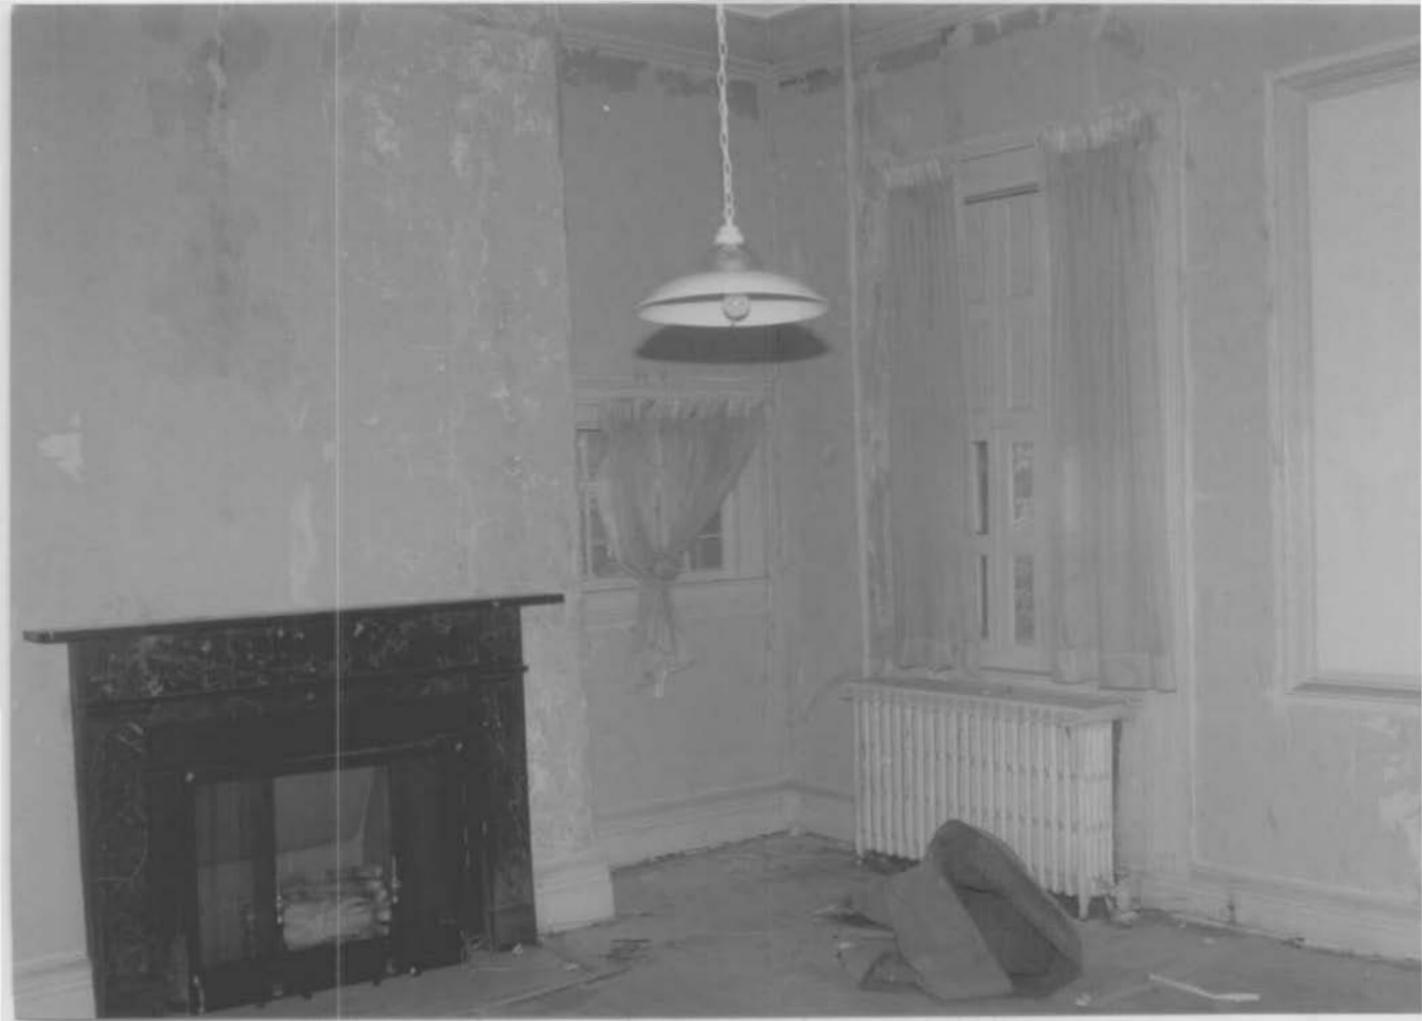
7/11

North rm, vw. north

The north room has carpet laid over linoleum, and the same baseboard and architrave as the passage. The cornice and ceiling

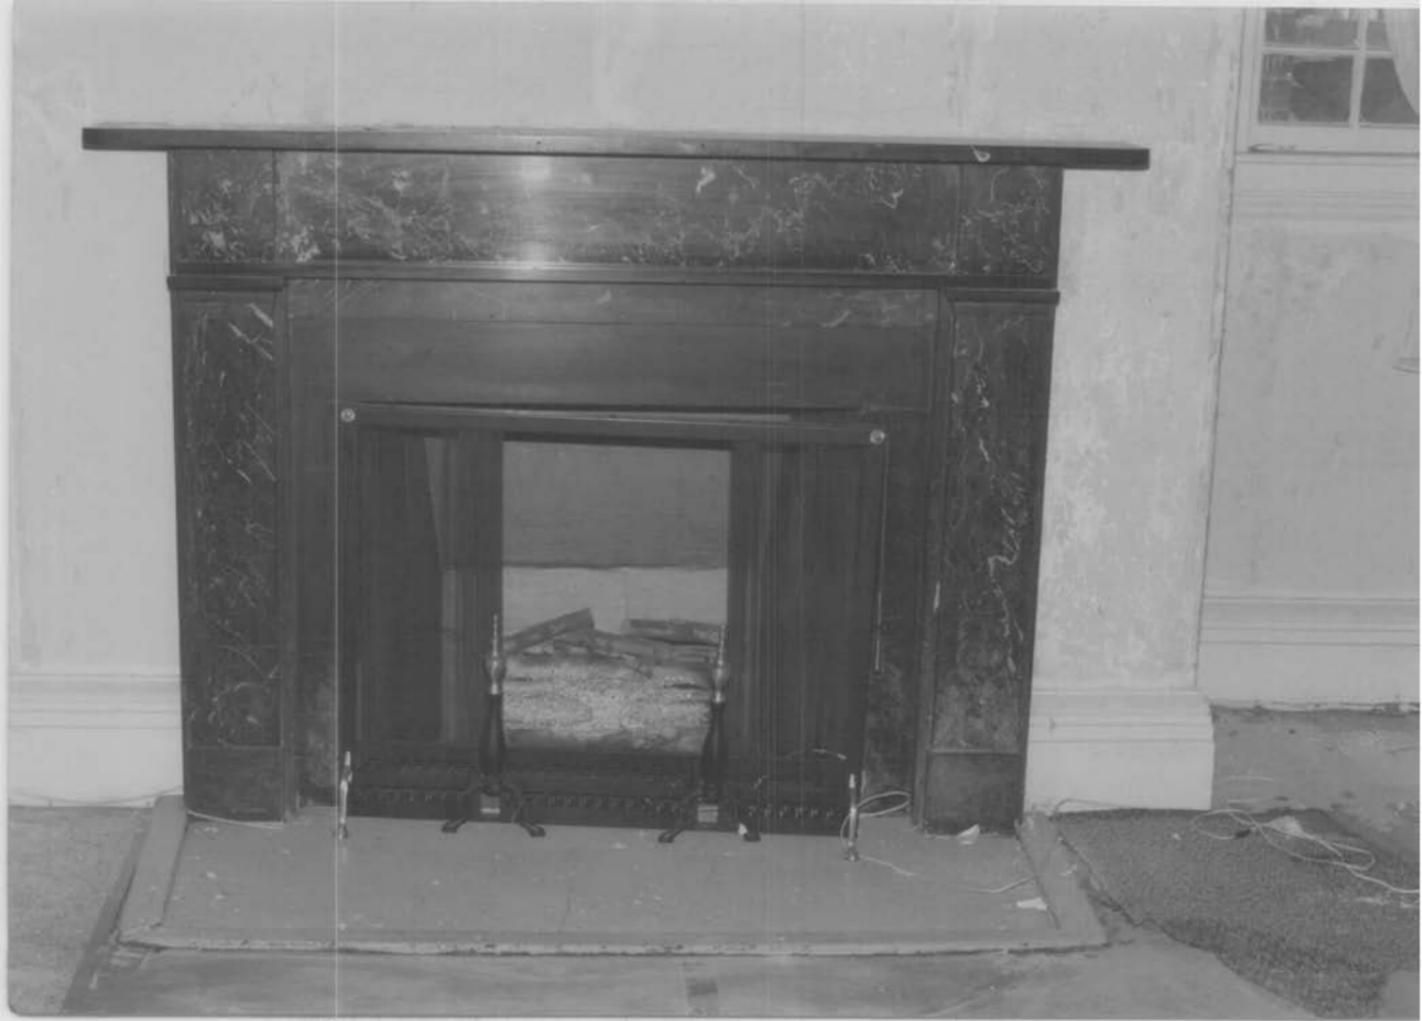
8/11

North rm. mantel

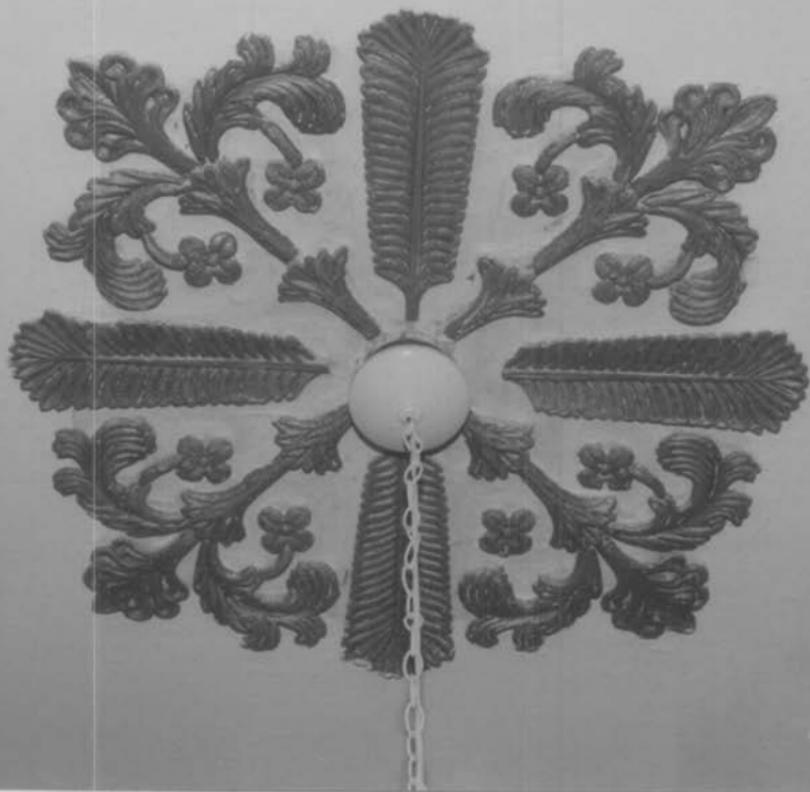
9/11

Northon ceiling medallion

medallion are identical to the east room. There is a typical eight-panel door on the southwest wall, set to the south. It has cast-iron butt hinges with fast joints and a mortise lock marked "Stanley" that has silver plate knobs. The lock is fastened with blunt-tip screws. On the northeast elevation is a fireplace with splayed, parged jambs and a hearth that is painted concrete or mortar. There is a black marble mantel with white and yellow veining. It has pilasters with quirked Greek ovolo capitals, plain impost and frieze, a plain shelf, and a marble surround. A circular patch on the northeast side of the chimney is probably where a bell crank was. On either side of the fireplace is a pair of eight-light casements with a small ogee cornice. The northeast windows and shutters are identical to those in the east room. Between the windows is a tall plaster panel recessed in the wall, with deeply sunk fields and quirked Greek ovolo and bead moulding. The ceiling has the ghost of plaster ornament that seems to have been similar to that on the east room ceiling, but it is not as well defined.

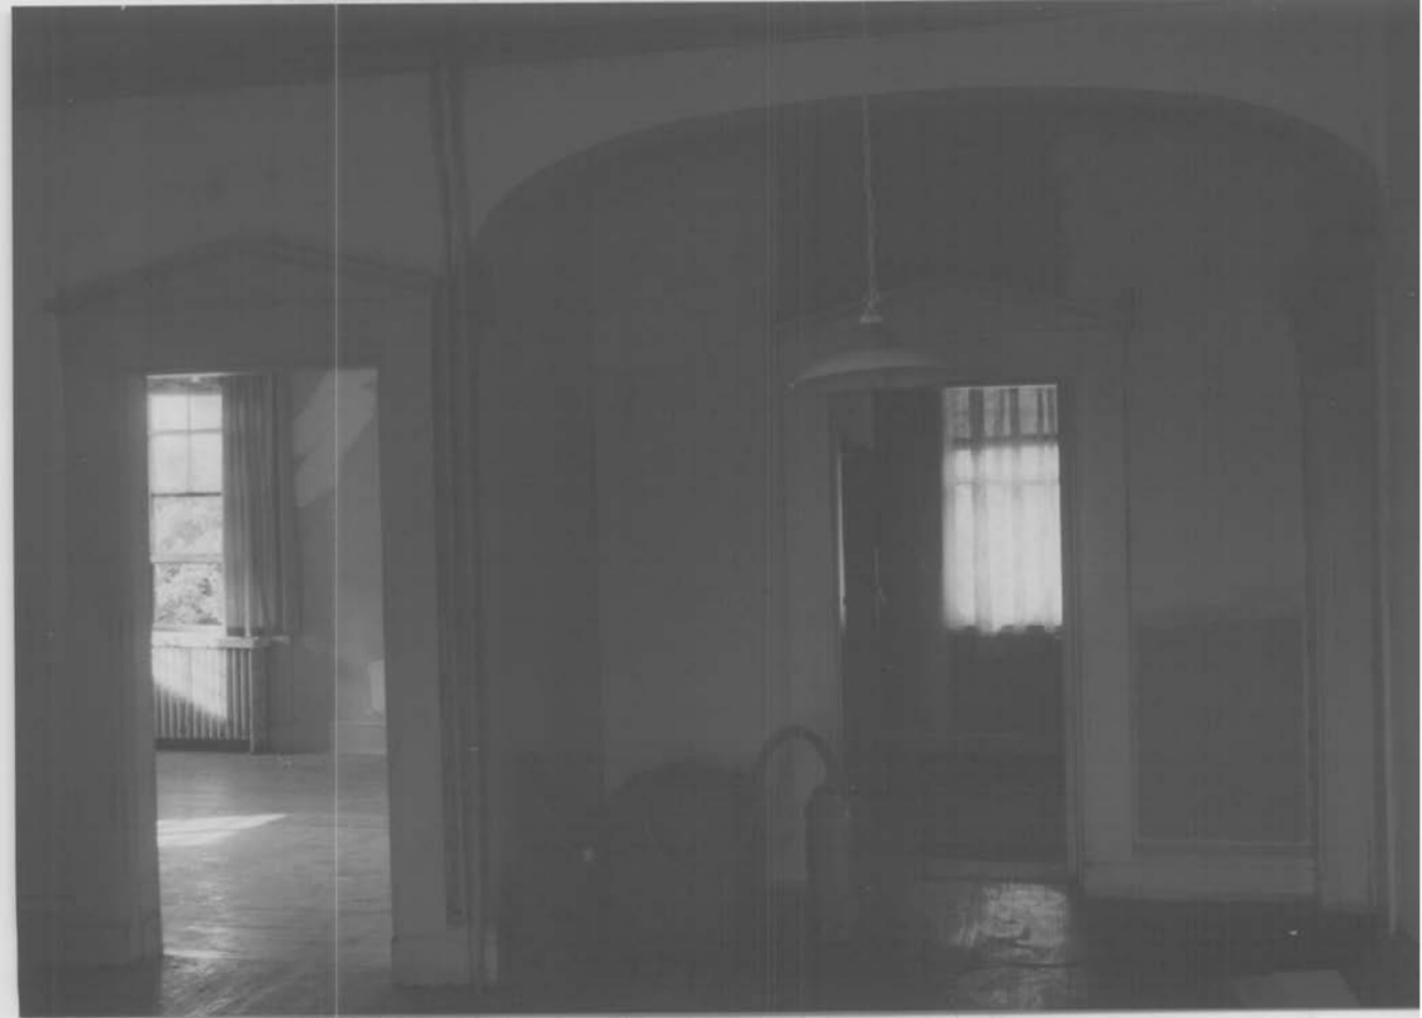
10/11

2nd sty passage - view northeast

The second story passage has 2 ½-inch pine flooring that runs northeast-southwest, and the baseboard is identical to the first story. The door architrave is plain, with a beaded interior edge, is head cut, and has a pediment. There is a run plaster cornice with a Greek ovolo at the bottom and a slight cove at the ceiling with a fillet and bead. There is a plaster ceiling medallion with a row of small acanthus on the inside and alternating acanthus and roses with foliage on the outside. On the northeast elevation the wall of the center bay is recessed, and has a segmental arch. The southwest window matches those of the first story, with the architrave matching the doors but without the pediment. The panel beneath the windowsill matches those of the first story. The second story ceilings are 10 feet, 5 inches high.
