INVENTORY FORM FOR STATE HISTORIC SITES SURVEY

Lee-Lickle House (Site)

Washington and Allegheny¹⁰³ Aves. (Southwest Corner)

Towson

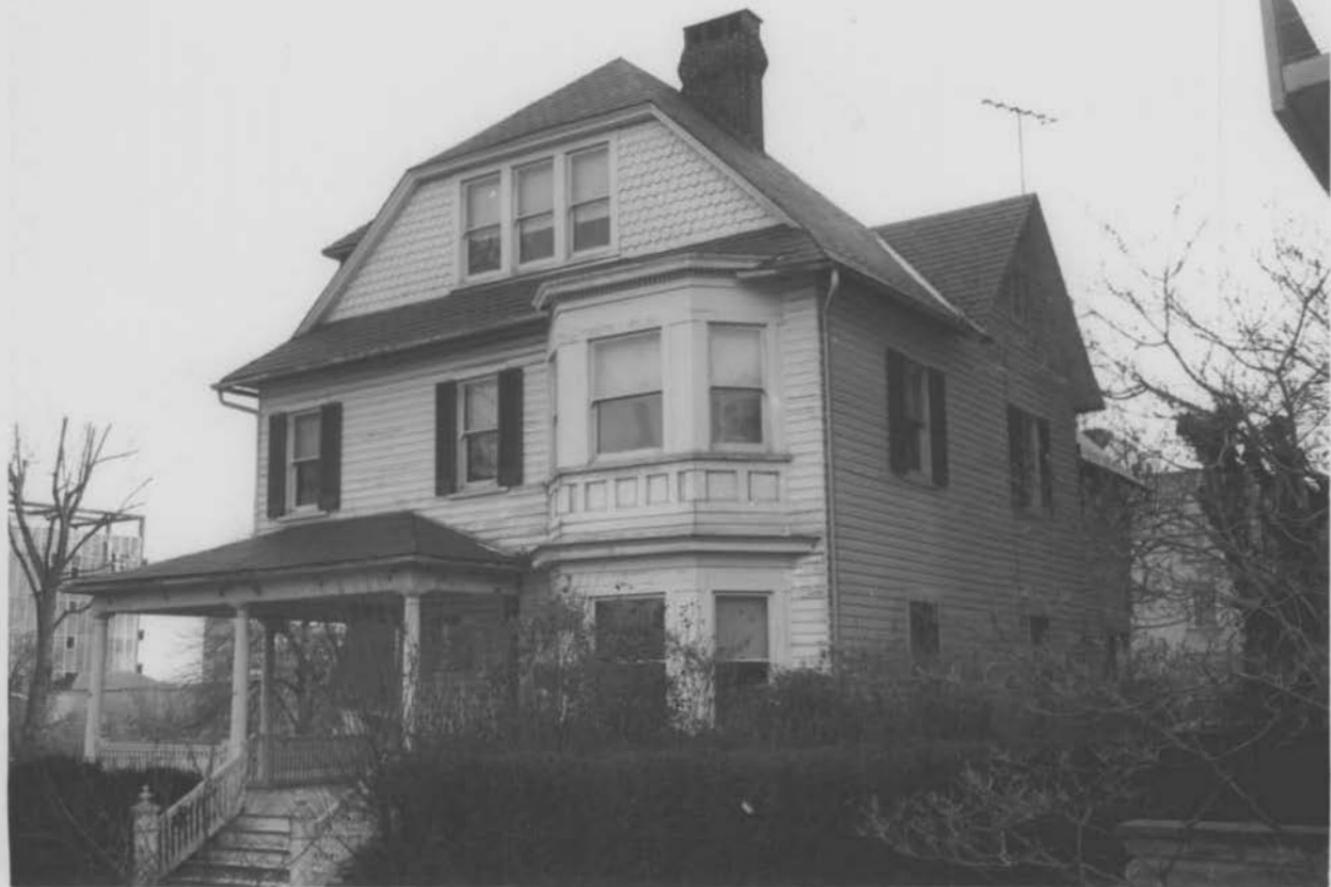
N.W. CORNER

LEE-LICKLE HOUSE

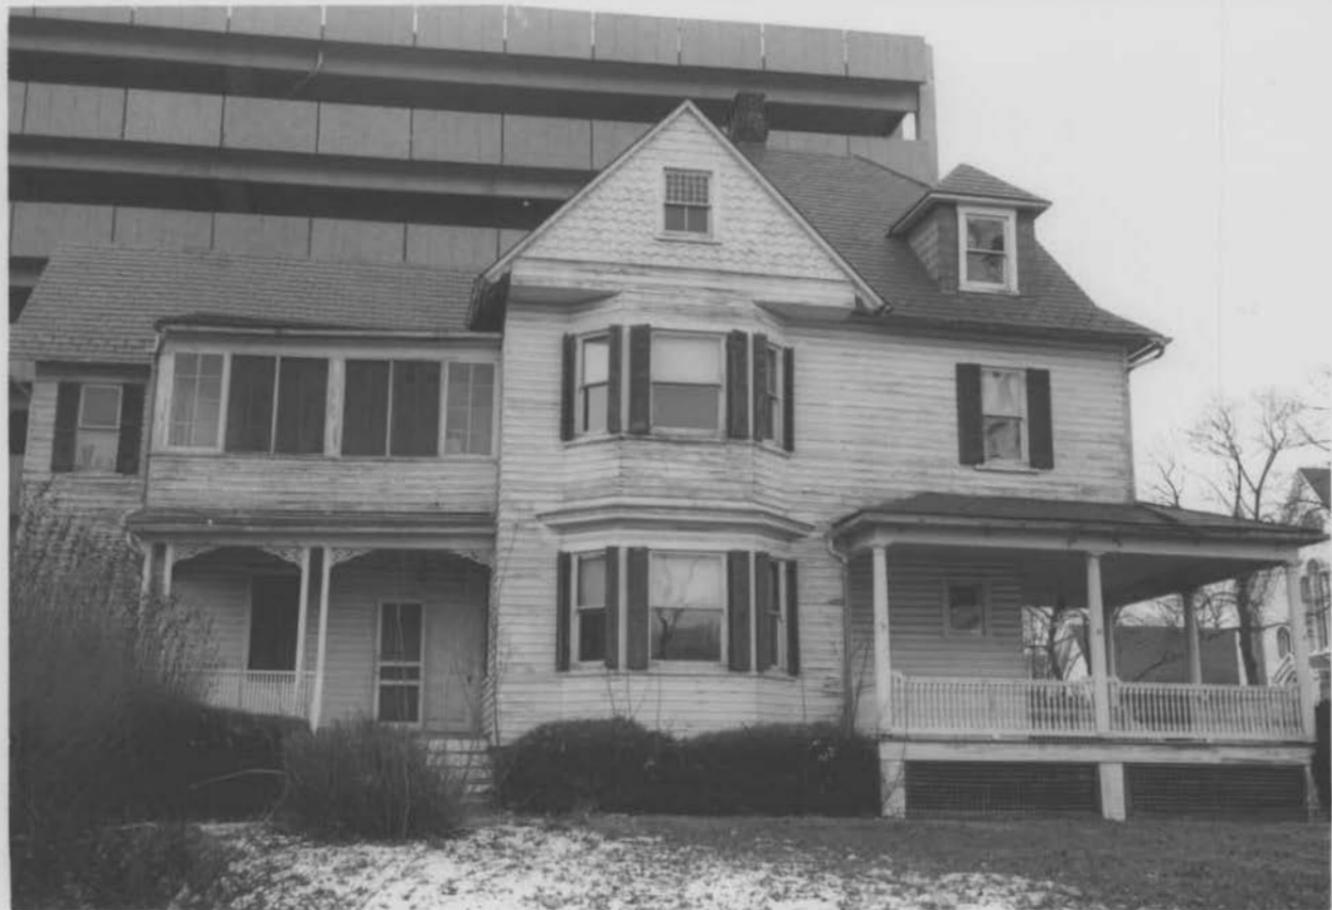
LEE-LICKLE HOUSE
E. FACADE

which is differentiated primarily by the formal porch entrance. Another swell-front can be seen in the central bay of this facade. It lights the dining room downstairs and an upstairs sitting room. A deeply corniced and sharply pitched gable tops the swell-front. This gable is vented by a decorative 18/1 window. A hipped roof dormer with a 1/1 window caps the north bay. A two story wing takes up the south bay. Porches cover both stories. The lower porch has the same turned columns and brackets as the back (south) porch. The upper porch or gallery is perceived as original by virtue of the same beveled siding as is seen in the exterior having been used to panel the interior wall. No proof exists that this was a "sleeping porch" but its proximity to the sleeping rooms and the sliding windows and screens supports such a description.

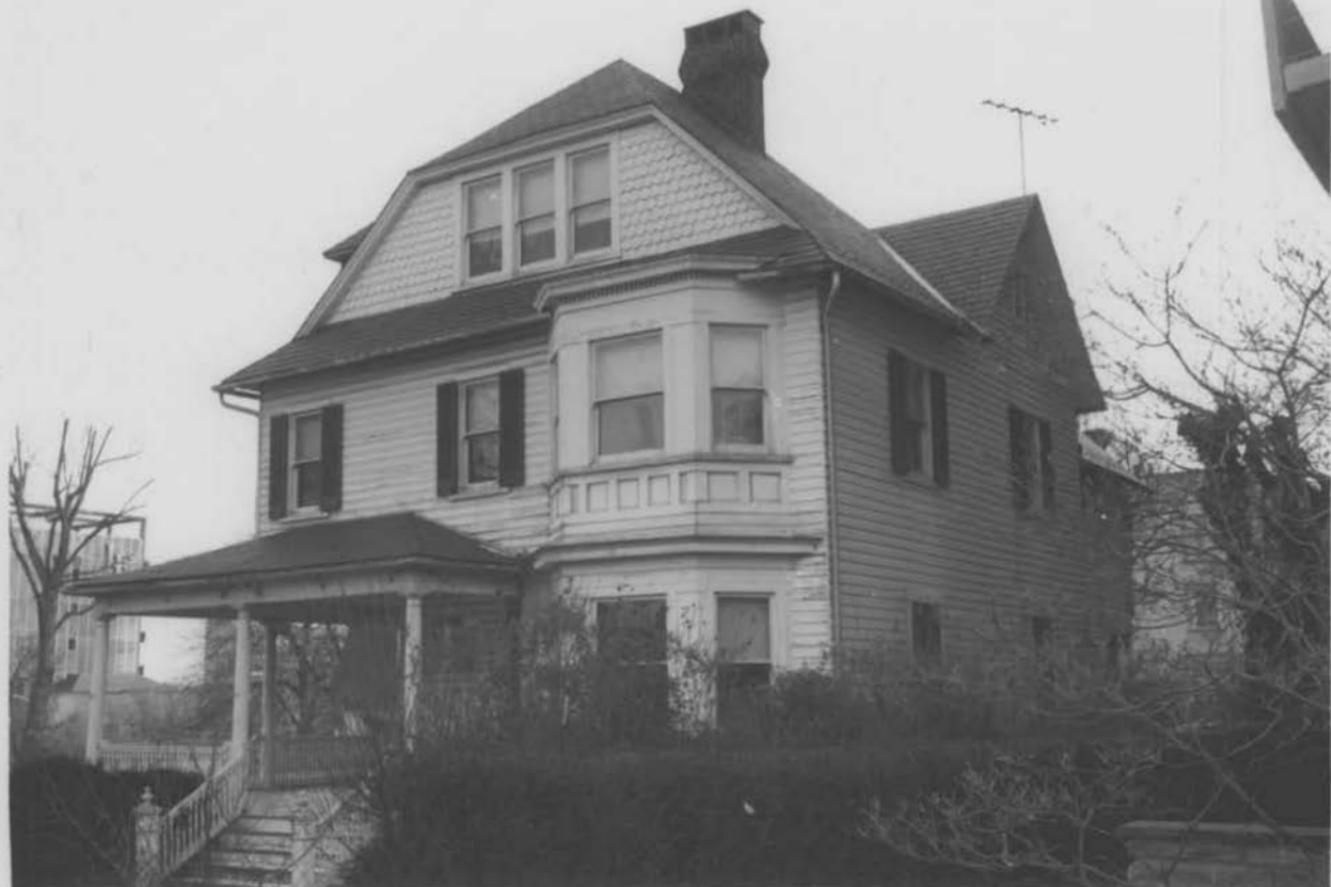
N.W. CORNER

LEE-LICKLE HOUSE

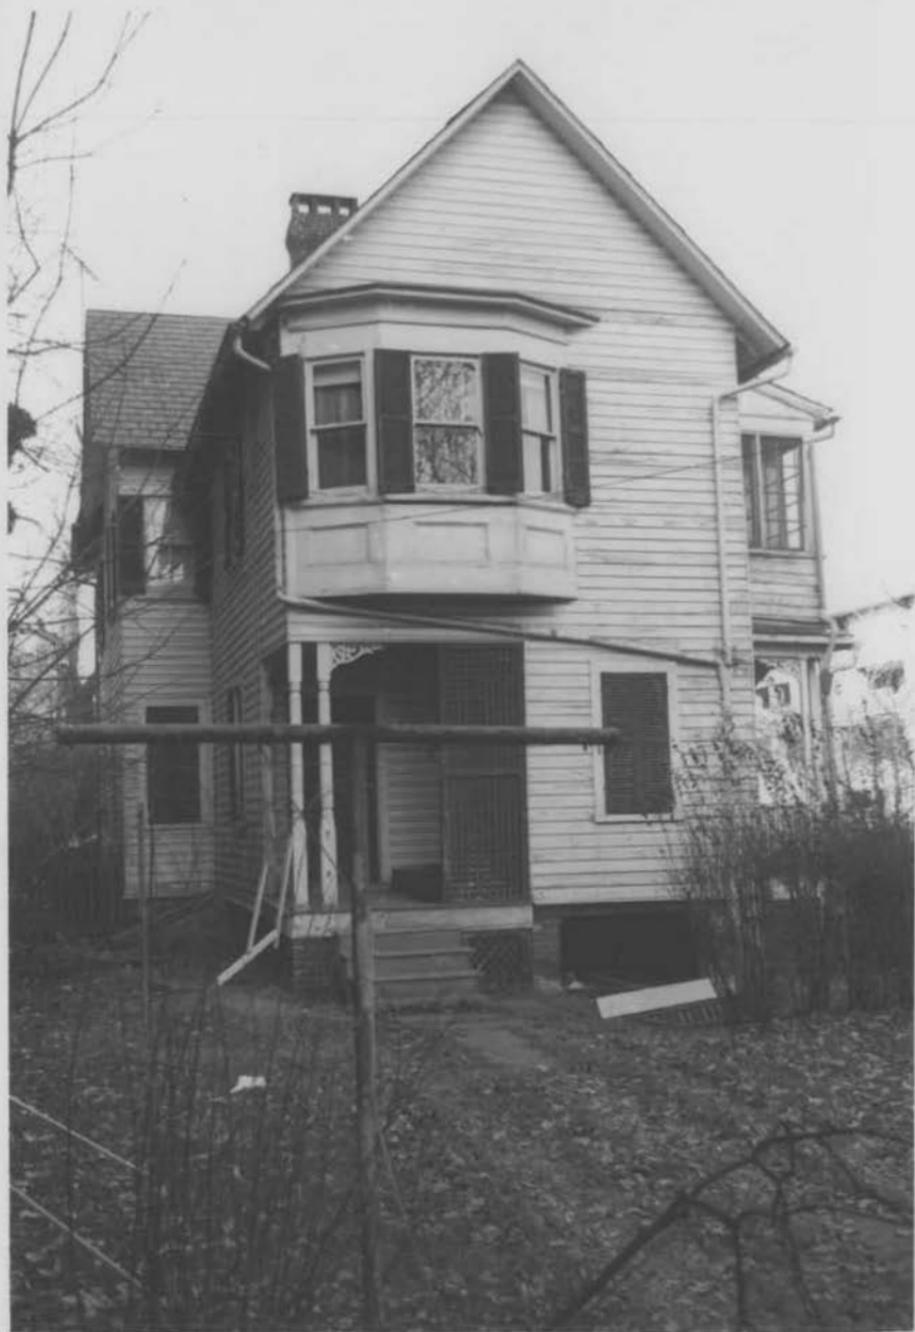
LEE-LICKLE HSE.
S.

The south side or end of the house is narrow due to the T-plan of the house. It is two bays in width. A porch occupies the west bay and makes the southwest corner a negative space on the first story. The pantry windows vent the East on the first floor and a three sided bay window lights the second story.
