MARYLAND HISTORICAL TRUST
DETERMINATION OF ELIGIBILITY FORM

Property Name: Woodstock Laundry Log Cabin Inventory Number: BA-1581
Address: 10820 Old Court Road Historic district: ___ yes no
City: Woodstock Zip Code: 21163 County: Baltimore County
USGS Quadrangle(s): Ellicott City
Property Owner: Maryland Department of Natural Resources Tax Account ID Number: 1600005160
Tax Map Parcel Number(s): 0001 Tax Map Number: 86
Project: Documentation of the Woodstock Laundry Log Cabin Agency: Maryland Department of Natural Resources
Agency Prepared By: JMA
Preparer's Name: Sarah G. Traum Date Prepared: 7/19/2015

Maryland Historical Trust Maryland Inventory of Historic Properties Form

Inventory No. BA-1581

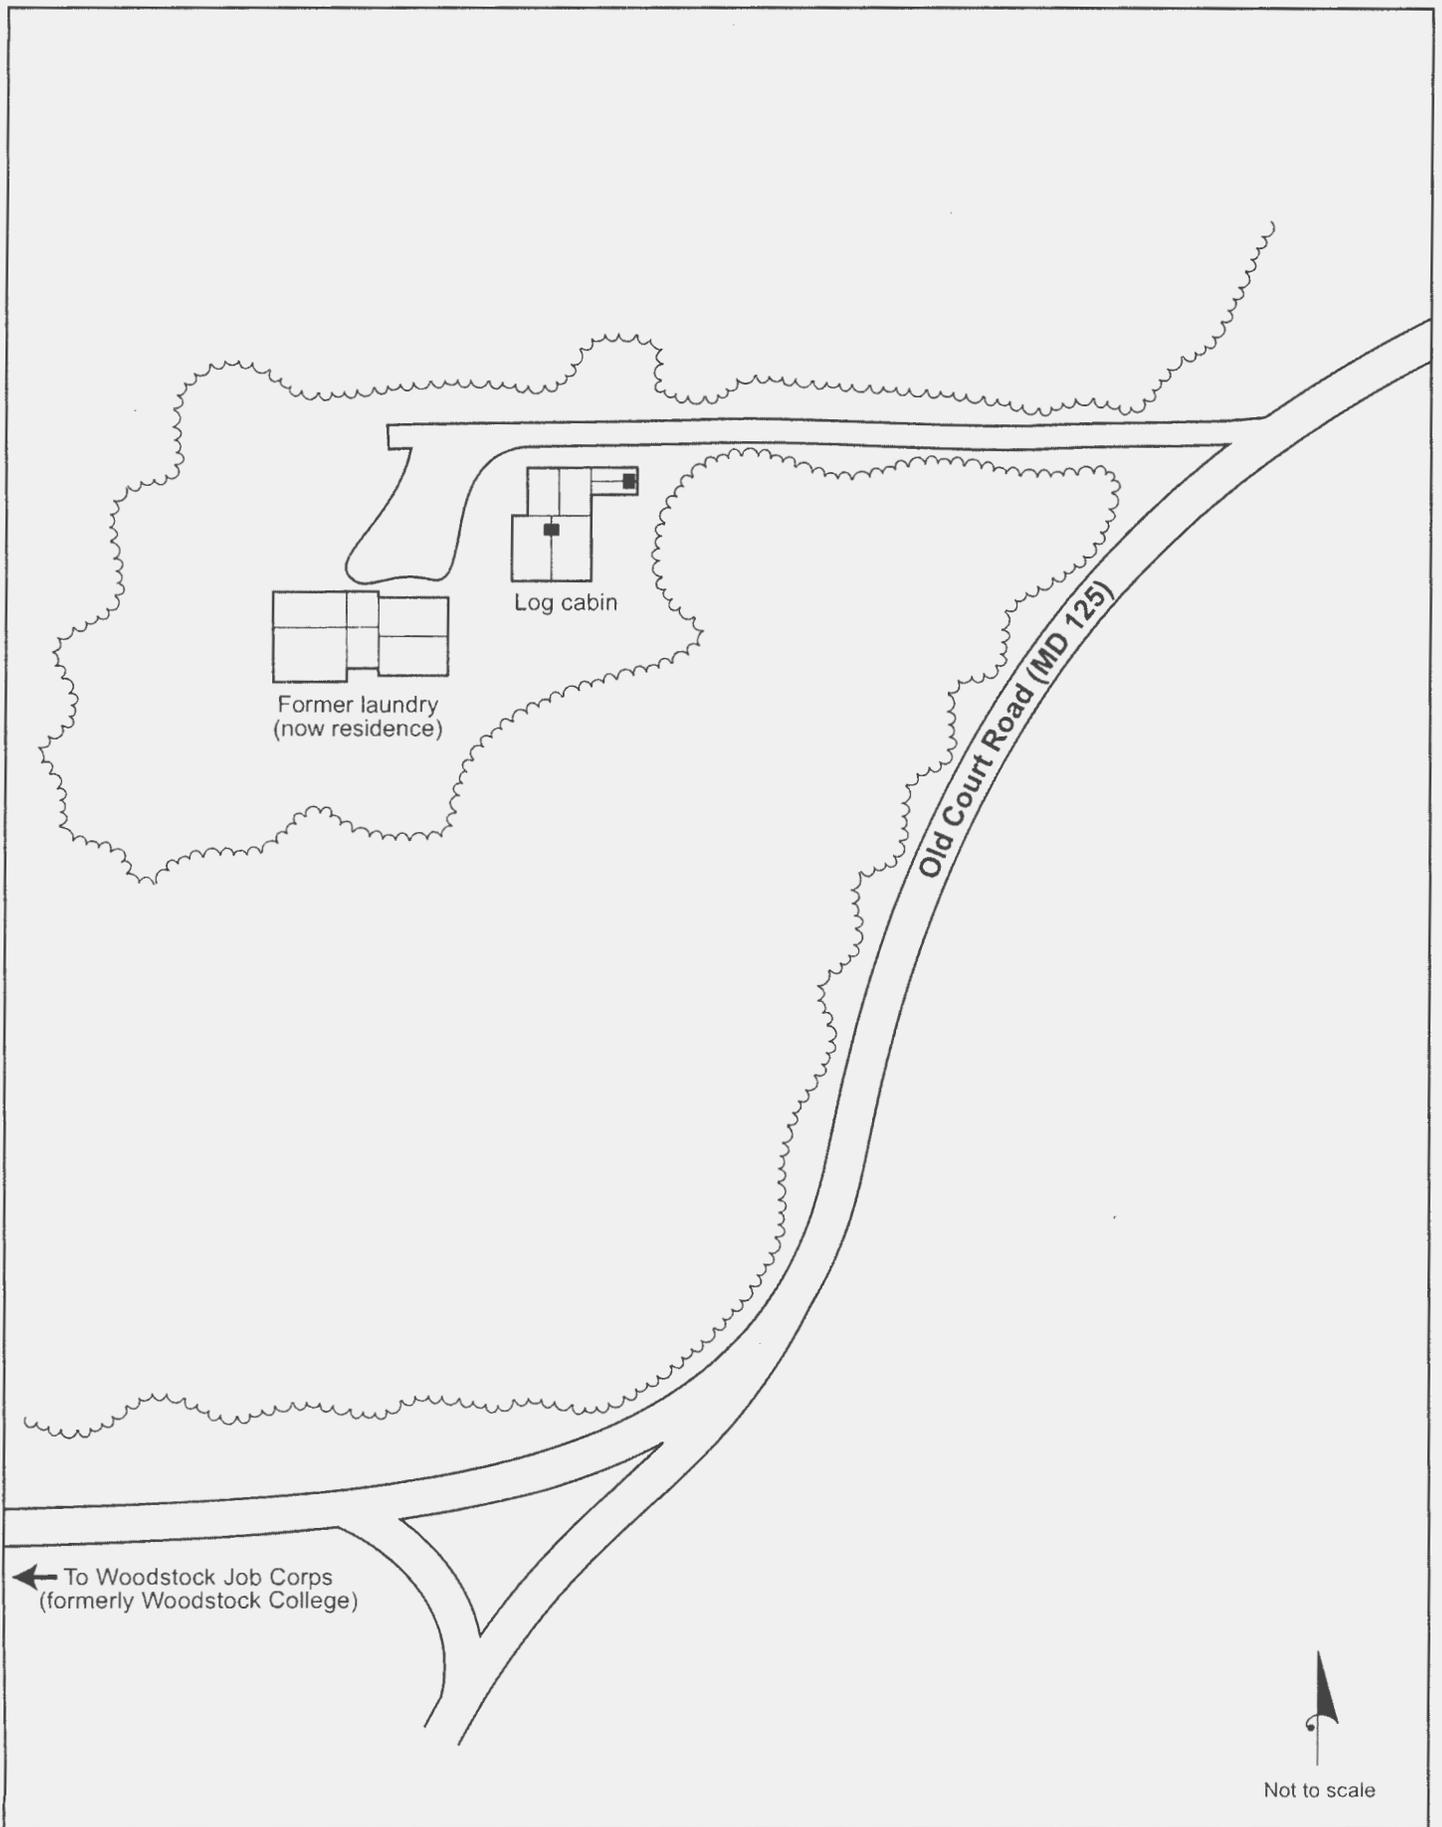
Resource sketch map of the Woodstock Laundry Log Cabin (MIHP BA-1581), Patapsco Valley State Park, Baltimore County, Maryland.

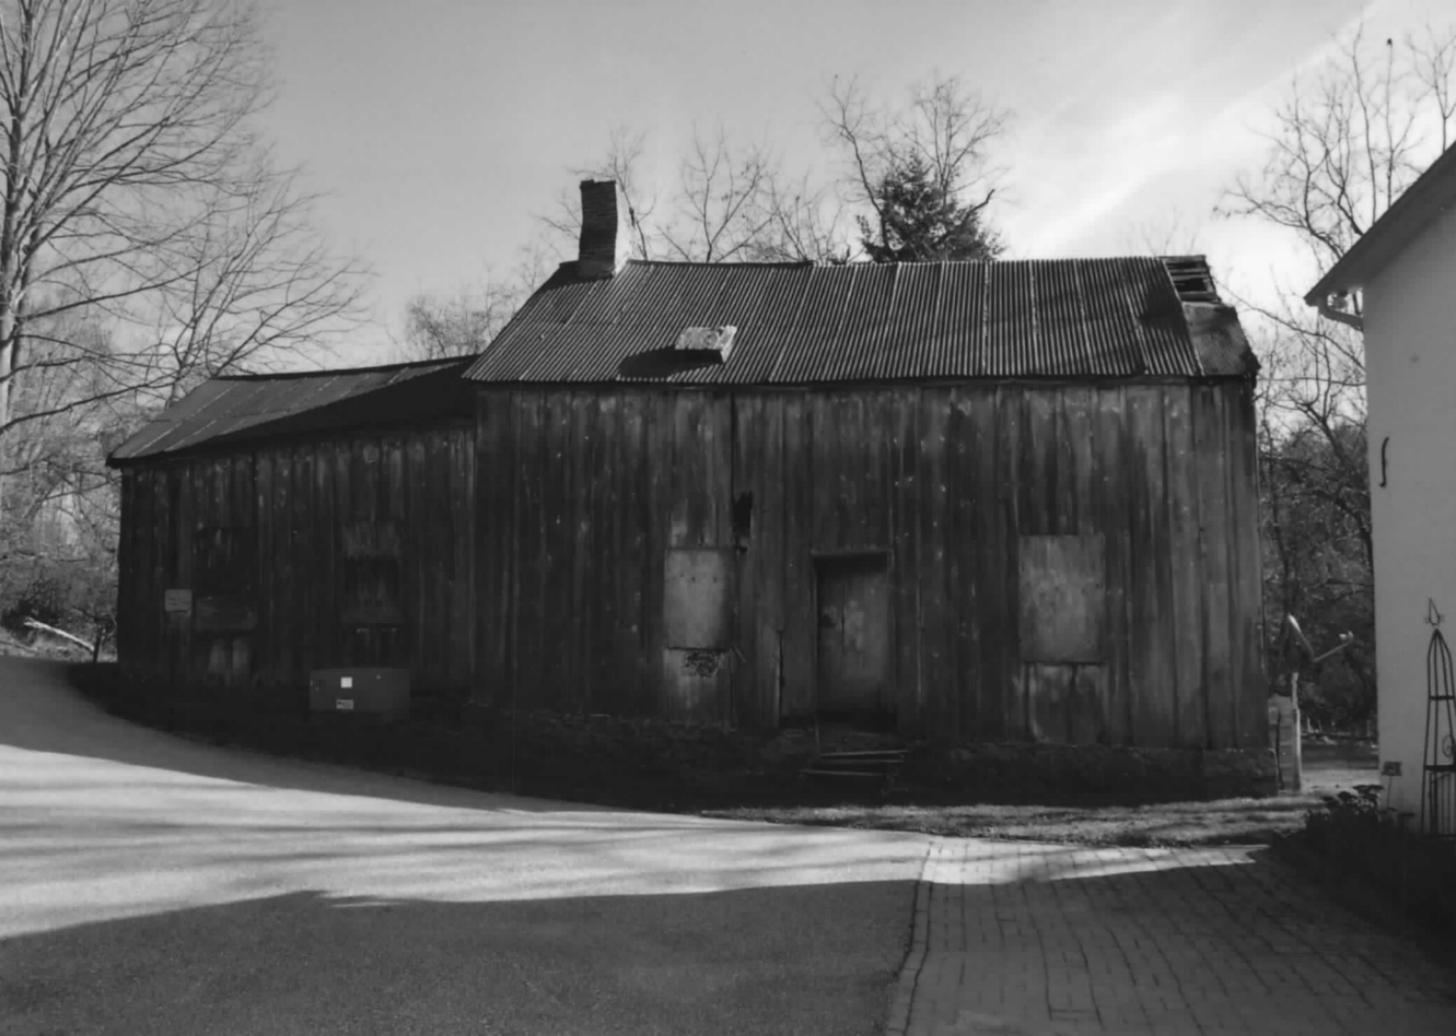
BA-1581
WOODSTOCK LAUNDRY LOG CABIN
BALTIMORE COUNTY, MD
NOVEMBER 2014
S. TRAUM
CABIN, WEST ELEVATION
1/7
BA-1581-2014-11-19_01

Photo file name	Description
BA-1581_2014-11-19_01	Cabin, west elevation, view toward east.
BA-1581_2014-11-19_02	Cabin, view toward southeast.
BA-1581_2014-11-19_03	Cabin, detail of log construction in northwest corner.
BA-1581_2014-11-19_04	Cabin, east wing, view toward northwest.
BA-1581_2014-11-19_05	Cabin, southeast corner, view toward northwest.
BA-1581_2014-11-19_06	Cabin, southeast corner, detail of log construction and stone chinking, view toward northwest.
BA-1581_2014-11-19_07	Cabin, east wing, interior, view toward east.

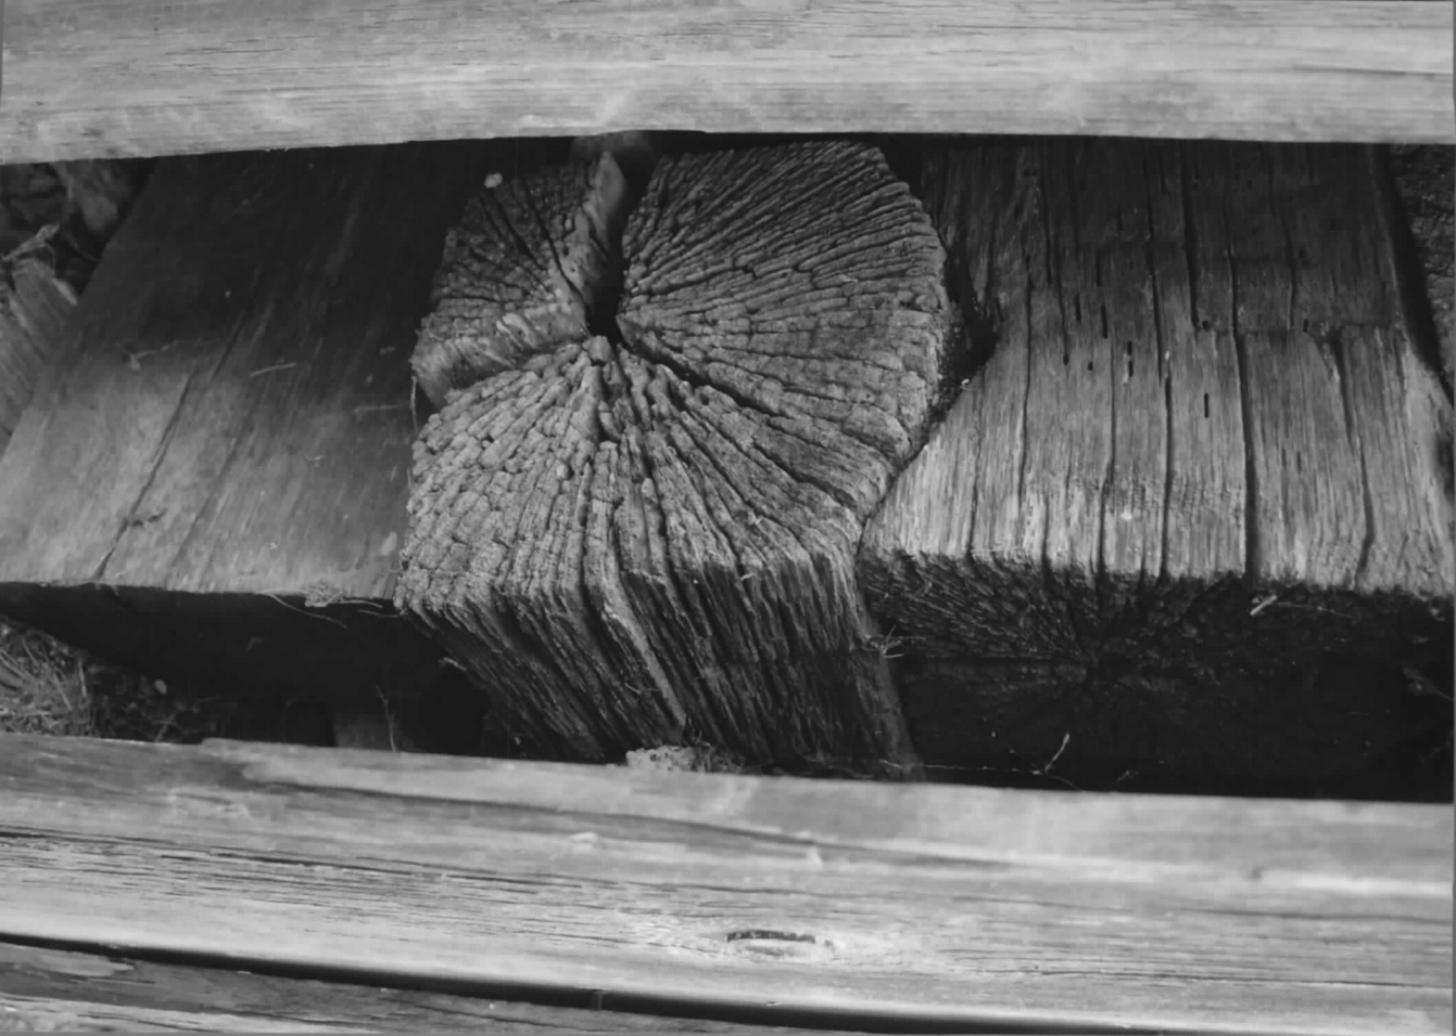
BA-1581 - 2014-11-19-03

S. TRAUM
CABIN, NORTHWEST CORNER, DETAIL
317

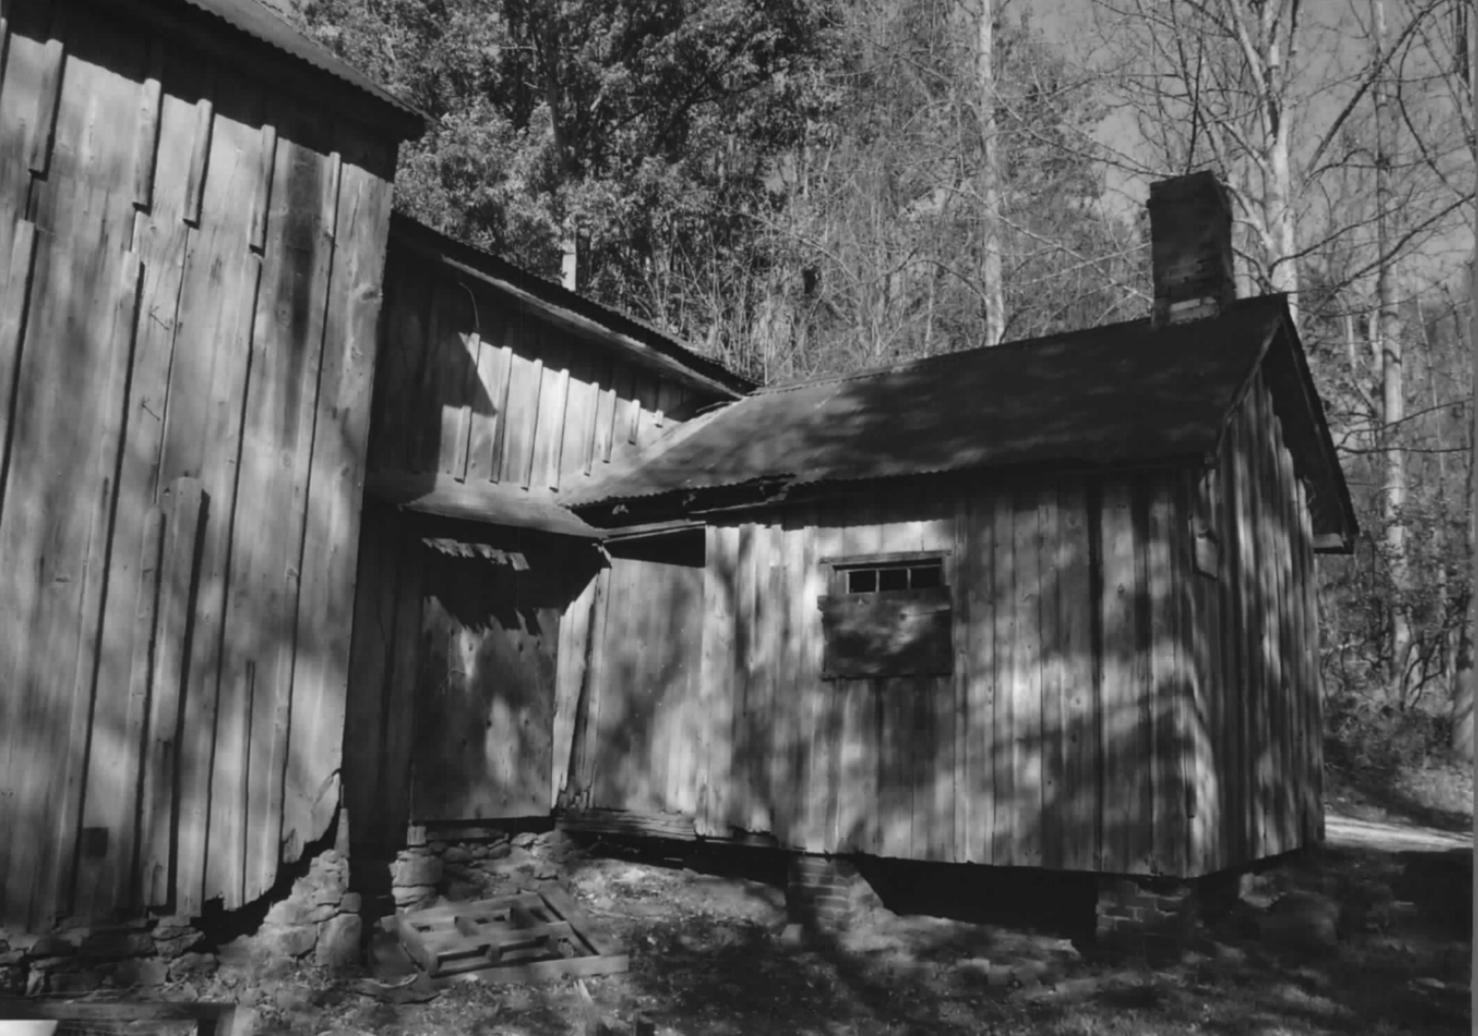
4/7
BA-1581-2014-11-19-04

BA-1581
WOODSTOCK LAUNDRY LOG CABIN
BALTIMORE COUNTY, MD
NOVEMBER 2014
S. TRAUM WING
CABIN, EAST

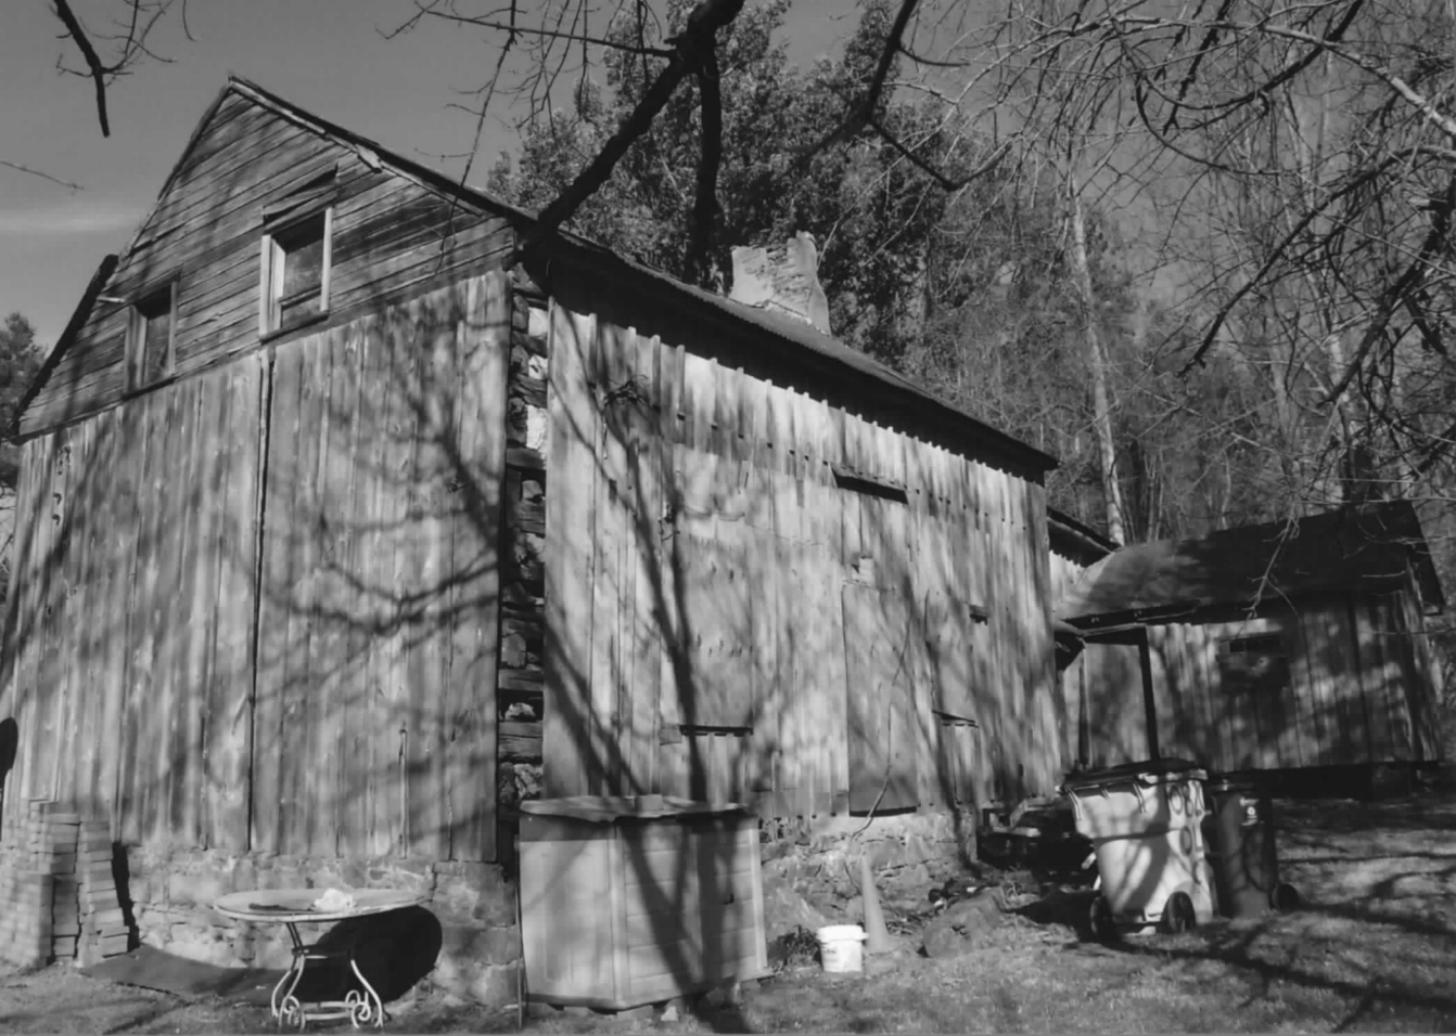
BA-1581_2014-11-19_05

BA-1581
WOODSTOCK LAUNDRY LOG CABIN
BALTIMORE COUNTY, MD
NOVEMBER 2014
S. TRAUM
CABIN, SOUTHEAST CORNER
5/7

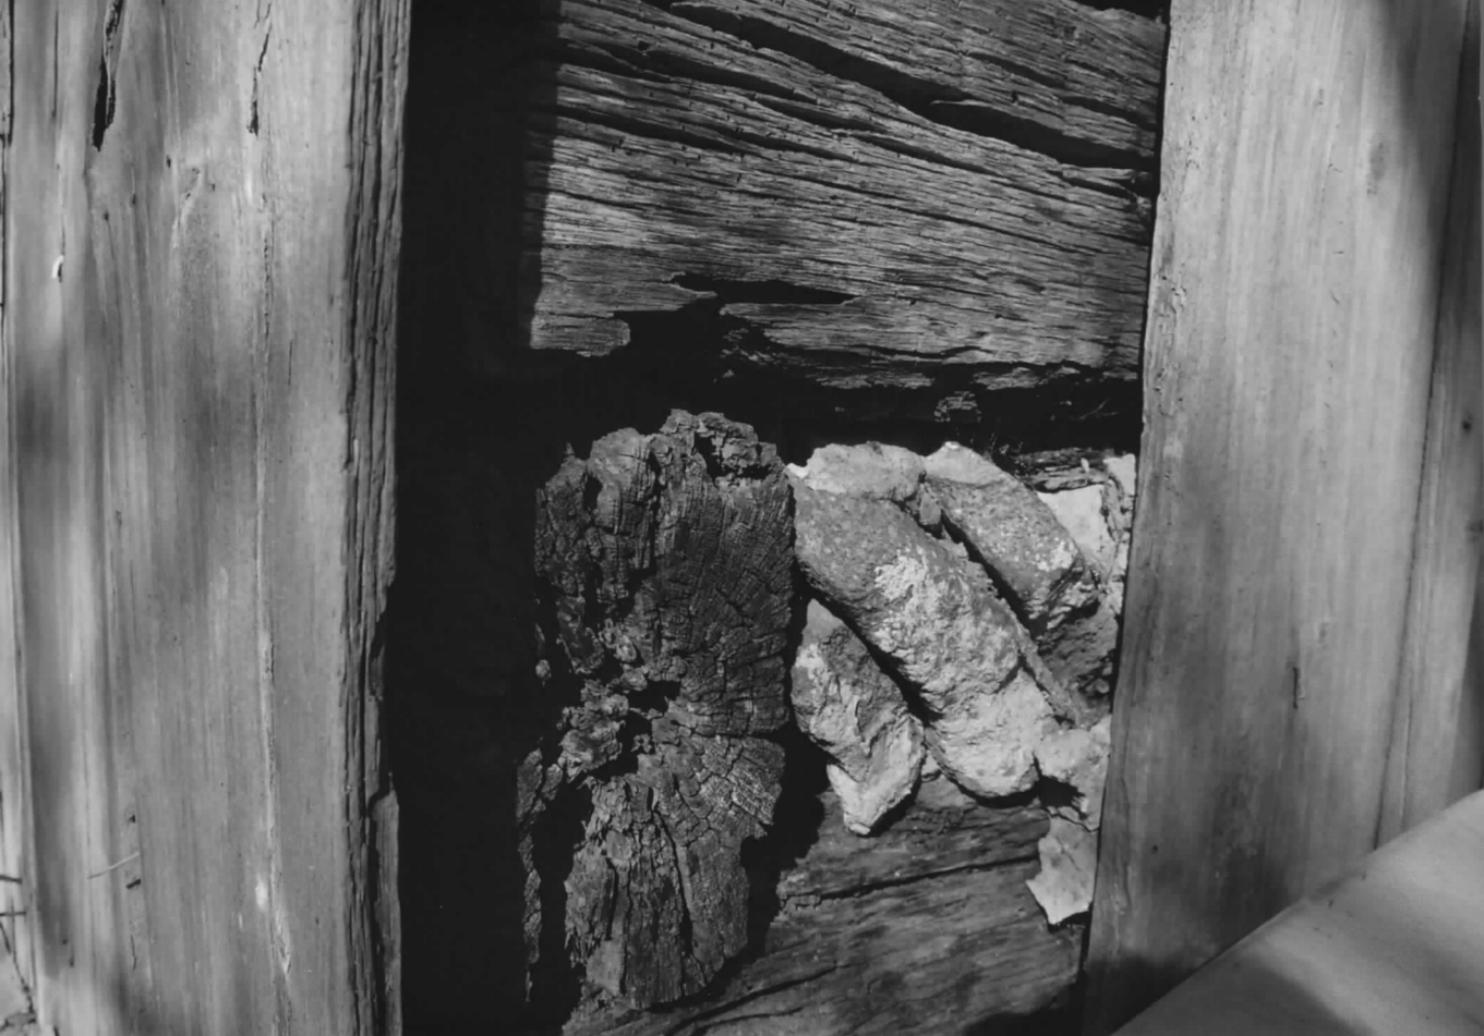
BA-1581-2014-11-19-06

CABIN, SOUTHEAST CORNER, LOG CONSTRUCTION AND CHIMNEY DETAIL

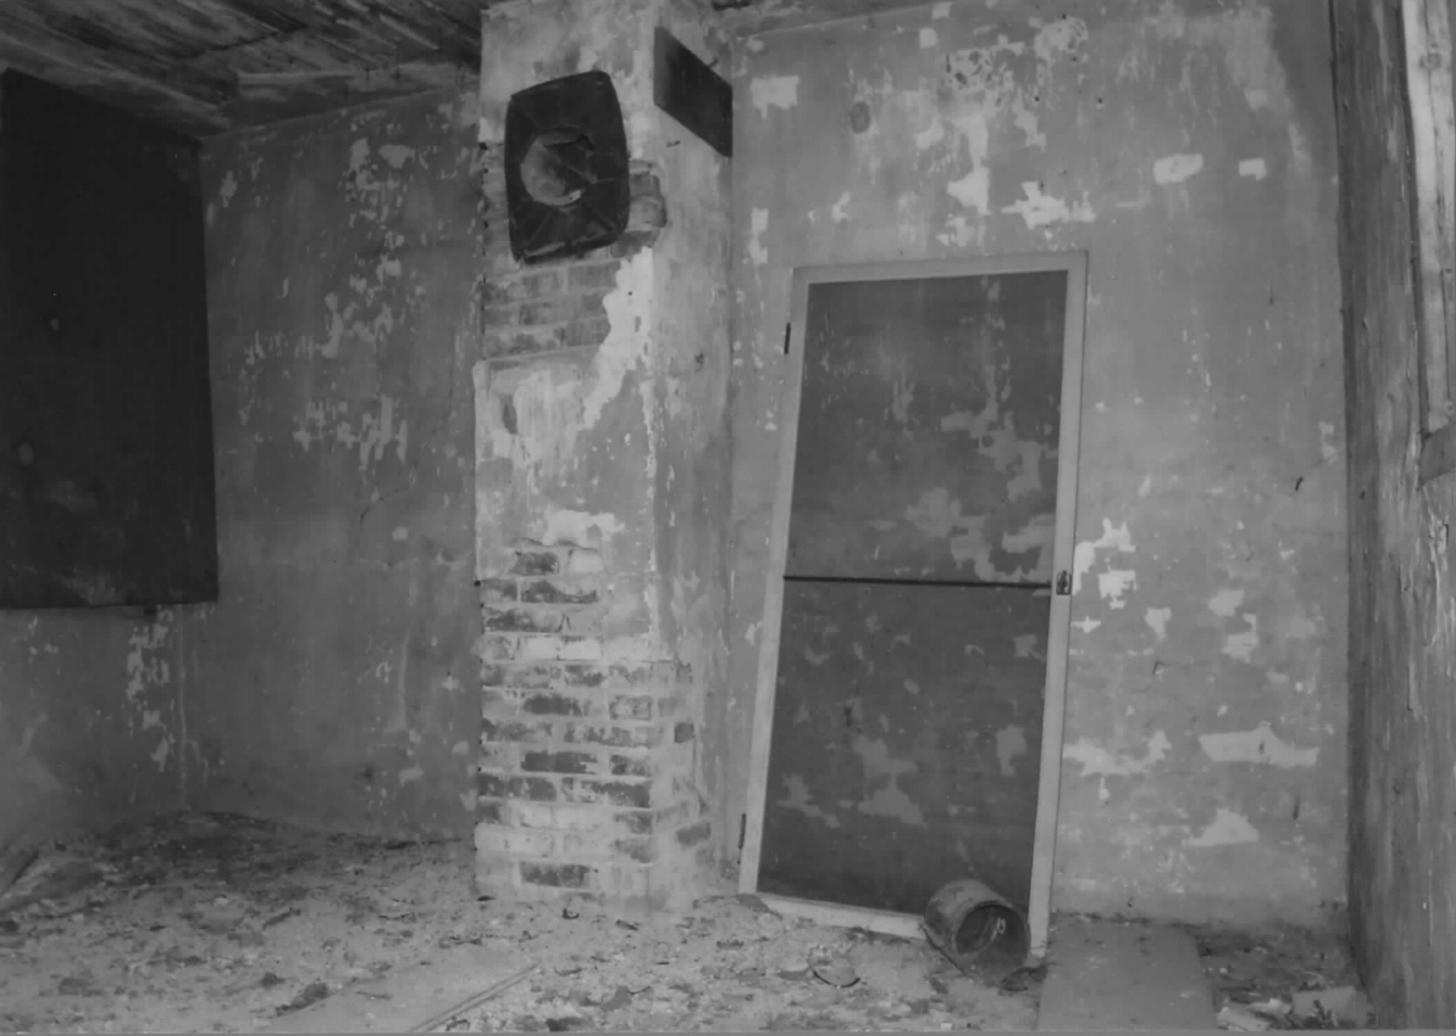
BA-1581-2014-11-19-07

measures two bays wide and one bay deep. It stands on brick piers and has a corrugated metal roof with a brick chimney rising through the eastern gable. The exterior is board-and-batten, and the windows are boarded over. The door on the south elevation is not boarded over and allows a view of the interior of this block. The single-room interior of this block has a painted plaster finish.

CABIN, EAST WING INTERIOR

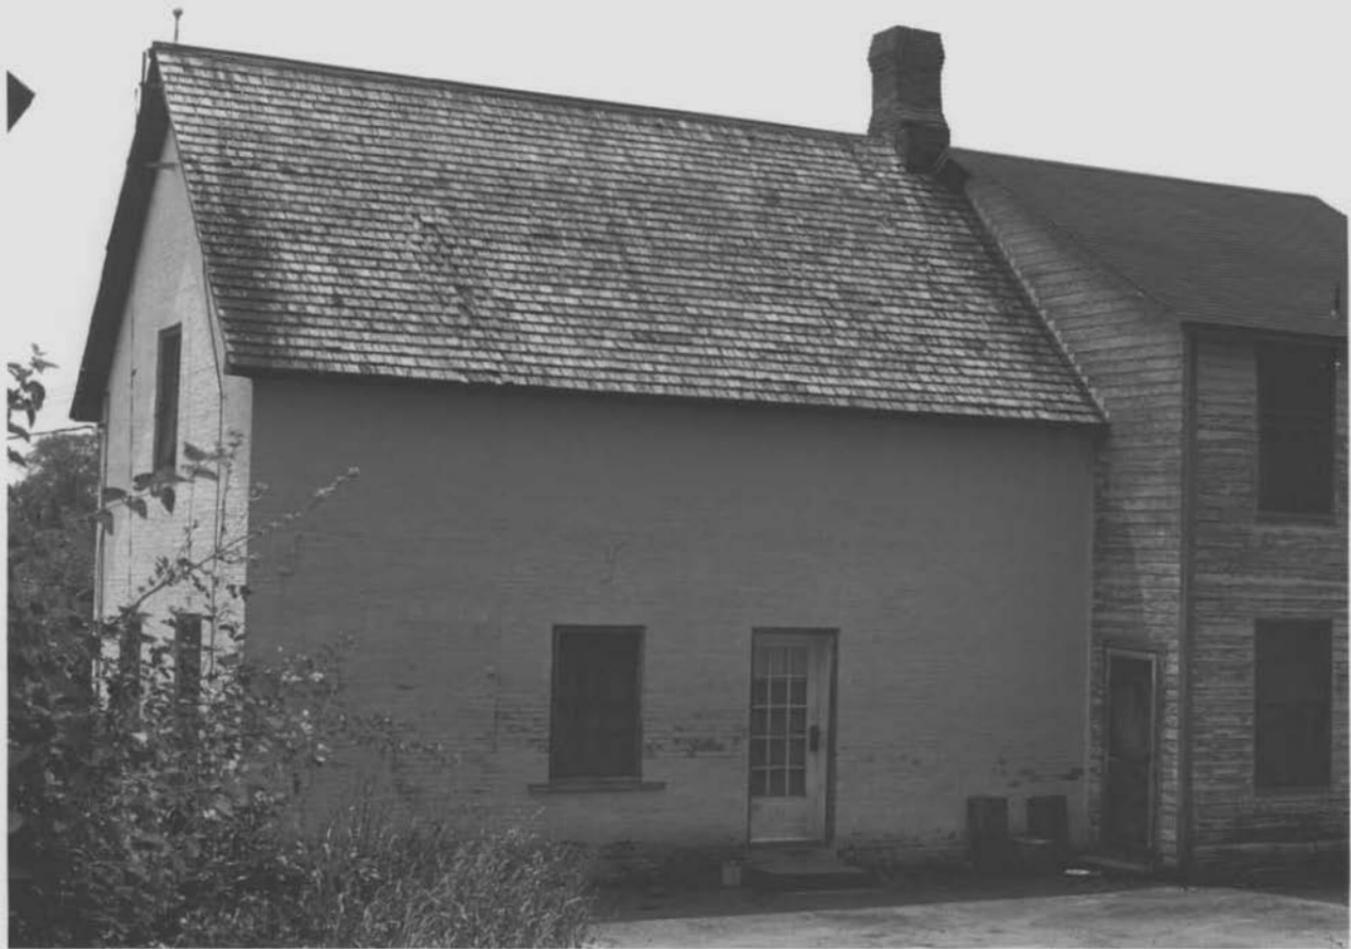
BA-1581

North Elevation

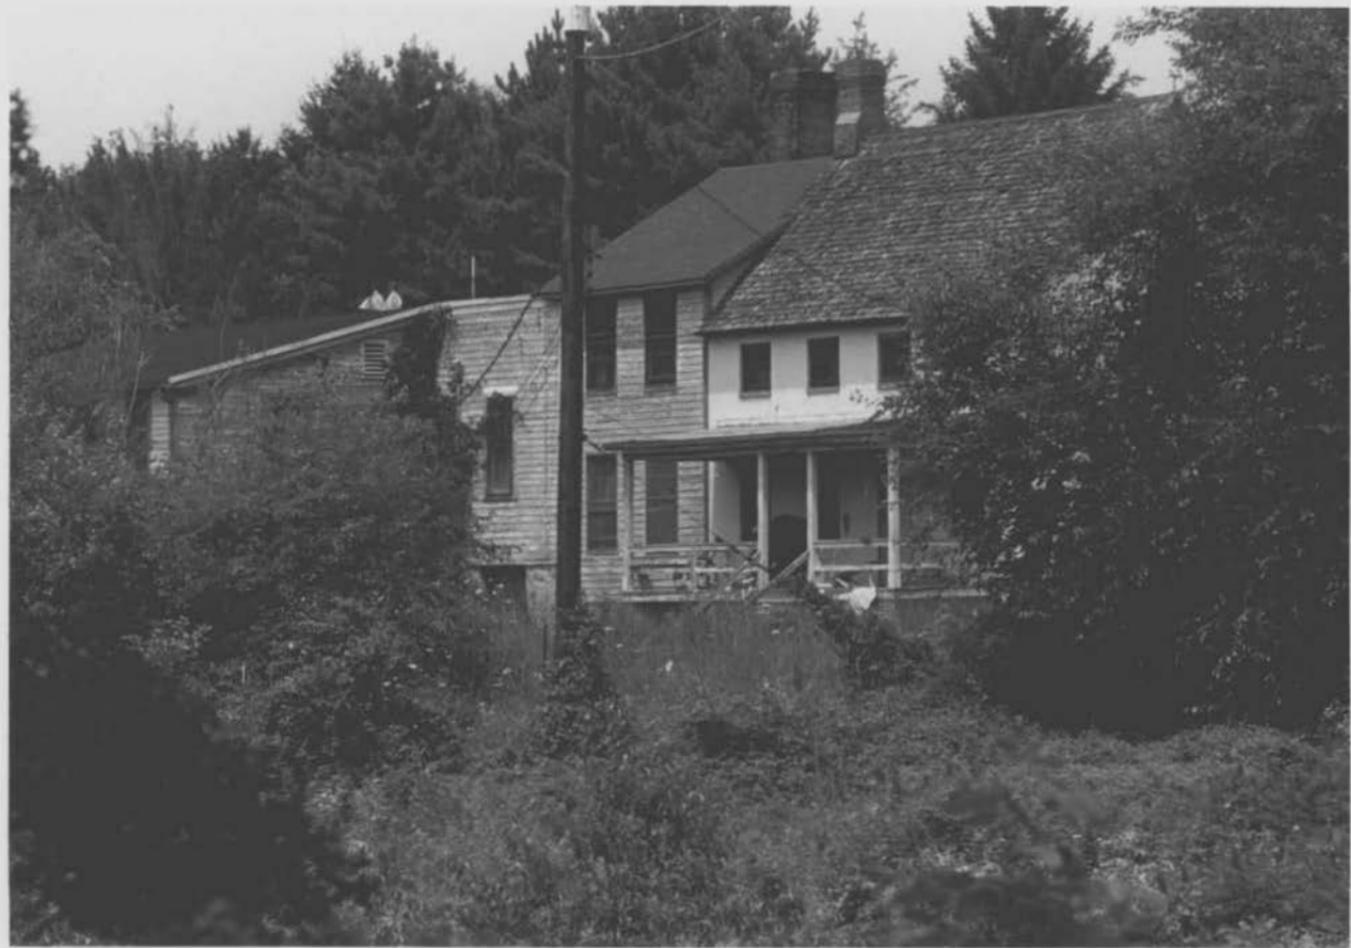
BA - 1581

South Elevation
