MARYLAND HISTORICAL TRUST
DETERMINATION OF ELIGIBILITY FORM

Property Name: Richard W. Henderson House (Thornton Hill Farm) Inventory Number: BA-186
Address: 14601 Western Road _____ City: Sparks Zip Code: 21152-9630
County: Baltimore USGS Topographic Map: Hereford
Owner: James A. Walsh and Sandra S. Walsh Is the property being evaluated a district? _____yes
Tax Parcel Number: 256 Tax Map Number: 34 _____ Tax Account ID Number: 2000005253
Project: Walsh Property Floodplain Study Agency: MDE Permit Tracking #200366127/N66158
Site visit by MHT Staff: X no yes Name: _____ Date: _____
Is the property located within a historic district? X ___yes ___no

BA-186
 Richard W. Henderson House
 Sparks Vicinity
 Baltimore County, Maryland
 Hereford Quadrangle

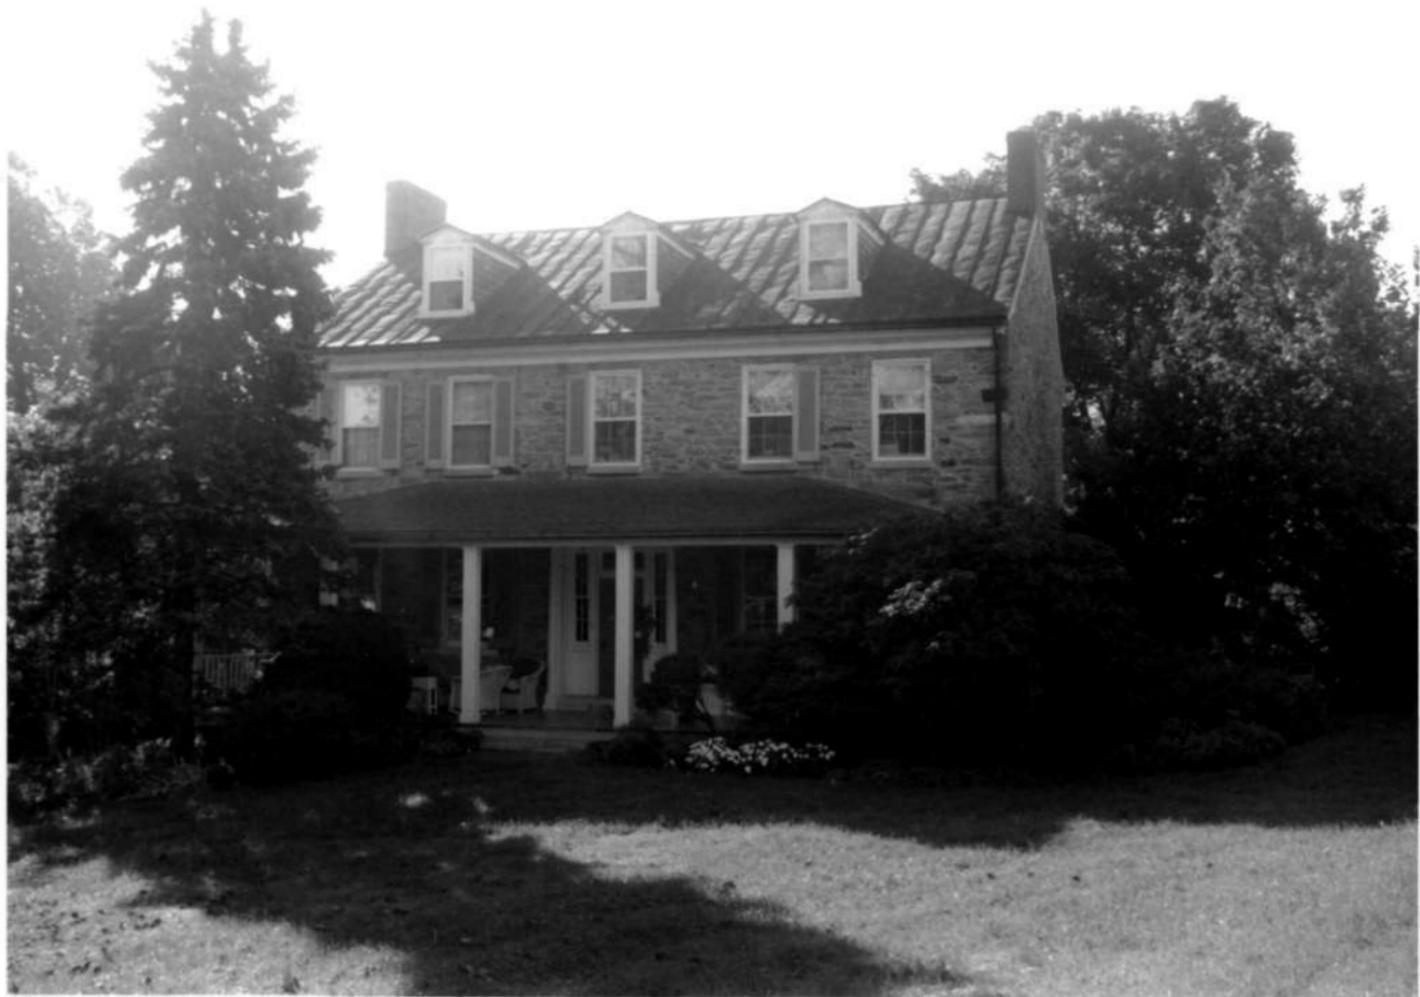
1/8

Front (N) elevation

The main dwelling faces north. The earliest sections of the house are a two-and-one-half-story, gable-roofed, stone main block with an 1840 date stone and a ca. 1840 three-story, shed-roofed, stone kitchen wing that extends from the east end of the main block's rear (south) elevation. These earliest sections create an L-shaped footprint. A one-story, gable-roofed, stone and wood-frame addition with a 1991 date stone was constructed by the current owners along the rear elevation of the kitchen wing. A similar ca. 1991 addition extends from the east elevation of the kitchen wing. With the exception of the 1991 additions, the dwelling basically retains the form and materials described in MIHP Form BA-186 prepared in 1976 (Black and Wollon 1976a).

The main block and kitchen wing are constructed of randomly laid stone. Windows are six-over-six-light, wood-frame units with stone sills; most windows on the front (north) elevation of the main block have louvered blinds. Roofs of both sections are sheathed in standing-seam metal.

The two-and-one-half-story, five-bay-by-three-bay rectangular main block has a central hall floor plan. The gable roof features three gabled dormers on each slope. On the rear roof slope, the two dormers on the east end have been added since the 1976 documentation. An interior brick chimney rises on each gable end. Initials "MPM" and the date "1840" are inscribed in the west chimney. An undecorated wood cornice is located along the front and rear elevations of the main block. The centrally located, wood front door is recessed within paneled jambs ornamented with engaged Tuscan columns. The door has two side-by-side, vertical panels and is crowned by a three-light transom. Four-over-four-light sidelights set over wood panels flank the door. A full-width, one-story, hipped-roof porch with a wood floor and ceiling spans the front elevation of the main block. The porch features square wood posts; a wood railing with square balusters is located on the east end of the porch.

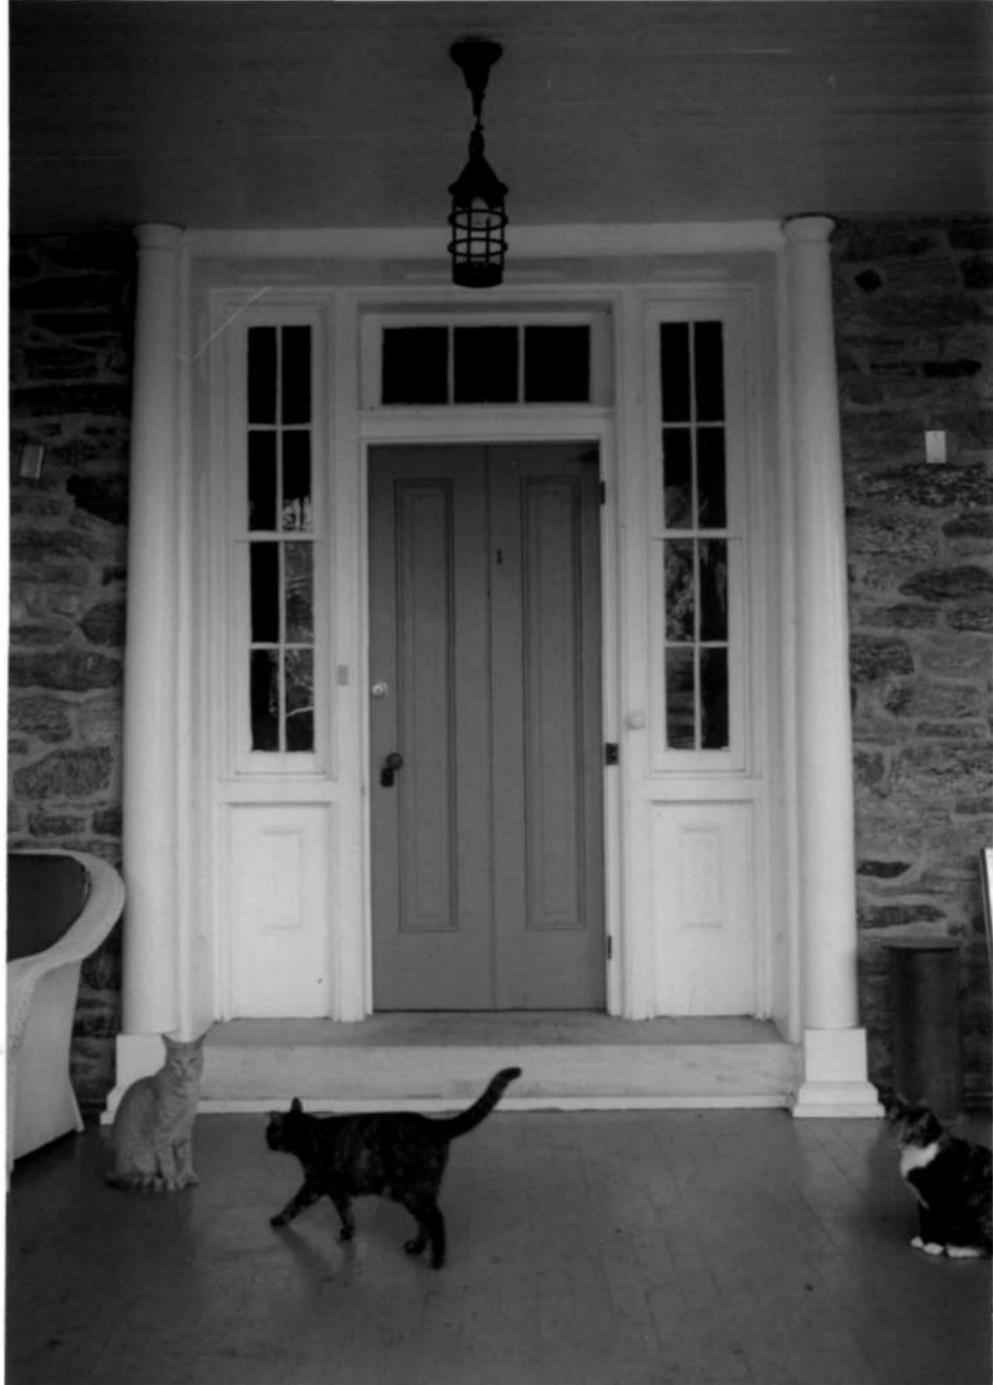
2/8

Front door, N elevation

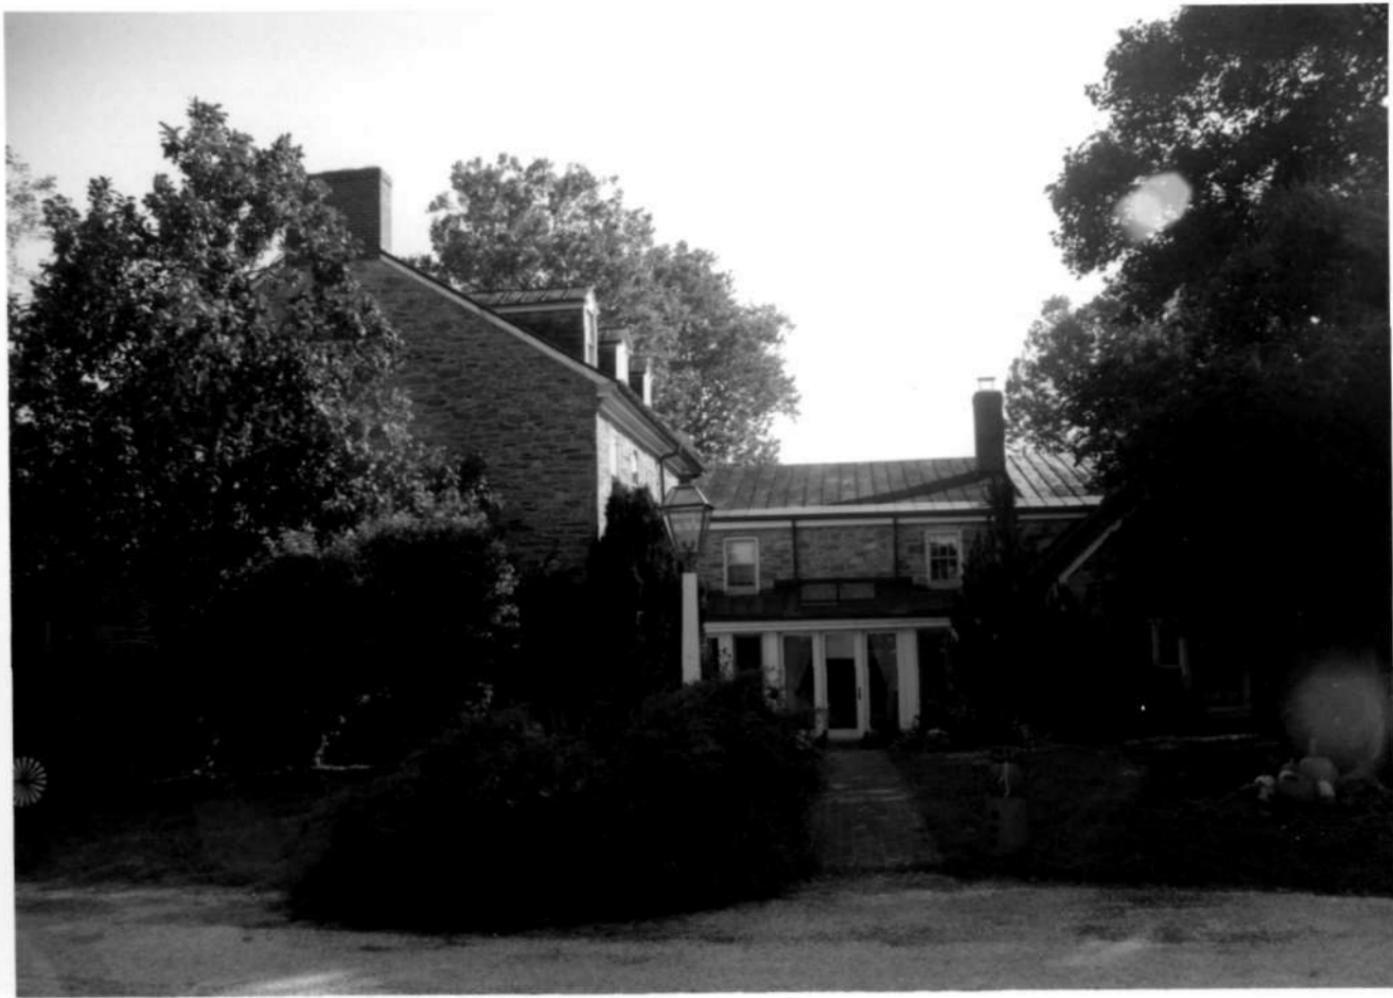
3/8

W elevation

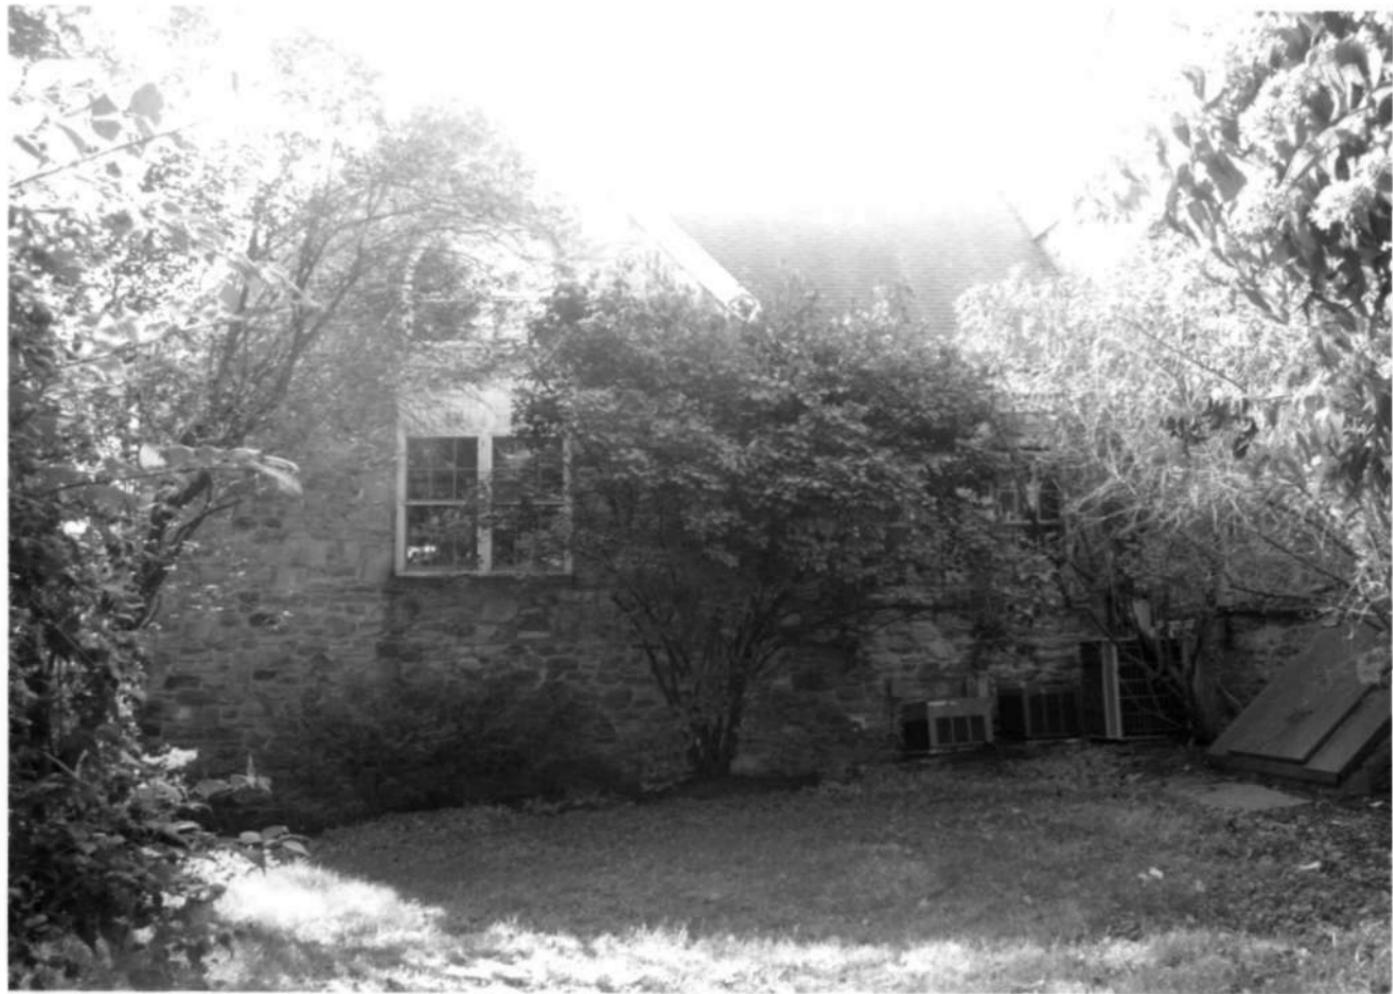
4/8

Side (E) addition - front (N) elevation

The one-story, gable-roofed, stone and wood-frame addition along the east side of the kitchen wing exhibits similar characteristics as the 1991 addition described above. The front part of the addition is constructed with randomly laid stone; the front (north) elevation features a large, arched window. Remaining windows in the stone part are wood-frame, six-over-six-light units. The back part of the addition is of wood-frame construction and includes a

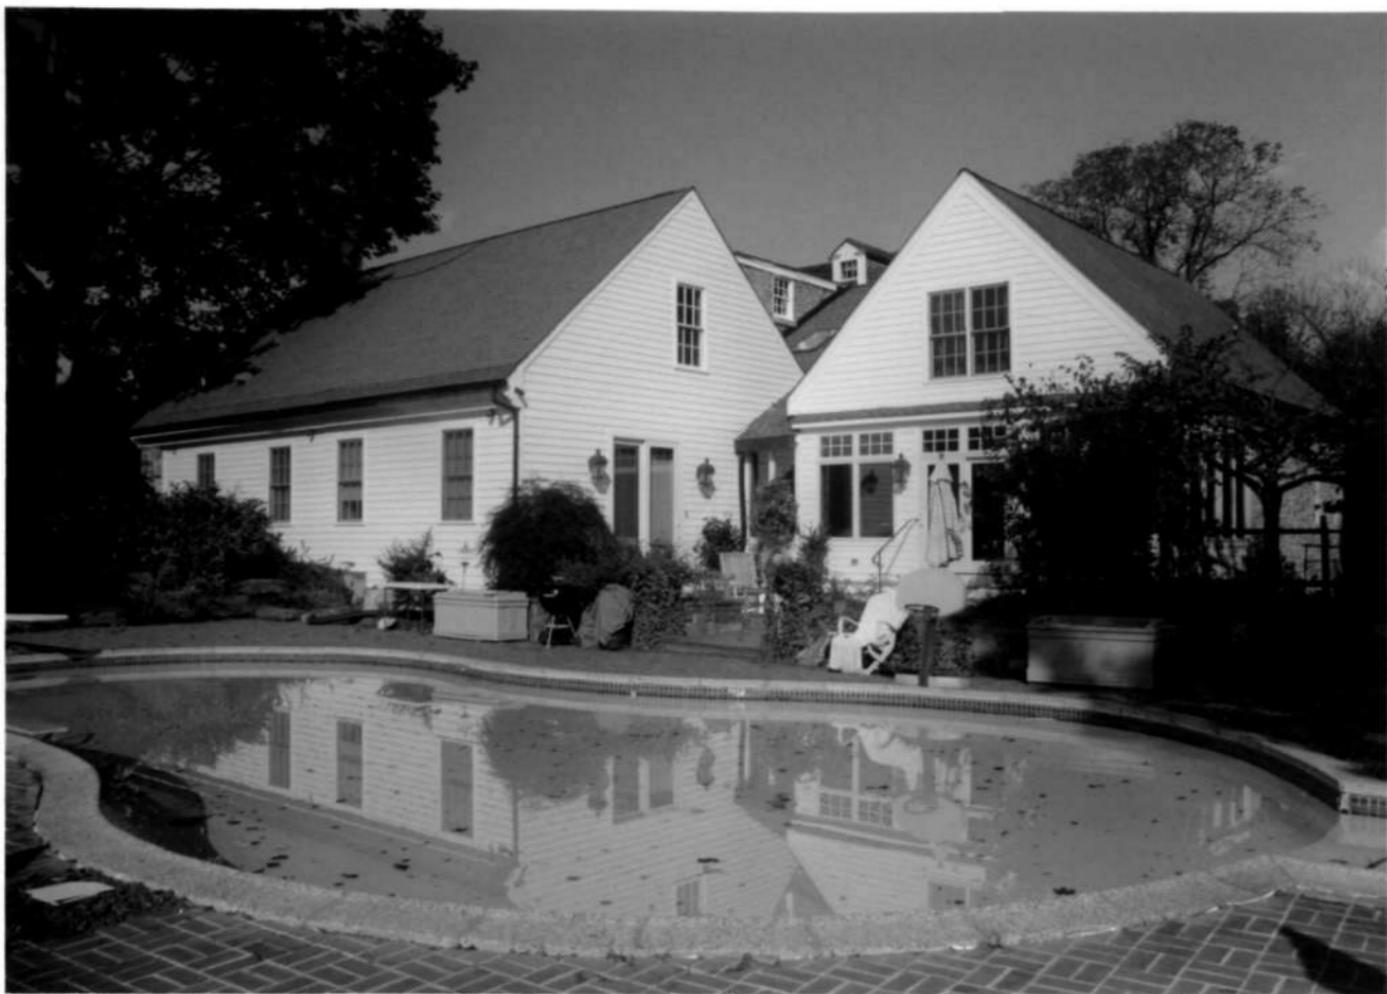
5/8

Rear (S) elevation

The one-story, gable-roofed, stone and wood-frame addition along the rear elevation of the kitchen wing features a date stone in the west gable. The date stone is inscribed with the initials "JSW" and the date "1991." The roof is sheathed in asphalt shingles; an interior brick chimney projects from the roof ridge. The west wall of the addition is constructed with randomly laid stone and features a multi-light bay window. Remaining walls are of wood-frame construction clad with horizontal, beaded wood siding. Windows are wood-frame, six-over-six-light units. A set of glazed paired doors is located on the east elevation.

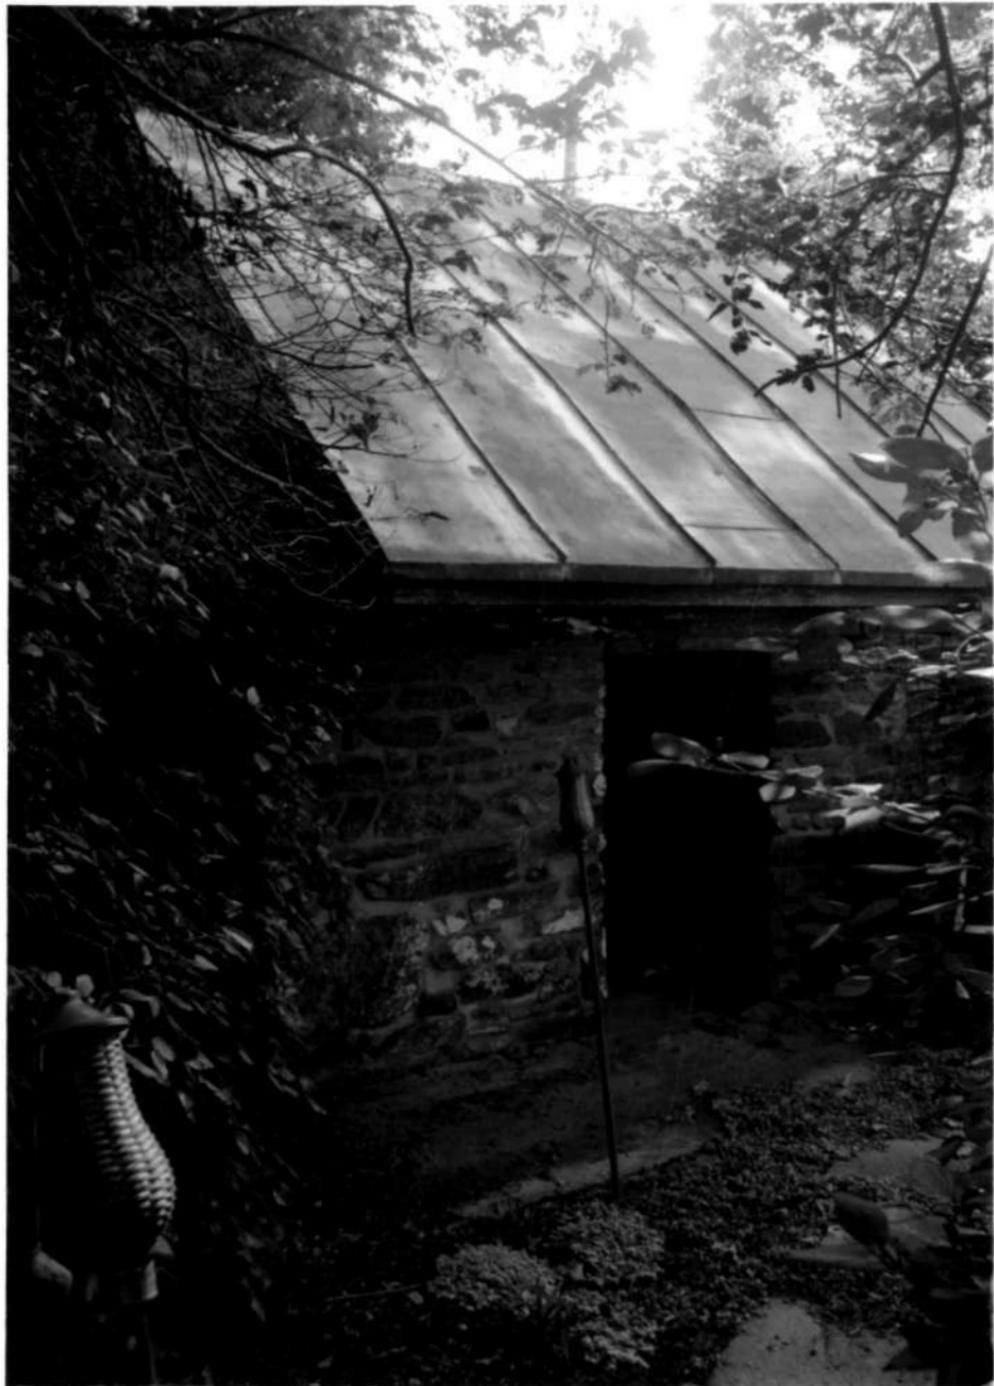
6/8

Springhouse -

Front (W) elevation

A stone springhouse comprising one story and a loft is located east of the dwelling. The building appears to be contemporary with the original sections of the house, which were built ca. 1840. The square springhouse faces west and terminates in a gable roof sheathed in standing-seam metal. The roof slope overhangs the front (west) wall, which contains a centrally located door opening. A window opening is located on each remaining elevation. The south gable features a door opening to the loft. All window and door openings are unfilled. The springhouse has a poured-concrete floor. Ceiling joists run east to west and are half-round, hewn logs with cut nails; these joists support wide floor boards in the loft. Evidence of a spring is not visible.

The ca. 1840 stone springhouse stands adjacent to the Richard W. Henderson House. The Western Run-Belfast Road Historic District contains many nineteenth-century springhouses due to the abundance of springs. Most springhouses in the district were constructed with stone, a durable material that survived well in a damp environment (Black and Wollon 1976b:7-7). The ca. 1840 stone springhouse near the Henderson House is typical of those constructed in the region. Applying National Register Criterion C, the springhouse possesses the qualities of significance and integrity necessary to be a contributing resource to the Western Run-Belfast Road Historic District. The springhouse retains integrity of location, design, setting, materials, workmanship, feeling, and association.

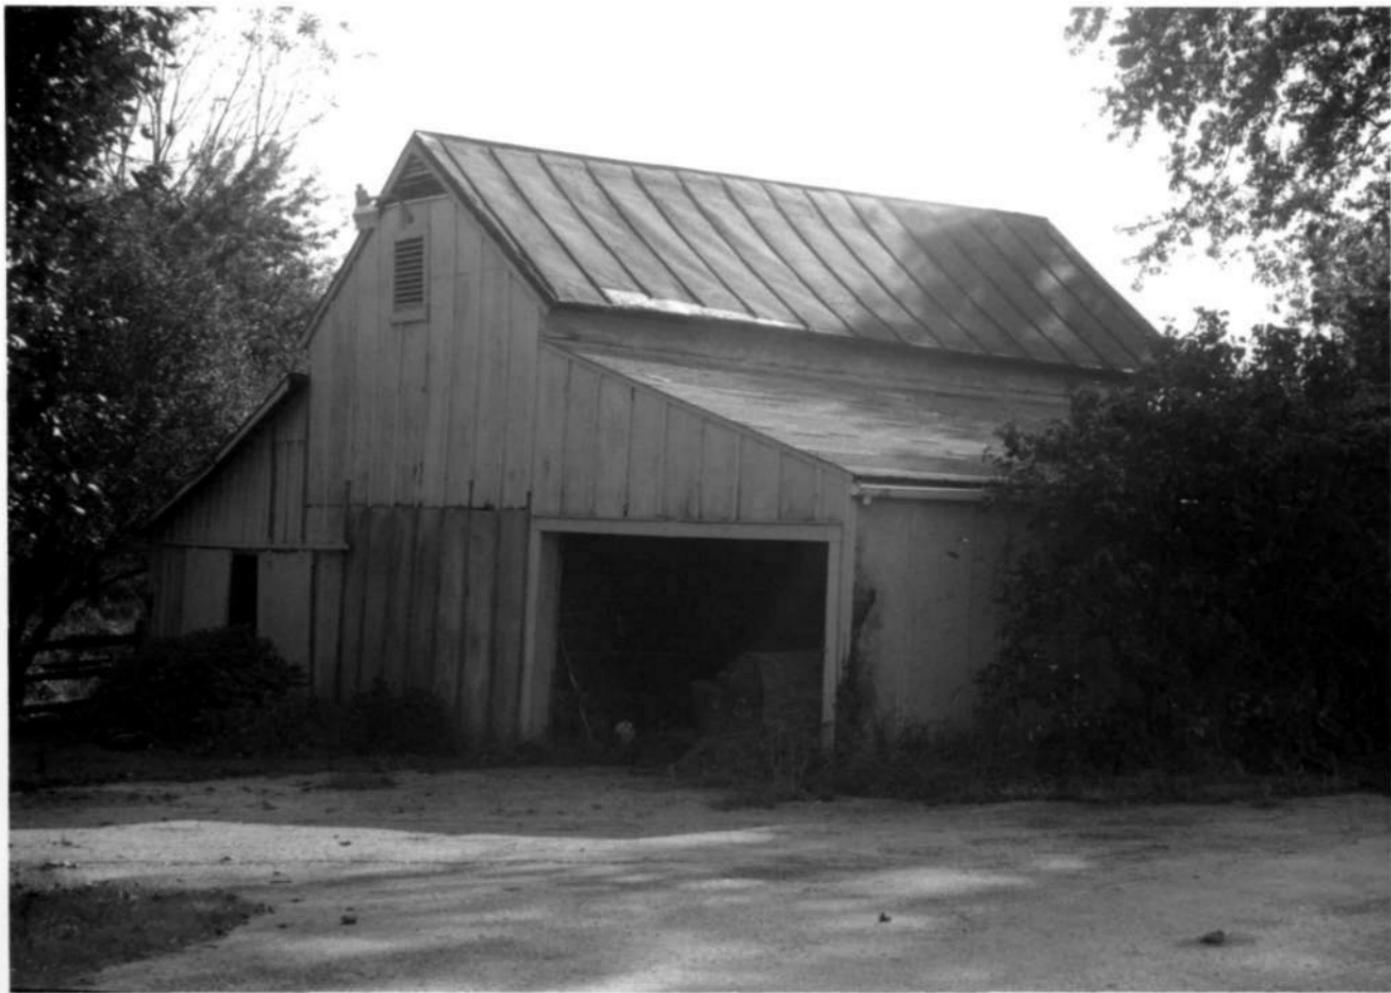
7/8

19th century barn w/20th century additions-
NW corner

A nineteenth-century outbuilding that originally may have been a small barn is located south of the dwelling. The two-story, wood-frame, gable-roofed building has a twentieth-century, wood-frame addition on each side elevation. Each addition is one story in height with a shed roof. Exterior walls of the building are clad with board-and-batten siding and plywood with furring strips. The roof of the building is sheathed in standing-seam metal and asphalt shingles. A one-story, plywood garage addition is located along the building's rear elevation.

Although the nineteenth-century barn with twentieth-century additions may possess significance, the building no longer retains sufficient integrity of design, materials, feeling, and association to be a contributing resource to the Western Run-Belfast Road Historic District. The cow barn, silo, corn crib, animal pens, and tenant house are twentieth-century buildings that post-date the period of significance emphasized in the Western Run-Belfast Road Historic District nomination. Applying National Register Criterion C, these buildings and structures do not possess the significance necessary to be contributing resources to the historic district.

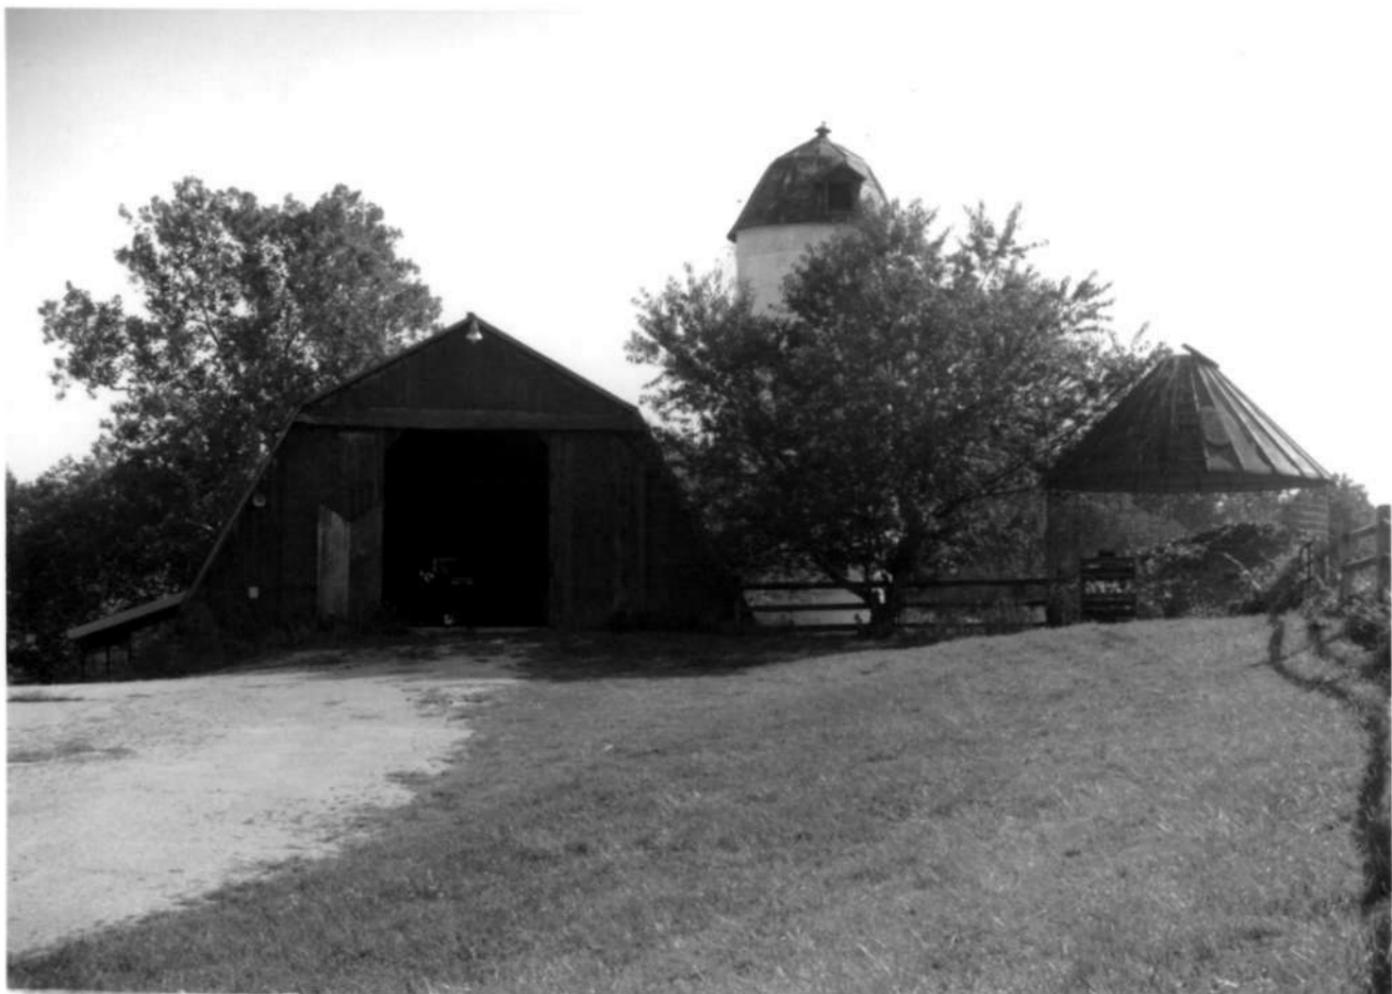
8/8

Cow barn, silo, corn crib - W elevations

An early to mid-twentieth century cow barn is located southeast of the dwelling. The barn has a concrete-block lower level and a wood-frame upper level that terminates in a gambrel roof with an east-to-west ridge. The west elevation of the barn is built into a bank. A set of double vertical-board sliding doors located in the west gambrel open onto the top of the bank. The sides of the door frame are constructed with large, square posts. The roof is sheathed in standing-seam metal. The wood-frame sides of the gambrel roof are clad with vertical boards. The interior floor of the upper level has wide, circular-sawn floor boards. The lower level of the barn, which features metal-frame windows and beaded vertical-board sliding doors, appears to shelter horses. There is no evidence of a former dairy.

A concrete-block, circular silo is located south of the cow barn. External metal bands secure the concrete blocks. A metal, conical hipped roof with a gabled dormer caps the silo.

A wire, circular corn crib is located southwest of the cow barn. The corn crib has a poured-concrete floor, a louvered side opening, and a conical roof sheathed in standing-seam metal.
