INVENTORY FORM FOR STATE HISTORIC SITES SURVEY

17 Linden Terrace

Towson

BA-2157

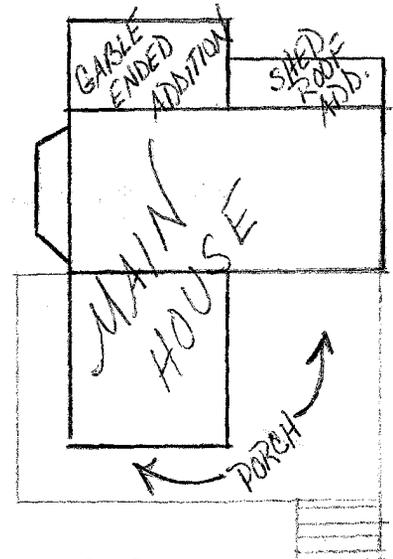
The north facade, as indicated on the sketch to the right, reflects the structural changes brought about by two probable additions in the rear of the house. A one story shed roof lean-to is located on the right or west side of the north facade. A small two story gable ended addition appears on the left east side. The shed roof addition contains a glass paneled door with a 2/2 sash window to the left. Above the shed roof is a 2/2 sash window. A door opening has also been cut into the north-south wing addition above the shed roof. A casement window has been added to the first floor of the north-south wing. An arched window appears in the attic of the wing. It seems possible that this was originally a sash window like those found on the other facades.

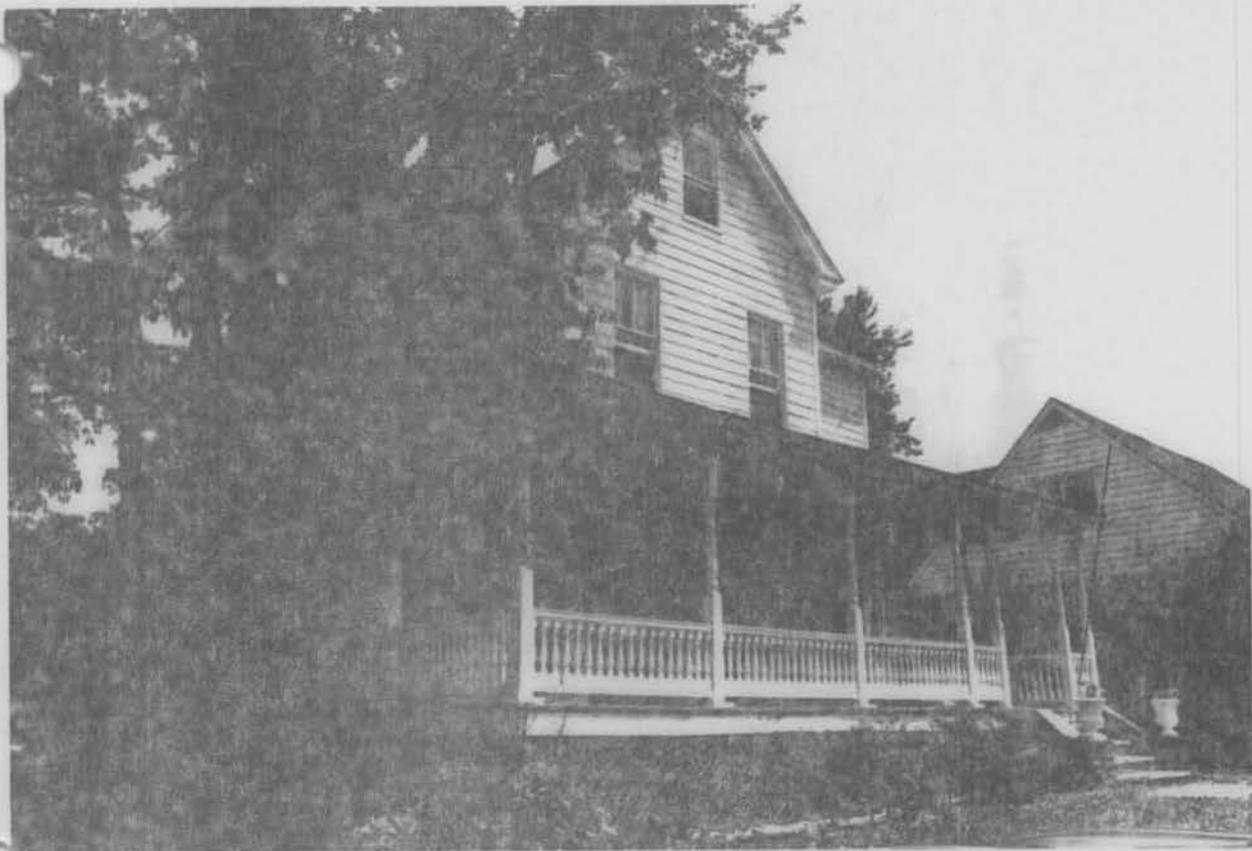
ABOVE: South-west Facade

The most striking feature on the main or south facade is the L-shape or wrap-around porch which surrounds the entire south and half of the west facades. Five stone steps lead to the porch which rests upon stone porch piers and is floored with tongue and groove boards. The original turned ballusters support a handrail while a lattice-like porch base surrounds the porch. Thirteen turned posts with knobs support the tongue and groove ceiling and the slightly hipped porch roof. Two metal brackets (recently added) adorn the posts on each side of the steps.

The fenestration on the west facade consists of the two story bay window and a 2/2 sash window with red louvered shutters. (The shutters on all the other windows were removed while renovation work was being done). A modern brick chimney flue also appears on this facade.

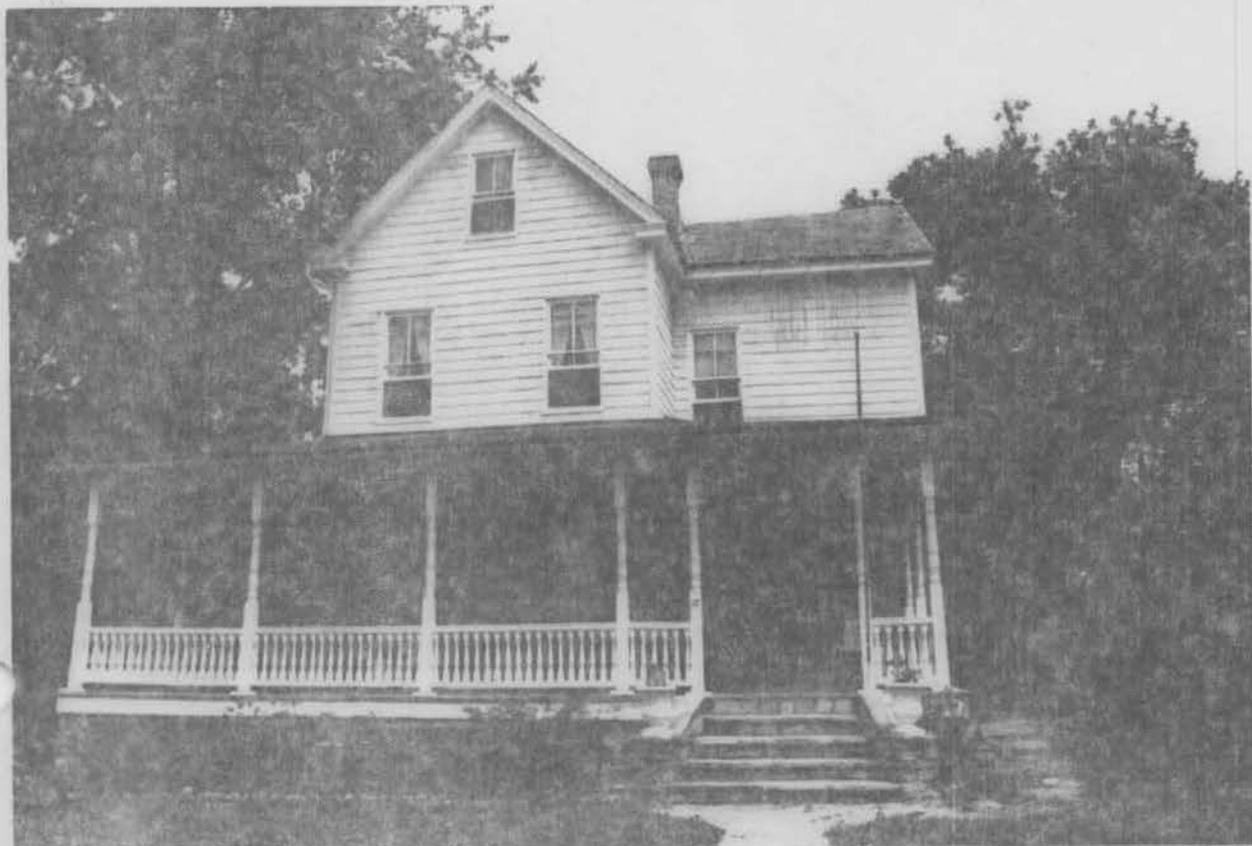
BELOW: South (Main) Facade

The entrance has recently been altered as was the window immediately to the right. A double door of lower inset square panels and upper rectangular arched panels is located at the top of the steps. Non-functional wood corbels decorate the door. A gothic arched stained glass window now appears to the right of the door where previously a double hung sash window stood. Two additional 2/2 sash windows appear on the first floor south facade. Three 2/2 sash windows are located on the second floor. The attic contains one 2/2 sash window.
