**MARYLAND HISTORICAL TRUST
DETERMINATION OF ELIGIBILITY FORM**

Property Name: Bloomsbury Avenue Gatehouse, Spring Grove Inventory Number: BA-2323
 Address: Spring Grove Hospital City: Catonsville Zip Code: _____
 County: Baltimore County USGS Topographic Map: Baltimore West
 Owner: DHMH Is the property being evaluated a district? yes
 Tax Parcel Number: _____ Tax Map Number: _____ Tax Account ID Number: _____
 Project: _____ Agency: _____
 Site visit by MHT staff: no yes Name: L. Bowlin, 1985 Date: _____

Bloomsbury Avenue Gatehouse

Maryland Historical Trust State Historic Sites Inventory Form

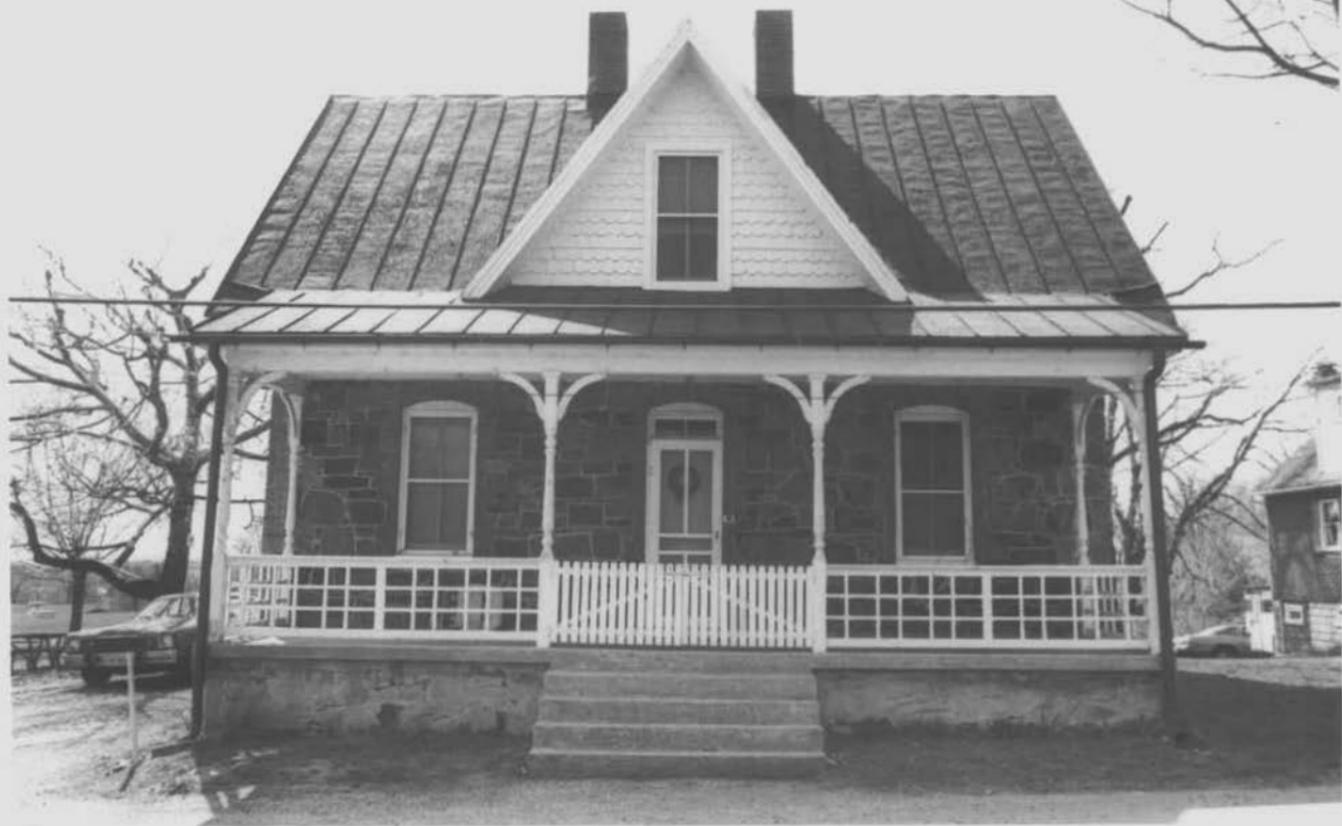
BA-2323

The northern facade is three bays wide, two bays deep. A wooden porch with a rubblestone foundation projects outward from the facade. The porch is framed by a wooden balustrade and turnposts. A simple design adorns these wooden elements. The porch has a wooden picket gate which opens to cement steps. The porch roof is tin as well.

The edges of rubblestone walls of the building have irregularly cut granite quoins. Though slightly darker in color, the quoins are difficult to distinguish from the rest of the rubblestone. Red bricks provide color contrast as they form Gibbs surrounds for the windows and door. A segmented arch lintel caps the openings. The 2/2 sash windows have wooden sills and surrounds. One window flanks each side of the doorway. The windows and the door have a carved wooden transom; the same design which matches the other transom on the gatehouses and the firehouse. The main door has an additional glass transom below the wooden detail. The entrance has both a screen door and a solid wooden door.

A cross gable juts out from the roof. Shiplap siding covers the face of the gable. Plain, exposed verges characterize the gable. There is a central window with a 2/2 sash. Two central, interior chimneys break the roof line just east of the gable. The individual chimneys are constructed of red brick.

NORTH WALL

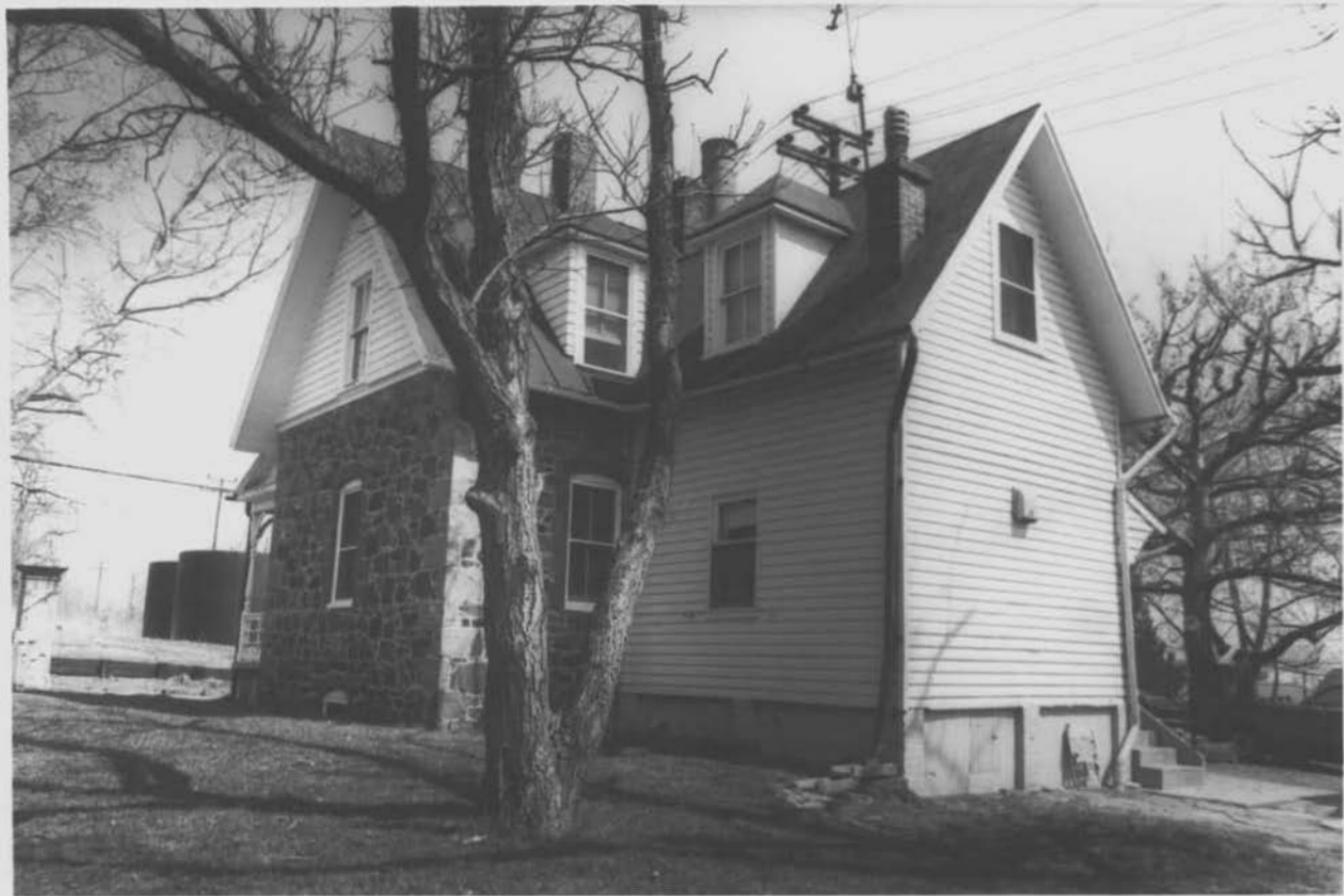
The architectural details of the western, eastern and southern faces of the rubblestone portion of the building are very similar. The ground level window wells have a two pane window with outer screens and the carved transom. A segmented arch brick lintel completes the description. The southeastern face reveals only the crest of the segmental arch lintel due to the wooden cellar entrance. The first floor windows have the same detail as the northern windows: Gibbs surround, wooden sill, carved transom, and segmented arch lintel. Shutter fixtures are visible. The west and east face have simple gabled ends with plain, projecting verges. The shiplap siding covers the gable ends. The centrally located windows have a 2/2 double-hung sash. They rest just below a triangular air vent. The louvered vent is formed by the peak of the gable. A hip dormer projects from the southern face. Built in clapboard siding, the dormer has a tin roof and 2/2 double-hung sash window with a simple wooden surround.

BA - 2323
BLOOMSBURY AVENUE GATEHOUSE
SPRING GROVE HOSPITAL CENTER
CATONSVILLE, MARYLAND
WEST AND SOUTH WALL
DON JEWELL, 4/86
NEGATIVES AT MHT
