**MARYLAND HISTORICAL TRUST
DETERMINATION OF ELIGIBILITY FORM**

Property Name: Tool House, Spring Grove Inventory Number: BA-2327
 Address: Spring Grove Hospital City: Catonsville Zip Code: _____
 County: Baltimore County USGS Topographic Map: Baltimore West
 Owner: DHMH Is the property being evaluated a district? yes
 Tax Parcel Number: _____ Tax Map Number: _____ Tax Account ID Number: _____
 Project: _____ Agency: _____
 Site visit by MHT staff: no yes Name: L. Bowlin, 1985 Date: _____
 Is the property is located within a historic district? yes no

Tool House, Spring Grove

Maryland Historical Trust State Historic Sites Inventory Form

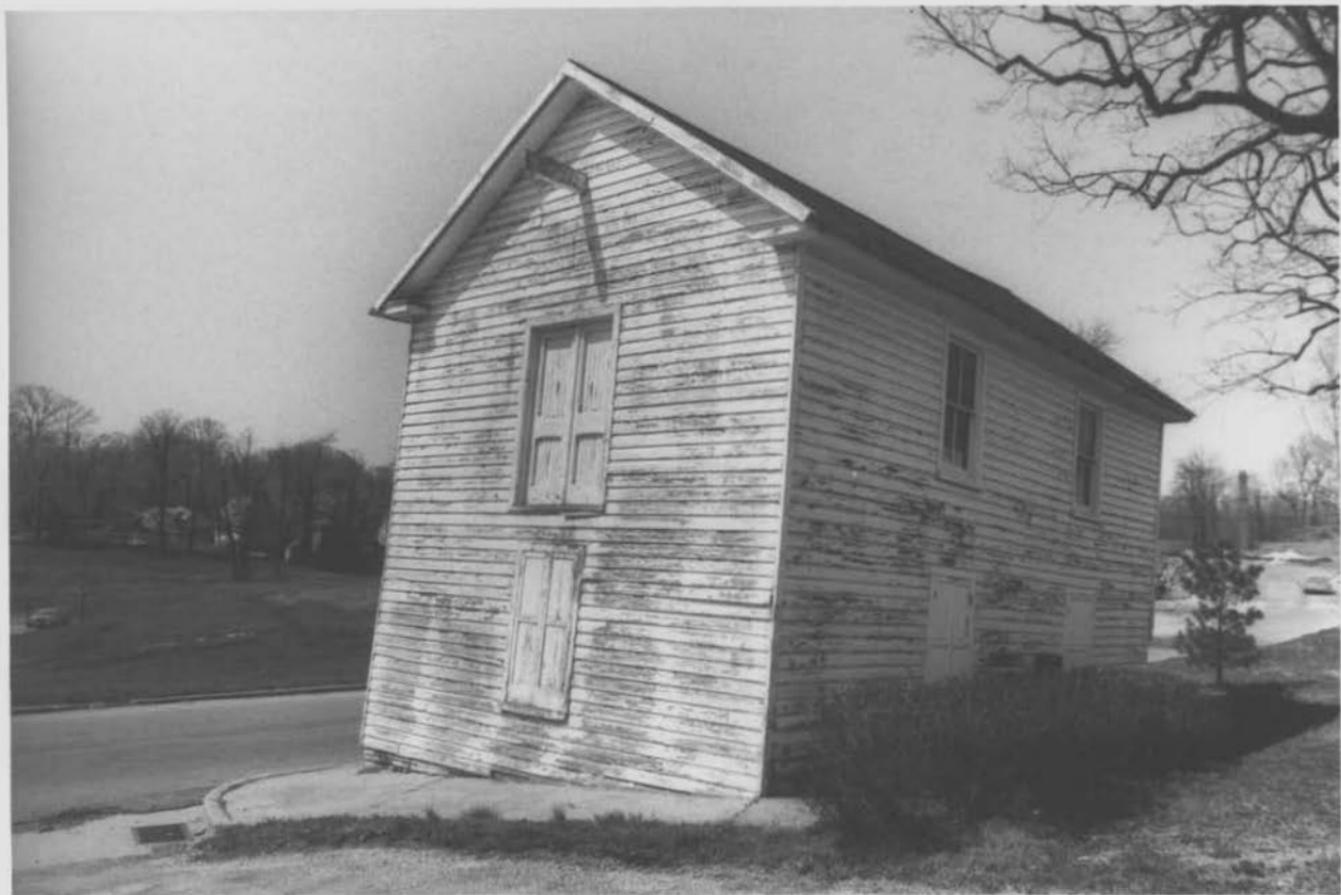
EAST AND NORTH WALL

The east and west faces exhibit simple gable ends with boxed returns and plain projecting verges. The west facade has a single, paneled door with a frame surround and a brick sill. The east face displays two centrally located openings. The first floor opening is a window with the standard treatment. The second floor opening is a double door, constructed of clapboard. Above the door, a pulley attached to a board projects away from the wall.
