INVENTORY FORM FOR STATE HISTORIC SITES SURVEY

**1 NAME**  
 HISTORIC OREGON FURNACE STORE

AND/OR COMMON KURTZ HOUSE

# OREGON FURNACE BUILDINGS

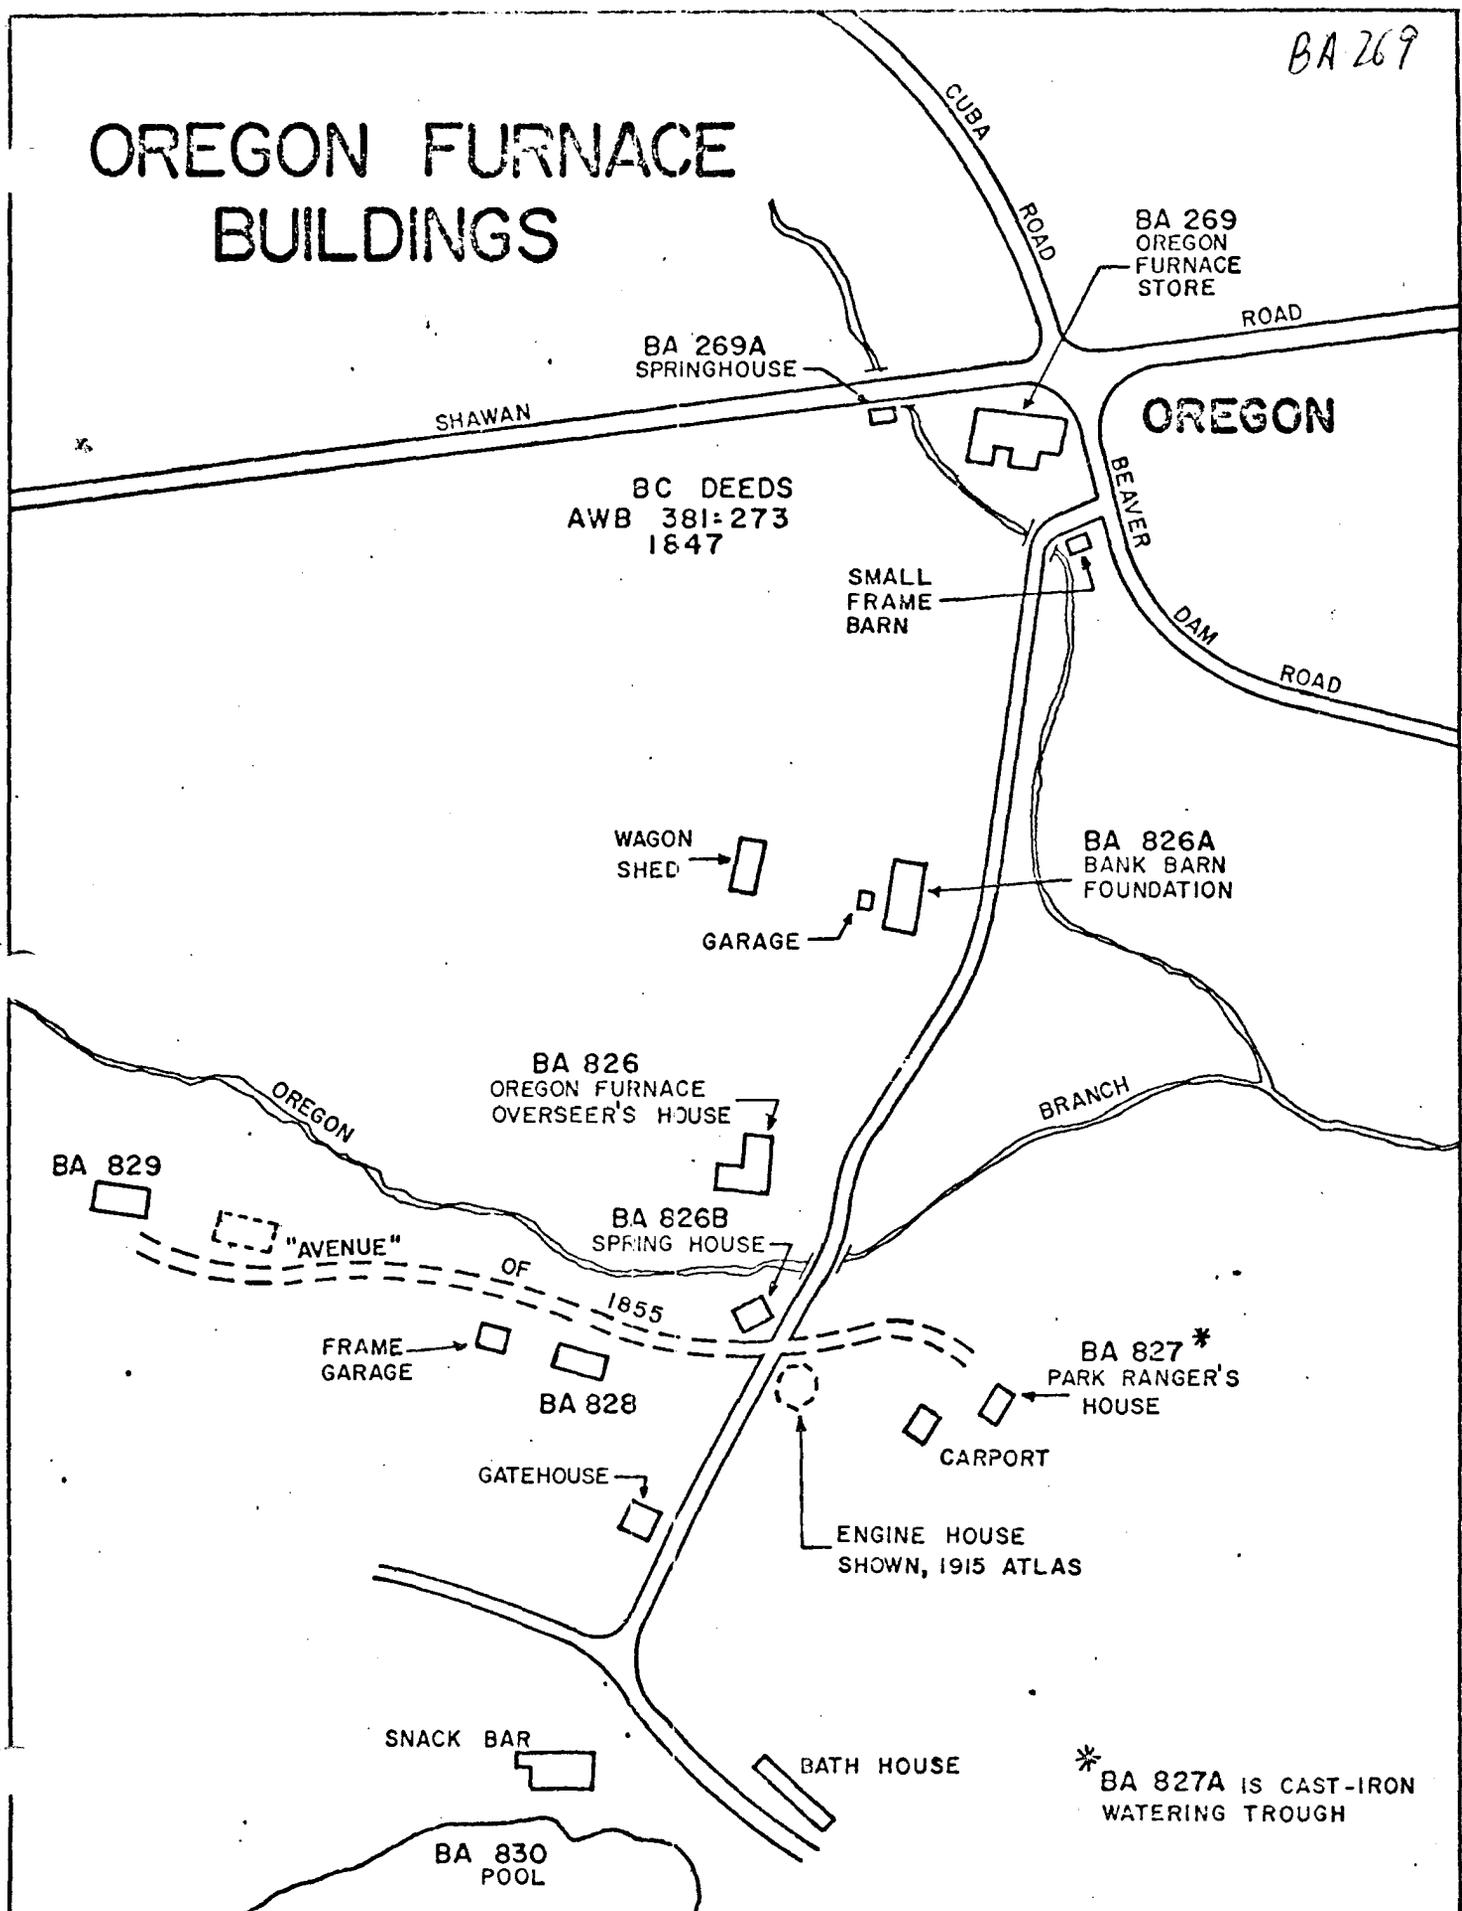
BA 269  
OREGON  
FURNACE  
STORE

BA 269A  
SPRINGHOUSE

BA 826A  
BANK BARN  
FOUNDATION

BA 826  
OREGON FURNACE  
OVERSEER'S HOUSE

ENGINE HOUSE  
SHOWN, 1915 ATLAS

BA 830  
POOL
