Maryland Inventory of Historic Properties number: BA-2707

MARYLAND INVENTORY OF HISTORIC BRIDGES
HISTORIC BRIDGE INVENTORY
MARYLAND STATE HIGHWAY ADMINISTRATION/
MARYLAND HISTORICAL TRUST

SHA Bridge No. B0108 Bridge name Roland Avenue over Roland Run

Bridge Type METAL GIRDER

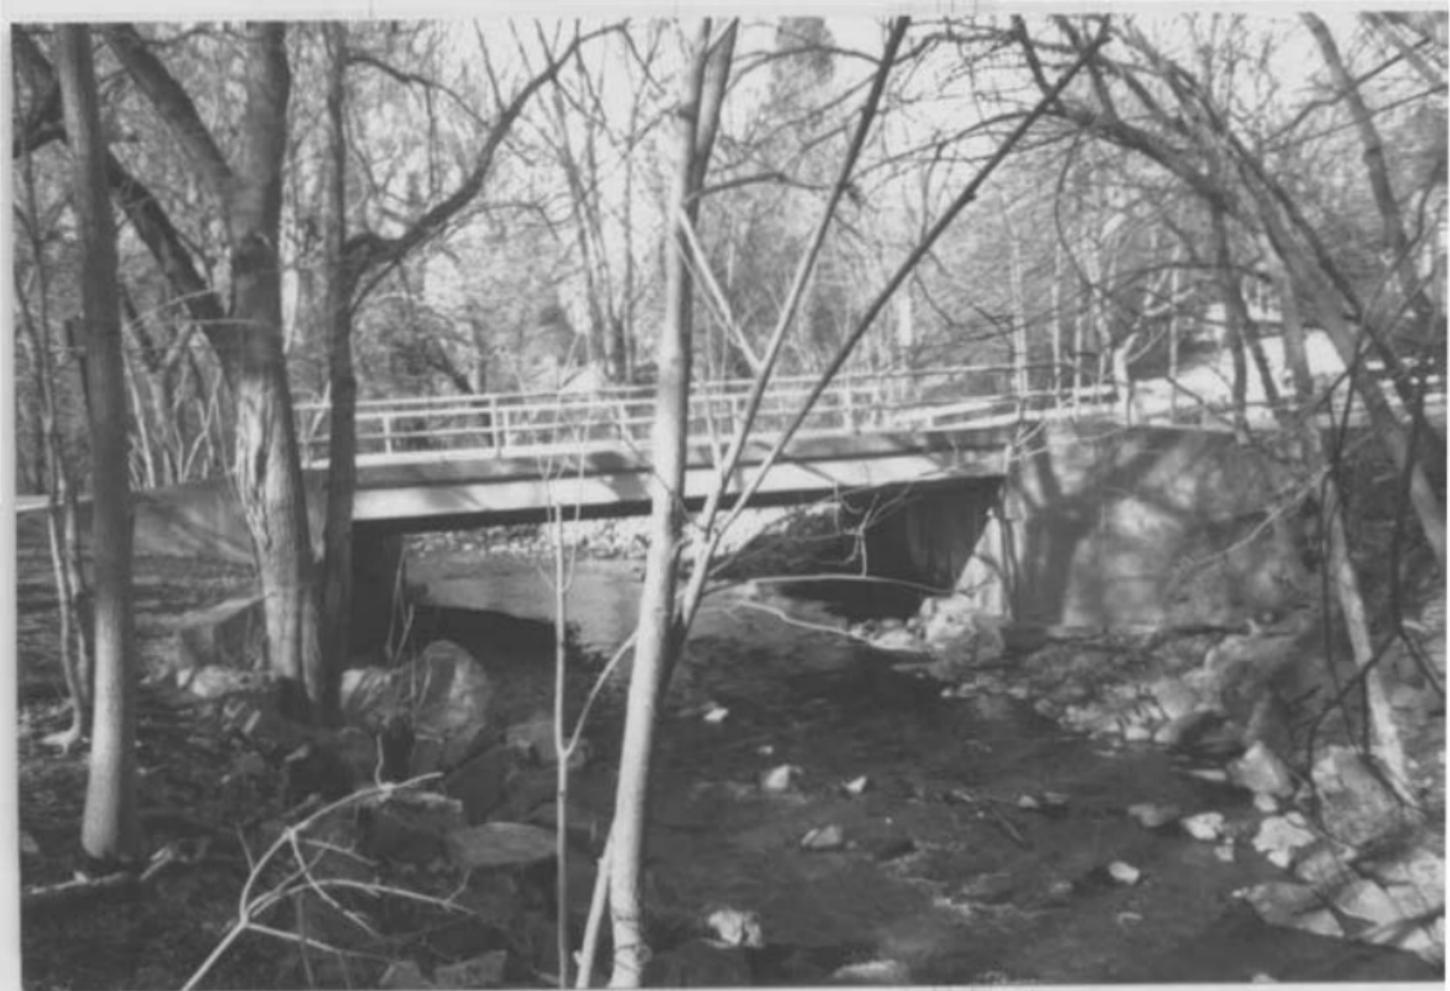
1. ~~BA~~-2707
2. Roland Ave over Roland Run
3. Balto. Co MD
4. Eric Huffitts
5. 3/97
6. MD SHPO
7. east approach
8. 1 of 6

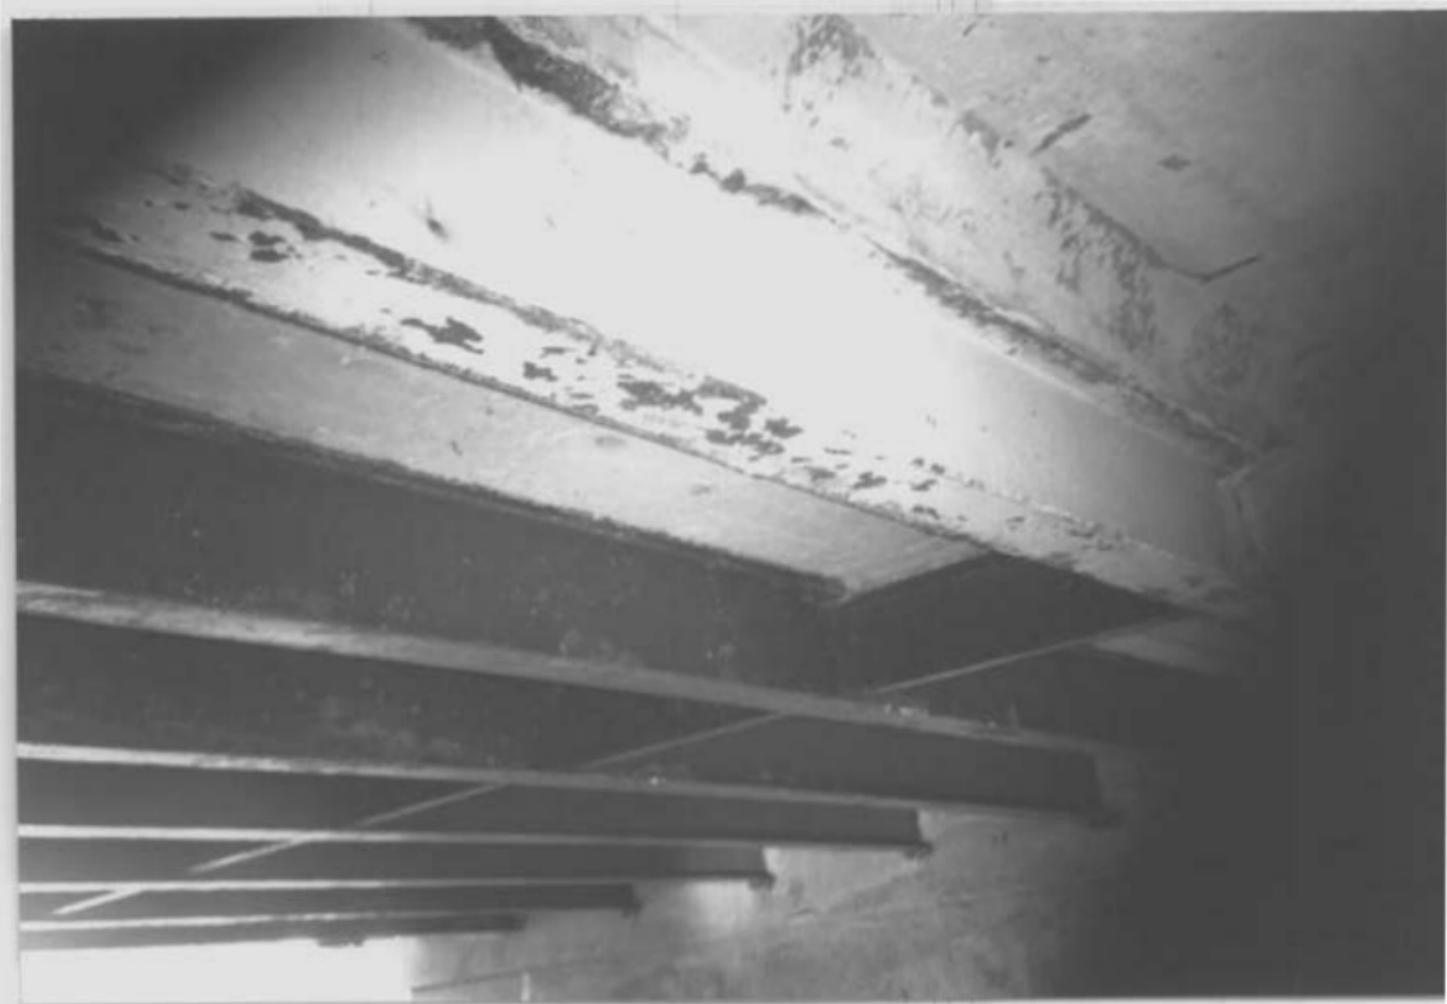
1. BA-2707
2. Roland Ave. over Roland Run
3. Baltimore Co. MD
4. Eric Gruffitts
5. 3/97
6. MD SHPO
7. west approach
8. 2 of 6

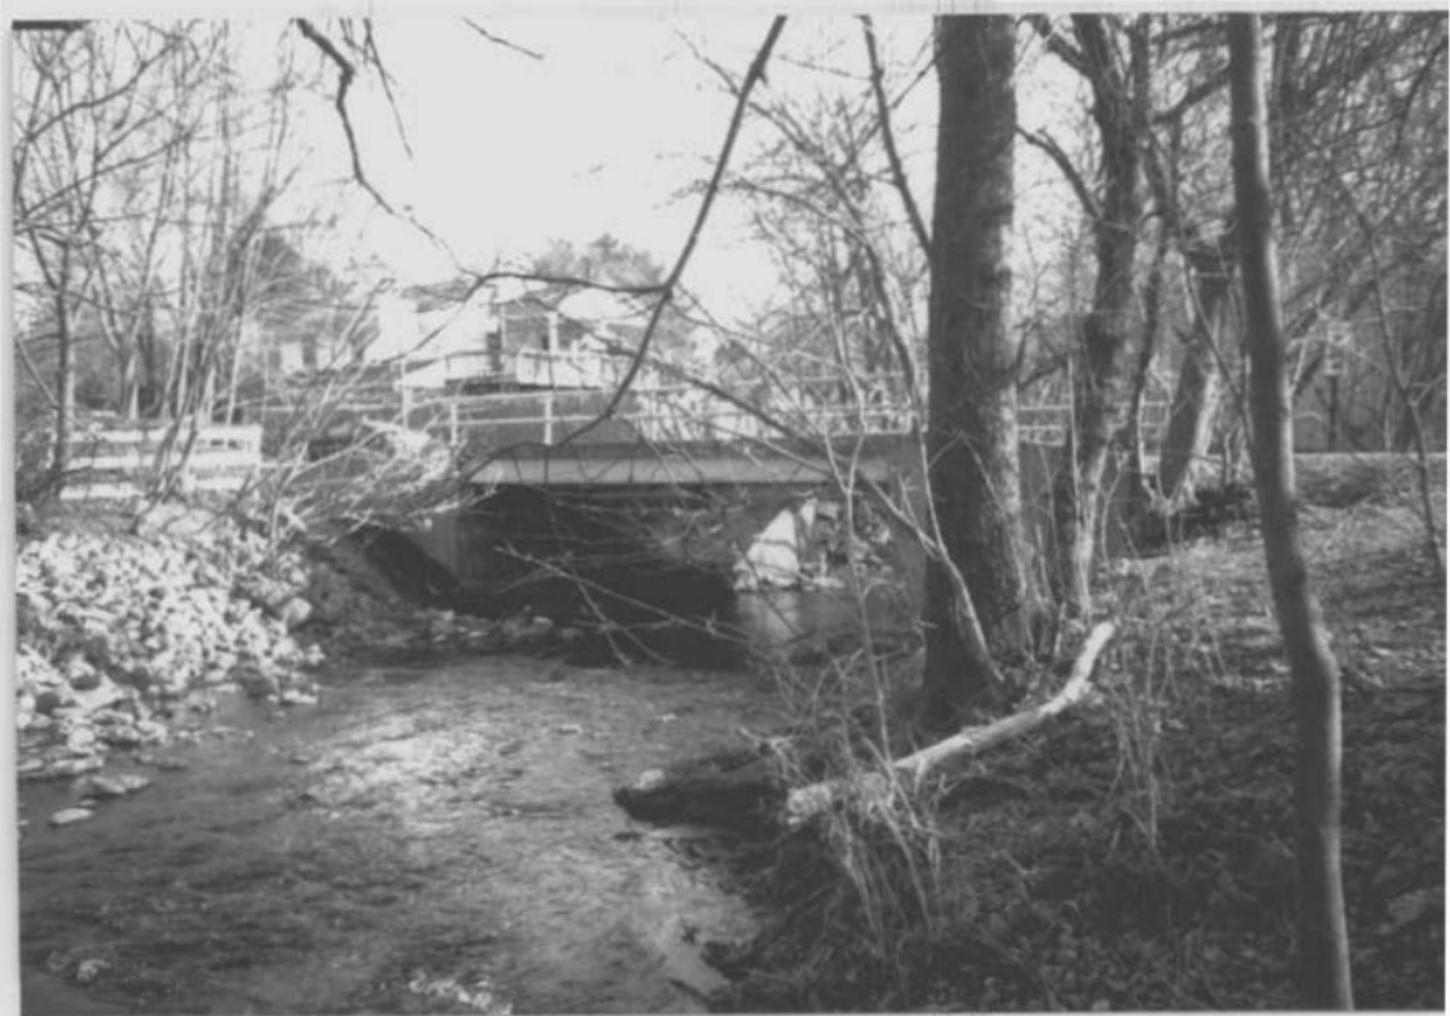
1. BA-2707
2. Roland Ave over Roland Run
3. Balto Co, MD
4. Eric Duffitts
5. 3/97
6. MD SHDO
7. south elevation
8. 3 of 6

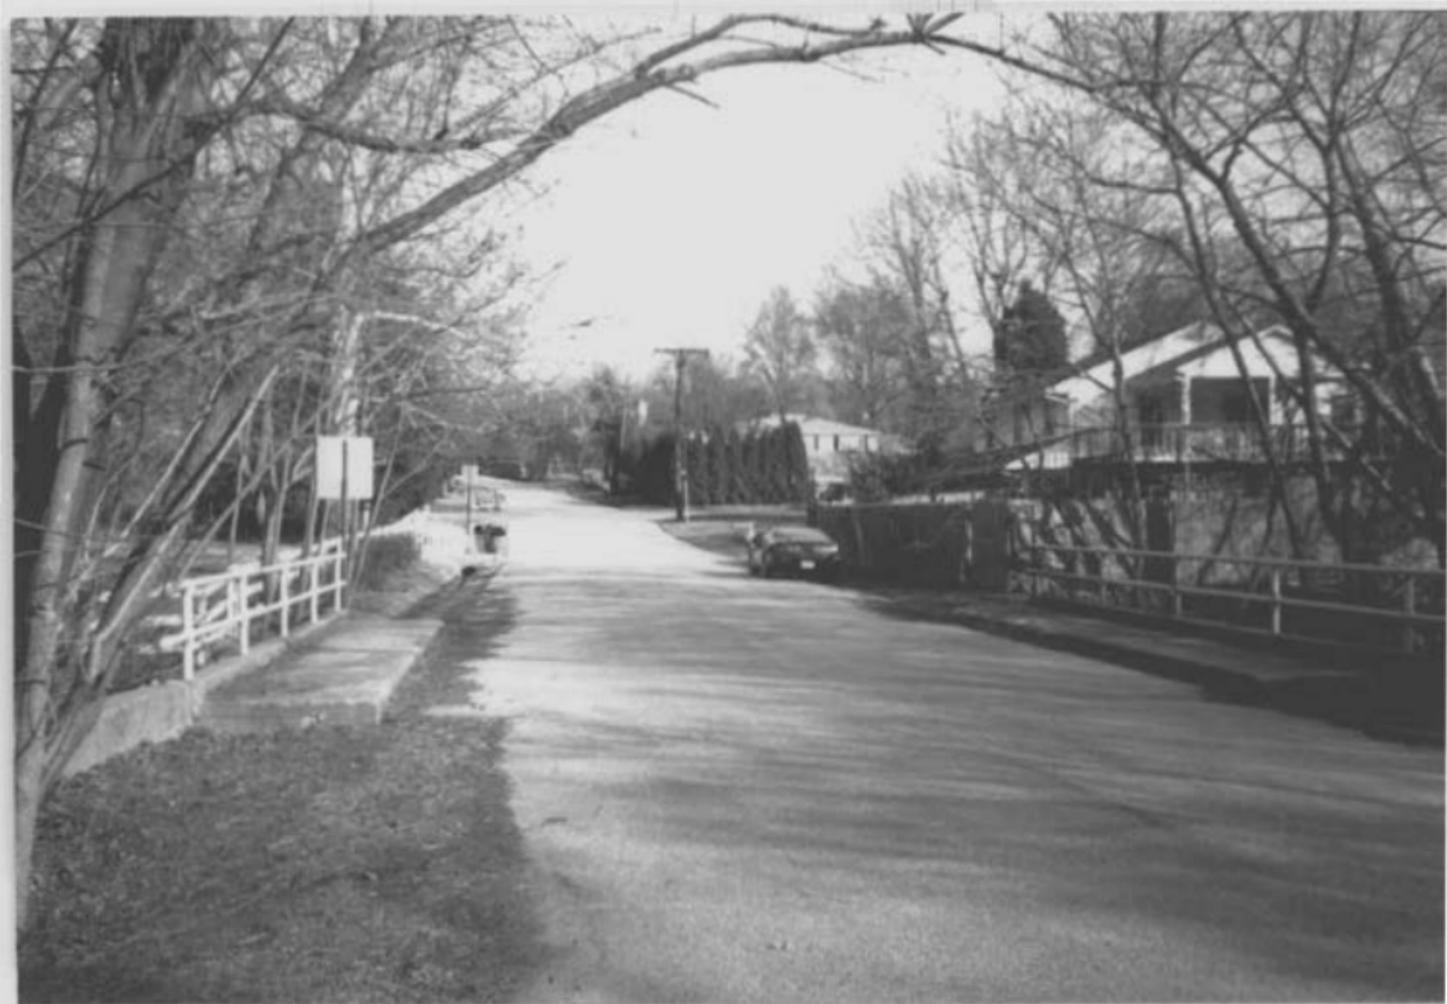
1. BA-2707
2. Roland Ave over Roland Run
3. Balto. Co. MD
4. Eric Griffiths
5. 3/97
6. MD SHPO
7. north elevation
8. 5 of 6

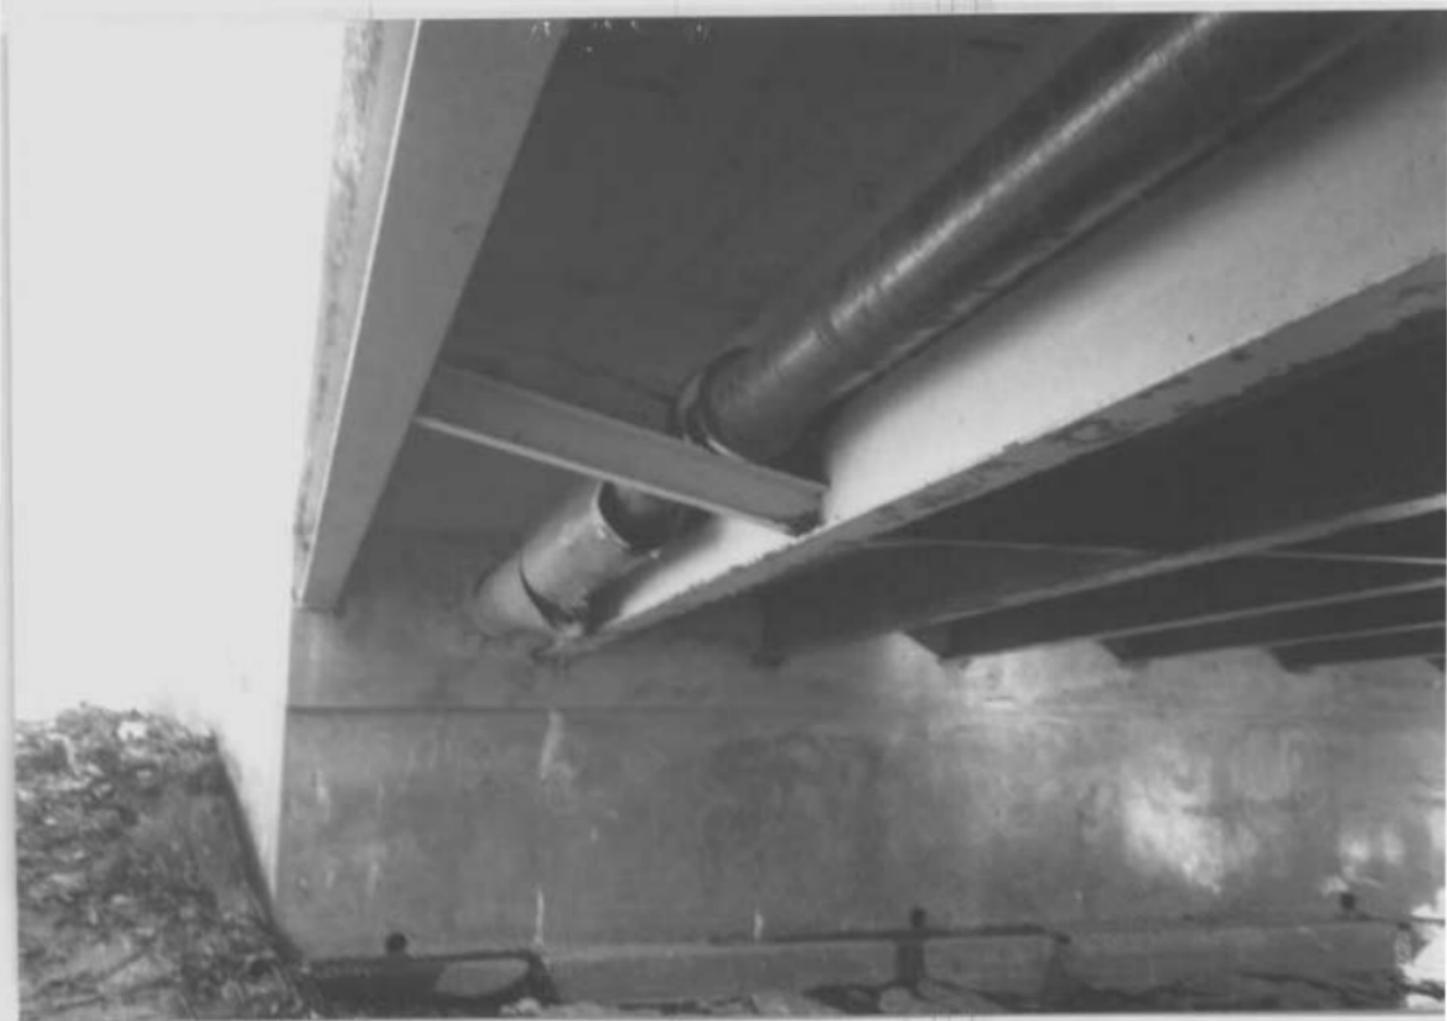
1. BA-2707
2. Roland Ave over Roland Run
3. Balto. Co, MD
4. Eric Griffiths
5. 3/97
6. MD SHPO
7. SW wing wall
8. 6 of 6
