Maryland Inventory of Historic Properties number: PA-2711

Name: Belmont Ave. over Del. Run.

Maryland Inventory of Historic Properties
Historic Bridge Inventory
Maryland State Highway Administration
Maryland Historical Trust

MHT Number BA-2711

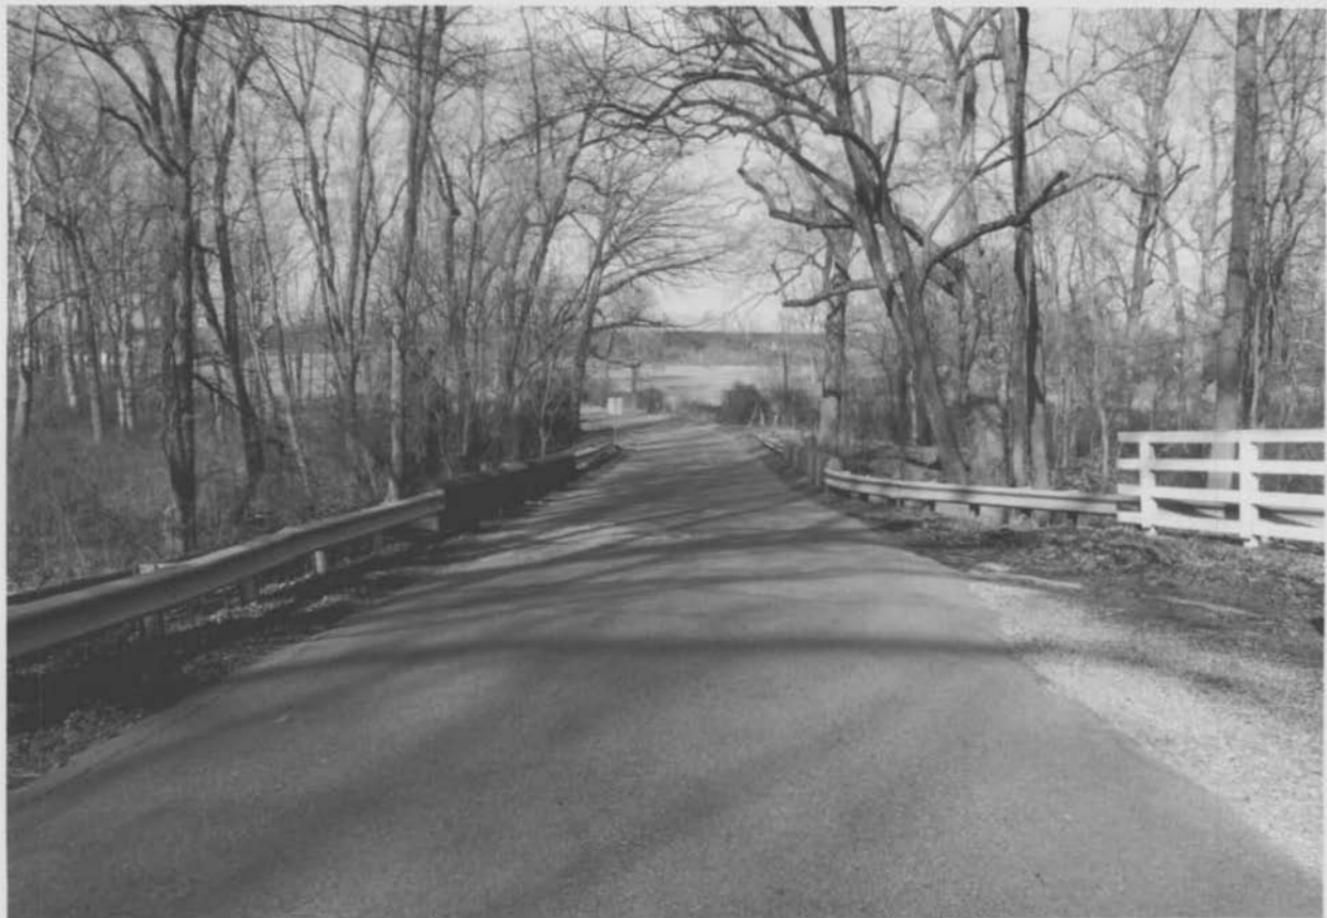
- 1 BA-2711
- 2 (B0178) Belmont Ave. over Delaware Run
- 3 Baltimore County, Md.
- 4 D. Dierck
- 5 1/95
- 6 MD 5470
- 7 South Approach Looking North
- 8 105 3

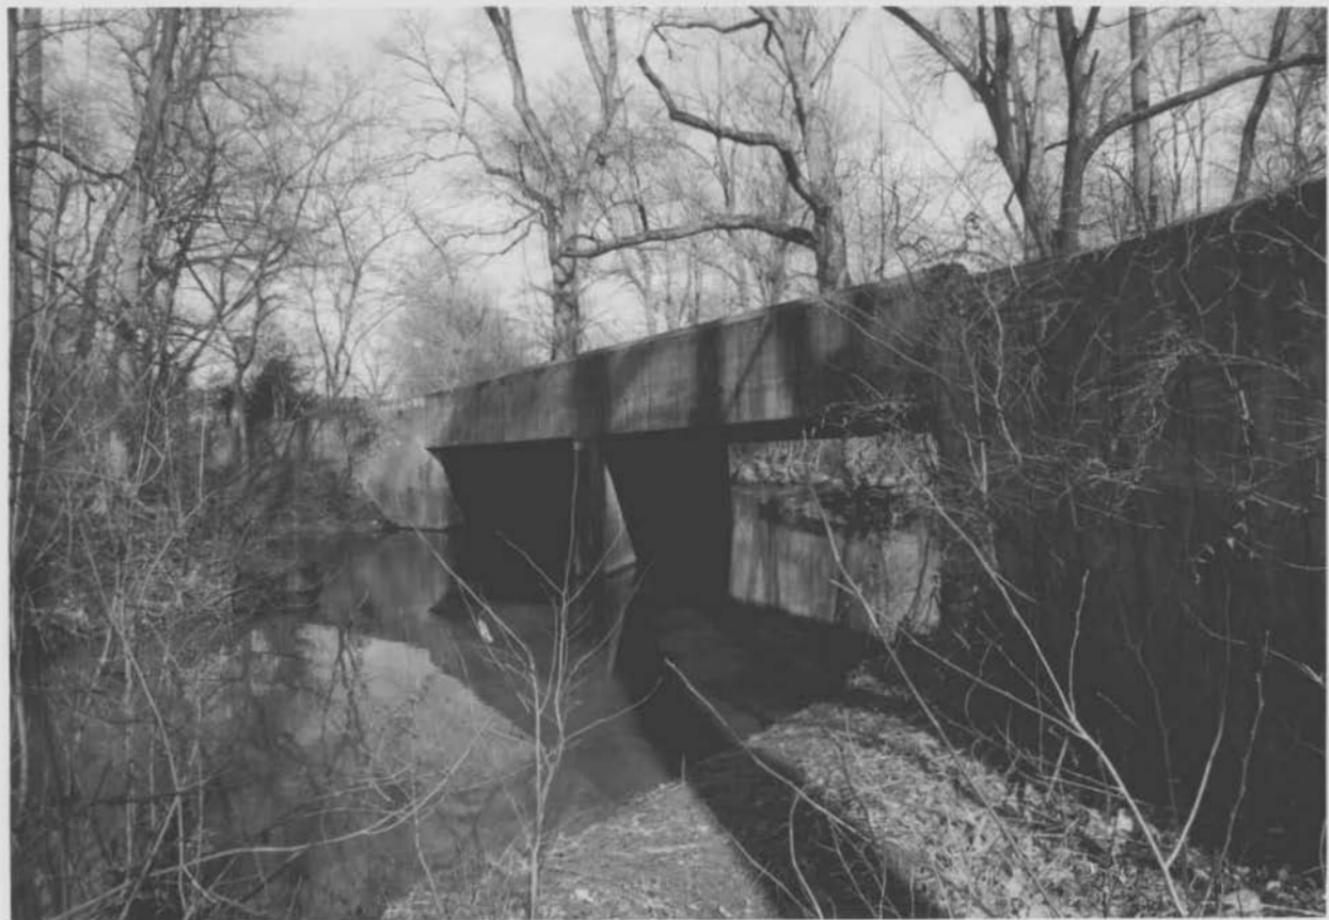
8 2 of 3

7 West Elevation Looking NORTHEAST

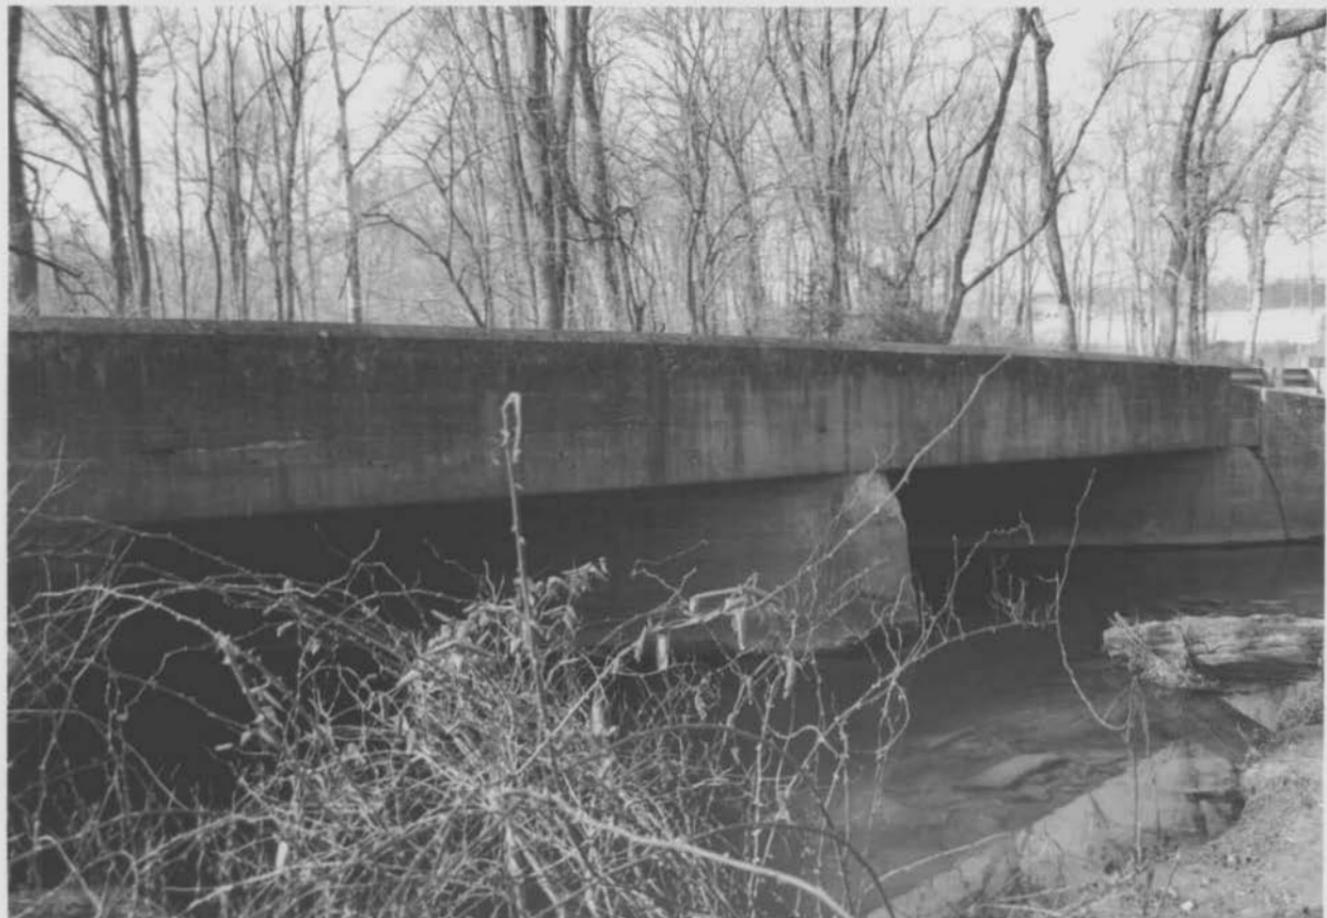
- 1 BA-2711
- 2 (B-0178) BELMONT Ave over Delaware R.R.
- 3 Baltimore County, MD
- 4 D. Dickl
- 5 1195
- 6 MD SHPO
- 7 EAST ELEVATION Locking NORTHWEST
- 8 3 of 3
