Maryland Inventory of Historic Properties number: BA-2780
Name: Up Over Sulphur Springs Rd.

MARYLAND INVENTORY OF HISTORIC BRIDGES
HISTORIC BRIDGE INVENTORY
MARYLAND STATE HIGHWAY ADMINISTRATION/
MARYLAND HISTORICAL TRUST

SHA Bridge No. 3005 Bridge name US 1 over Sulphur Springs Road

Bridge Type METAL GIRDER
 MHT # BA-2780
 Map BALTIMORE SW D-12
 County BALTIMORE
 Bridge # and name 3005
 US 1 OVER SULPHUR SPRING ROAD

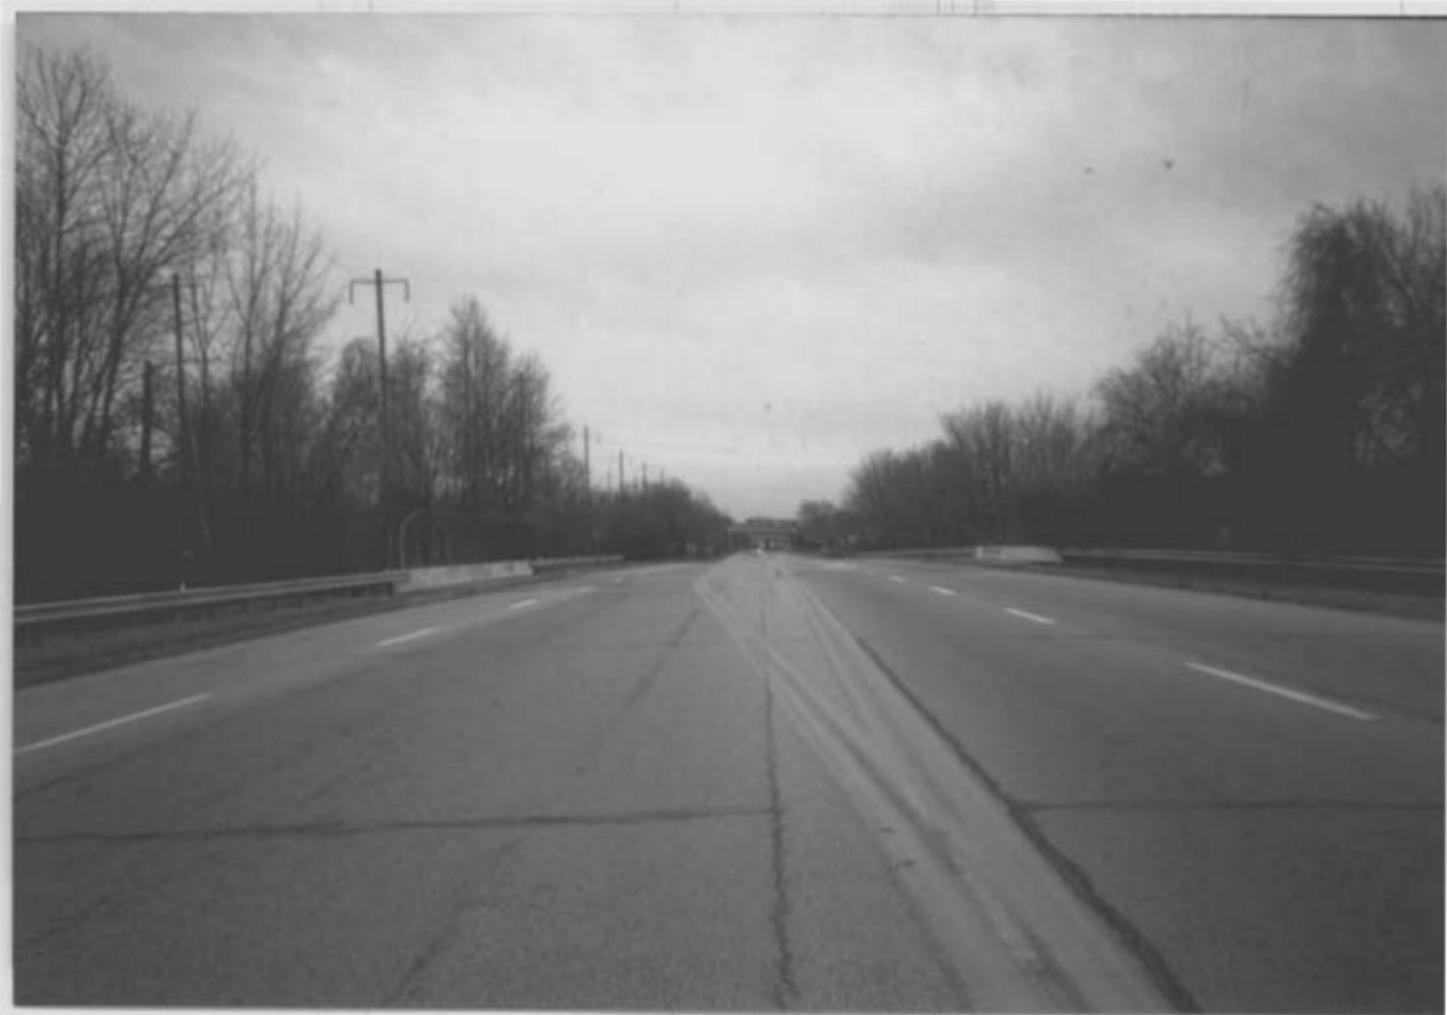
8. 2 of 6

7. south approach

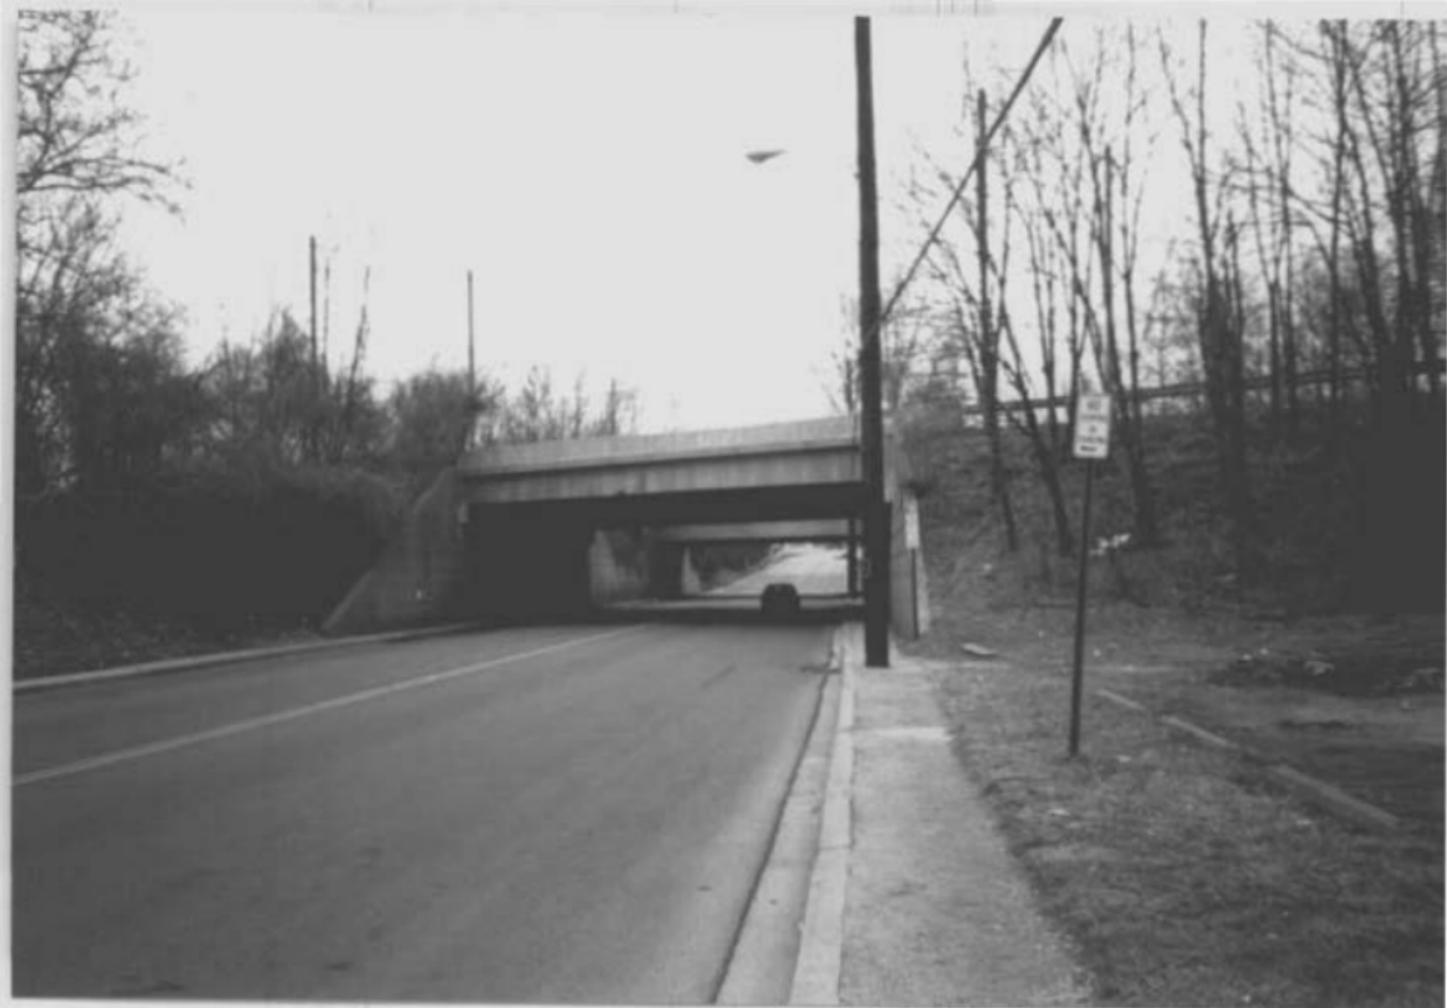
8. 3 of 6

7. west elevation

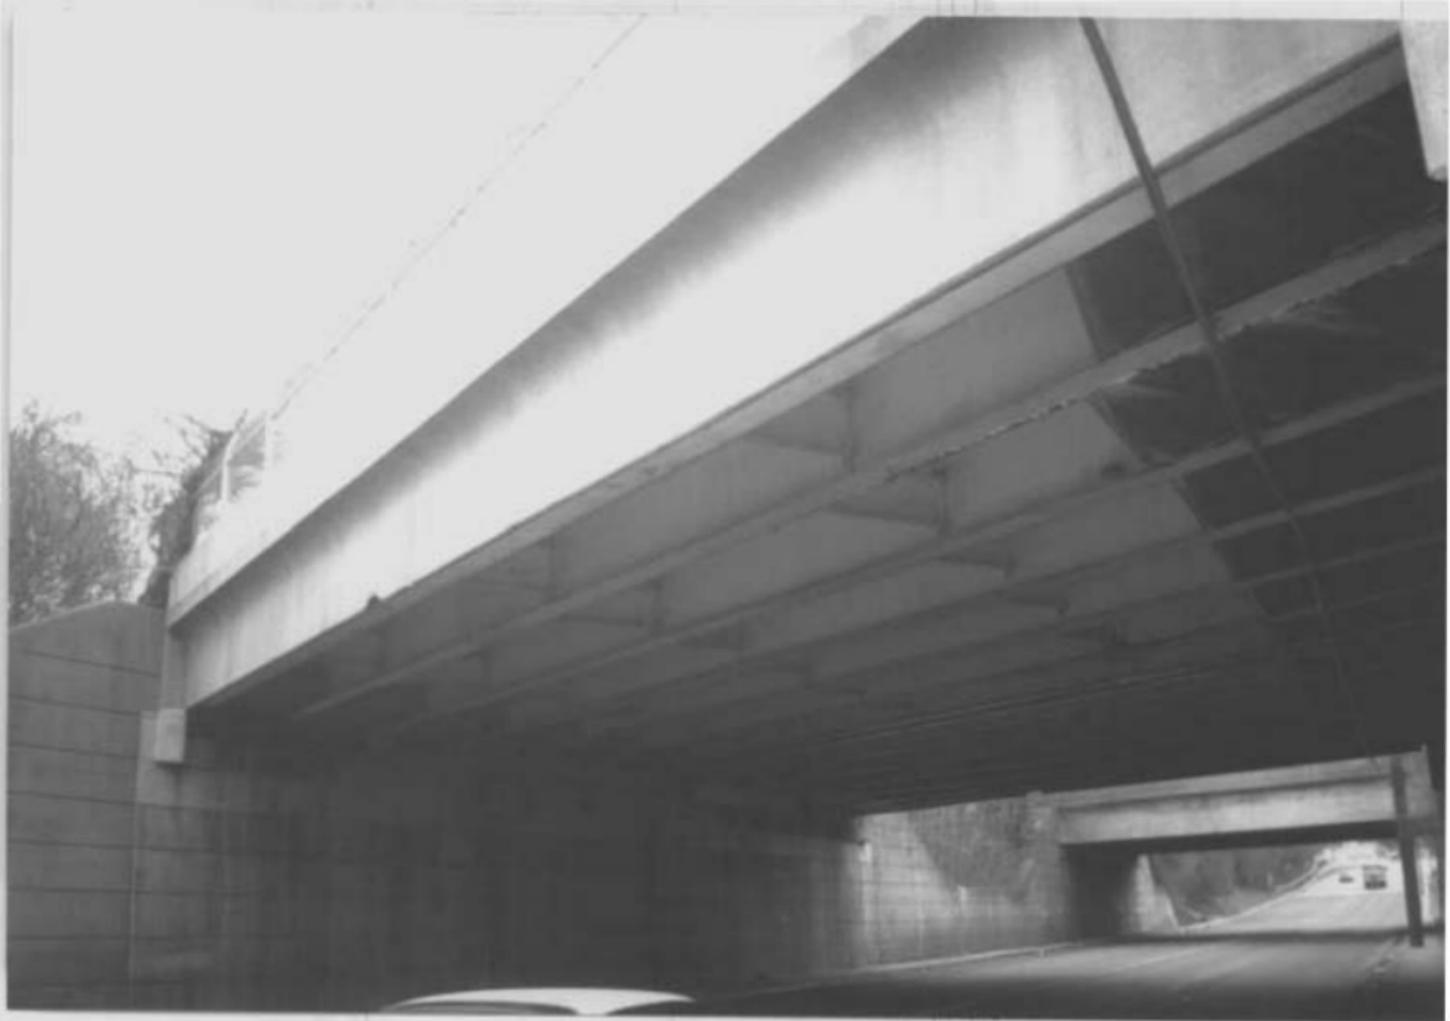
According to the 1996 inspection report, this structure is in fair condition with minor section loss, cracking, spalling, and scour. The asphalt wearing surface has several patches and irregular cracking. The concrete has vertical and irregular cracking in the abutments and wing walls. The south abutment has a large spall at the top with exposed reinforcing bars. The I-beams all have peeling paint and areas of moderate rust. Beams 7 and 8 have heavy rust, scale, and pitting. The fixed bearings have heavy rust with some scale, pitting, and section loss. The concrete parapet is in good condition, but has fine vertical cracking.

1. BA-2780
2. US 1 over Sulphur Spring Rd.
3. Baltimore County
4. Eric Griffiths
5. 3/97
6. MD SHPO
7. girder detail + north abutment
8. 4 of 6

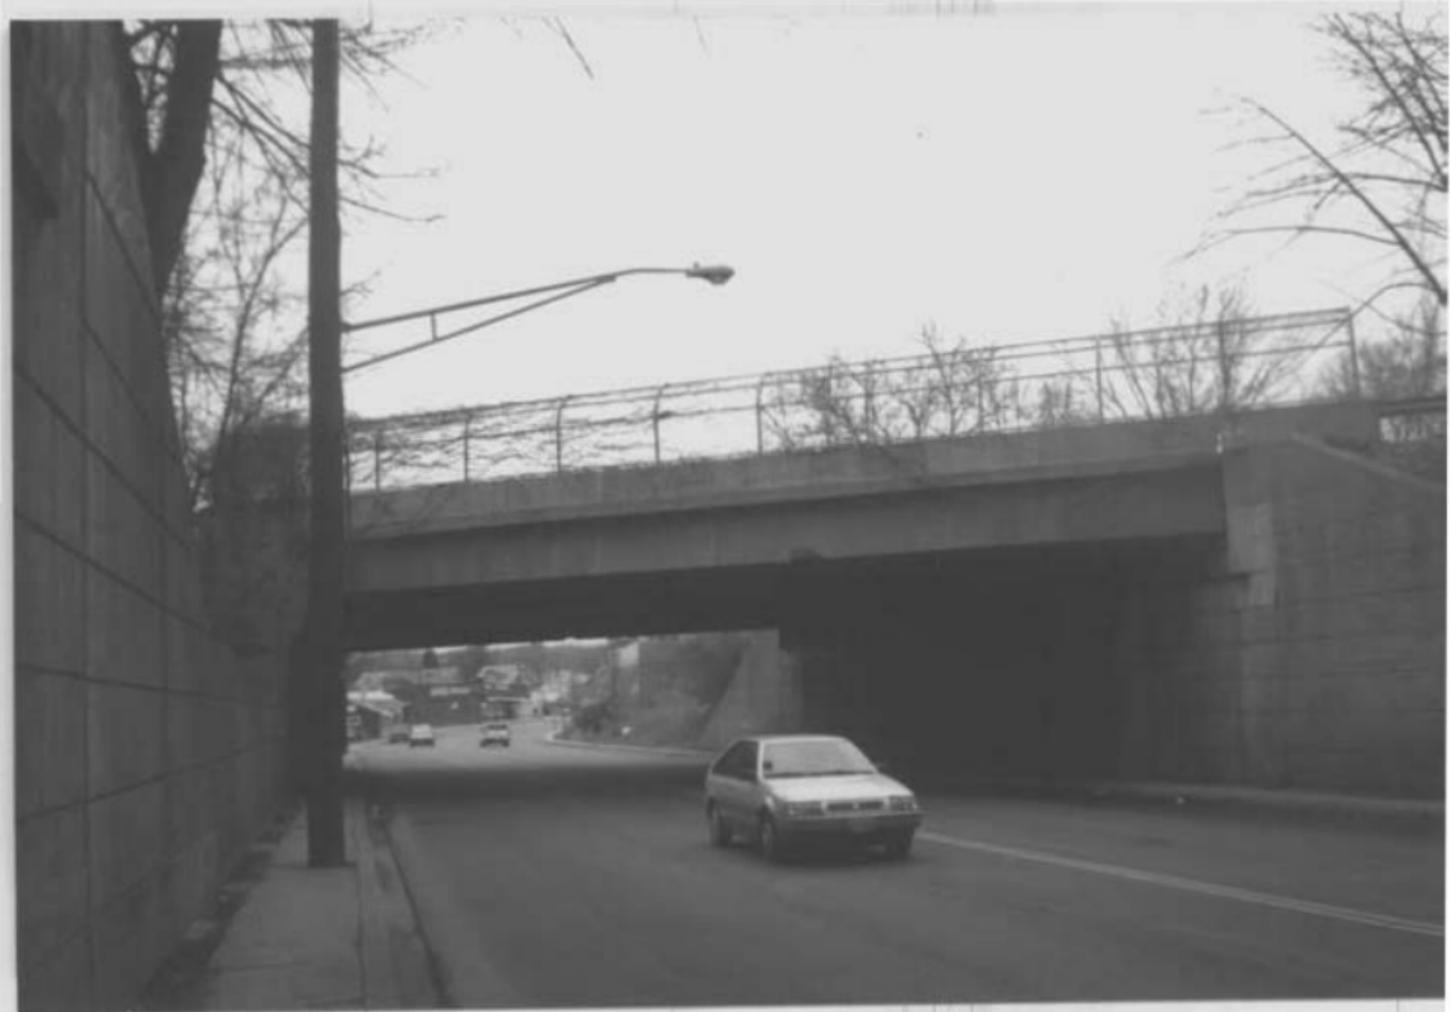
1. BA-2780
2. US 1 over Sulphur Spring Rd
3. Baltimore County
4. Eric Guffitts
5. 3/97
6. MD SHPD
7. east elevation
8. 5 of 6

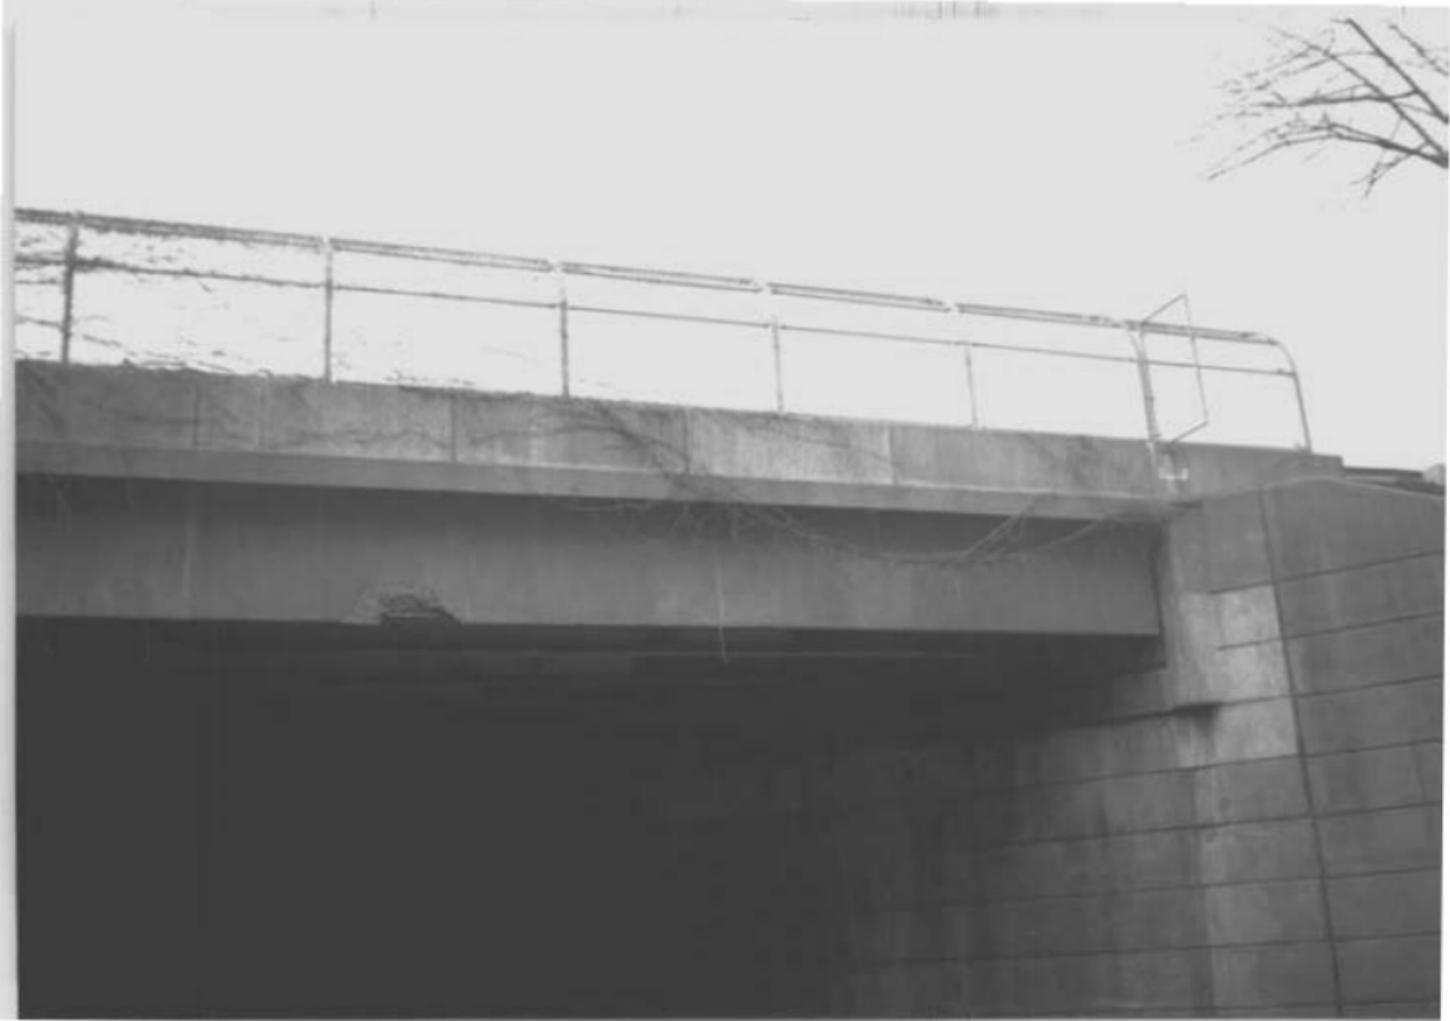
Reconstruction plans of the bridge from 1978 indicate that the bridge originally had solid panel parapets, which were removed and replaced with modern concrete parapets with a pedestrian barrier in 1978.

1. BA - 2780
2. US 1 over Sulphur Spring Rd
3. Baltimore County
4. Eric Shuffitts
5. 3/97
6. MD SHAD
7. detail of parapet
8. 6 of 6
