Maryland Historical Trust

Maryland Inventory of Historic Properties number: BA-2785

Name: 3045/ MD88 over Indian Run

SHA Bridge No. 3045 Bridge name MD 88 over Indian Run

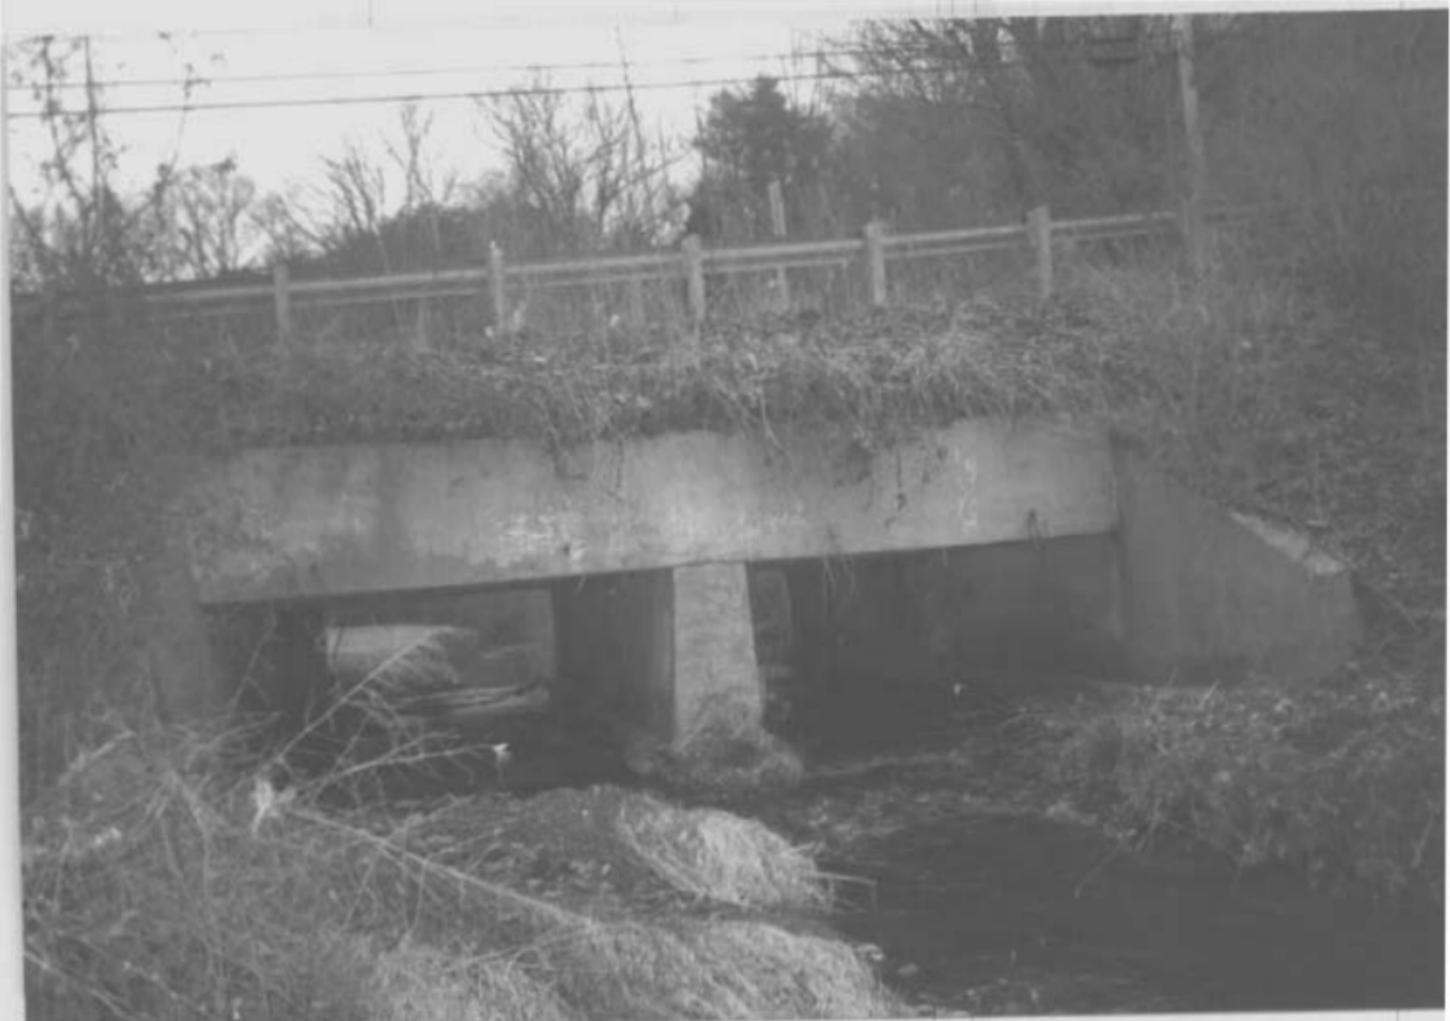
8. 1 of 5

7. south elevation

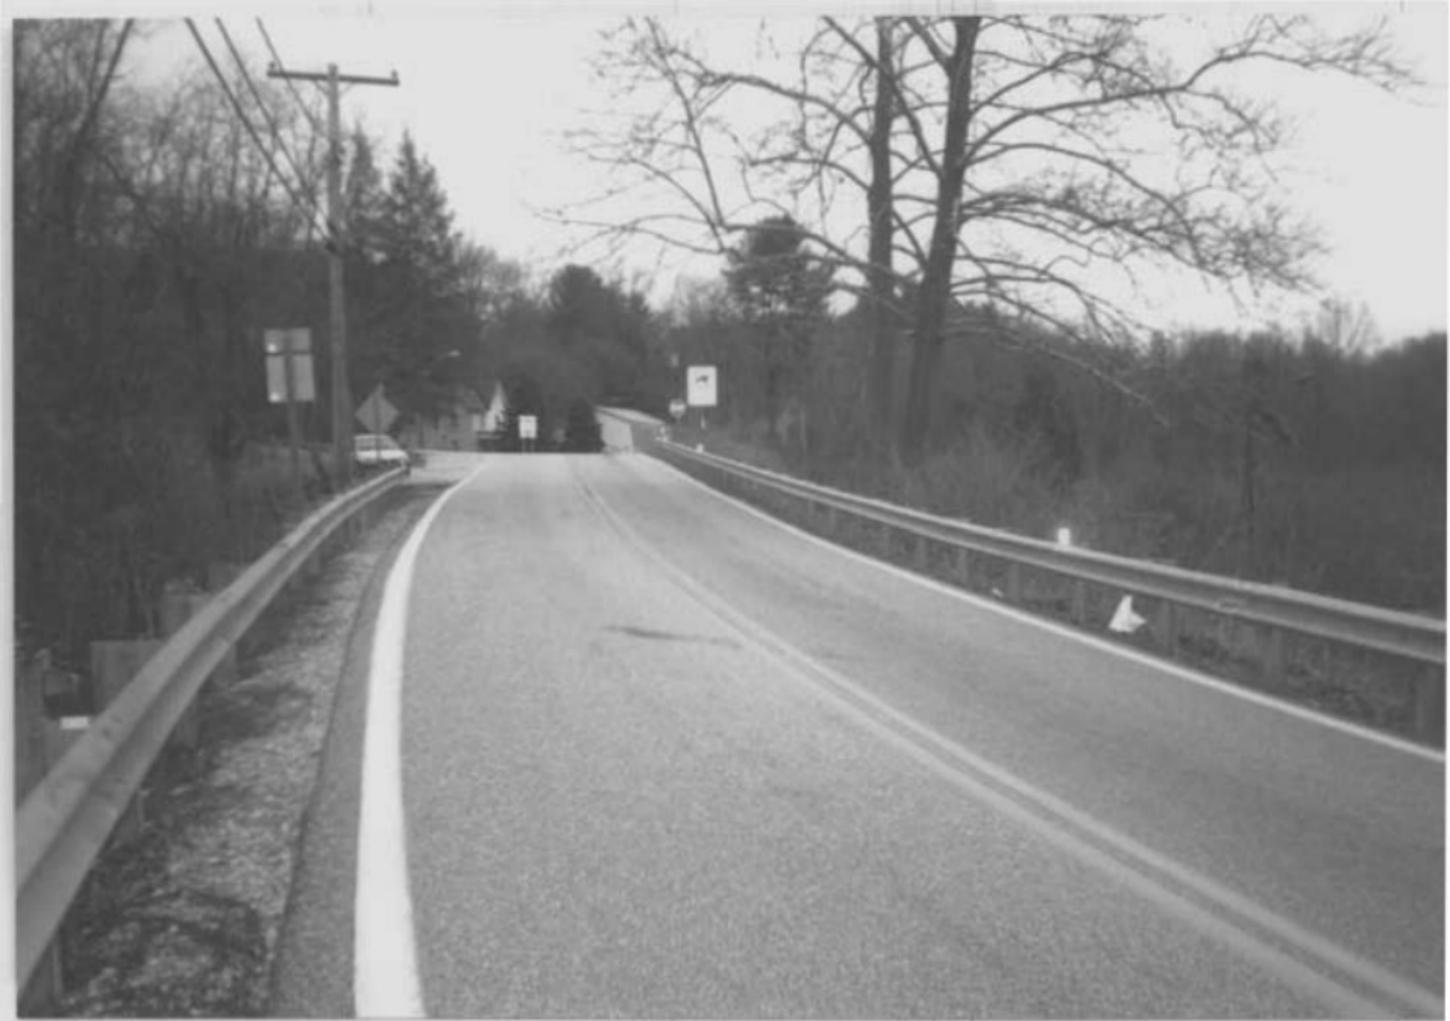
1. BA - 2785
2. MD 88 over Indian Run (3045)
3. Baltimore County
4. Eric Griffiths
5. 3/97
6. MD SHPO
7. east approach
8. 2 of 5

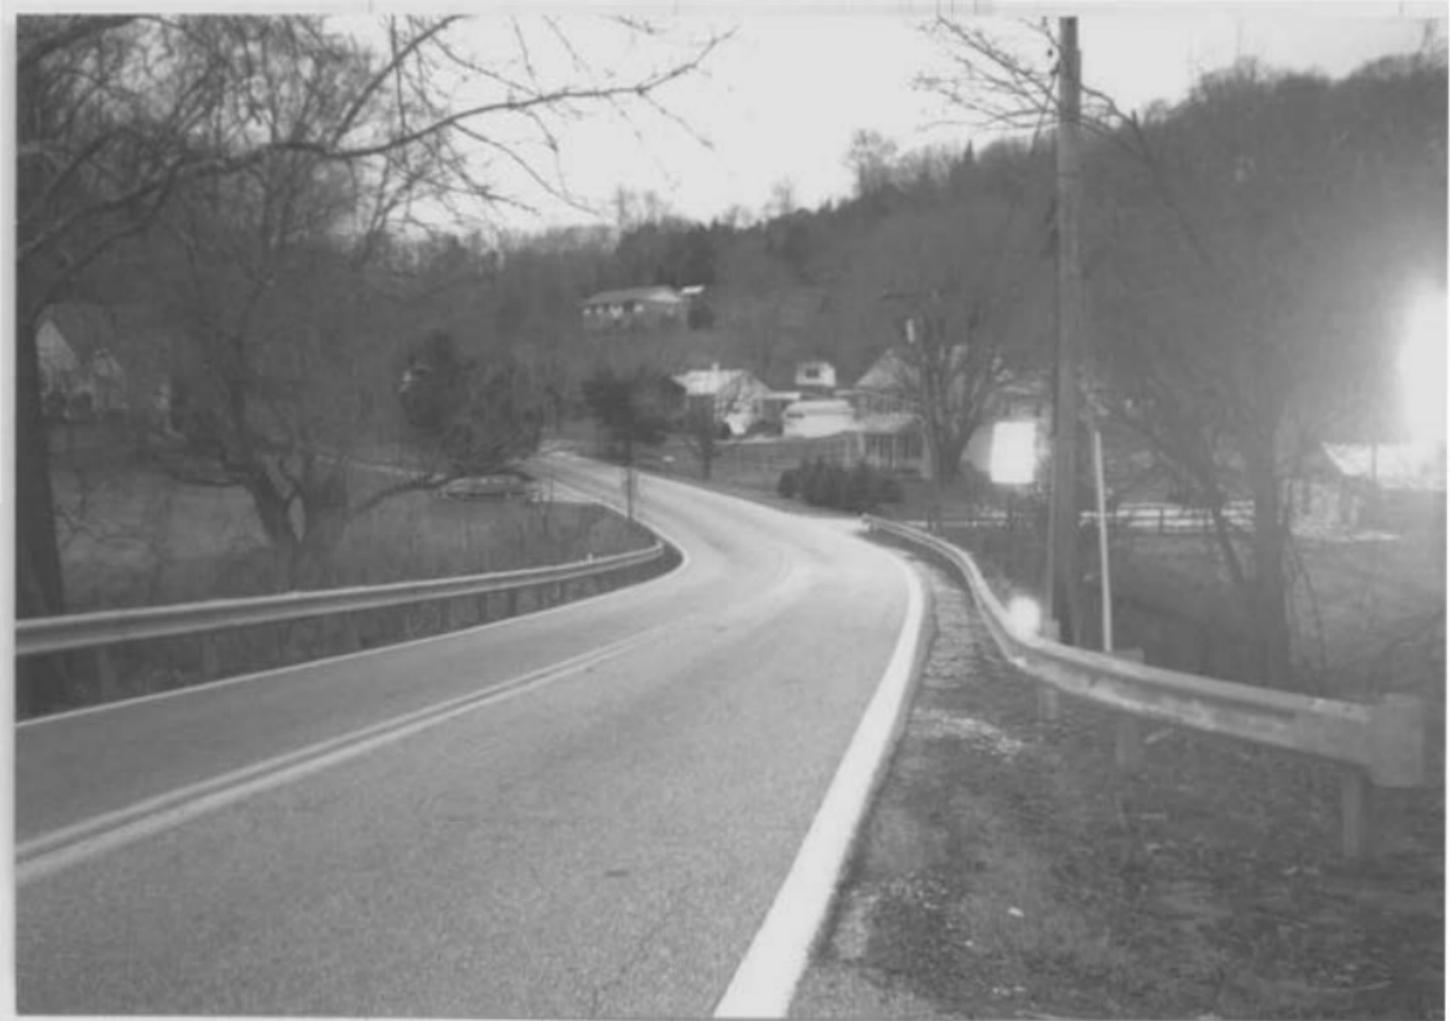
1. BA-2785
2. MD 88 over Indian Run
(3045)
3. Baltimore County
4. Eric Griffitts
5. 3/97
6. MD SHPO
7. west approach
8. 3 of 5

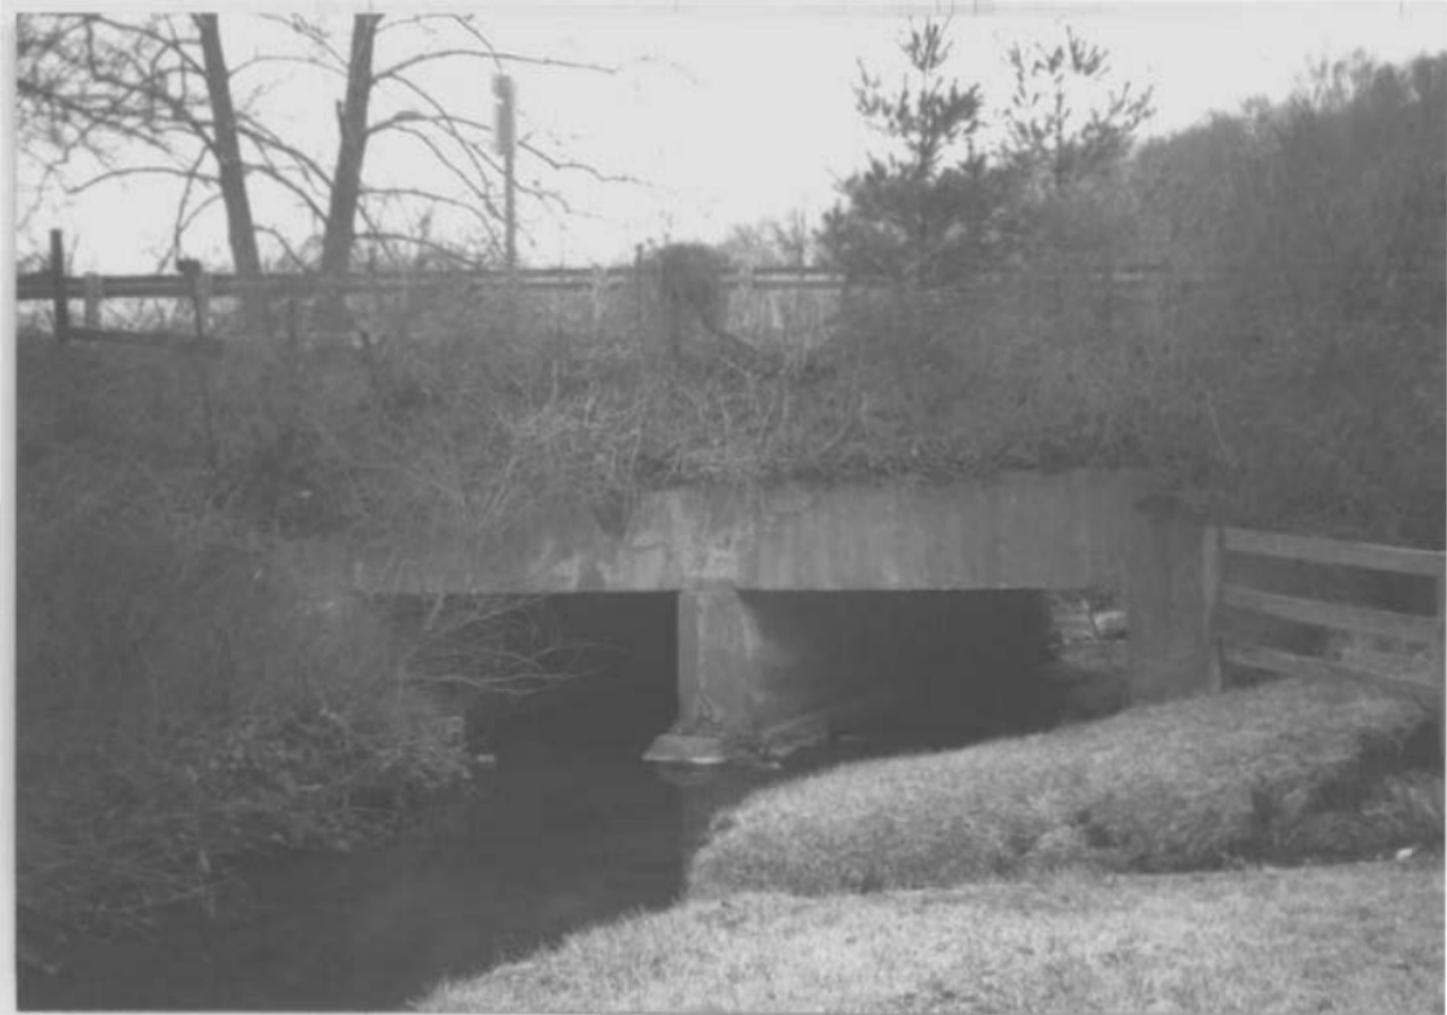
1. BA-2785
2. MD 88 over Indian Run
(3045)
3. Baltimore County
4. Eric Shuffitts
5. 3/97
6. MD SHPO
7. north elevation
8. 4 of 5

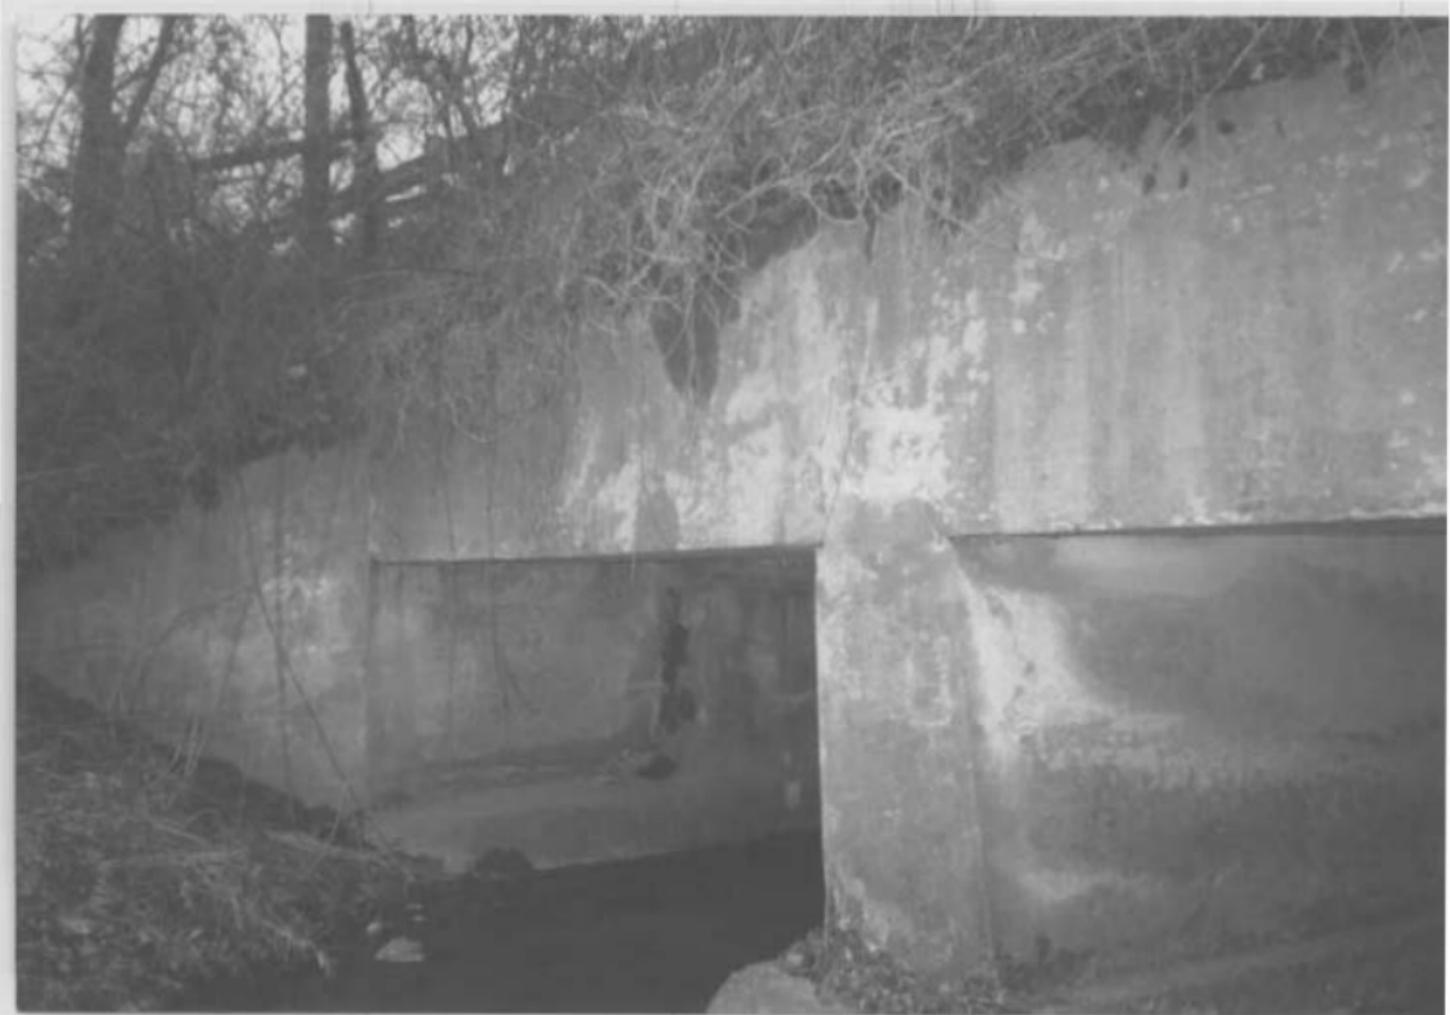
According to the 1996 inspection report, this structure is in fair condition with minor section loss, cracking, and spalling. The concrete slab has light scale and fine irregular cracks. The asphalt wearing surface has some minor cracking. The concrete in the abutments has vertical and irregular cracks and heavy spalling with large aggregate exposed. The wing walls have some fine irregular cracks and light scale.

The bridge retains the character-defining elements of its type, as defined by the Statewide Historic Bridge Context, including the slab, abutments, wing walls, and pier. However, severe deterioration of the abutments has compromised the integrity of this element.

1. BA-2785
2. MD 88 over Indian Run
3. Baltimore County (3045)
4. Eric Greffitts
5. 3/97
6. MD SHPO
7. detail of slab & east abutment
8. 5 of 5
