Maryland Inventory of Historic Properties number: BA-2812

Name: Piney Grove Rd. over CSX Railroad

MARYLAND INVENTORY OF HISTORIC BRIDGES
HISTORIC BRIDGE INVENTORY
MARYLAND STATE HIGHWAY ADMINISTRATION/
MARYLAND HISTORICAL TRUST

SHA Bridge No. B 0140 Bridge name Piney Grove Road over CSX Railroad

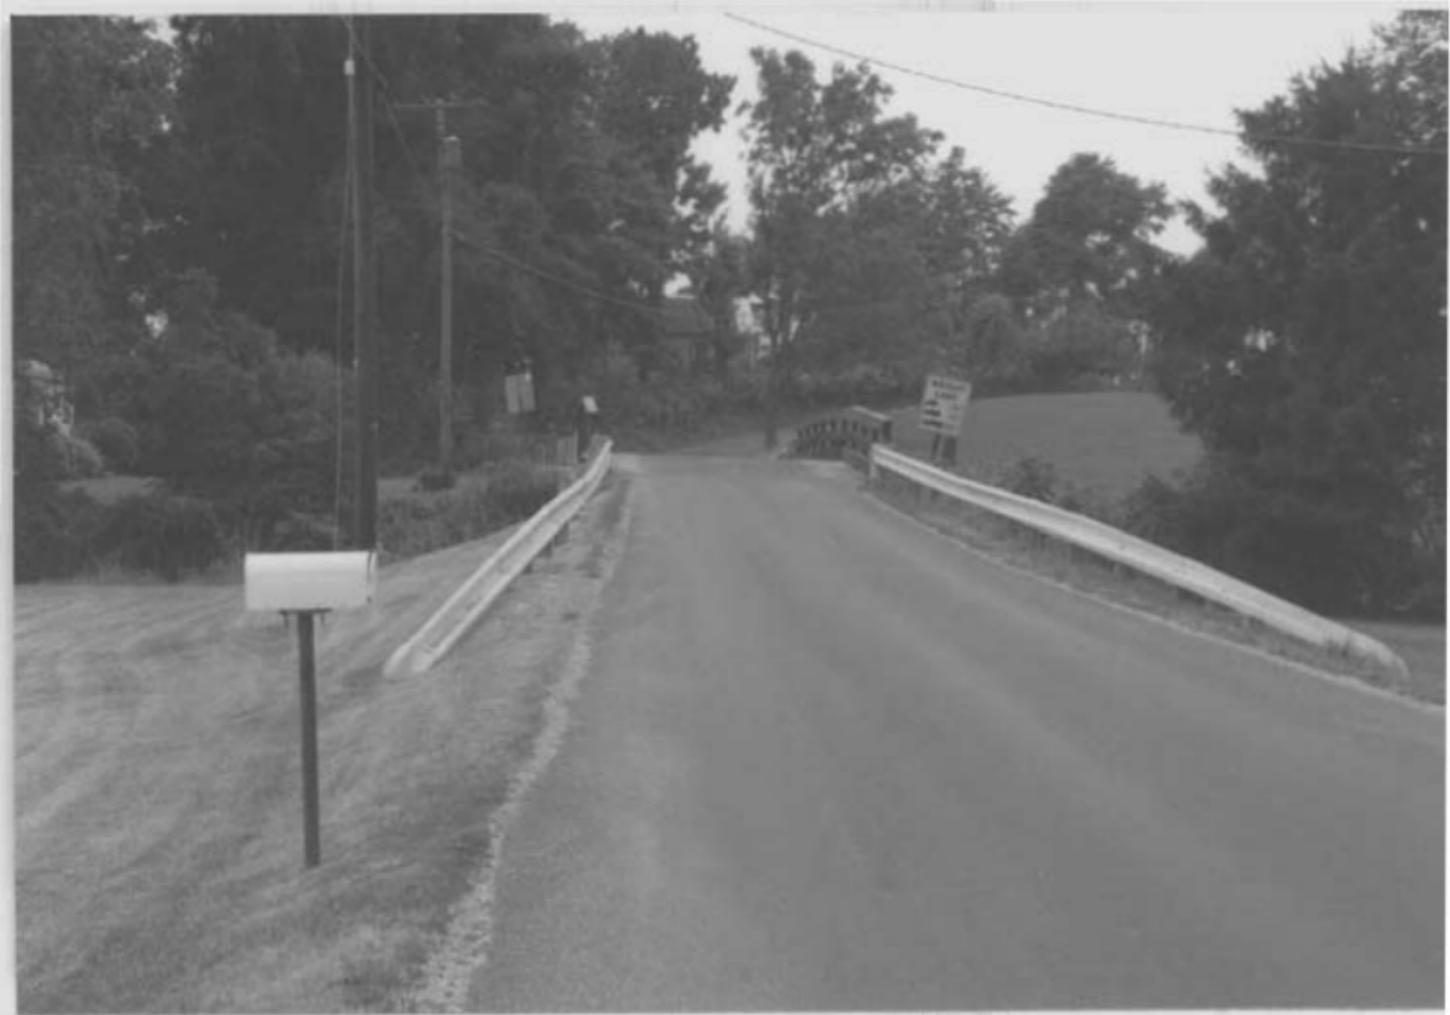
1. BA-2812
2. B140, Piney Grove Road over CSRR
3. Baltimore County, MD
4. Tim Tamburino
5. July 1997
6. MD SHPO
7. East approach
8. 1 of 5

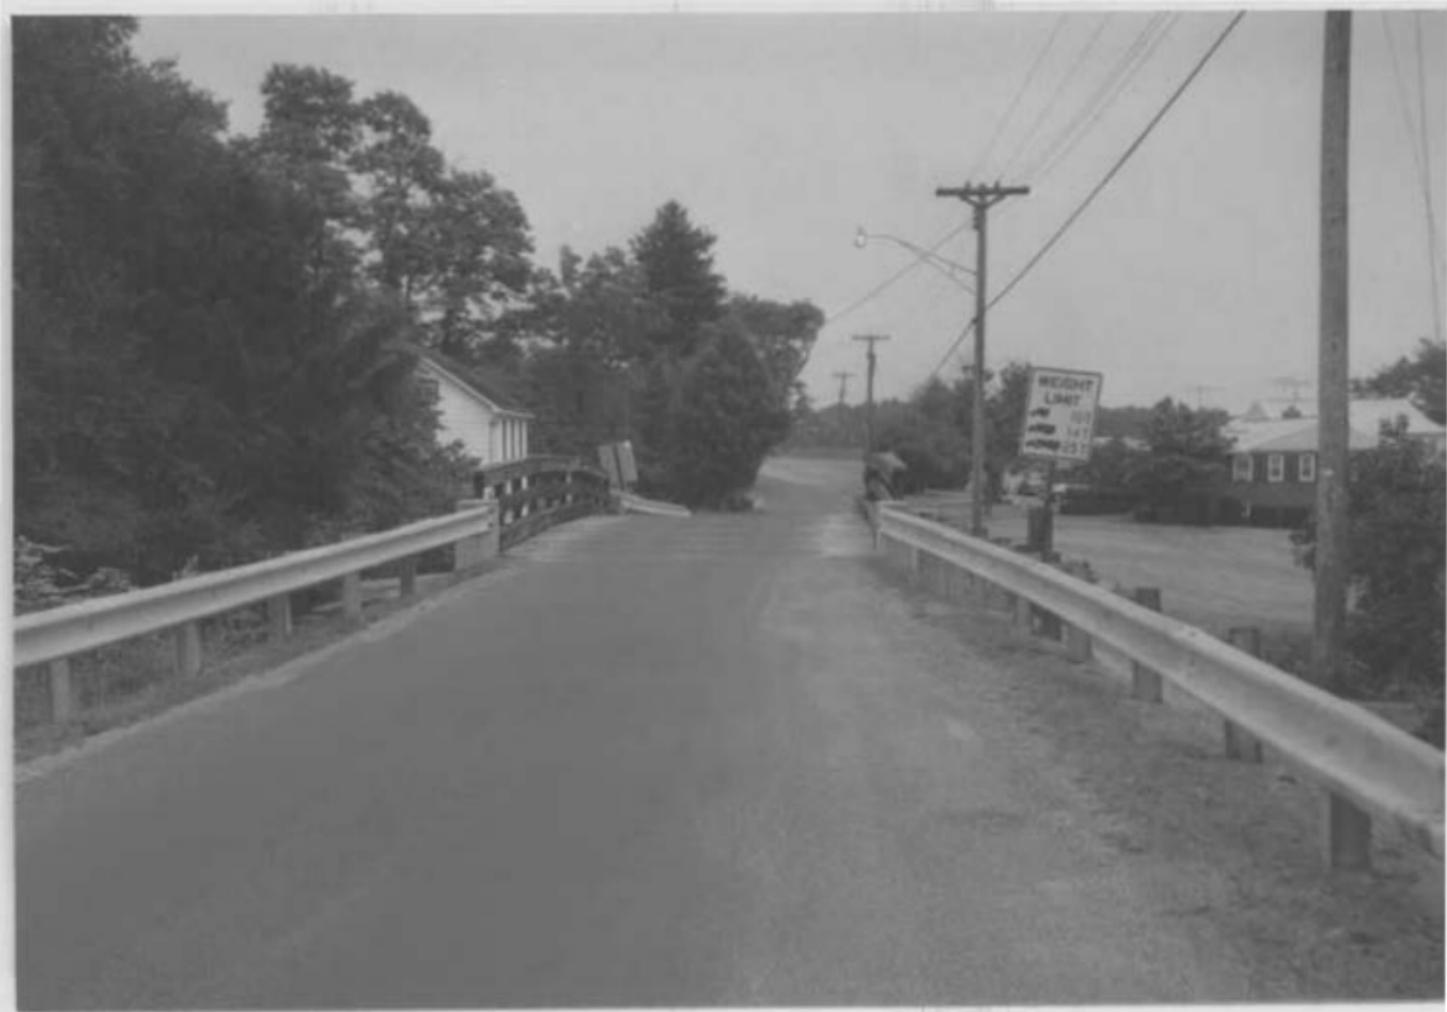
1. BA-2812
2. B140, Piney Grove Road over CS&RR
3. Baltimore County, MD
4. Tim Tamburrino
5. July 1997
6. MD SHPO
7. West approach
8. 2 of 5

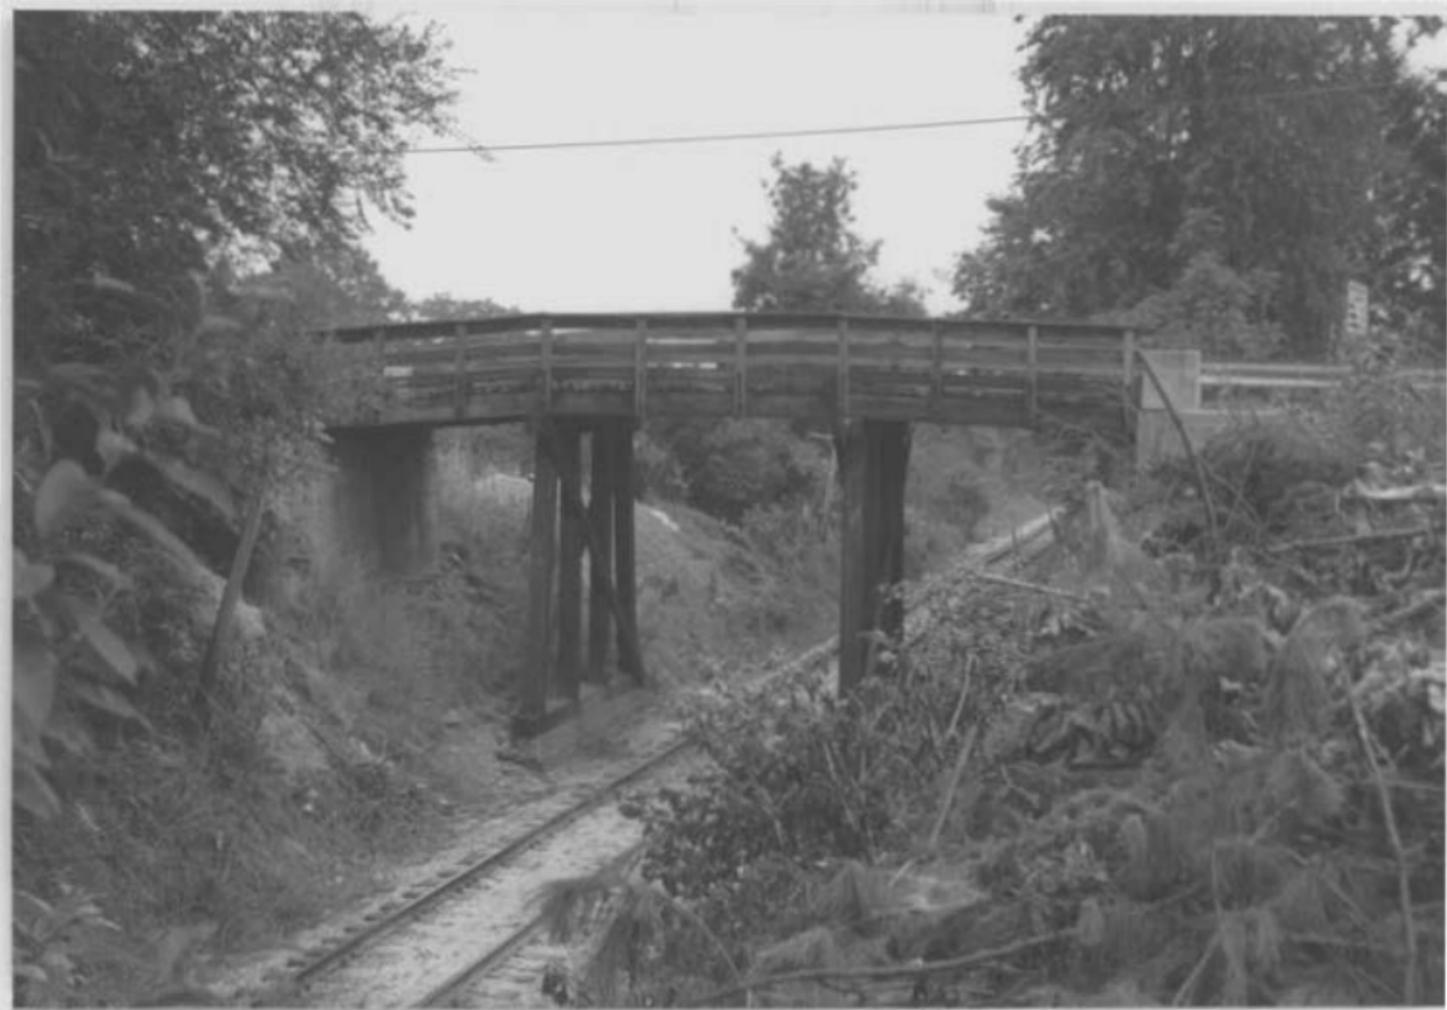
1. BA-2812
2. B140, Piney Grove Road over C&D RR
3. Baltimore County, MD
4. Tim Tamburino
5. July 1997
6. MD SH&PO
7. North elevation
8. 3 of 5

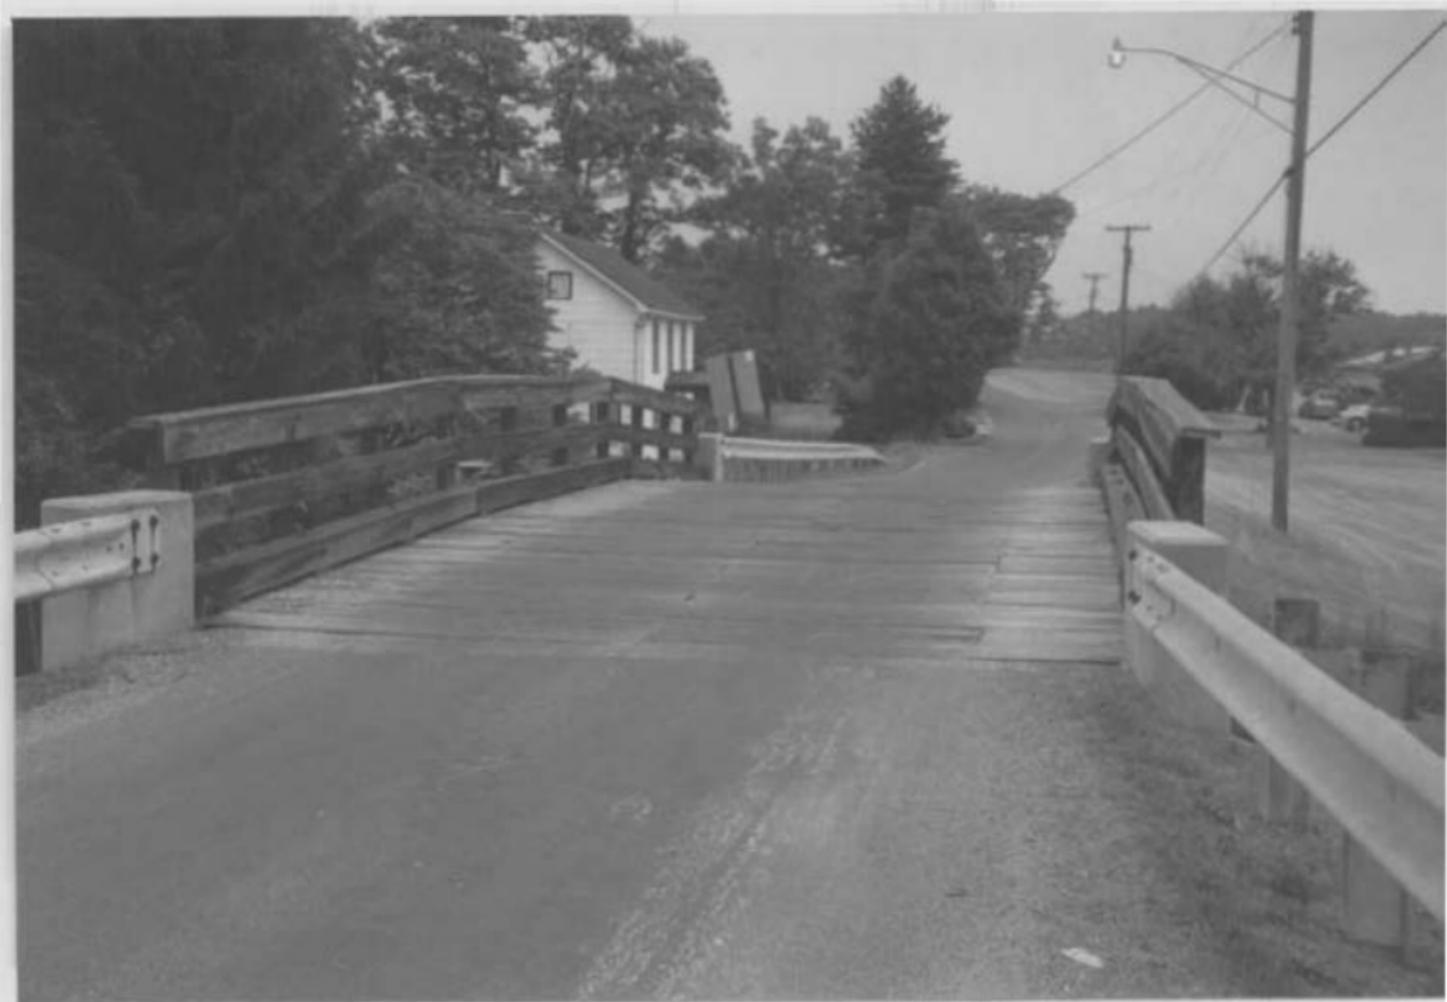
According to the 1995 inspection report, the overall condition of the structure is fair. The superstructure is in satisfactory condition with a heavily weathered timber plank deck. The timber planks comprising the deck are loose and worn with isolated splits and decay. The timber stringers have minor splits at isolated locations with minor corrosion on the hardware. The substructure is in fair condition. The wingwalls have cracking, spalling, scaling and efflorescence. The east abutment has a large fracture crack at the south end and both abutment footings are exposed. The timber caps and columns exhibit minor splitting and the hardware has minor corrosion. The pier footings have minor scaling and isolated cracking. The roadway approaches have asphalt wearing surfaces. The approach pavements are slightly worn and exhibit minor scaling at the edges of the roadway.

1. BA - 2812
2. B 140, Pinney Grove Road over CSX RR
3. Baltimore County, MD
4. Tim Tamburrino
5. July 1997
6. MD SHPO
7. Timber deck and wood railing
8. 4 of 5

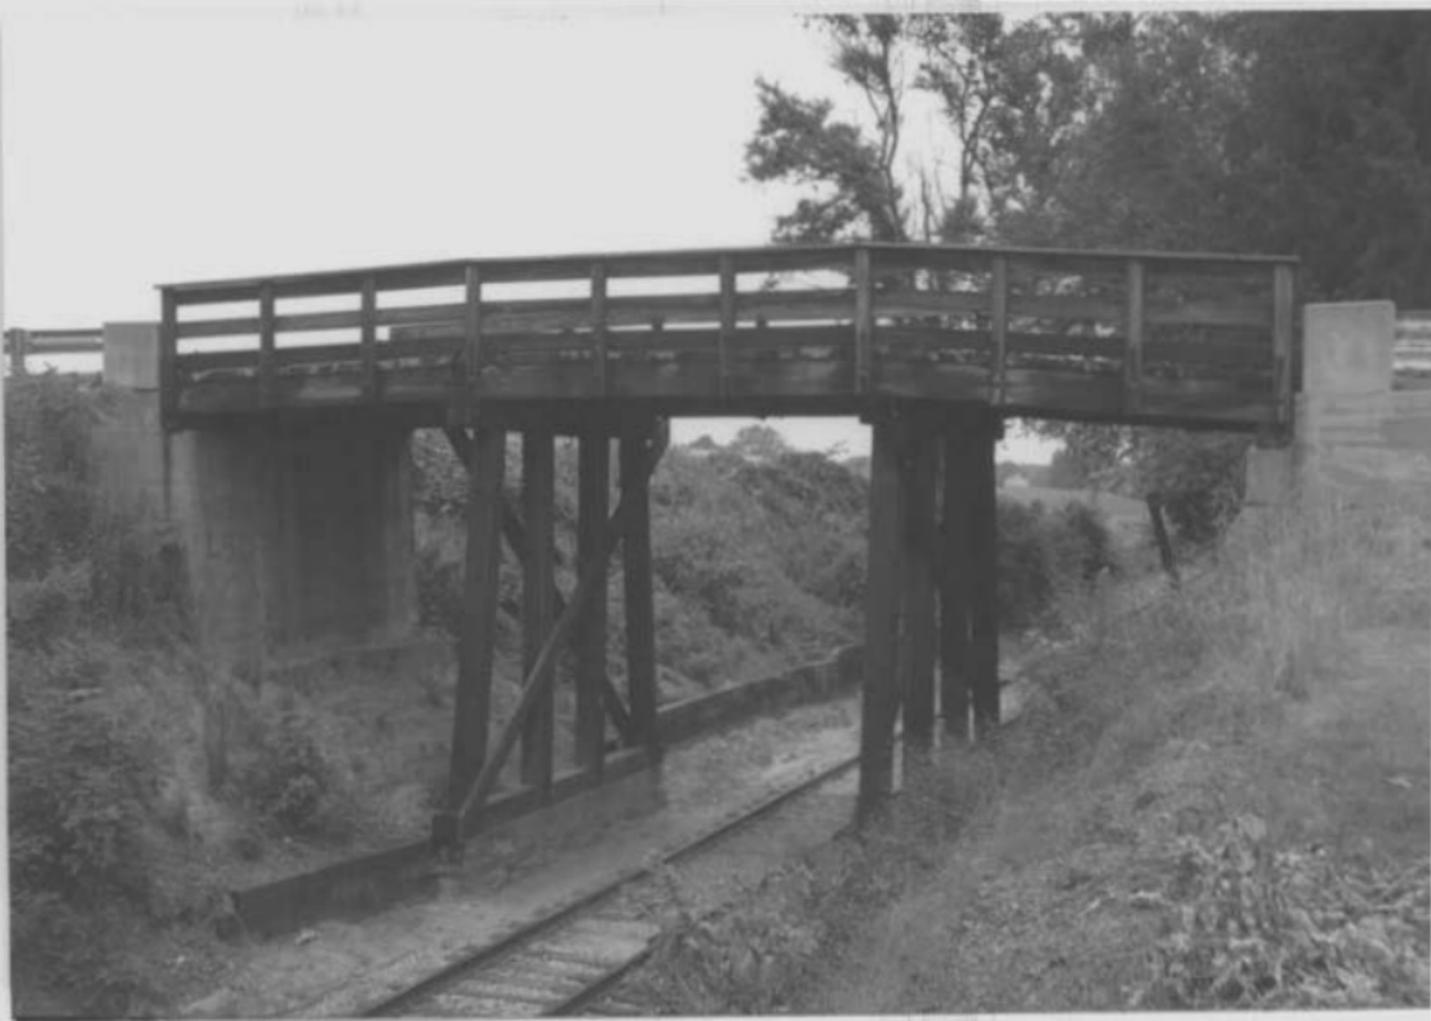
1. BA - 2812
2. B149, Piney Grove Road over CS+RR
3. Baltimore County, MD
4. Tim Tamburrino
5. July 1997
6. MD SHPO
7. South elevation
8. 5 of 5
