Maryland Inventory of Historic Properties number: BA-2862

Maryland Inventory of Historic Properties
Historic Bridge Inventory
Maryland State Highway Administration
Maryland Historical Trust

SHA Bridge No. 3067 **Name:** MD 126 over Gwynns Falls

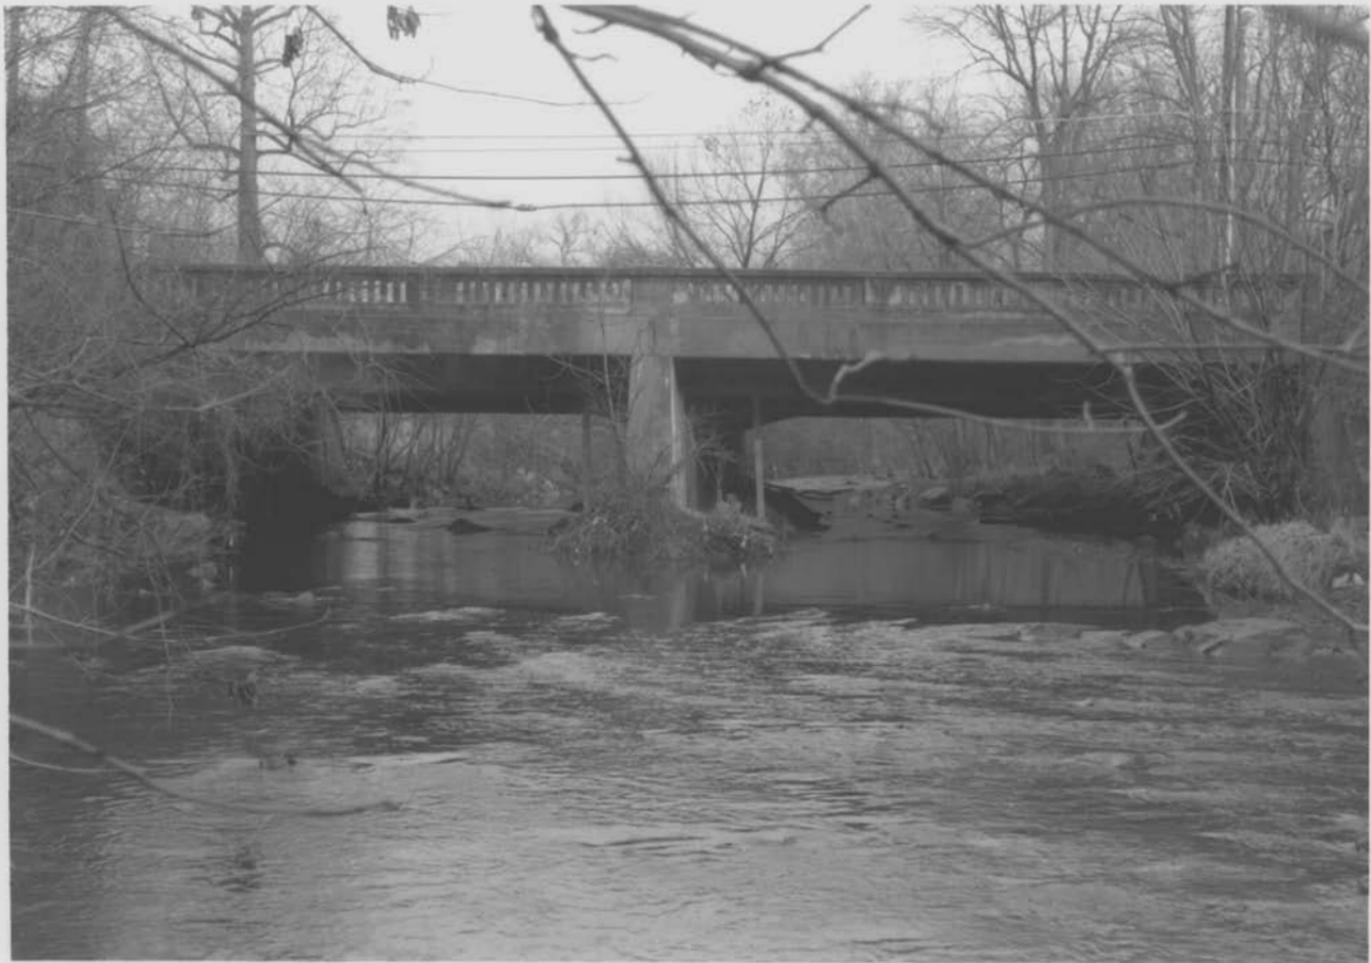
1. BA-2802
2. 3067, MD 126 OVER Cwynns Falls
3. BALTIMORE COUNTY
4. WALLACE, MONTGOMERY & ASSOC.
5. 12/97
6. MD SHPO
7. ELEVATION LOOKING UPSTREAM
8. 1 OF 5

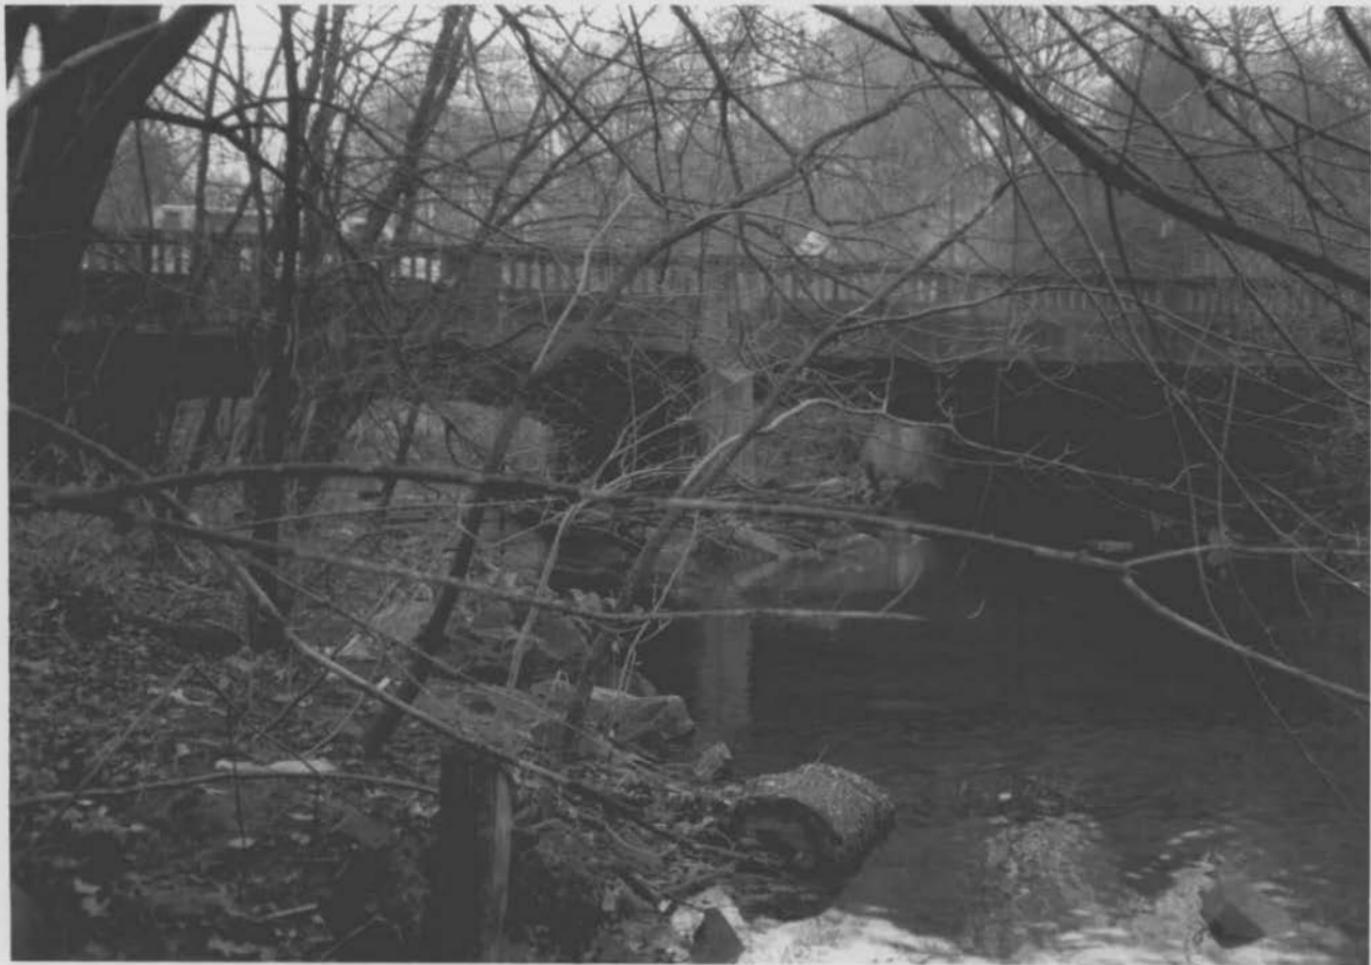
1. BA-2862
2. 3067, MD 126 OVER GWYNNS FALLS
3. BALTIMORE COUNTY
4. WALLACE, MONTGOMERY & ASSOC.
5. 12/97
6. MD SHPO
7. ELEVATION LOOKING DOWNSTREAM
8. 2 OF 5

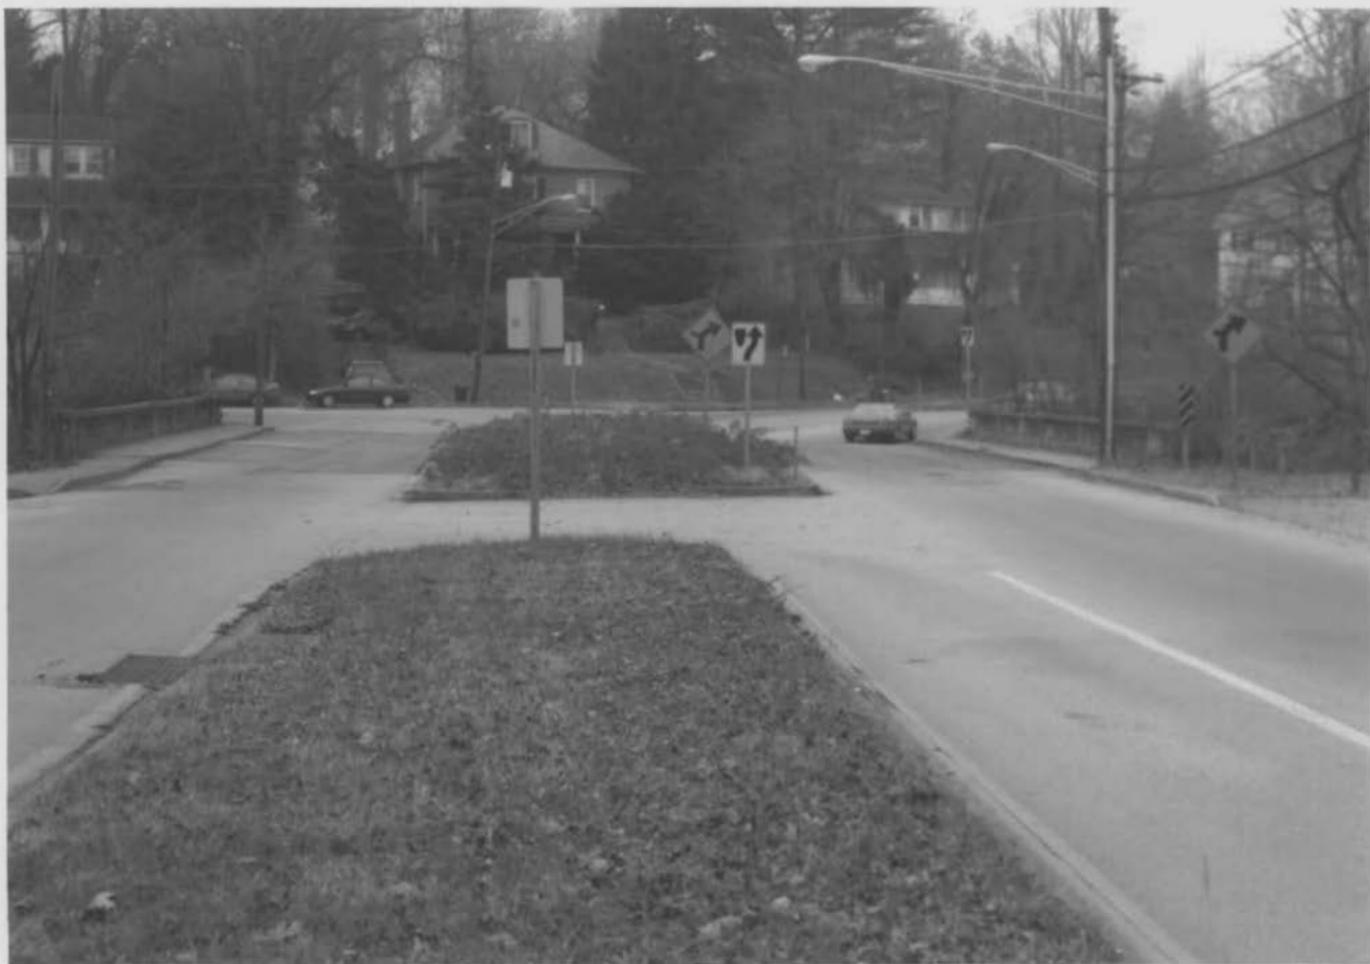
1. BA-2862
2. 3067, MD 126 OVER GWYNNNS FALLS
3. BALTIMORE COUNTY
4. WALLACE, MONTGOMERY & ASSOC.
5. 12/97
6. MD SHPO
7. LOOKING WEST
8. 3 OF 5

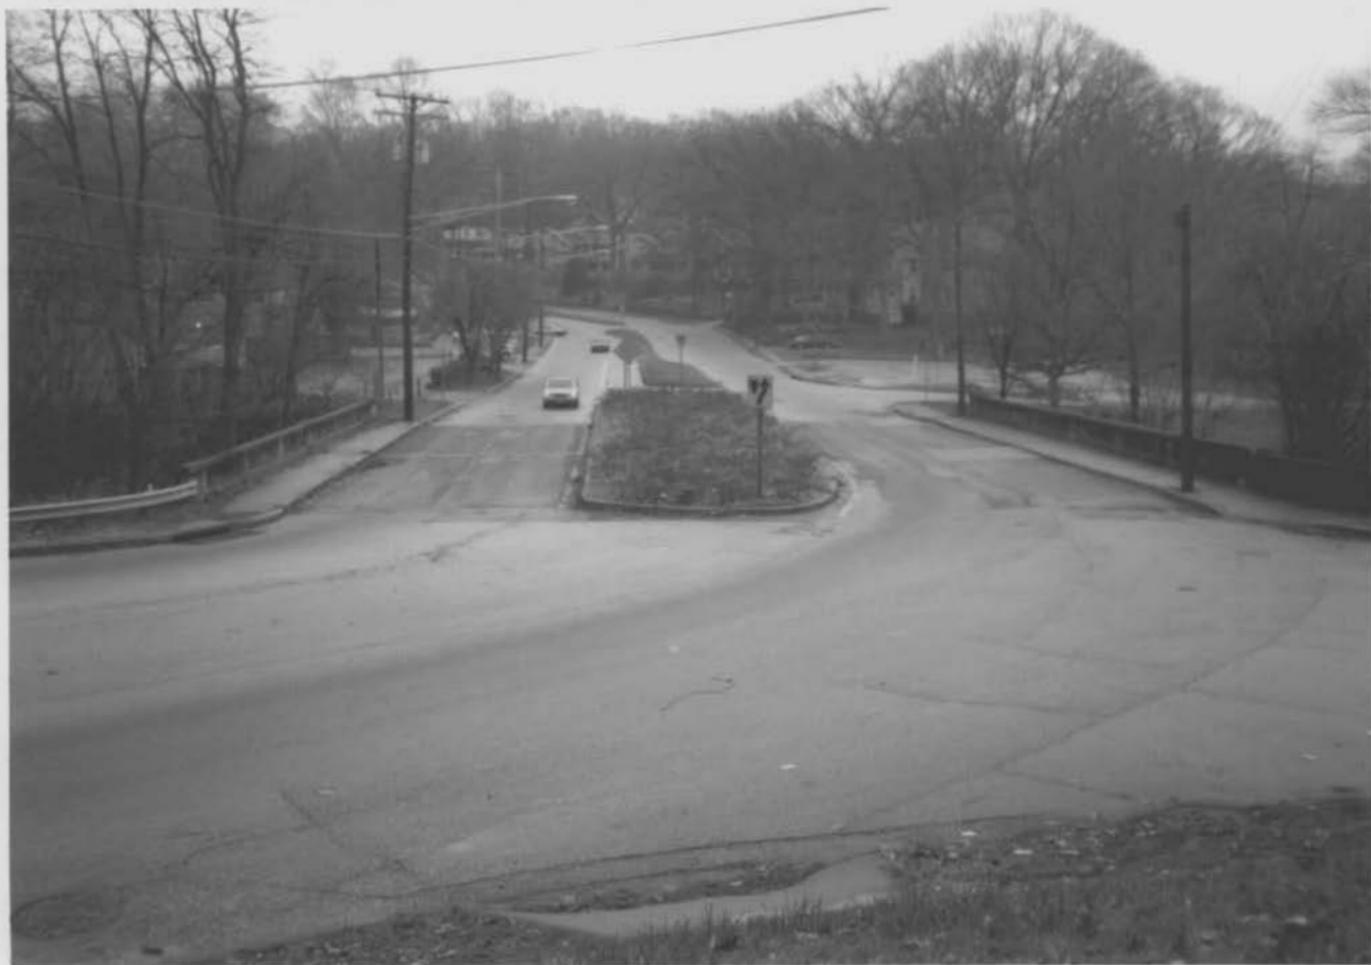
1. BA-2862
2. 3067, MD 126 OVER GWYNN'S FALLS
3. BALTIMORE COUNTY
4. WALLACE, MONTGOMERY & ASSOC.
5. 12/97
6. MD SHPO
7. LOOKING EAST
8. 5 OF 5

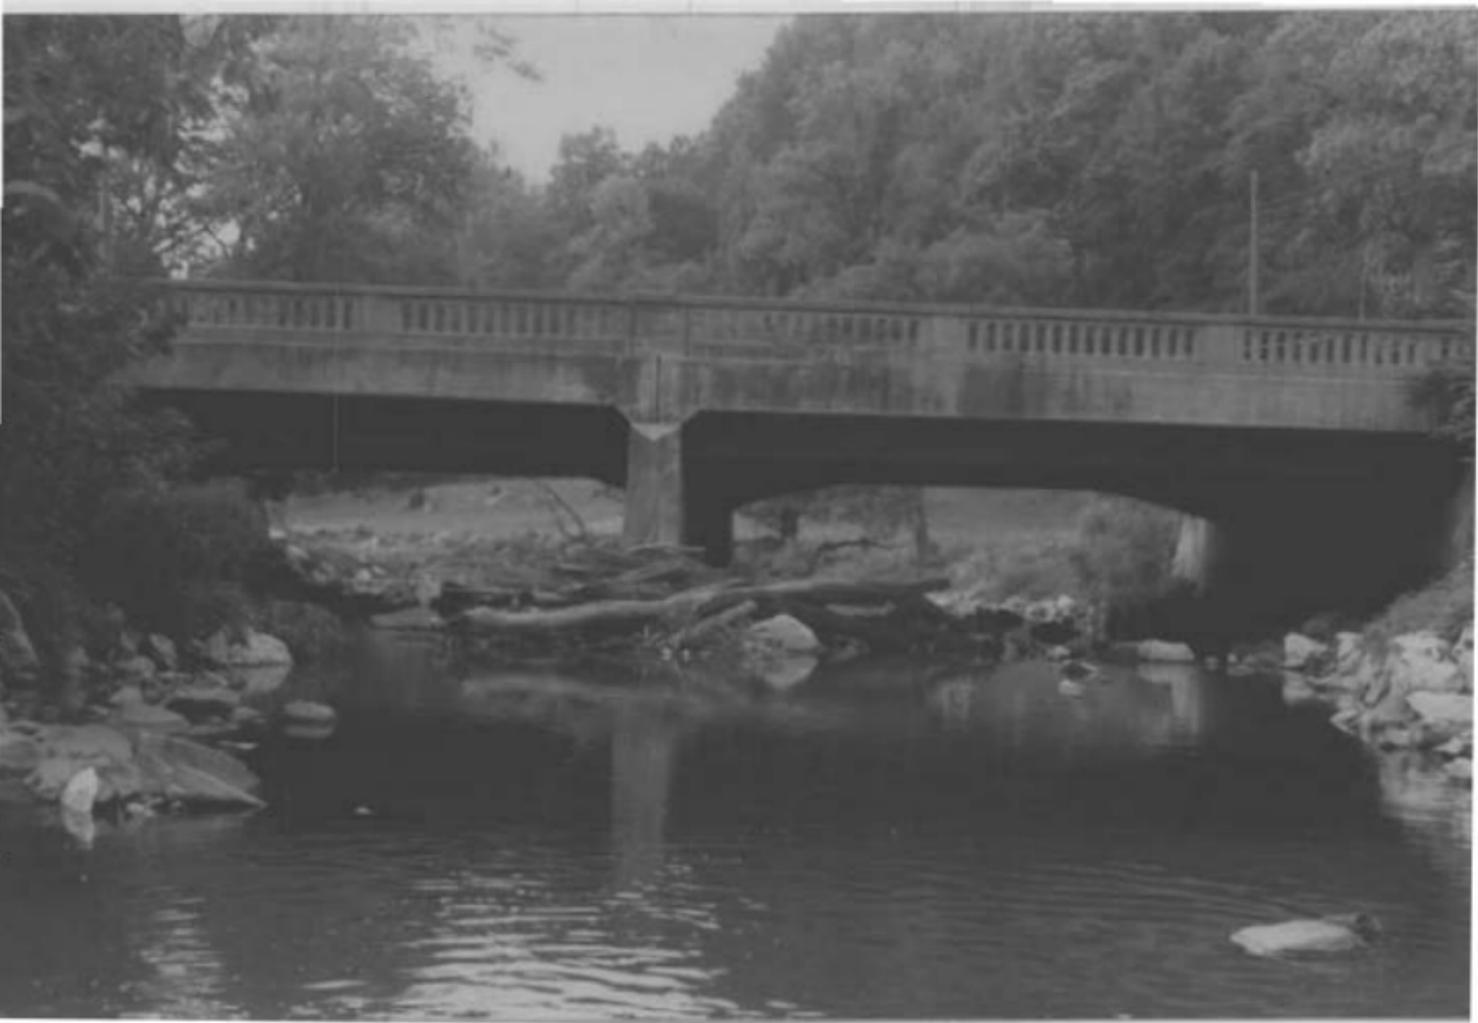
looking at ~~EAST~~ NORTH SIDE

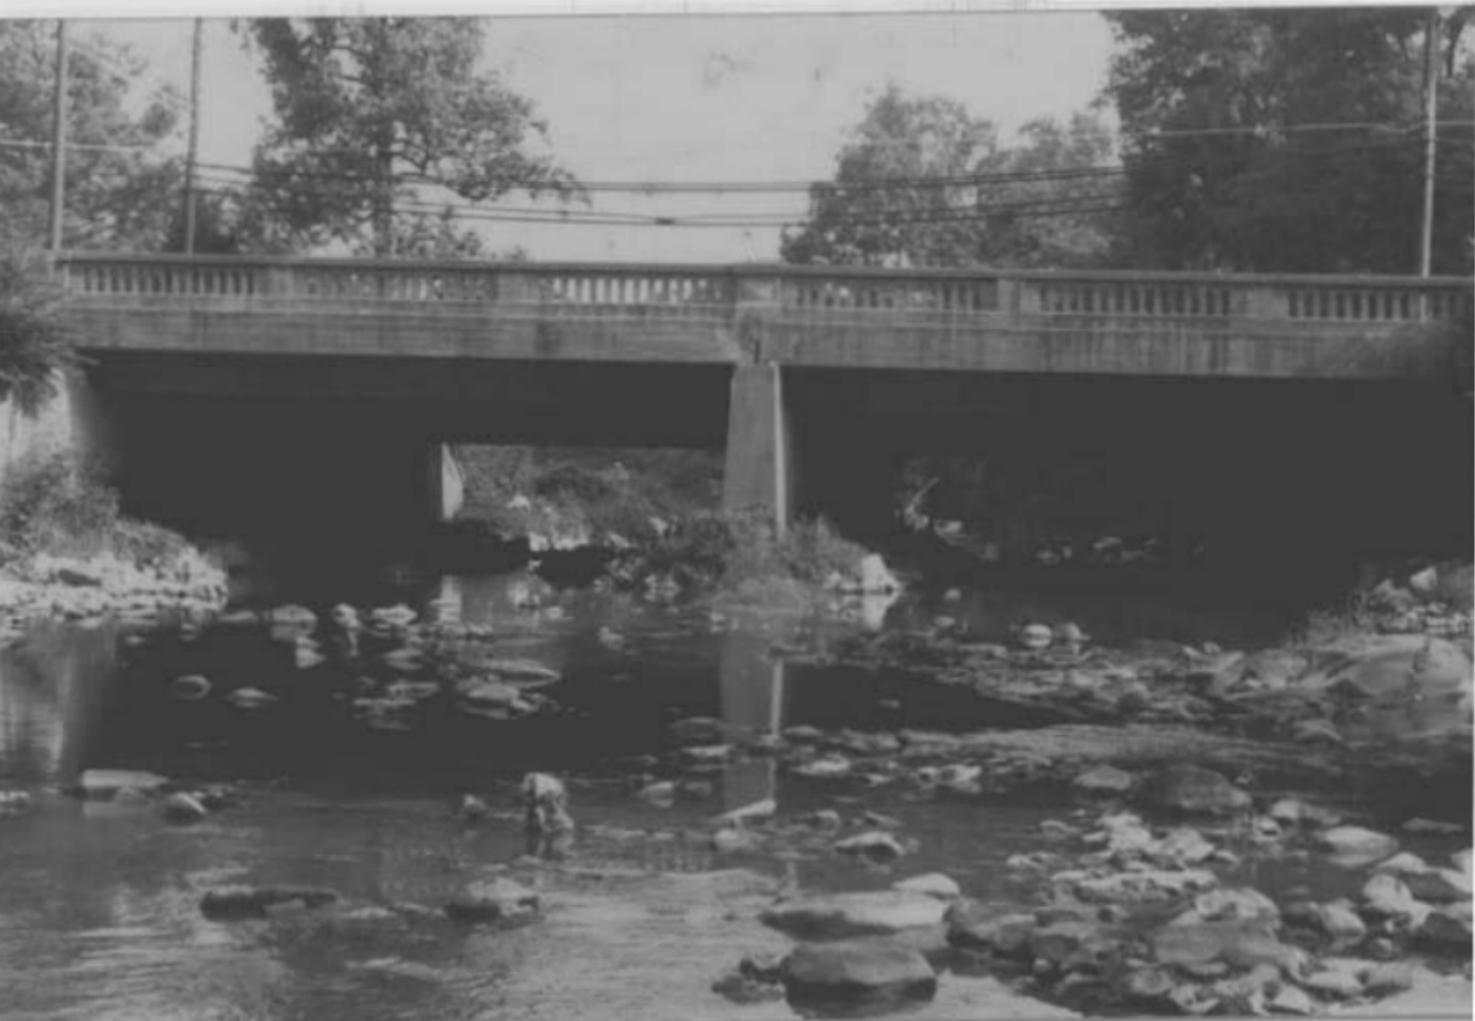
looking at south side
