**Addendum to  
Maryland Historical Trust  
Maryland Inventory of  
Historic Properties Form**

Inventory No. BA-3071

Name of Property: 7531 Belair Road (US 1)

**CAPSULE SUMMARY**  
**BA-3071**  
**House, 7531 Belair Road**  
**Baltimore County**  
**ca. 1905**  
**Private**

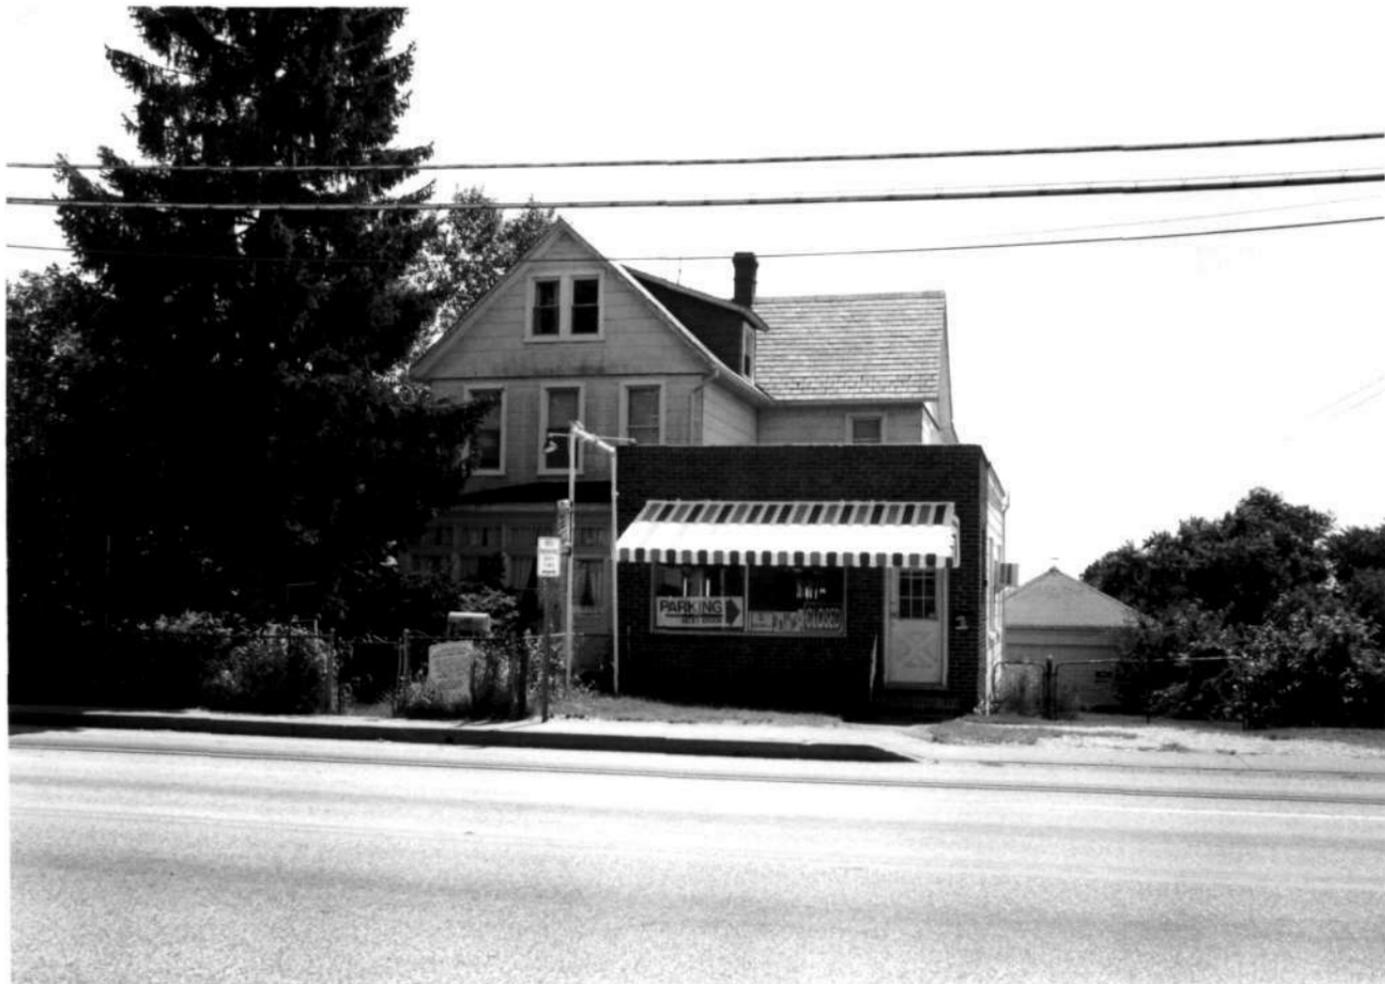
1 OF 4

NORTHWEST ELEVATION, LOOKING SOUTHWEST

The façade of the building fronts Belair Road to the northwest, consisting of the main block of the dwelling and the one-story commercial addition. The projecting main block, set within a front gable, is three bays wide and one bay deep. The first story historically had a wrap-around porch that has since been enclosed and partially removed. The enclosure of the porch, which remains on this projecting gable, has four 1/1 double-hung, metal sash windows. This continuous row of windows is set within molded wood surrounds and topped by four-light fixed transoms. Below the windows, the former porch has a solid balustrade clad with asbestos shingles. A single-leaf entry door with lights and panels allows access to the enclosed porch. A half-hipped roof clad with asphalt shingles covers the porch. The second story of the projecting bay has three equally spaced 1/1 double-hung, metal sash windows with wide molded surrounds. A pair of 1/1 double-hung, metal sash windows illuminates the half-story of the gable. A shed roof dormer with a single 1/1 double-hung, metal sash window protrudes from the southwest side of the projecting gable.

The western corner of the building, presenting an L-shape, has been altered by the construction of a one-story wood frame addition that has since been augmented by a brick clad commercial storefront. This storefront is clad with a six-course Flemish bond brick veneer. The northwest elevation of the brick clad addition has a long rectangular picture window with metal surrounds and the single-leaf entry door. The door has nine-lights over a cross panel, and is accessed by brick steps with a metal rail. The northeast and southwest sides of this brick clad storefront have small multi-light glass block windows with brick rowlock sills. The wood frame addition is set on a solid stone foundation that has been parged. It is covered with asbestos shingles, trimmed by an ogee-molded cornice, and has a flat roof. The sides of the addition have two equally spaced 1/1 double-hung, metal window openings with wide wood surrounds that have been covered with metal. Two basement level windows are symmetrically aligned. These rectangular openings hold two-light fixed windows with wood sills.

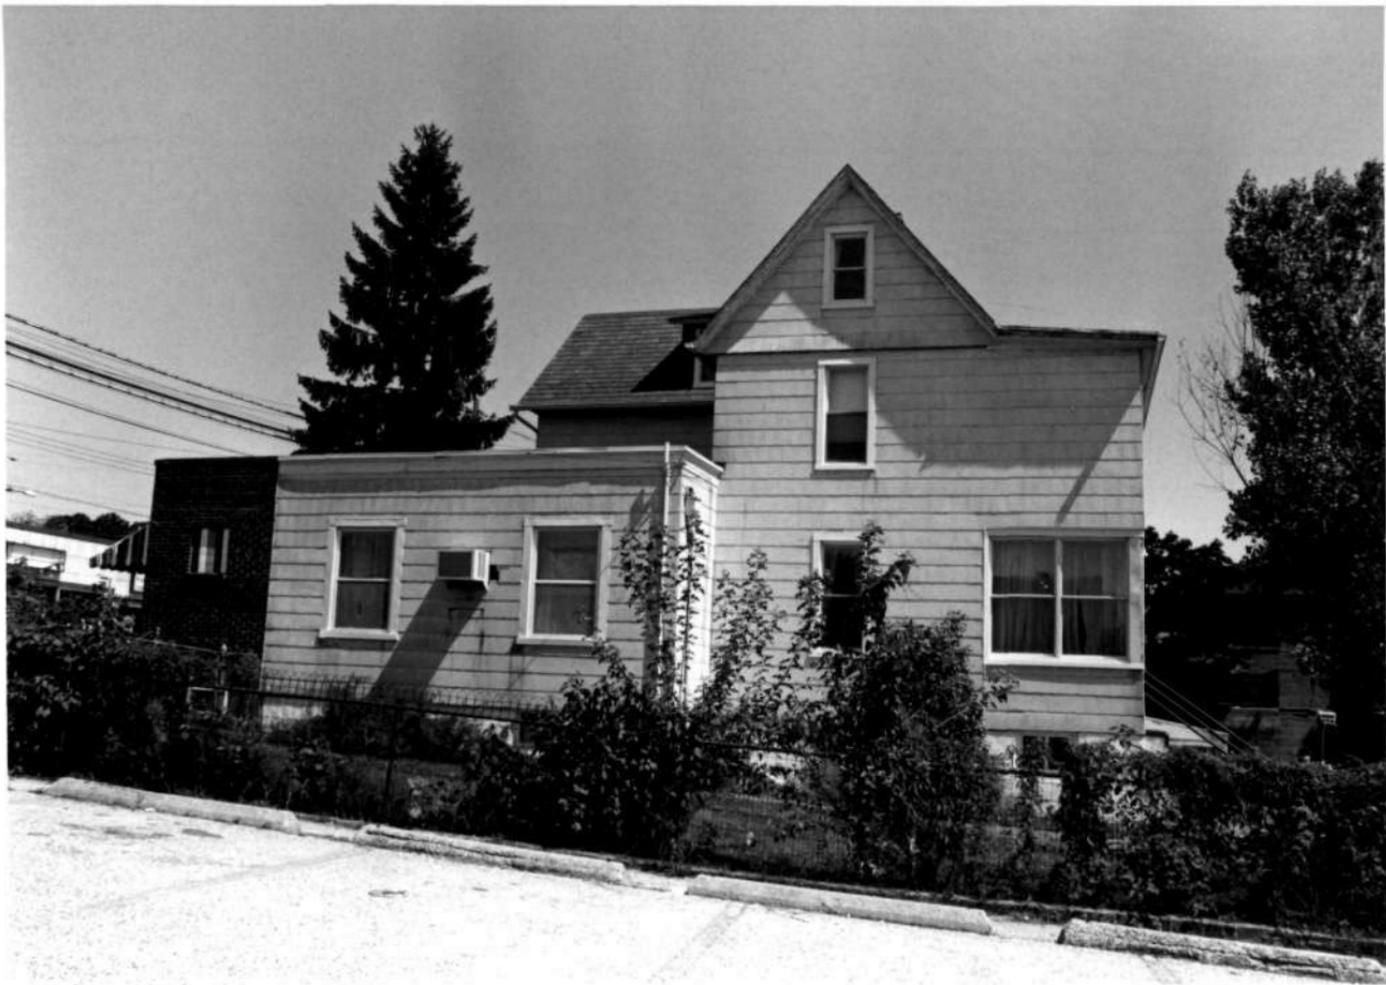
2 OF 4

SOUTHWEST ELEVATION, LOOKING NORTH

The southwest elevation of the main block is symmetrically fenestrated with 1/1 double-hung, metal sash windows on the first and second stories, as well as the gable end. A single two-story bay at the south corner of the southeast elevation of the main block has extended the wall to two bays. The material and form of this bay suggests it was original, although open on the first story. The continuous foundation visible on the southwest elevation is pierced by three rectangular openings, holding three-light fixed windows with wood sills. In the south corner bay are two large 1/1 double-hung, metal sash windows that wrap around the corner of the building. At the southeast elevation, the wrapping windows include a very narrow 1/1 double-hung, metal sash, a single-leaf entry, and larger 1/1 double-hung, metal sash window. The entry holds a multi-light paneled door with a single-light transom.

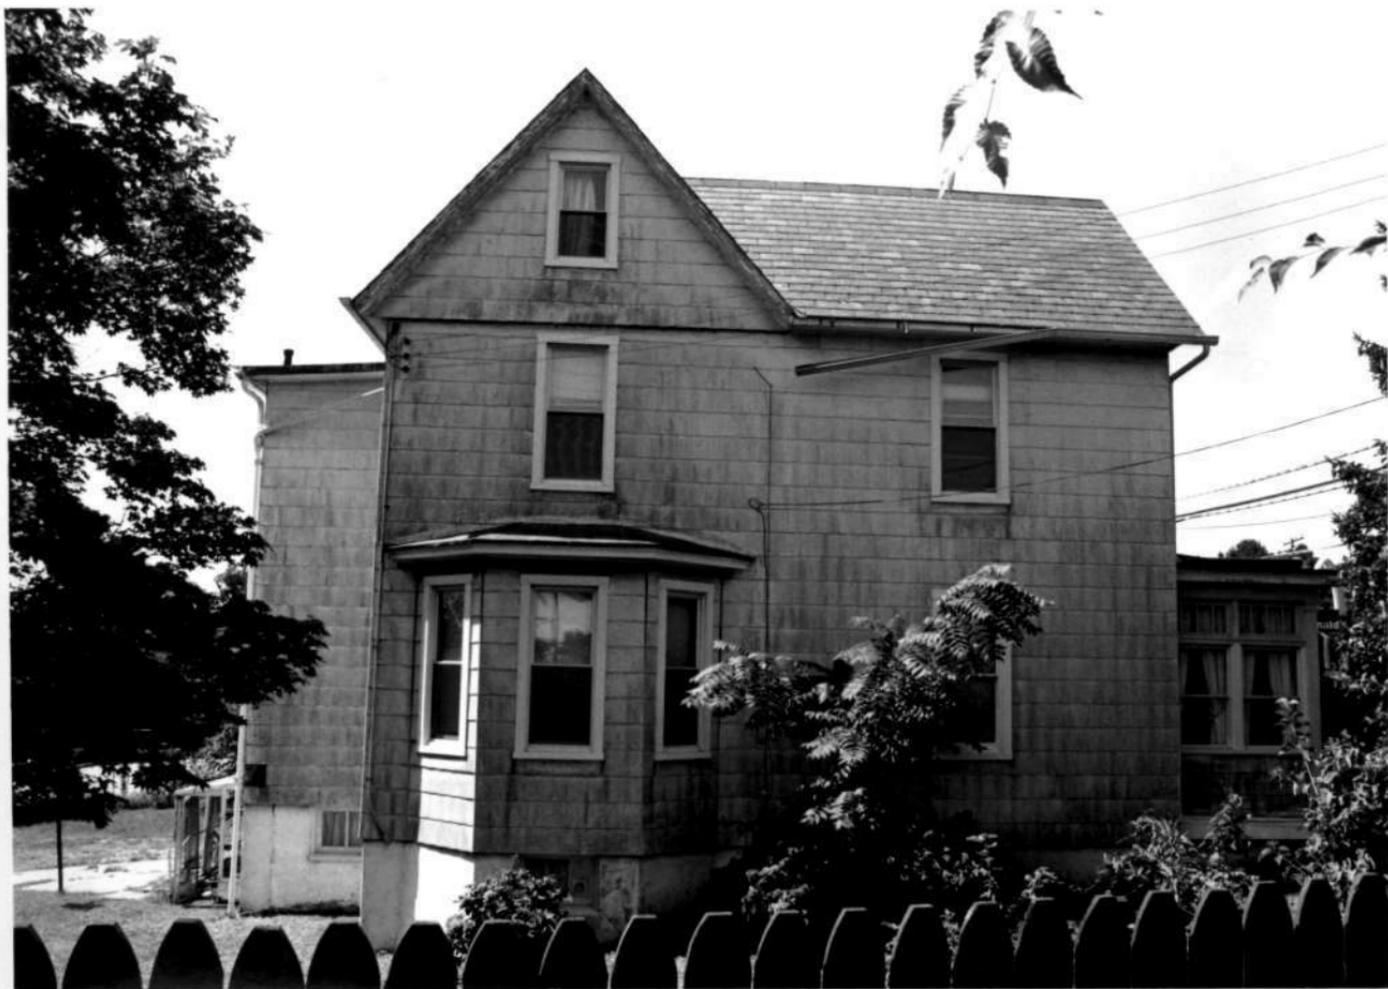
3 OF 4

NORTHEAST ELEVATION, LOOKING WEST

The northeast elevation consists of the main block and the projecting gable bay on the northwest elevation. This two bay wide elevation is symmetrically fenestrated with single window openings and a canted bay window. The foundation is pierced by three window openings, two with three lights and one with two lights. The canted bay in the main block has a half-hipped roof, clad with asphalt shingles. Covered with asbestos shingles, the bay has three 1/1 double-hung, metal window openings. Symmetrically placed above is a 1/1 double-hung, metal window that is balanced by a smaller 1/1 double-hung, metal window in the gable end. The first and second stories of the projecting bay have single 1/1 double-hung, metal windows.

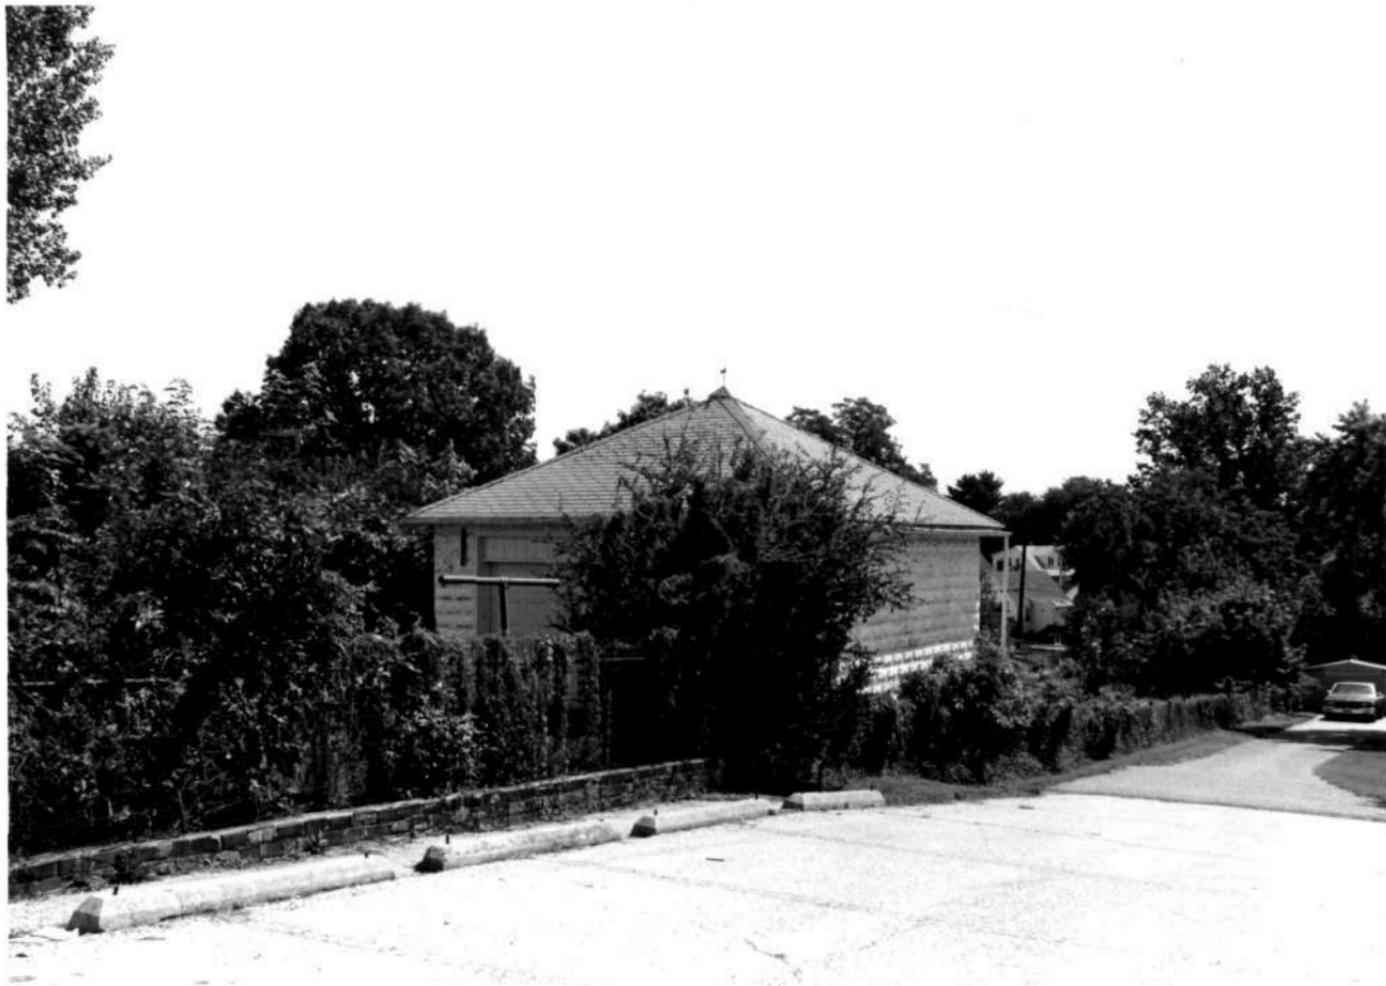
4 OF 4

GARAGE, LOOKING EAST

A one-story masonry garage, dating from the mid-1920s, is located to the south of the former dwelling. This structure is constructed of rock-faced concrete blocks. A wide replacement garage door is located on the northwest elevation. The hipped roof is clad with asphalt shingles and has exposed rafter ends. Patented in 1900, rock-faced concrete block instantly became one of the leading building materials in the United States. The concrete blocks were a cheap, quick, and easy alternative to more traditional materials, with a block costing between thirteen and twenty cents to make in 1910. Advertisers also pointed out that it was fireproof, required no paint, and needed little care. Notwithstanding all these advantages, one of the most important reasons for the
