#BA-316

1. STATE Maryland
 COUNTY Baltimore
 TOWN Lutherville VICINITY
 STREET NO. 226 Melancton Avenue

HISTORIC AMERICAN BUILDINGS SURVEY INVENTORY

DATE OR PERIOD 1867
 STYLE Downing - Vaux Cottage
 ARCHITECT
 BUILDER John Graff Cockey

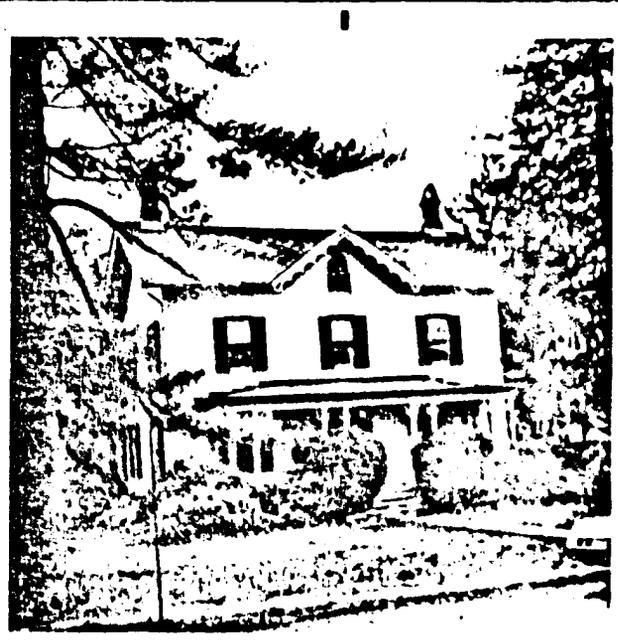
This small scaled, three bay cottage-house is a near perfect example of its style with interesting architectural details which primarily include the pierced verge boards in an inverted scallop design at the gable overhangs. The scallop motif terminates at each ridge in an ogee arch with a trefoil design above it. At the unornamented eaves of the house the scallop motif forms a simple loop. This is a fine example of surviving verges on a frame house.

A rather typical, though here somewhat early, central attic gable set at a right angle to the main low gabled roof dominated the front roof slope along with a pair of chimneys, one at each end of the ridge. A semi-circular arched window with six over six sash is set in the attic gable. All the windows typically have six over six sash including the end facades' two bays and are hung with louvered blinds except at the attic windows.

Under the overhang of the hexagonal shingled roof eaves are low attic windows set over each end bay of the front facade. A Half hipped porch roof spans across the three first floor bays with the central entrance and is supported on square columns set with open jig-saw cut corner brackets at each side of each capped column above a necking. The columns are grouped with four pairs spaced with jig-saw cut slat balusters.

A small story and half barn or carriage shed is at the rear with rather simple detailing of the gabled roof and openings. It is sheathed, like the house, with horizontal clapboard siding. Together with the house it all presents an interesting picture of a small domestic environment of the mid-
