**CAPSULE SUMMARY**  
**BA-0486**  
**Charlotte Fowble House**  
**3637 Black Rock Road**  
**Upperco, Baltimore County**  
**1870 ca.**  
**Private**

## 7. Description

Inventory No. BA-0486

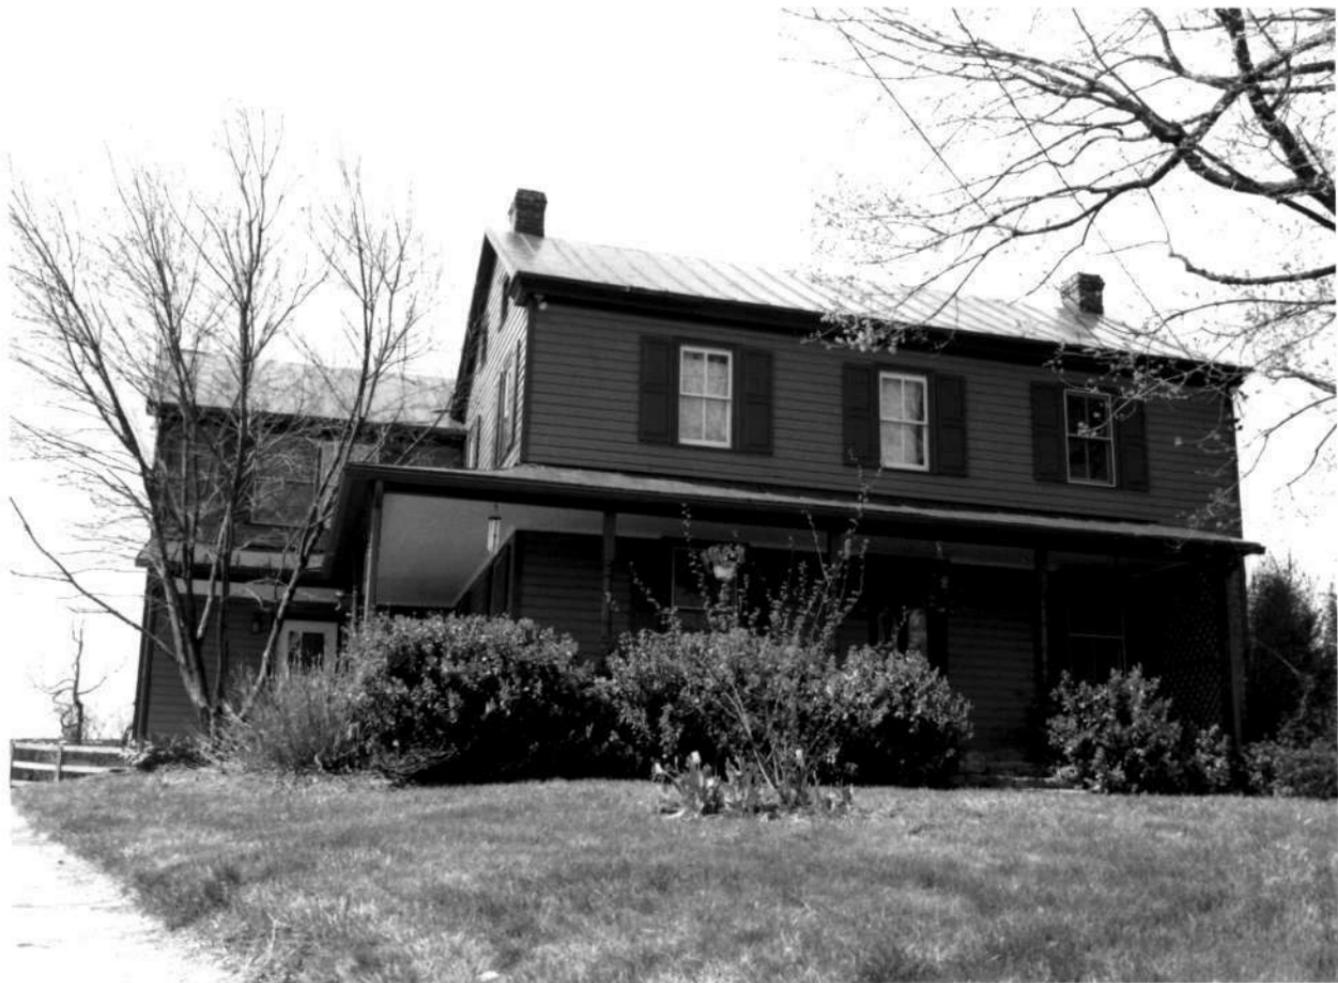
NE ELEVATION

Fronting northeast, this vernacular dwelling was constructed circa 1870 and includes hand-hewn logs on the interior. The original building stands two-and-a-half stories in height and three bays wide. The random rubble stone foundation supports a wood frame structure clad with wood German siding. The side gable roof clad with standing seam metal is pierced by two symmetrically placed interior-end brick chimneys with corbeled caps. Five 2/2 windows pierce the façade with square-edged wood sills and surrounds. A half-hipped porch with turned posts wraps around the first-story of the façade to the southeast. A two-story wood frame addition spans the rear elevation and connects the main dwelling to a circa 1870 dairy made with random rubble stone. The exterior of the dairy has been remodeled to reflect the 1995 addition.

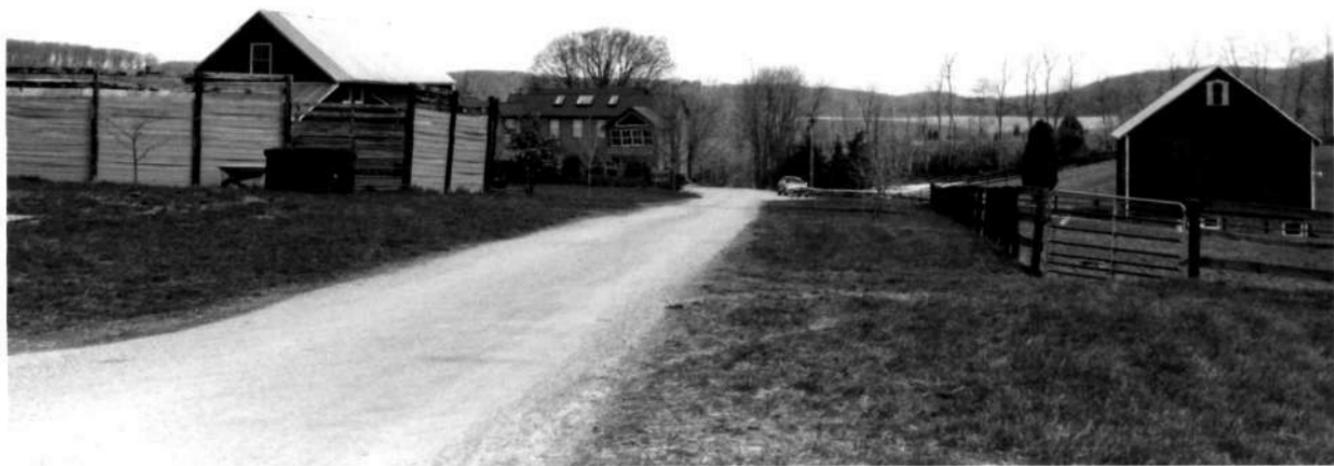
SW ELEVATION + OUTBUILDINGS

A circa 1995 hay barn has been rebuilt with original materials to replicate the circa 1870 barn that originally occupied the site. The random rubble stone foundation supports a wood frame structure clad with vertical board siding. The barn features a side gable metal standing seam roof, a double-leaf, beaded vertical board, sliding door, and a pointed-arch 1/1 window in the gable ends.

Located directly behind the main house is a circa 1870 barrack barn that has been turned into a dwelling circa 1980. The random rubble stone foundation supports a wood frame structure with board-and-batten siding. The roof is a side gable clad with metal standing seam. The new house has three shed roof additions and new vinyl windows.

Located at the end of the paved driveway are two circa 1980 barns. Both are one-story in height and have front gabled roofs. One is metal frame with standing-seam metal siding and roof. The other is wood frame with pressed vertical board siding and an asphalt shingle roof.
