**MARYLAND HISTORICAL TRUST
NR-ELIGIBILITY REVIEW FORM**

Property Name: Smith Brothers House Inventory Number: BA-931

Maryland Inventory of Historic Properties Form

Inventory No. BA-931

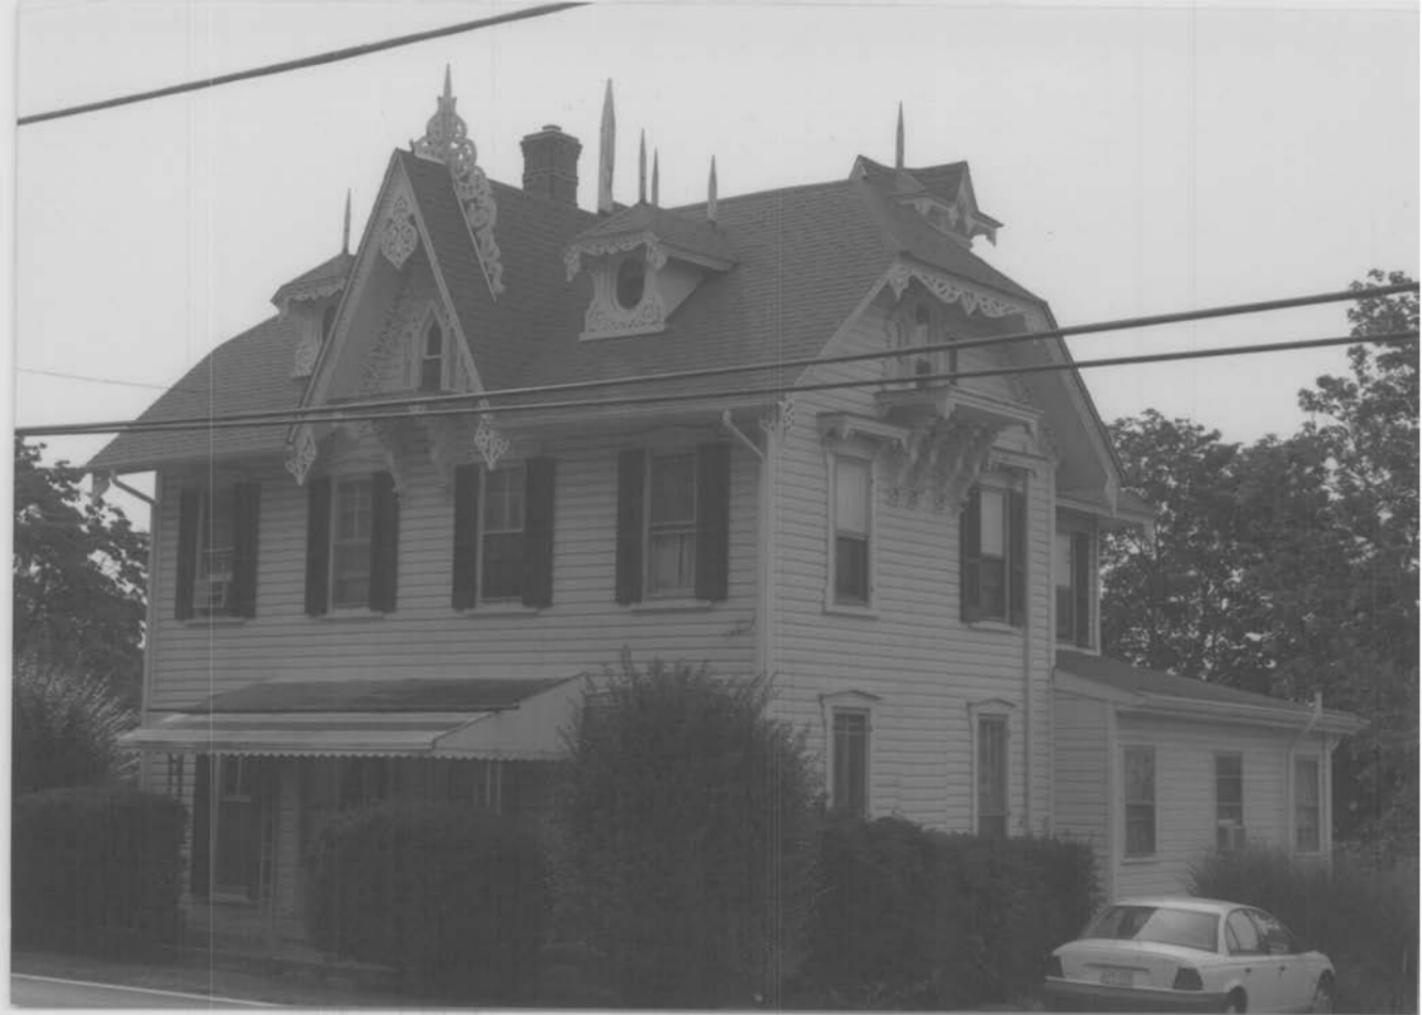
1/4

View of the Smith Brothers House, to
the southeast.

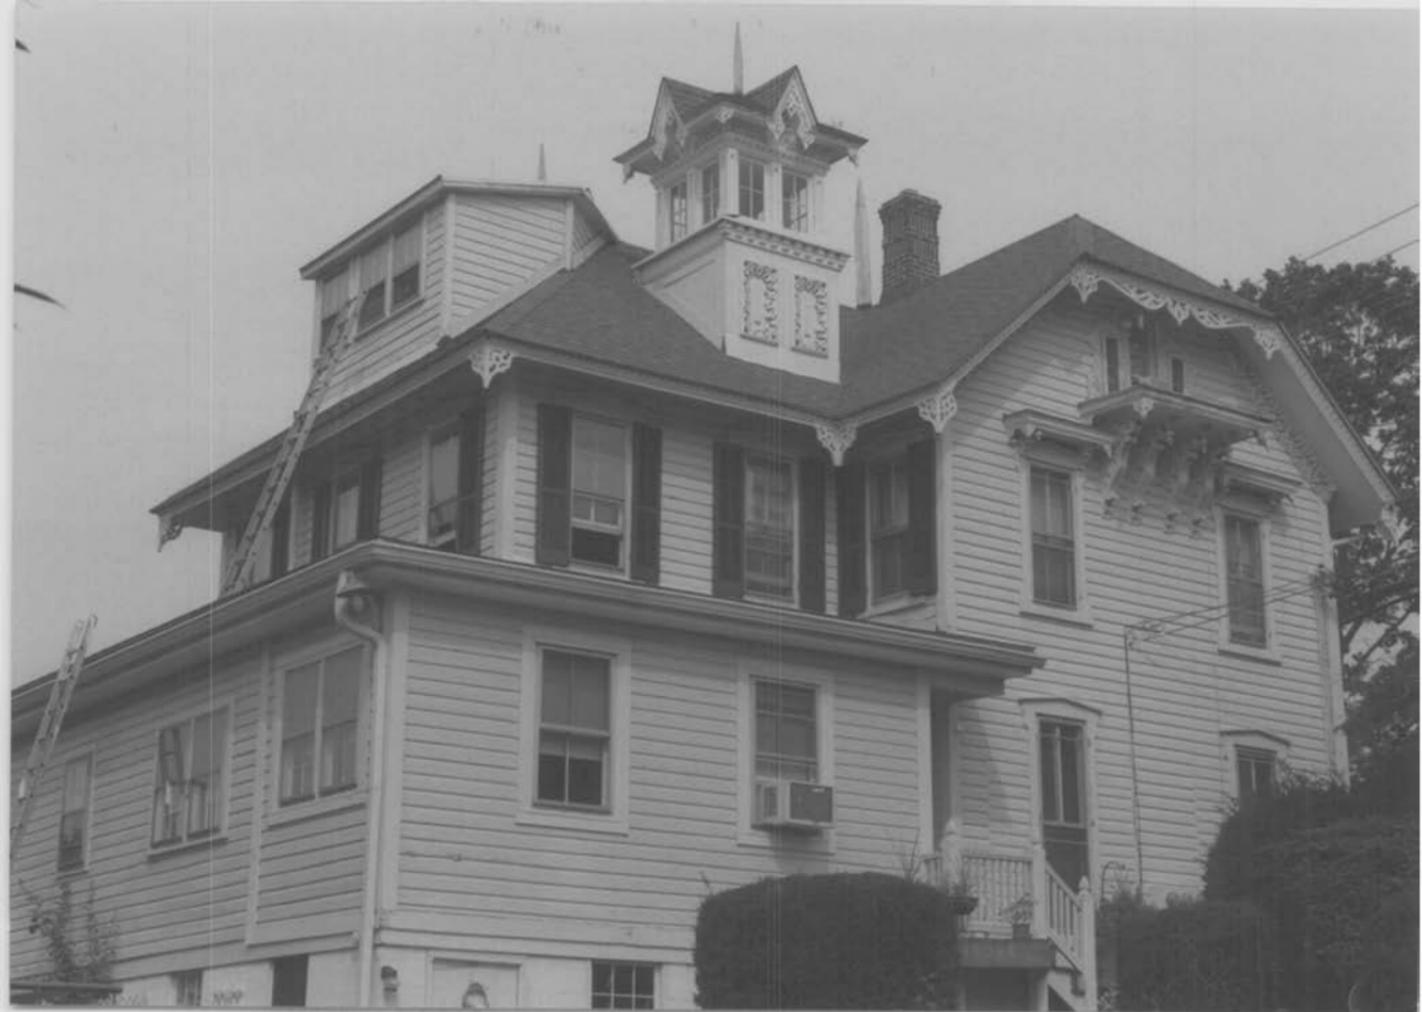
2/4

Smith Brothers House, to the
Northwest.

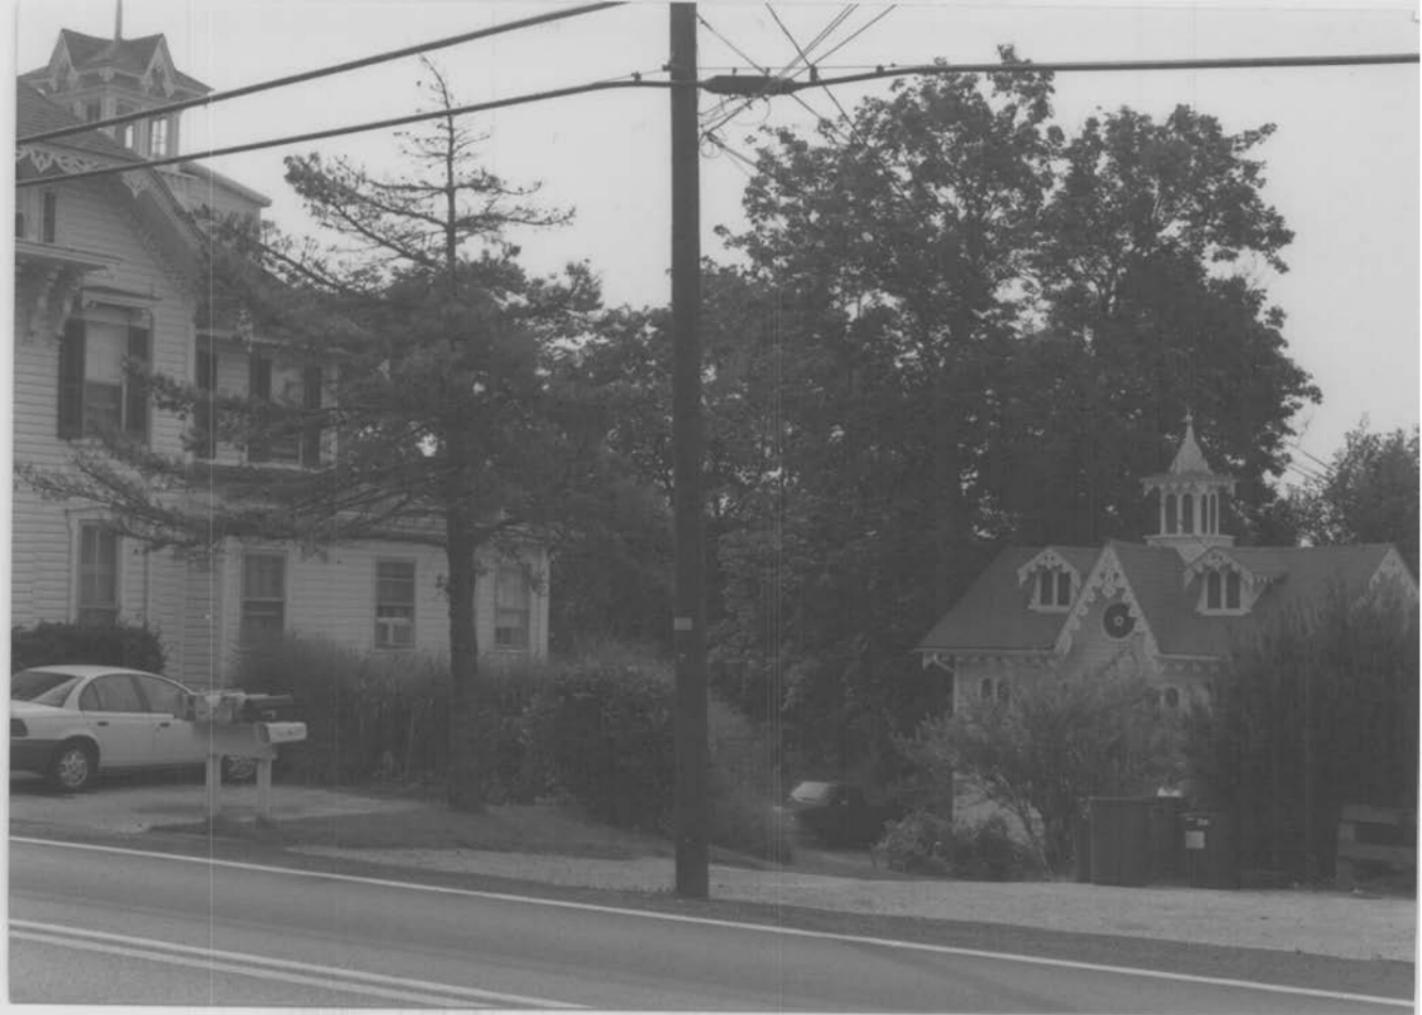
3/4

View of the Smith Brothers House and
Carriage house, to the southeast.

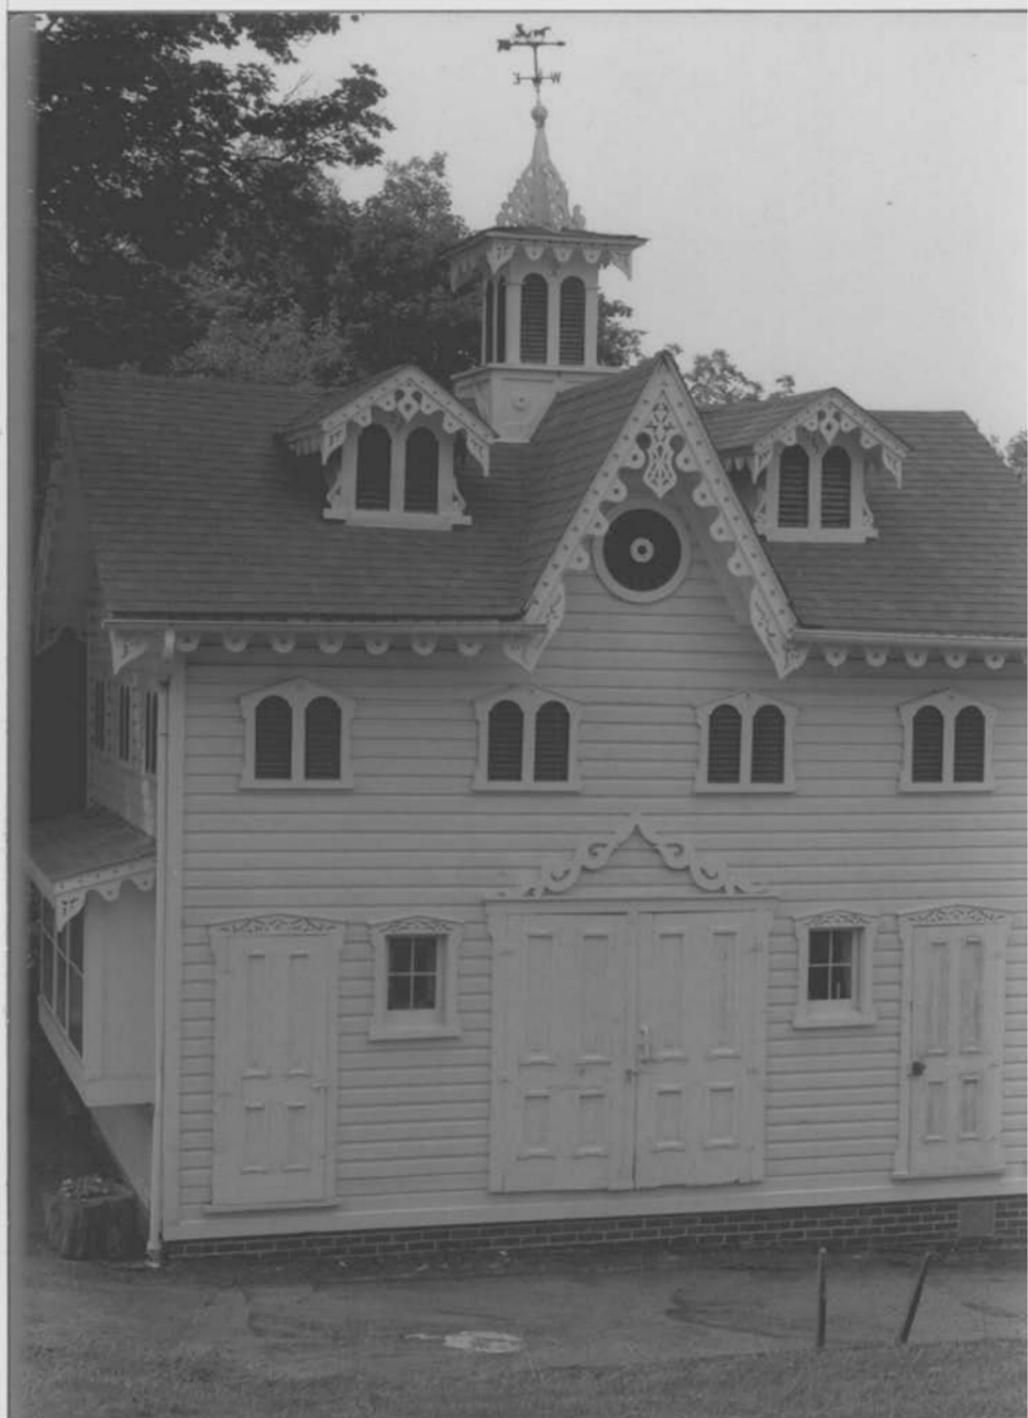
4/4

View of the Smith Brothers House
Carriage house (apartments), to the southeast.

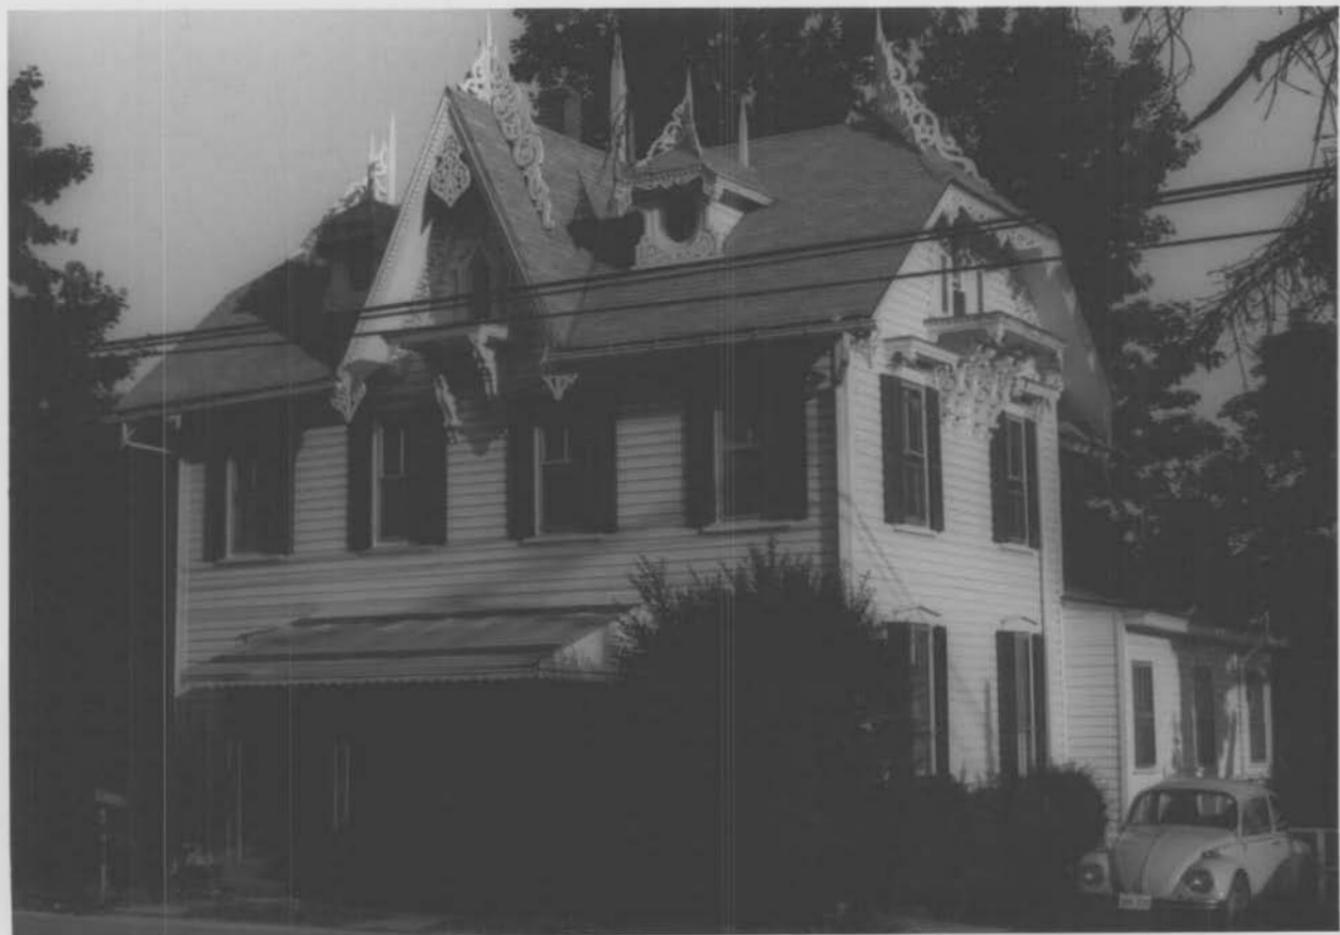
SMITH BROTHERS HOUSE BA 931
Baltimore County, Maryland
J. McGrain June 1980
Neg. located at MHT
Main (north) & west elevations
Photo 1 of 14

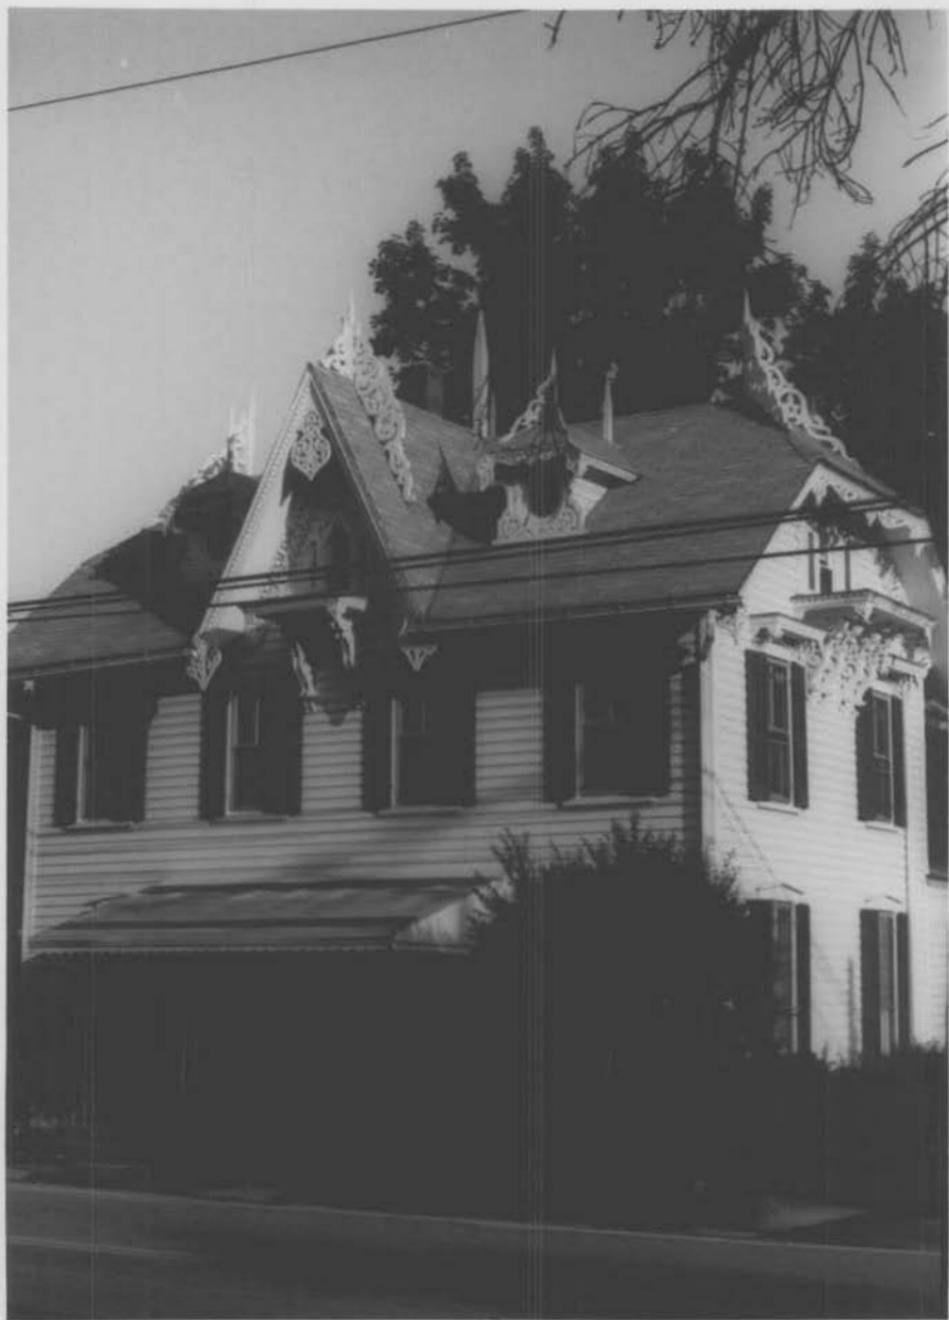
SMITH BROTHERS HOUSE
Baltimore County, Maryland
J. McGrain
Neg. located at MHT
Main (north) facade
Photo 2 of 14

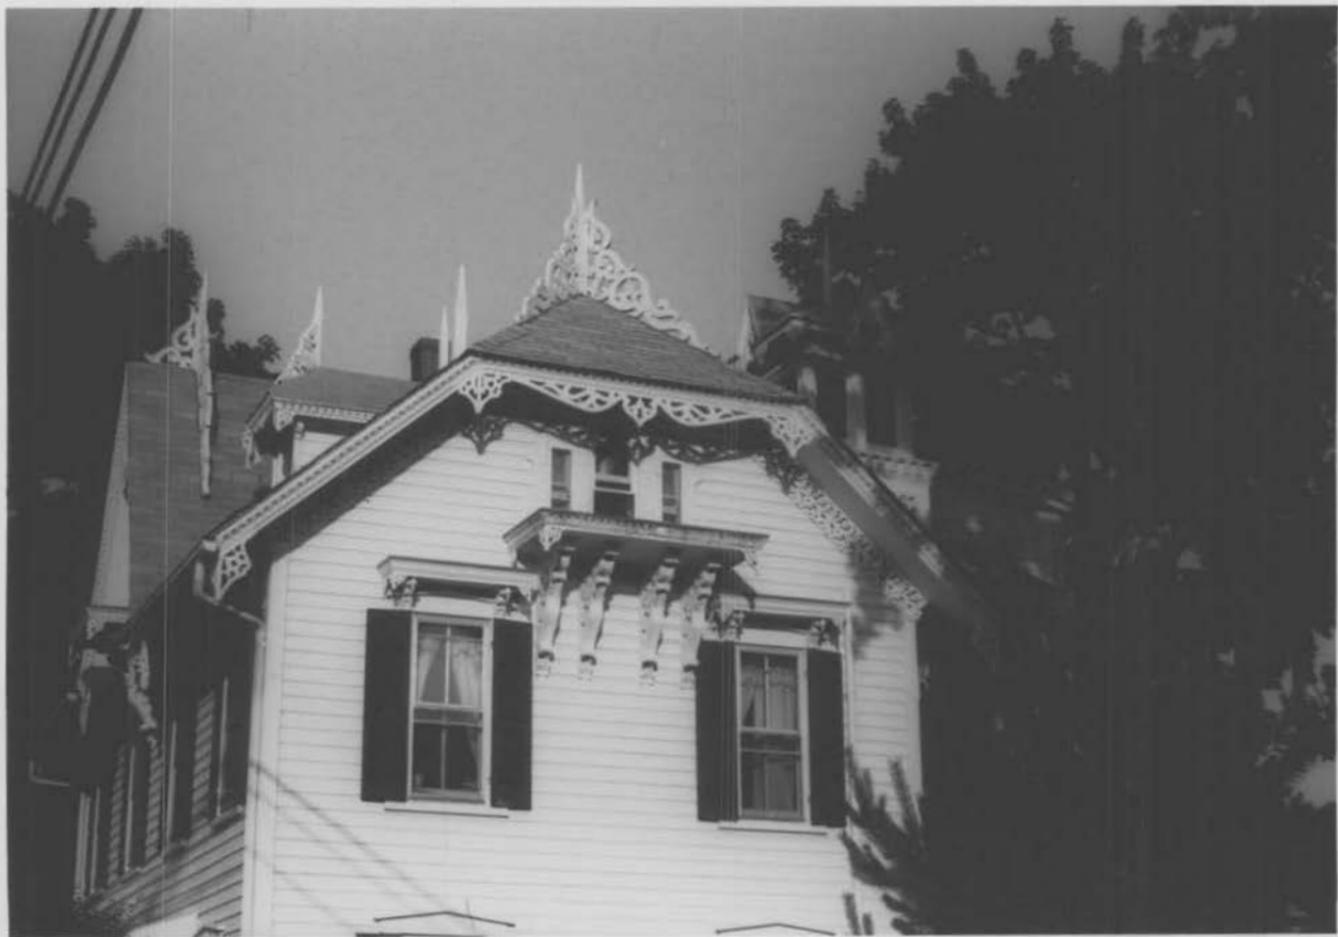
Photo 3 of 14

The main facade presents a cross-gable to the highway. The main roof is jerkinhead, with its slanted folds located at the east and west ends of the house.

West end, jerkinhead roof

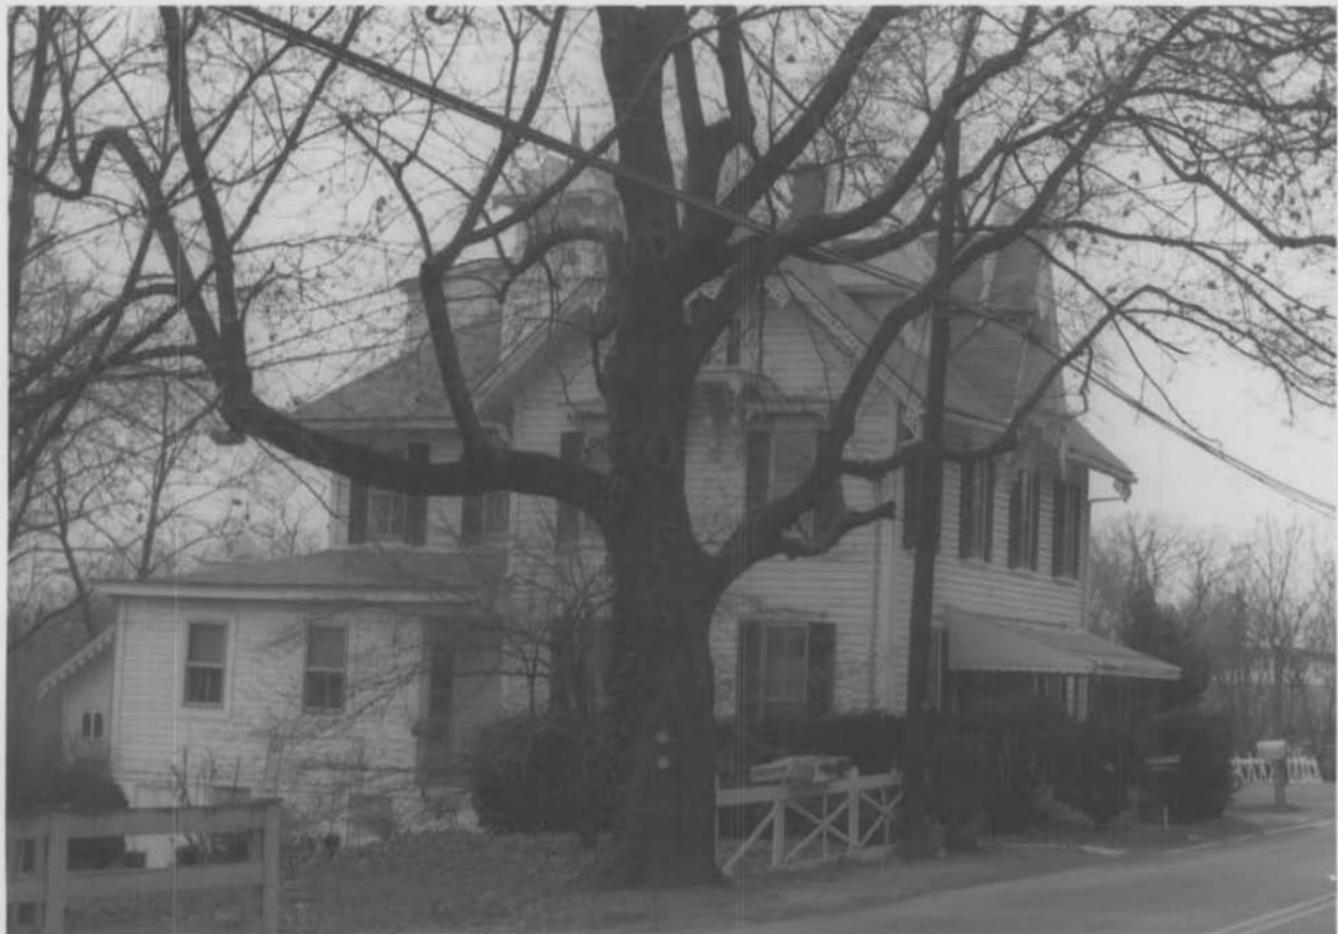
SMITH BROTHERS HOUSE BA 931
Baltimore County, Maryland
J. McGrain Nov. 1981
Neg. located at MHT
Main fac. & east end from east
Photo 4 of 14

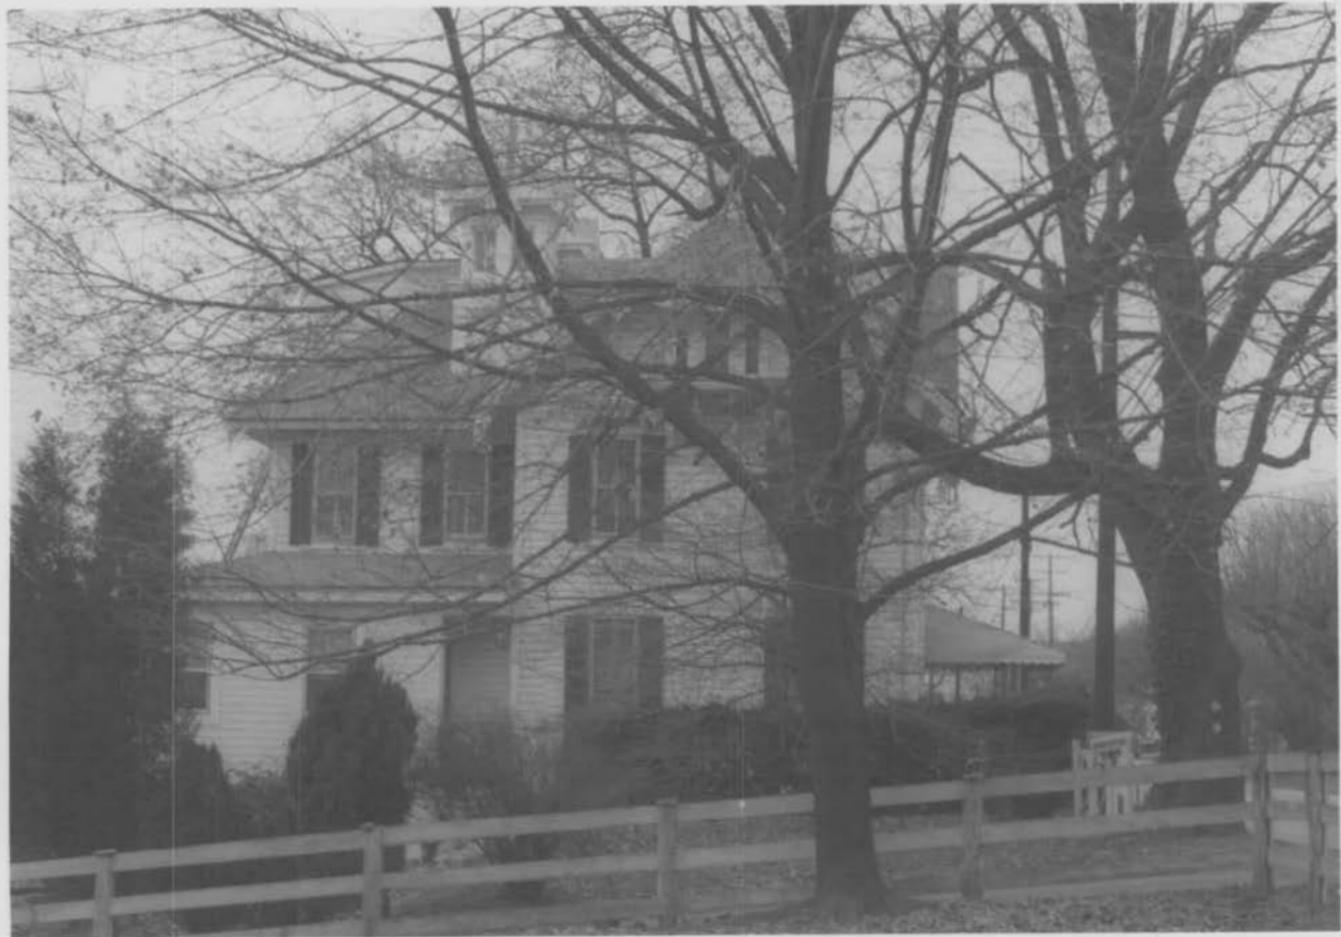
Photo 5 of 14

East end from east

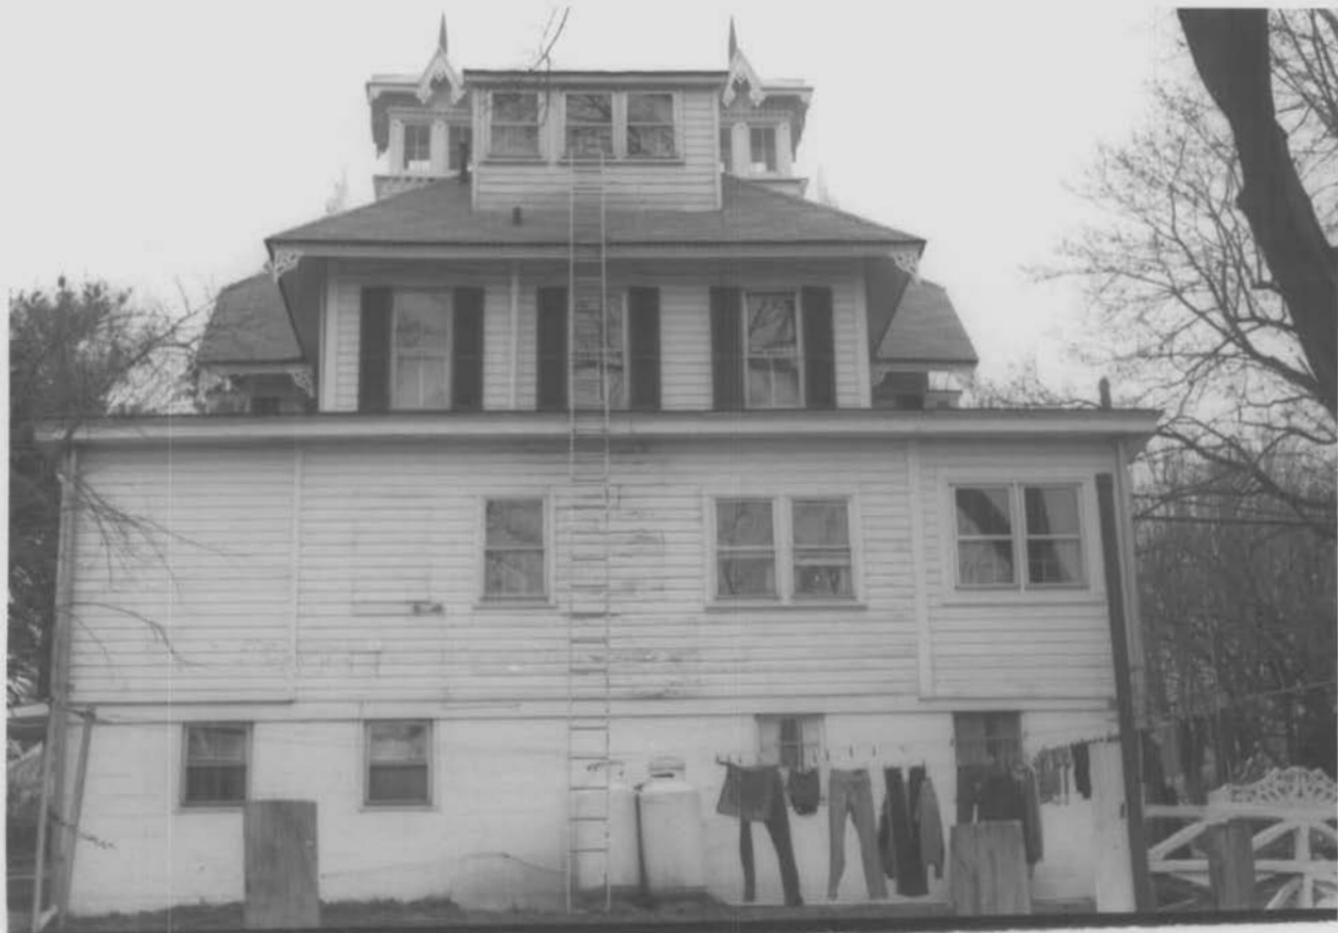
The rear wing of the house is both gable- and shed-roofed. Two square cupolas rise from the rear wing and are elaborately decorated with lace pendants, miniature cross-gables, and flat, applied wooden-lace banding or paneling. The cupolas are lighted by four pairs of 2-over-2 windows and each cupola is topped by a sharp wooden finial.

SMITH BROTHERS HOUSE BA 931
Baltimore County, Maryland
J. McGrain Nov. 1981
Neg. located at MHT
Rear, from south
Photo 7 of 14

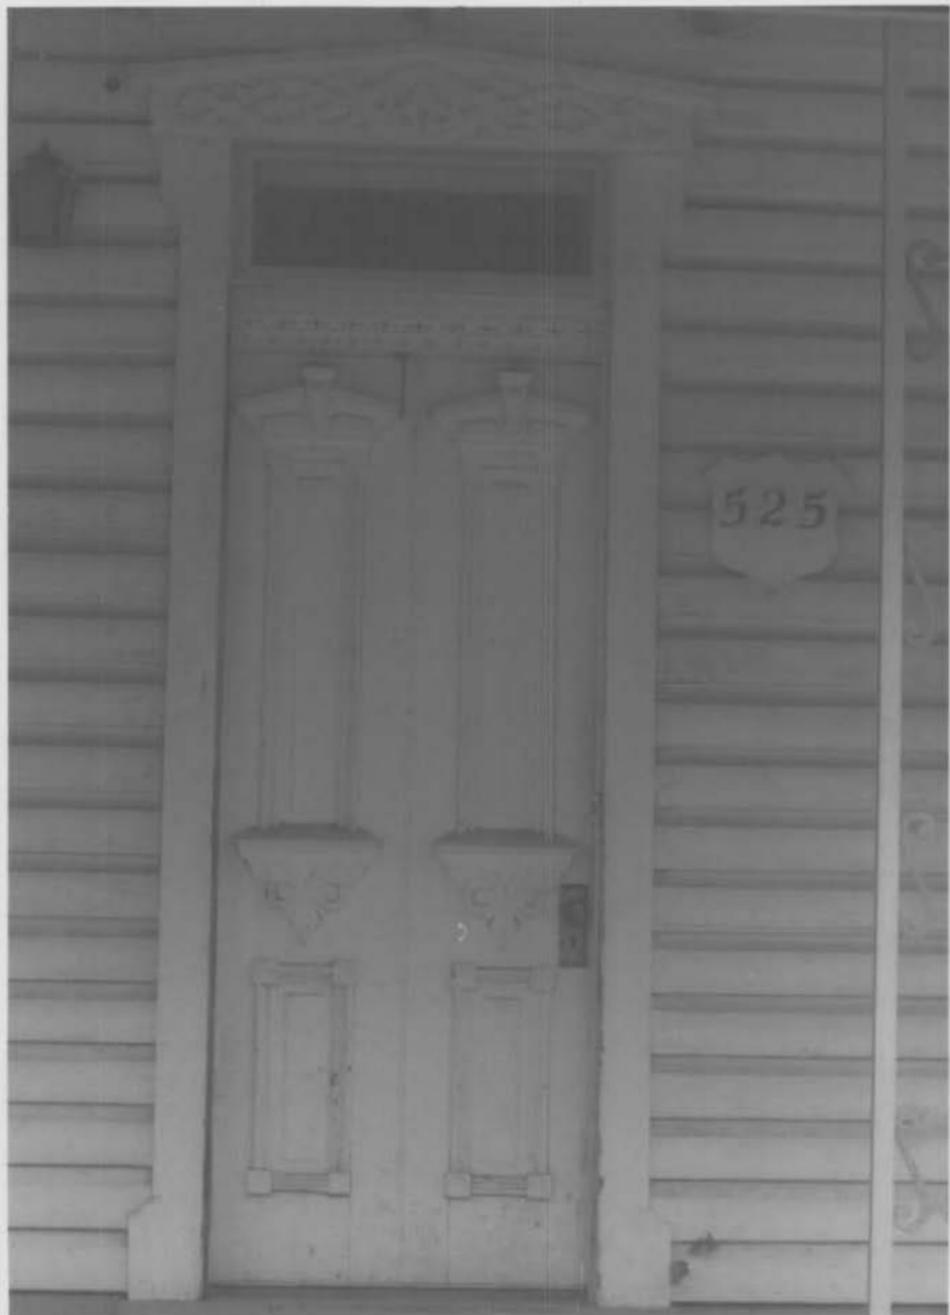
SMITH BROTHERS HOUSE BA 931
Baltimore County, Maryland
J. McGrain Nov. 1981
Neg. located at MHT
Applied decoration, west front door
Photo 6 of 14

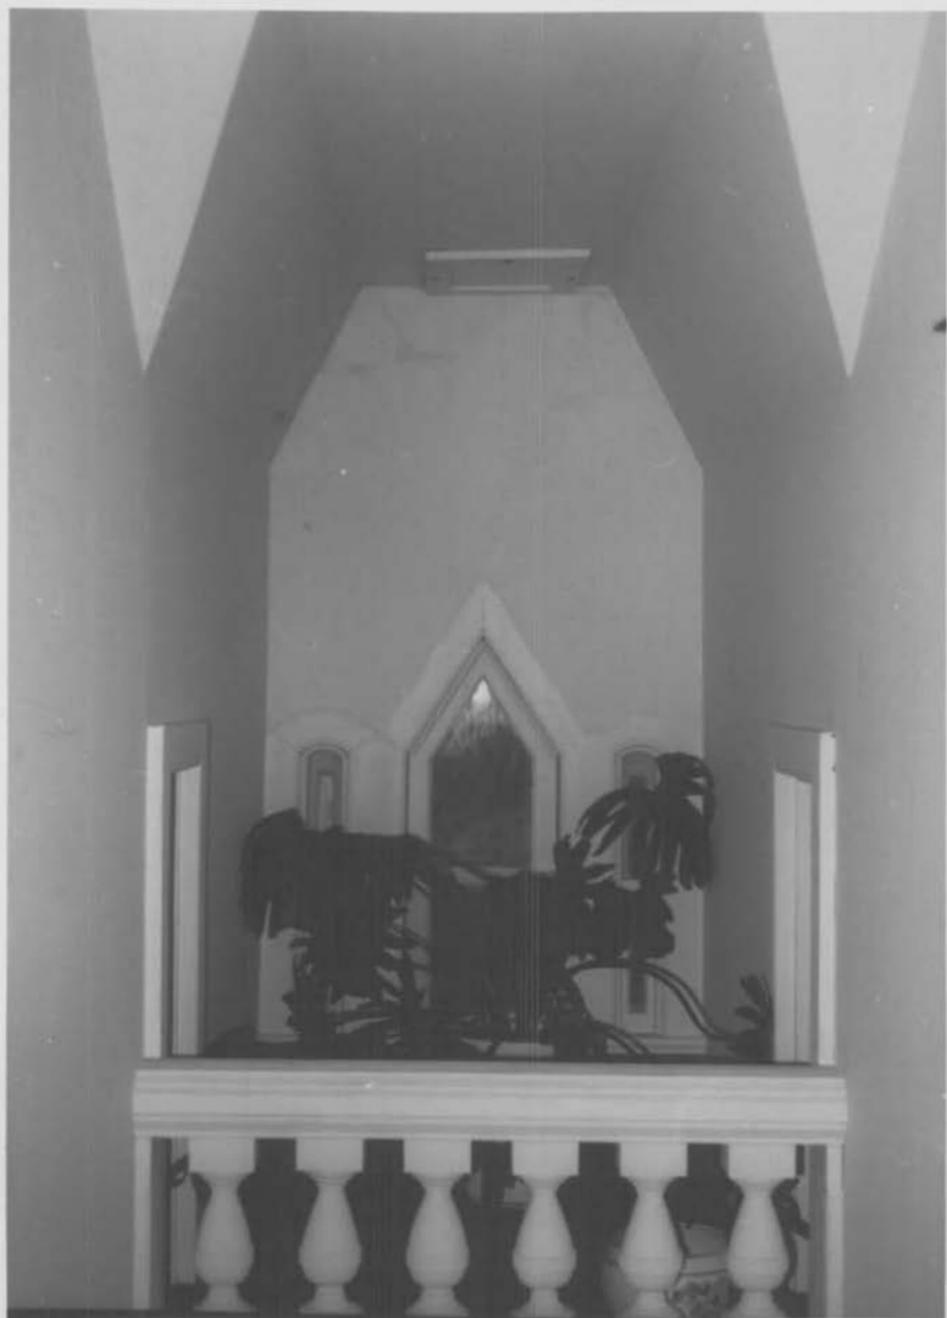
The central gable houses a set of three windows, and there is a platform behind the windows, railed with a classical (rather than Victorian) wooden balustrade. The main stairway descends to the second story under the dormer platform. The small floor space pro-

SMITH BROTHERS HOUSE BA 931
Baltimore County, Maryland
J. McGrain Nov. 1981
Neg. located at MHT
Interior of front cross-gable, attic
apartment
Photo 8 of 14

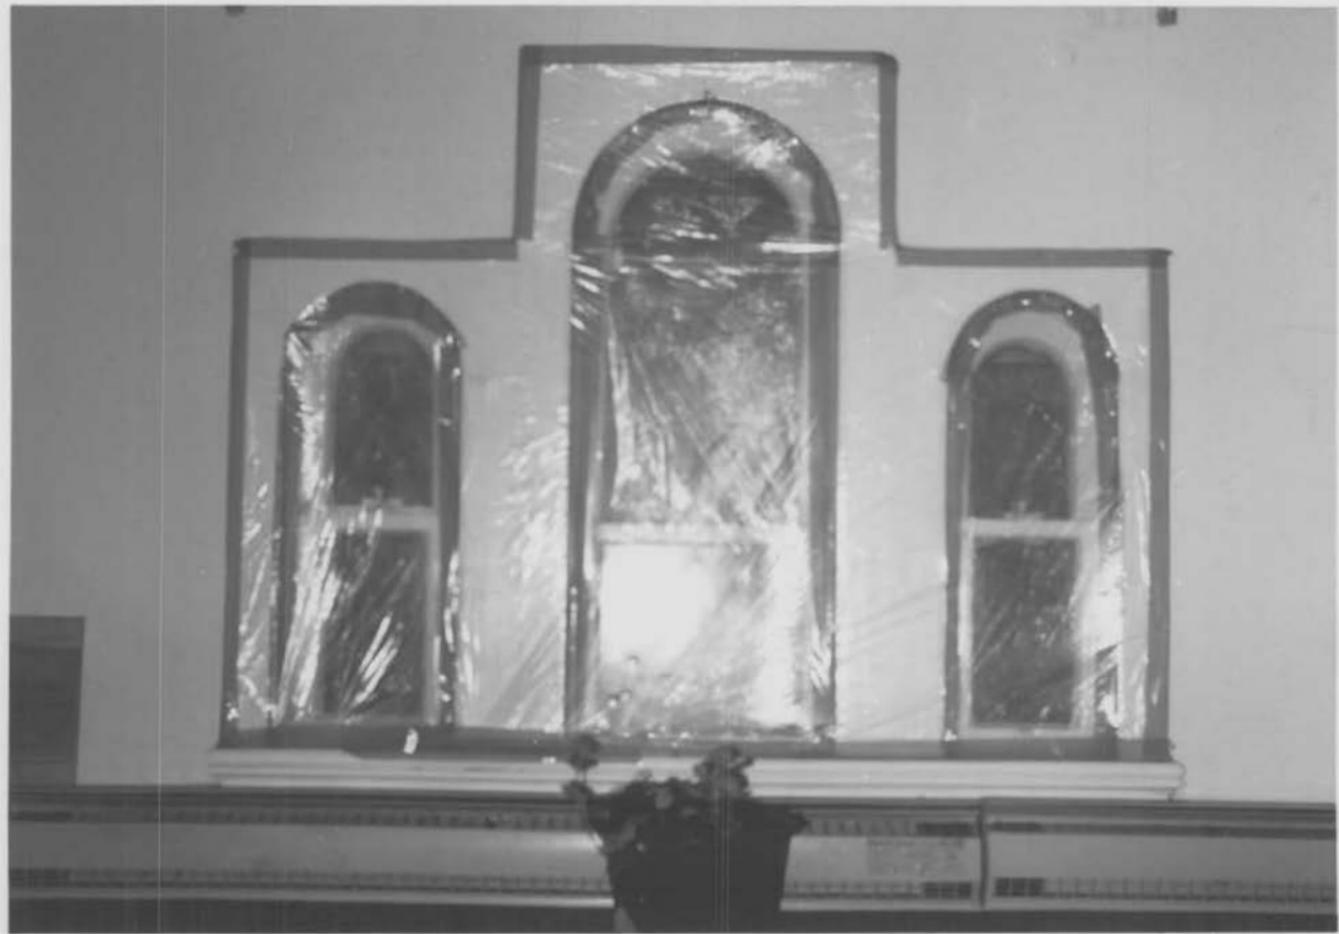
The interior of the house is remarkably plain and, having been made into apartments, some rooms were reduced in volume by the addition of passages and stairs. There are no good examples of fireplaces. Some of the door frames include bull's-eye corner blocks and some were provided with plain transoms. Most rooms contain the original floor planking. The attic contains the most interesting features. The attic was apparently a finished space from the beginning. The walls and interior recesses of the dormers are fully plastered. There are a number of small storage places under the eaves, some with paneled doors, others with board and batten doors. The room doors are unusually low. Two light shafts are provided by the two square cupolas that rise above the roofing. These spaces are almost too small to be of any use, but one serves as a pantry, the other contains a table for electronics hobby projects. Some of the fanciful dormer windows are oval and others are round-topped and lancet-topped. The oval windows open by pivoting; the other small windows—some sashes only about a foot high—actually function and slide upward. The attic dwellers find these windows at shoe-top level.

SMITH BROTHERS HOUSE BA 931
Baltimore County, Maryland
J. McGrain Nov. 1981
Neg. located at MHT
Interior of gable-end window sashes,
attic apartment
Photo 9 of 14

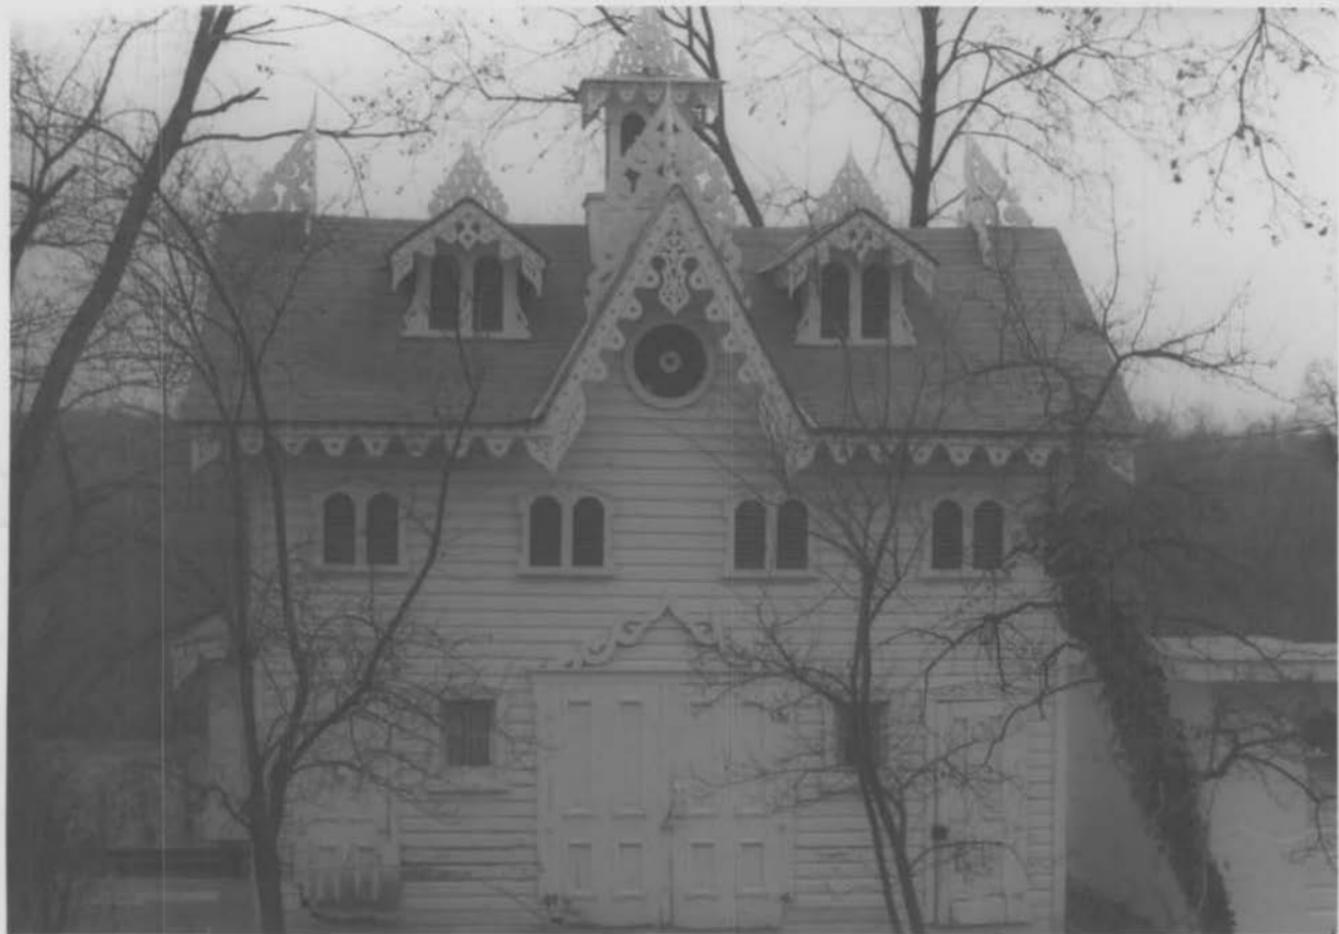
Photo 10 of 14

The north or main facade presents a pair of paneled doors to the highway at first-story level. Until recent restoration, the east end of the building contained garage doors, but has been re-worked to provide the living room with a full-width picture window composed of multiple square window lights.

Stable, main (north) g facade

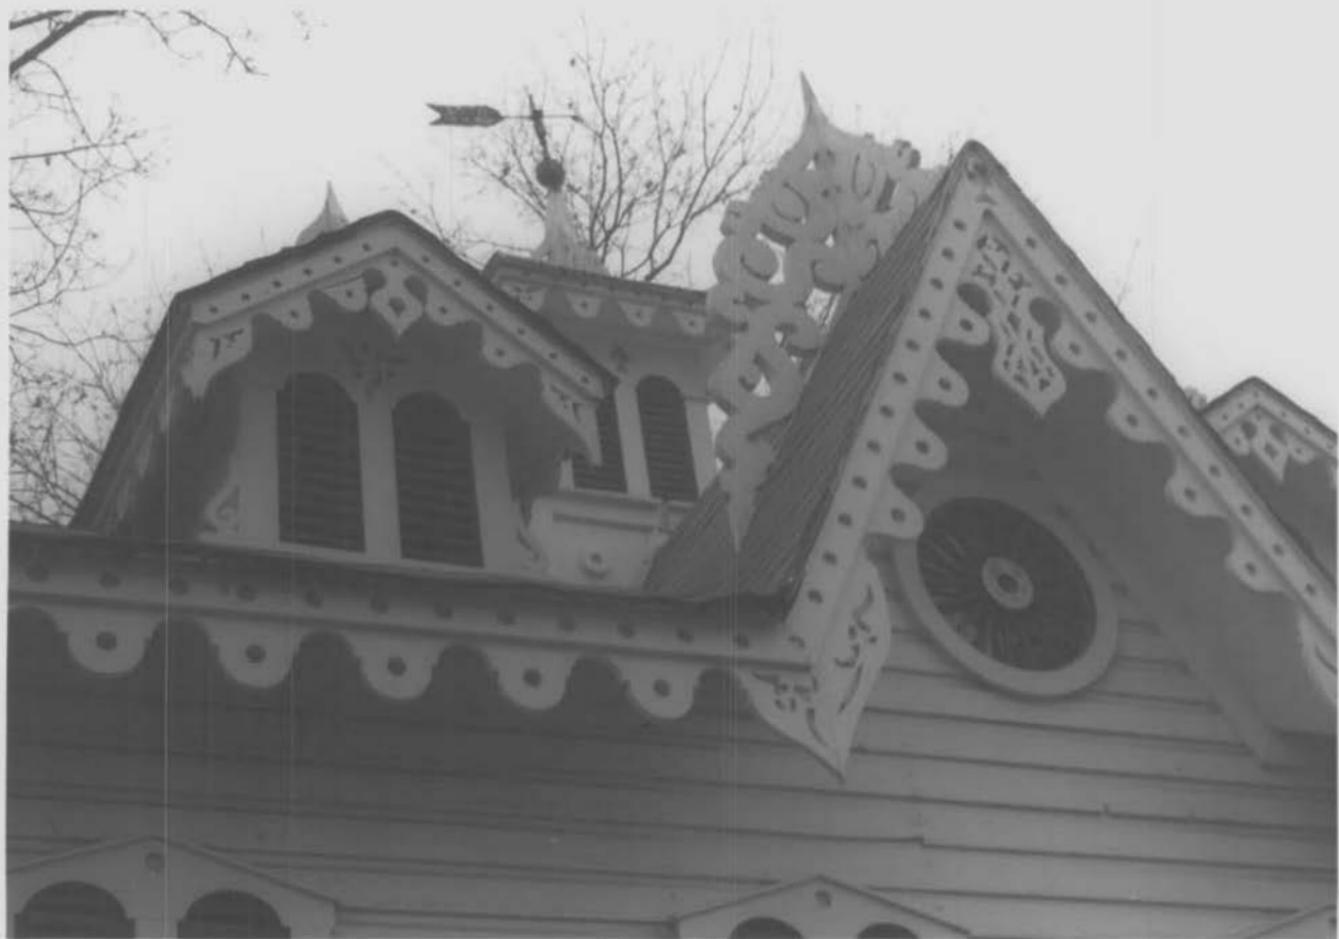
former hay-loading door has been made into a window - located at about shoe-top level. The gable ends of the stable contain what looks like sunburst decorations but are actually wagon wheels sawn in two. The main (or north) gable peak contains an entire wagon wheel as its decorative feature. Behind the wheel are panes of glass and plexiglass that help light the bedroom. One board reworked into the clapboarding over the doors is the old datemark-er from the house, many times painted white, but the numerals "1878" still showing through as if embossed.

SMITH BROTHERS HOUSE BA 931A
Baltimore County, Maryland
J. McGrain Nov. 1981
Neg. located at MHT
Stable (main) north facade, applied
 decoration
Photo 11 of 14

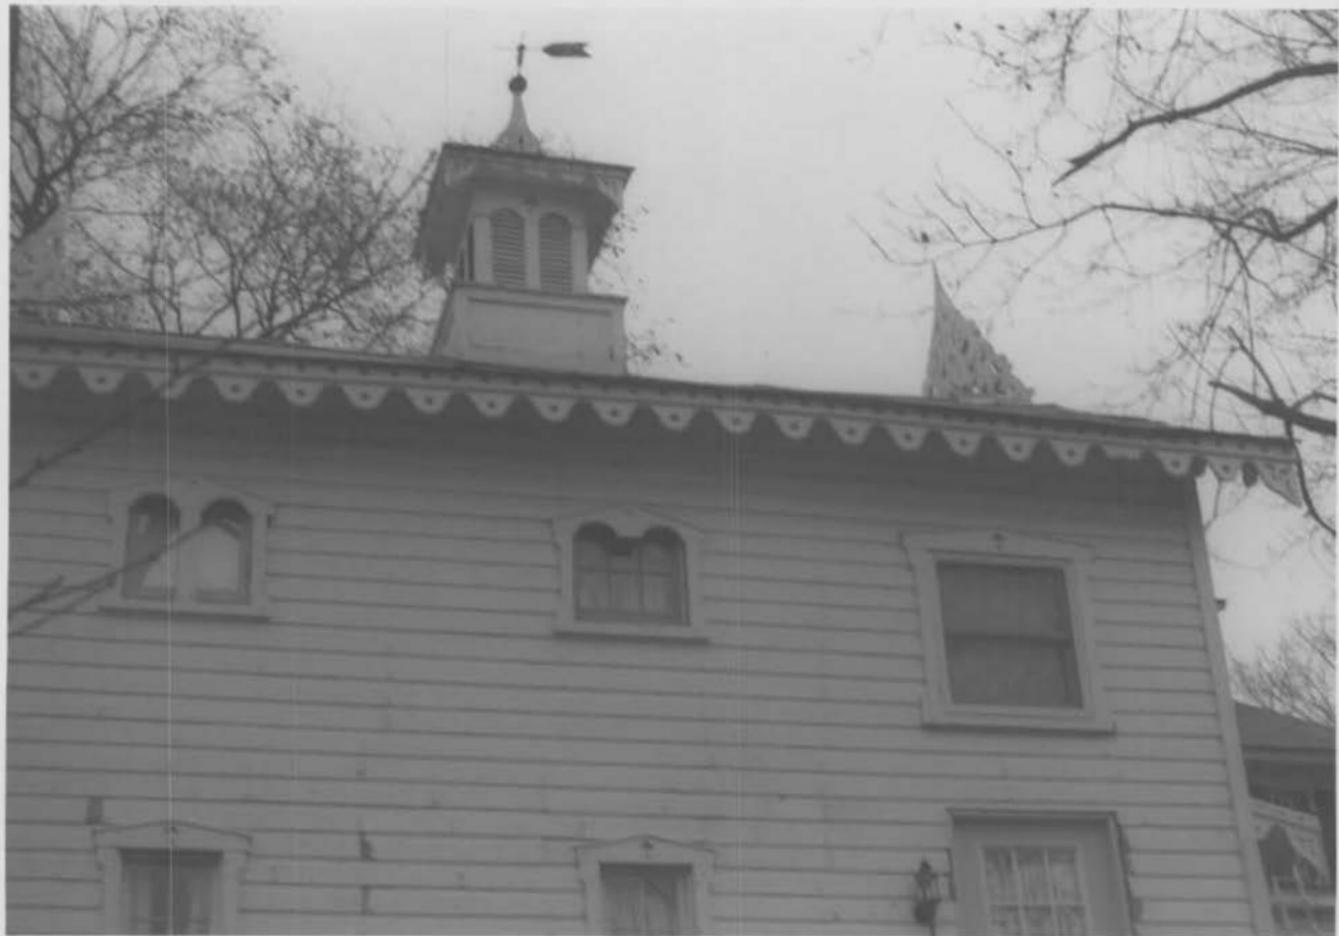
Photo 13 of 14

The south facade has a door at basement level and a newly cut door for a yet-completed porch.

Stable, rear
