**MARYLAND HISTORICAL TRUST
NR-ELIGIBILITY REVIEW FORM**

Property Name: Smith Brothers House Inventory Number: BA-931

Maryland Inventory of Historic Properties Form

Inventory No. BA-931

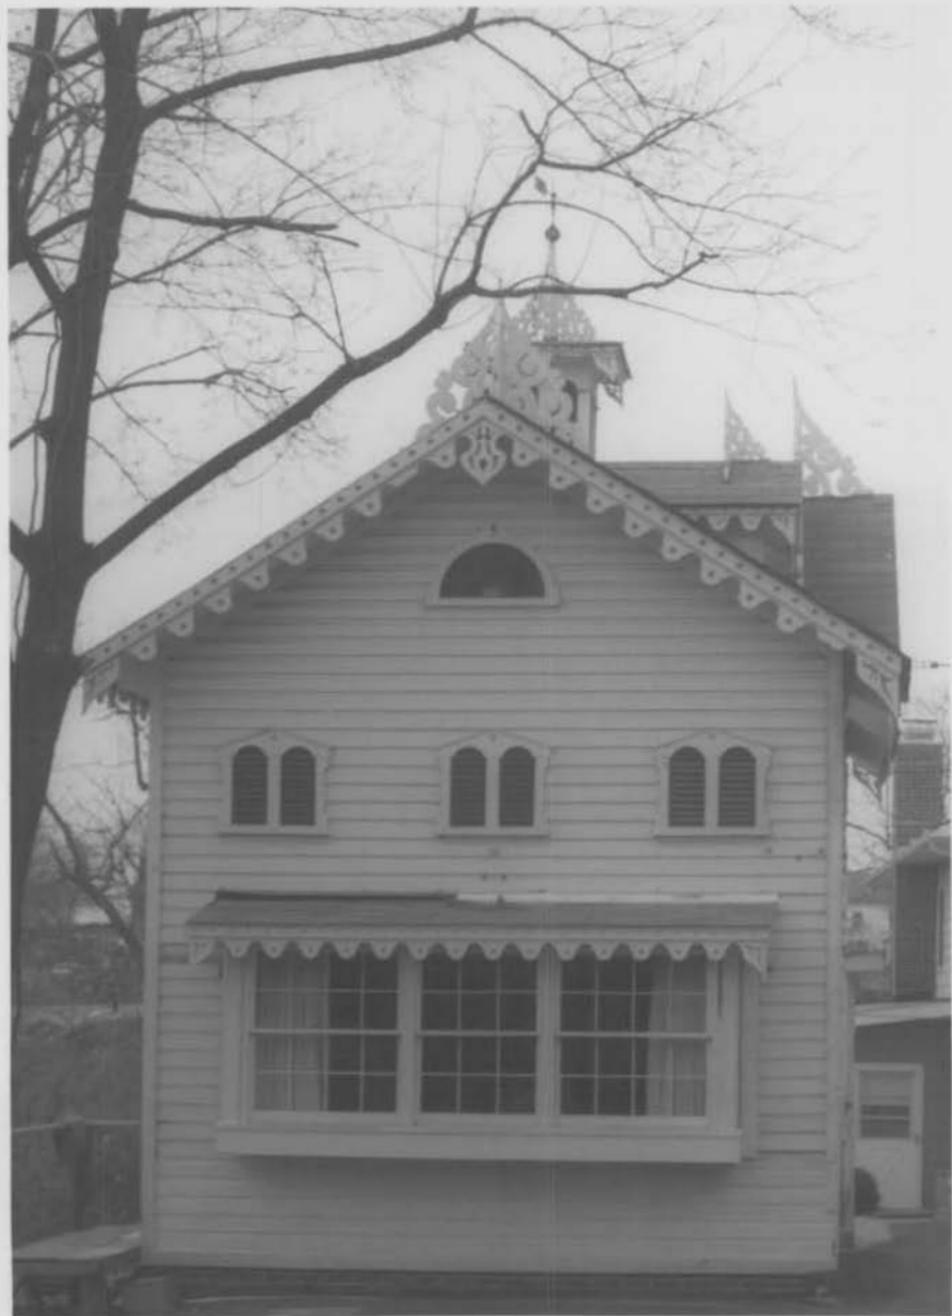
SMITH BROTHERS HOUSE BA 931A
Baltimore County, Maryland
J. McGrain Nov. 1981
Neg. located at MHT
Stable, east end
Photo 12 of 14

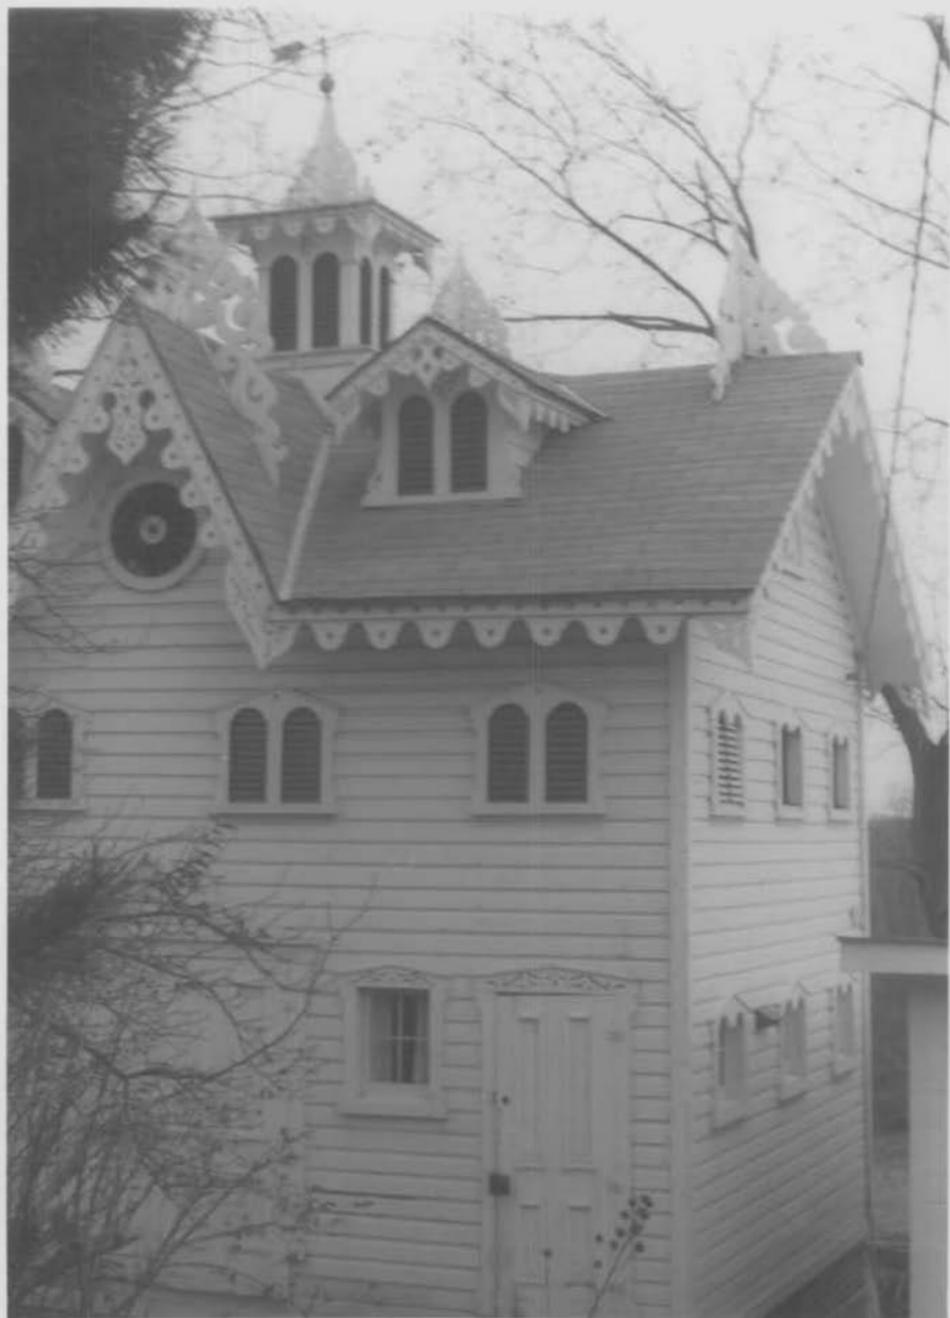
SMITH BROTHERS HOUSE BA 931A
Baltimore County, Maryland
J. McGrain November 1981
Neg. located at MHT
Stable, main (north) facade & west
end
Photo 14 of 14
