CAPSULE SUMMARY - RICHARDSON BARN (CT-1033)

# Maryland Historical Trust State Historic Sites Inventory Form

and/or common Richardson Barn

street & number 2095 Lloyd Bowen Road  not for publicationcity, town St. Leonard  vicinity of  congressional districtstate MD  county Calvert

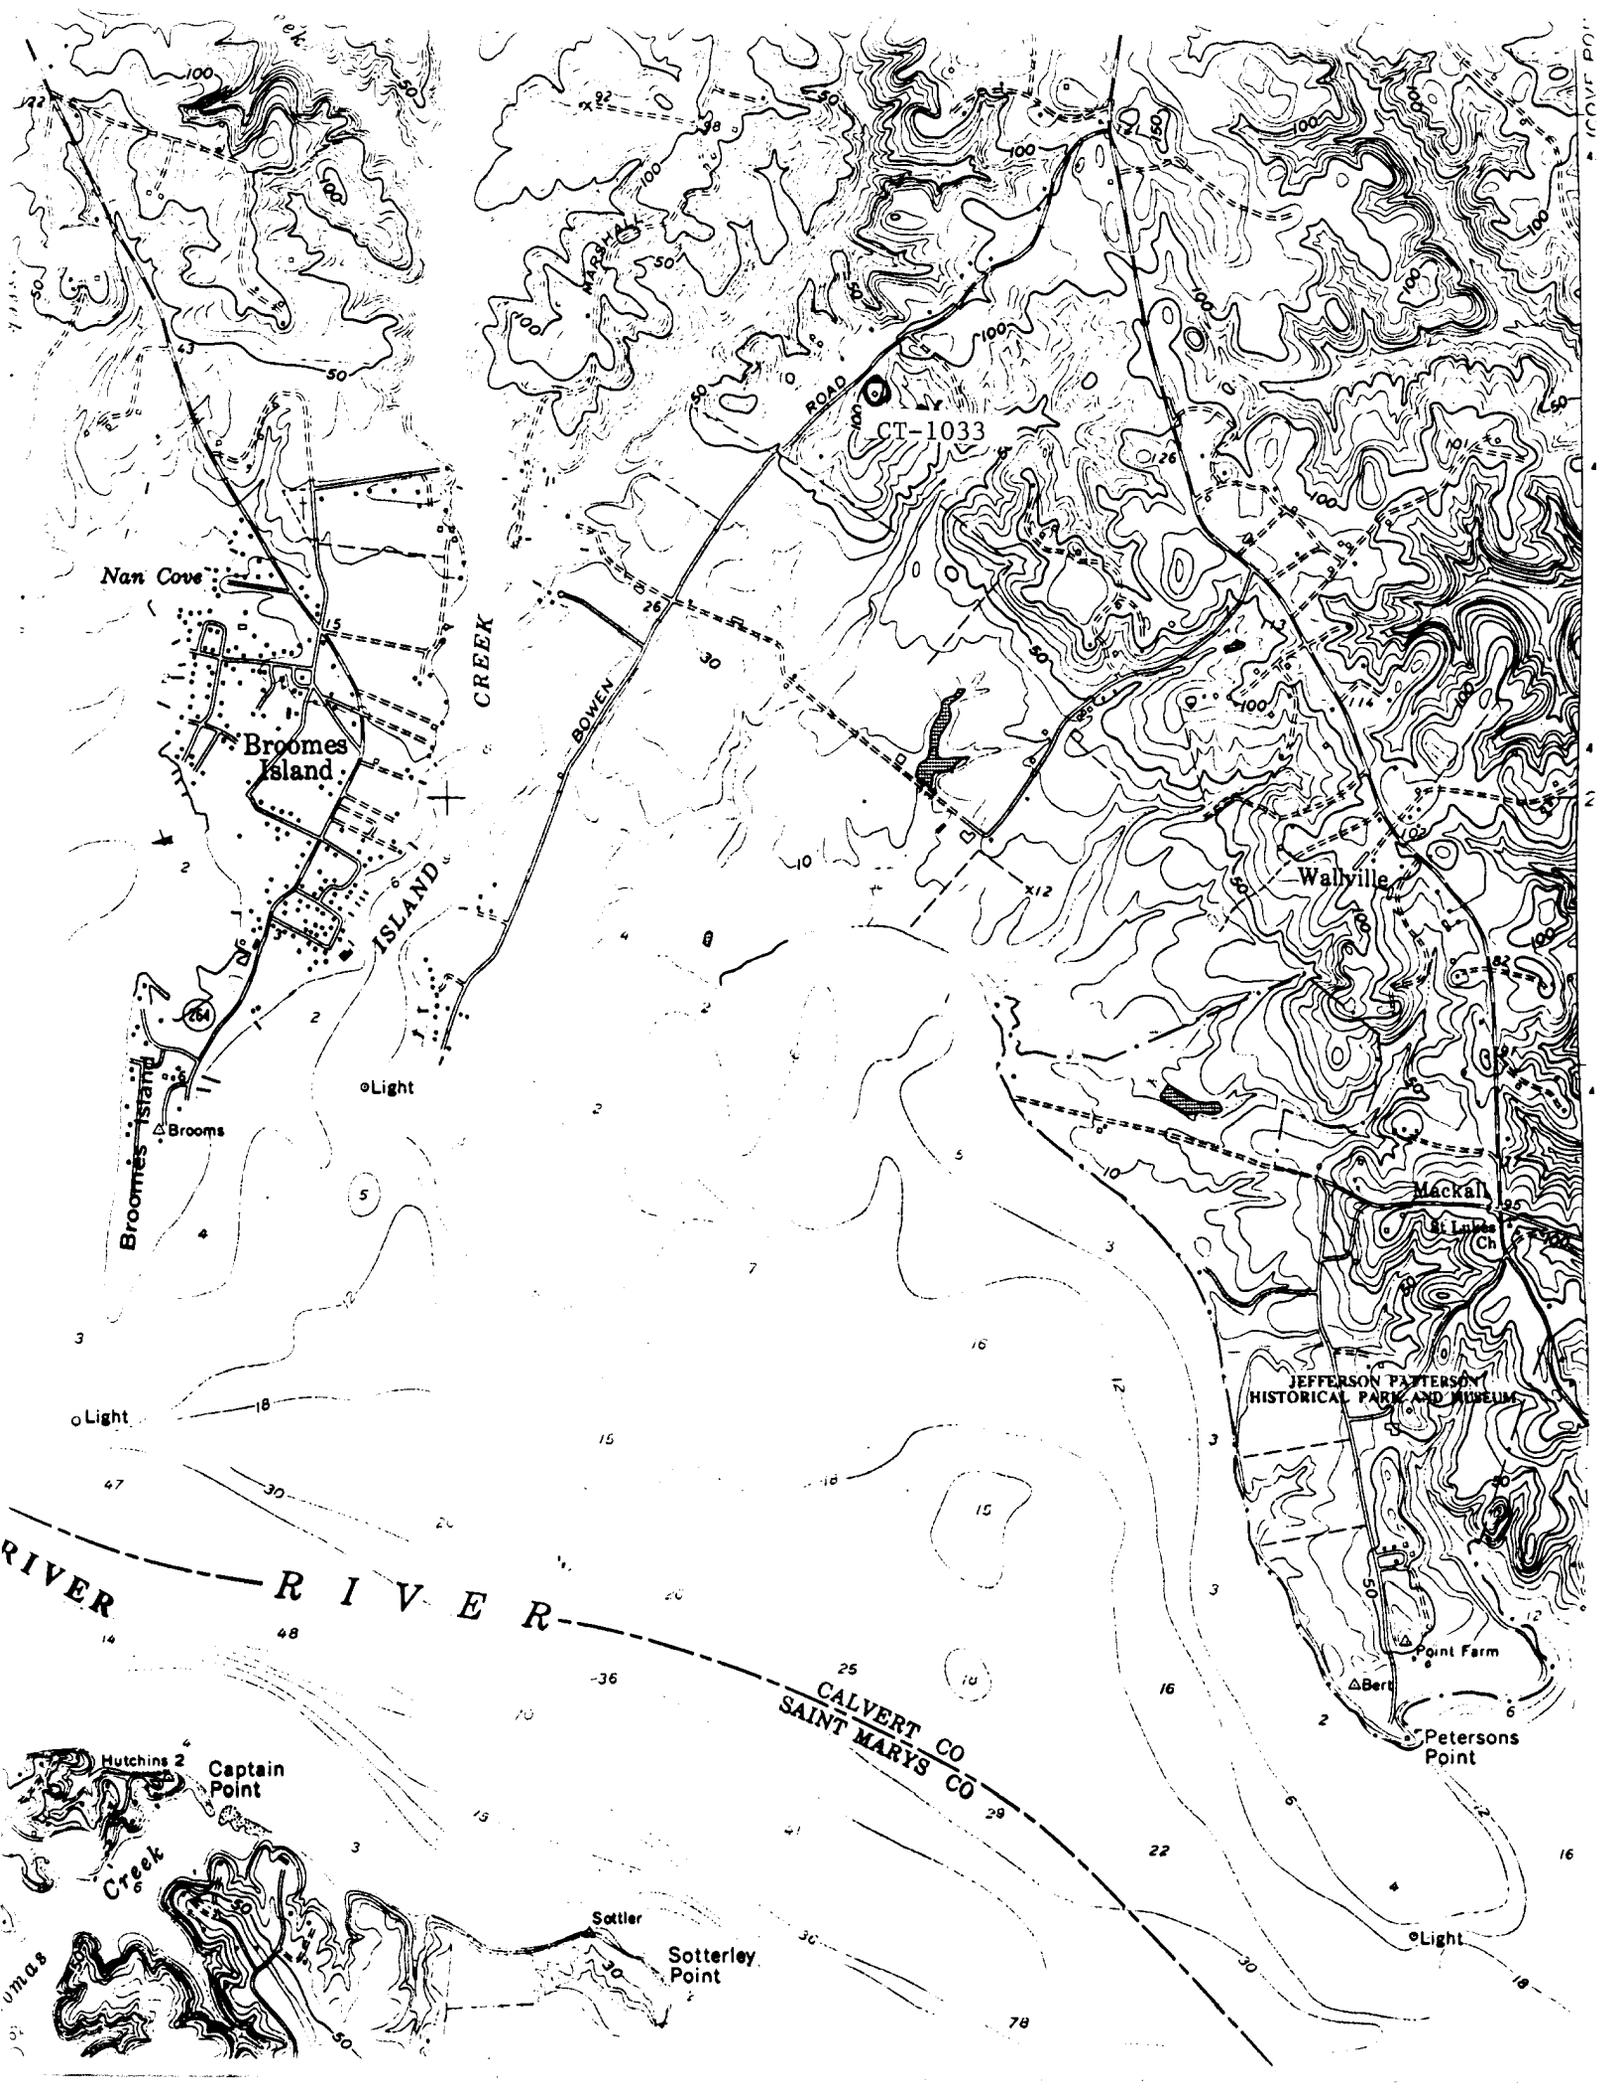
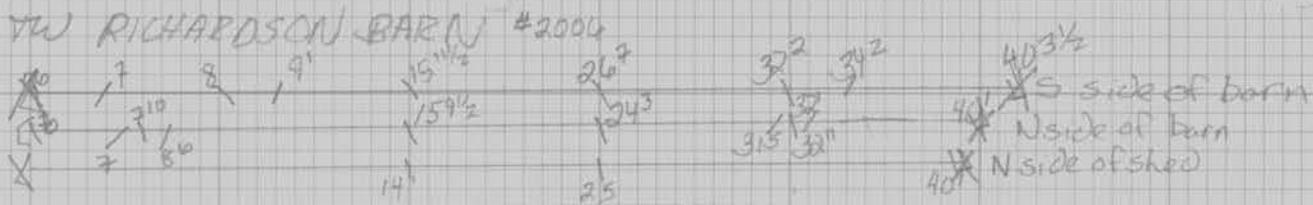
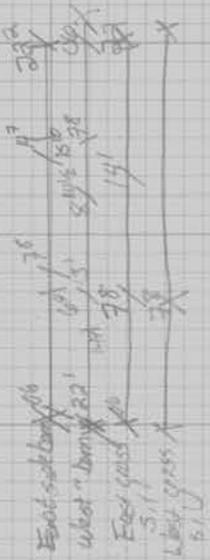
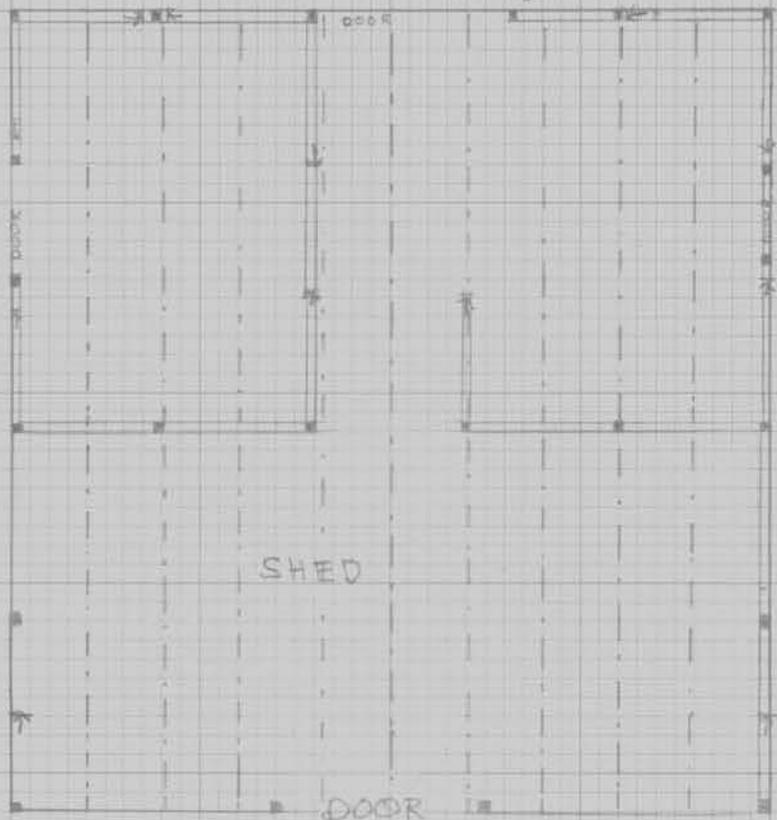
2/28/90 SCALE 1"=10' TW RICHARDSON BARN #2004

The transverse axis barn is divided into bays of eight, eight, ten, six, and eight feet (on the south side). The north side consists of five eight foot bays. It contains ten rooms. The southern facade door forms the ten foot wide bay. There is some evidence of an earlier door along along the north side of the barn wall, where the shed now stands. The shed is apparently an addition, as indicated by the existence of nails on the rafters of the barn below where it joined with the shed. These nails indicate that the barn roof (including this section) was at one time completely shingled. If the shed were original, it would have been unnecessary to shingle this portion of the roof.

The barn structure is supported by concrete blocks and poured concrete. Large unmortared field stones are inserted for additional support between the concrete block piers. The barn had two cross-sills originally, but one has been largely removed, perhaps in order to accommodate vehicle access. Timbers are circular sawn, and light, the nails are wire. The barn has verticle weatherboard siding with ventilation. The roof rafters are on four foot centers, and rest on a flat false plate. Windbraces and three collars help support the roof. There are shingle nailers in place under under the present metal covering. There are no poles down the central axis, and the tier poles span the twenty foot width of the barn. They are tied with twine and otherwise supported. The vertical hanging distance in this structure is four feet. A feed trough and manger are located in the west end of the barn on the north side.

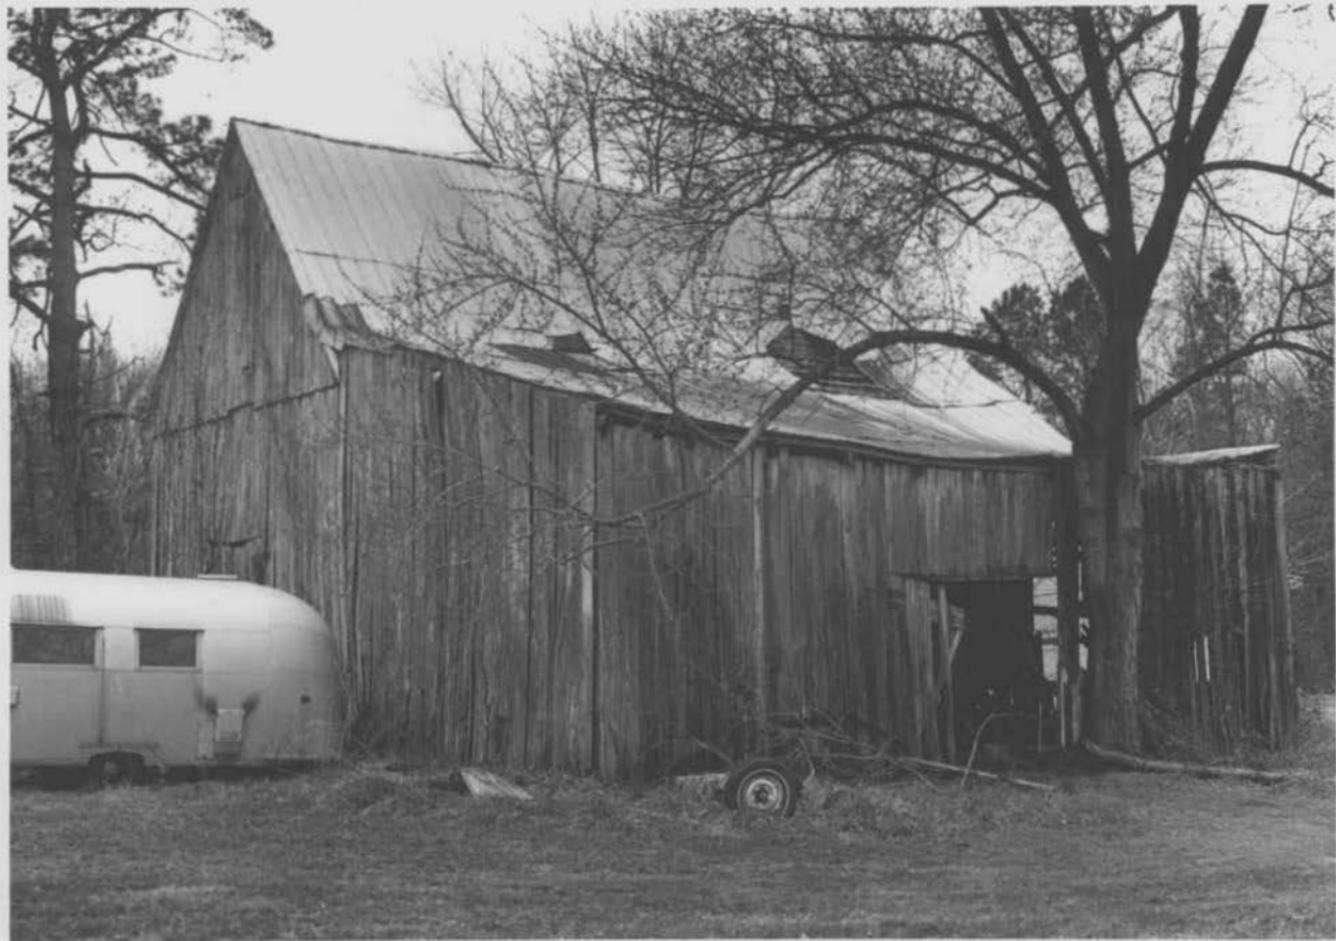
CT-1033 Richardson Barn  
St. Leonard  
Toad L. Williamson  
North  
February, 1993

Located in St. Leonard along J. Lloyd Bowen Road, this barn is located across the road, but apparently associated, from an early 20th century farm complex. Constructed of circular sawn timbers and wire nails with a center aisle plan, this measures 22 x 40 feet with a 20 x 40 shed on its north side. The steeply pitched roof and rather poor condition suggest a barn much older than it is in actuality. Both barn and shed are sided with vertical planks.
