MARYLAND HISTORICAL TRUST
DETERMINATION OF ELIGIBILITY FORM

Property Name: Horsmon Tobacco Barn C Inventory Number: CT-1067
Address: 1805 Parran Road Historic district: ___ yes no
City: St. Leonard Zip Code: 20685 County: Calvert
USGS Quadrangle(s): Broomes Island
Property Owner: HORSMON, RICHARD A & PHYLLIS J Tax Account ID Number: 157655
Tax Map Parcel Number(s): 206 Tax Map Number: 34
Project: Dominion's Cove Point Expansion Project Agency: FERC
Agency Prepared By: GAI Consultants, Inc.
Preparer's Name: Matthew G. Hyland Date Prepared: 5/17/2005
Documentation is presented in: MIHP form
Preparer's Eligibility Recommendation: ___ Eligibility recommended Eligibility not recommended
Criteria: A B C D Considerations: ___ A ___ B ___ C ___ D ___ E ___ F ___ G
Complete if the property is a contributing or non-contributing resource to a NR district/property:
Name of the District/Property: _____
Inventory Number: _____ Eligible: ___ yes Listed: ___ yes
To be visited by MHT Staff ___ yes no Name: _____ Date: _____

CAPSULE SUMMARY - HORSMON BARN 'C' (CT-1067)

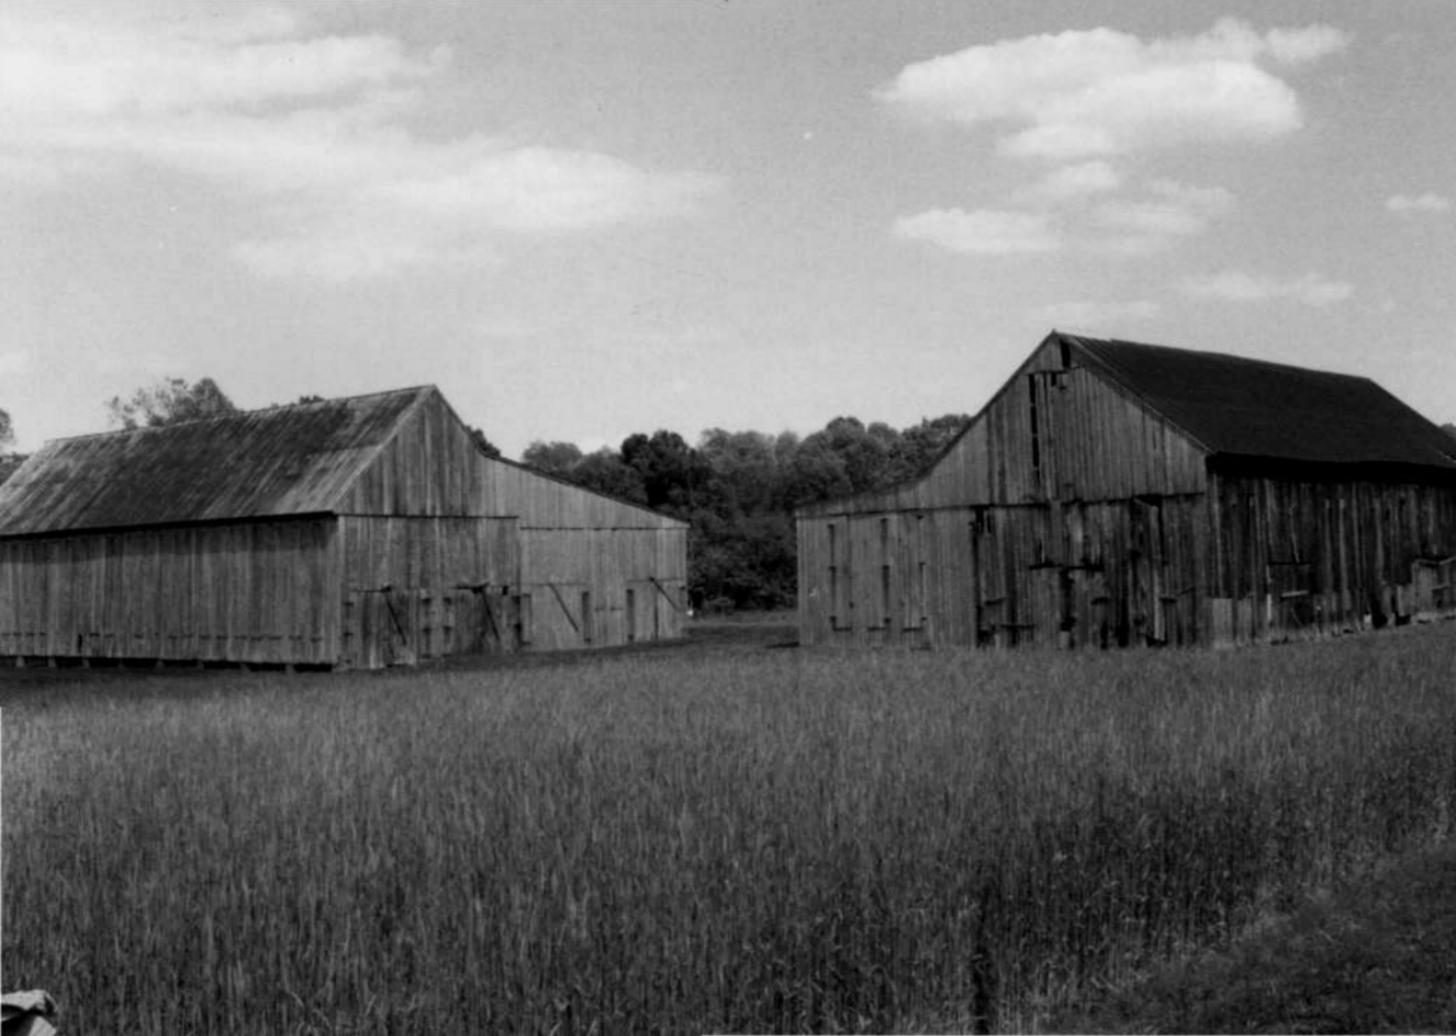
1/2

Barn C stands adjacent to an existing earth and gravel driveway that proceeds from the main road (Parran Road) through large fields and adjacent to a natural gas transmission pipeline. The barn is a wood frame building constructed on poured concrete pier foundations. The siding material consists of vertical wood boards. The barn has corrugated metal roof coverings. The tobacco barn contains approximately eight scaffolds each. A shed roof extension has been appended to the barn.

Horsmon Barns CT-1067 & CT-1068

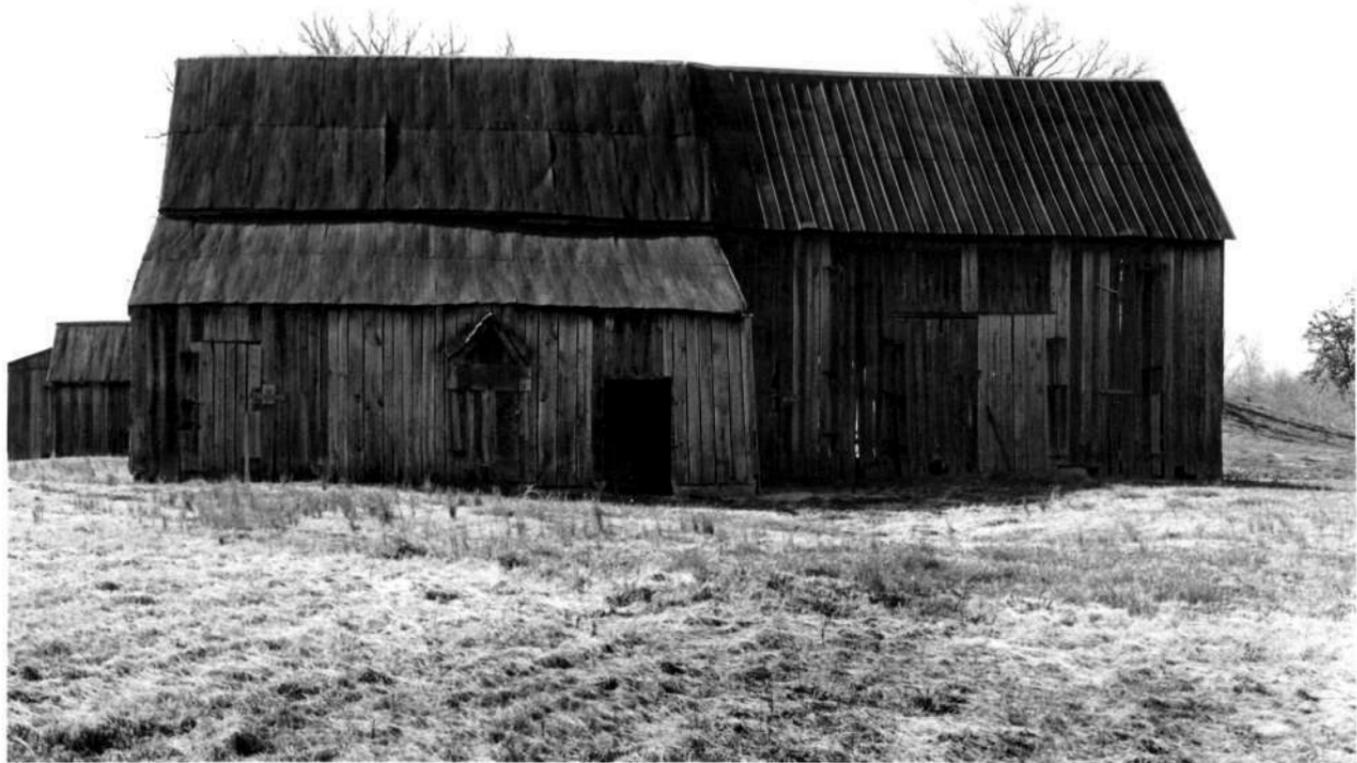
CT-1067 Hovsmon Barn "C"

South

March, 1990
