CAPSULE SUMMARY CT-1118

and/or common Hallowing Point Barn A

Survey No. CT-1118

CT-1118 Hallowing Point Barn 'A'

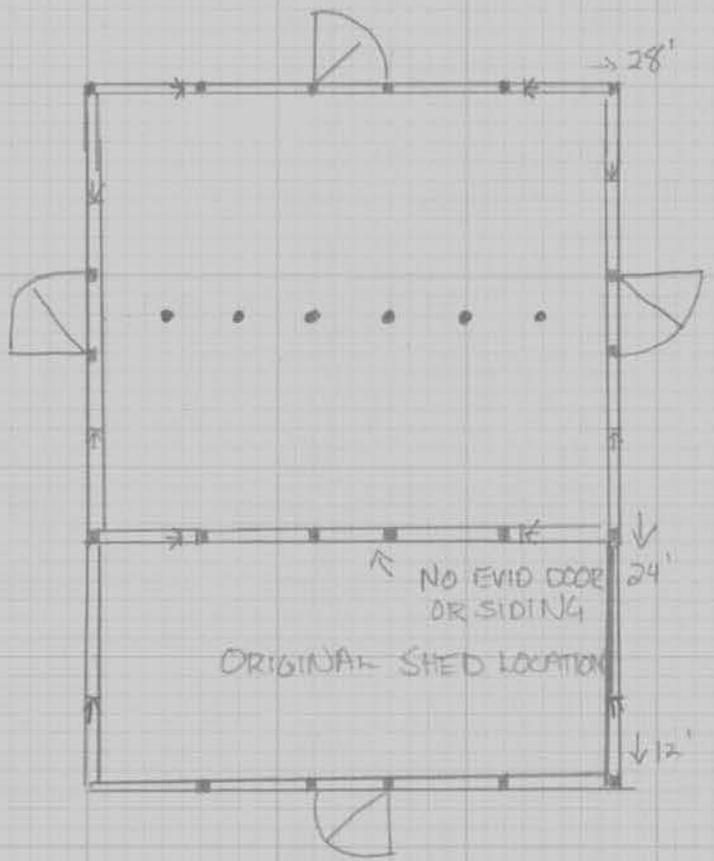
BARN # 2091 HALLOWING PT, BARN A 5/8/90 TW

Concrete block masonry piers and large unmortared field stones support the barn frame. The posts are hewn and joined via mortise and tenon joints with trunnels. Nails are cut, some have variety in heads, possibly early. The down braces are hewn and dovetailed. Horizontal nailers are circular sawn, mortised and nailed. Plain vertical siding with some hinged ventilation doors covers the exterior. There is one door on the east side, two on the west, and five on the north. There is some early siding of very wide two foot boards attached with fully mature cut nails on the north side of the barn. The rafters are on four foot centers and rest on a flat false plate. The top plate is hewn. There are no windbraces and three collars help support the roof. The tier poles are separated by forty inches vertical distance. They are peeled logs supported by bracket/boards nailed to the poles that run down the central axis. There is no evidence of siding or door ever extant on the south side of the barn, therefore the south shed is probably original. Almost all of the shed including tie beams, rafters, plates, braces, posts are circular sawn. Possible that it has been entirely rebuilt?
