CAPSULE SUMMARY CT-1144

Maryland Historical Trust State Historic Sites Inventory Form

and/or common Norfolk Barn C

7. DESCRIPTION CT-1144

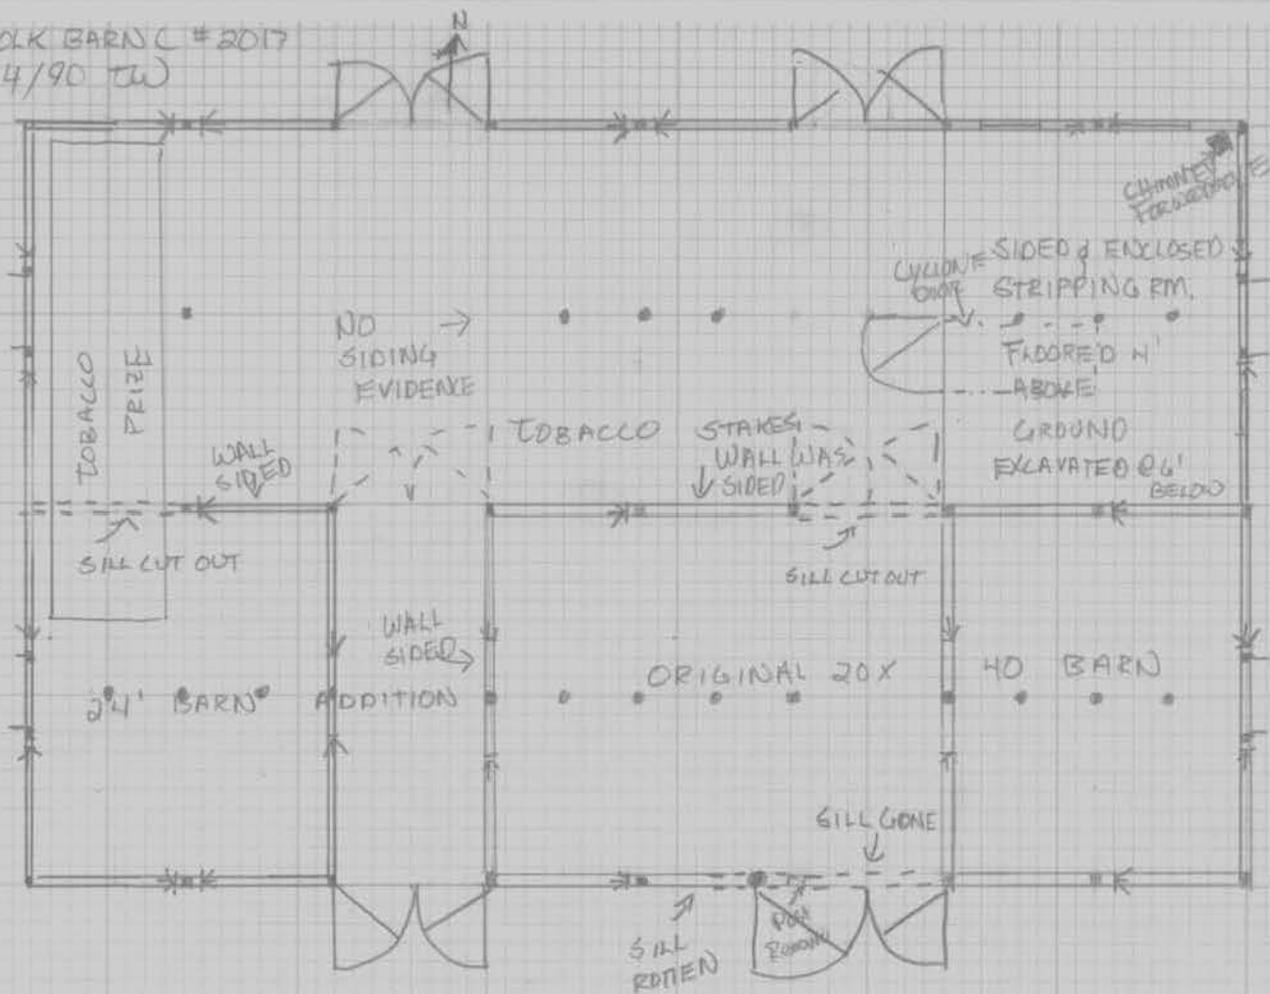
NORFOLK BARN C # 2017
5/24/90 TW

#2017 - Norfolk barn C 5/24/90 - Mr. Calvert Norfolk, Dunkirk MD
Private ownership, unoccupied.

Combination concrete blocks (new portion), wood blocks, and large unmortared fieldstones support the barn. All original timbers are circular sawn with wire nails. Some hewn sills in barn addition, probably the result of re-use of earlier timbers. Barn and addition posts are m/t w/ t. Twenty foot north addition has posts half-lapped and nailed. Down braces throughout are circular sawn and toe-nailed. The roof has been replaced. A storm destroyed the original roof. At that time, the twenty foot addition to the north was built and the roof was centered over the entire barn. Corrugated metal covers this replacement roof. The siding consist of vertical siding with single plank side-hinged ventilation doors one approximately every eight feet. The rafters are on four foot centers and rest on a flat false plate. There is one windbrace on each diagonal and four collars. The roof also has king posts and twenty feet and angled queen braces at ten and thirty feet. The tier poles are peeled logs separated by forty-one inches vertical distance in all of the barn. The poles down the center are peeled logs that are half-lapped and nailed to the tie beams. Older section and twenty-four foot addition poles have holes drilled and pegs inserted. The twenty foot addition poles are notched. There is a circular sawn horizontal screw prize in the barn.

Originally twenty by twenty-four foot barn. There is evidence of siding, old door posts, and the plates are separate. Later a twenty by twenty-four foot addition was built (ca. 1920). It was sided and had old doors, etc... A big storm ca. 1940 blew down the roof and at the time that was rebuilt, the twenty by sixty-four foot addition was built. The stripping area in the north addition is twenty by sixty four feet and has wood stove. It is inscribed "Buddy Norfolk 1941".

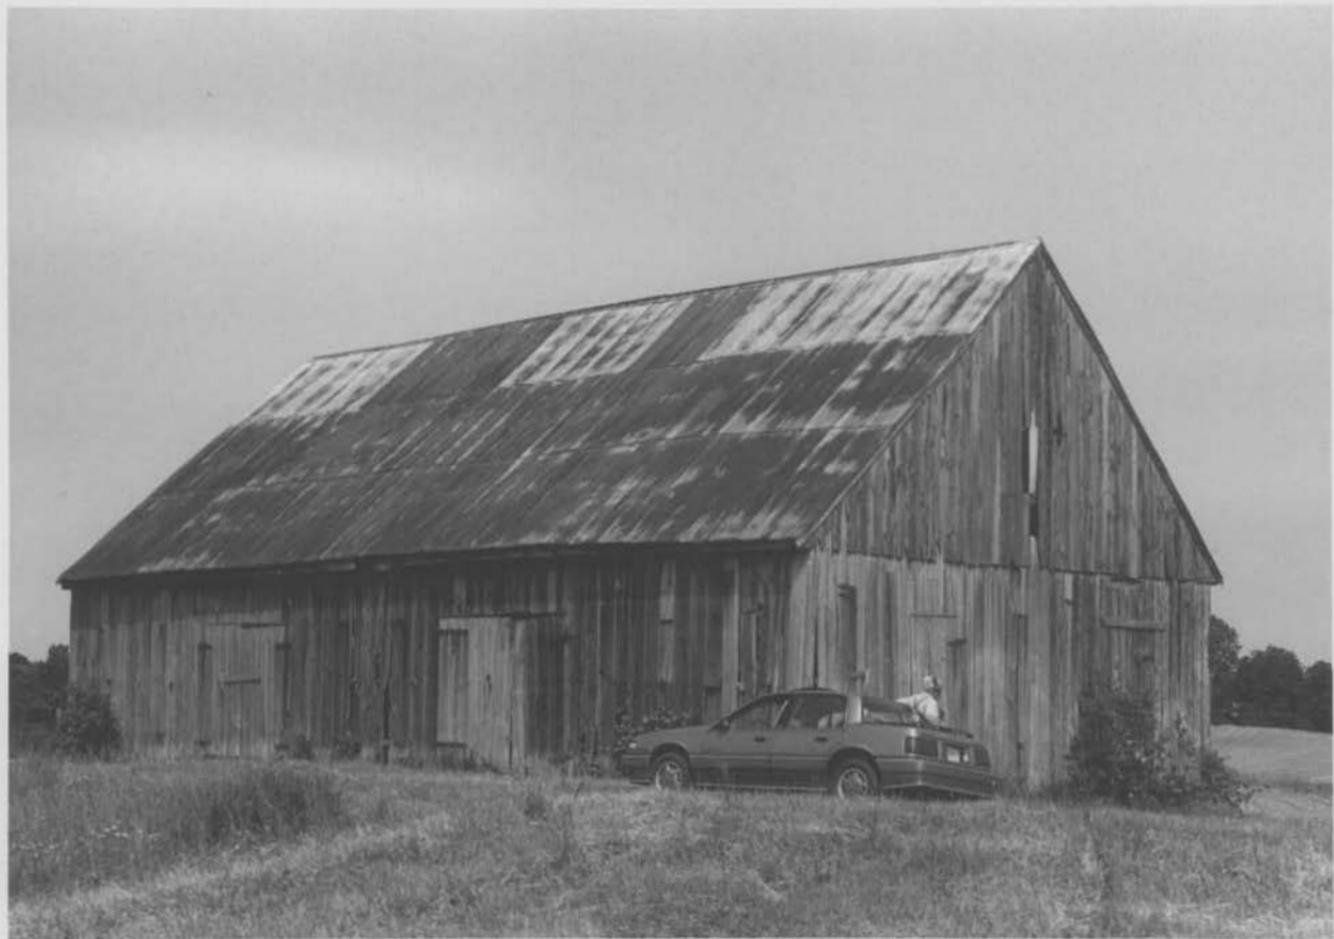
CT-1144

NORFOLK BARN 'C'

SOUTHEAST
